LINER INSPECTION AND CLOSURE REPORT

Spur Energy Partners
Stonewall 9 Fee #8H Battery
Incident ID: NAPP2134127547
Eddy County, NM

Paragon Environmental LLC
1601 N. TURNER ST. STE.500
Hobbs, NM 88240
575-964-7814

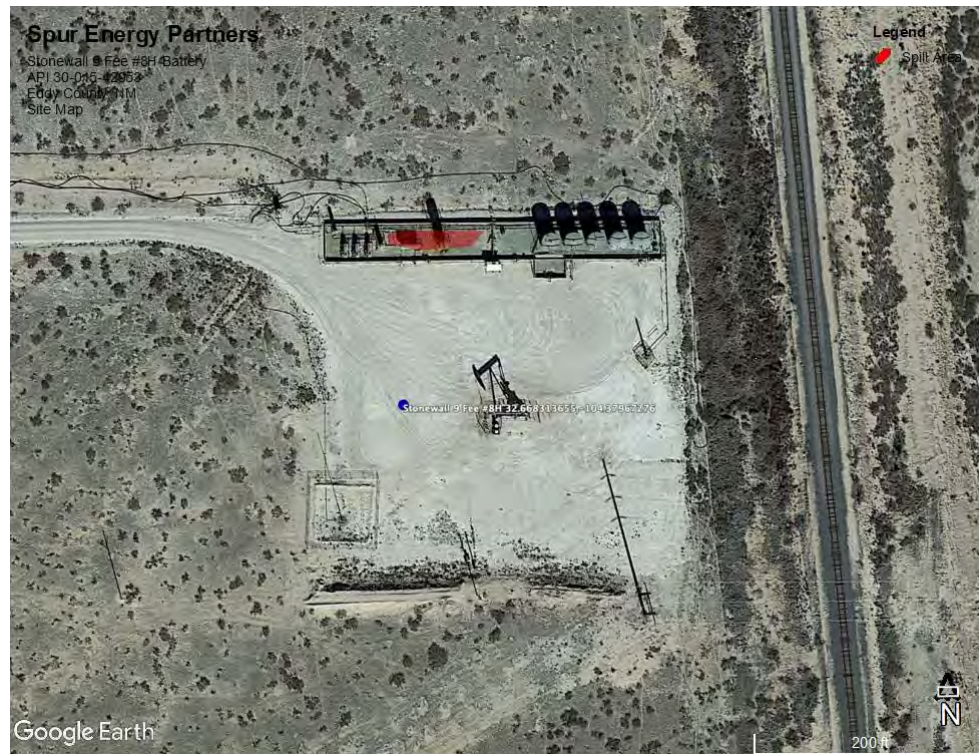
On July 12, 2022, Paragon went to the Stonewall and conducted an initial assessment. There was obvious staining on the liner from the spill. There was nothing outside the containment that showed any signs that the liner had been breached. Therefore, no samples were taken. See the site map below showing the affected area.

On July 29, 2022, Paragon returned to the site with equipment and personnel to conduct cleanup activities. We initially sprayed the affected area with surface cleaner. We then power washed and squeegeed the runoff to where the vacuum truck could capture the fluids.

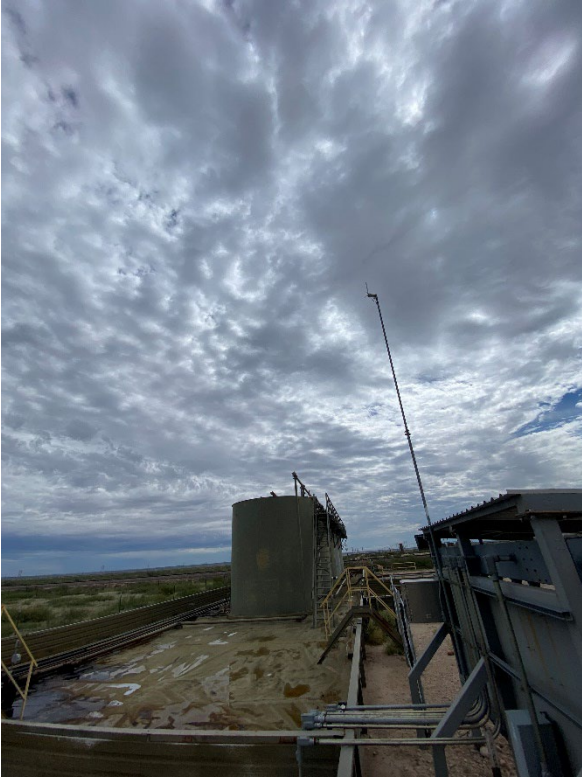
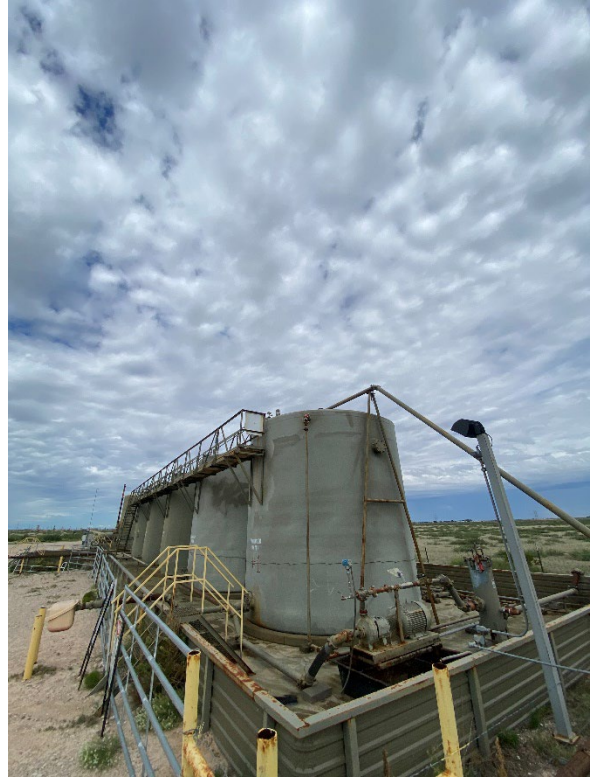
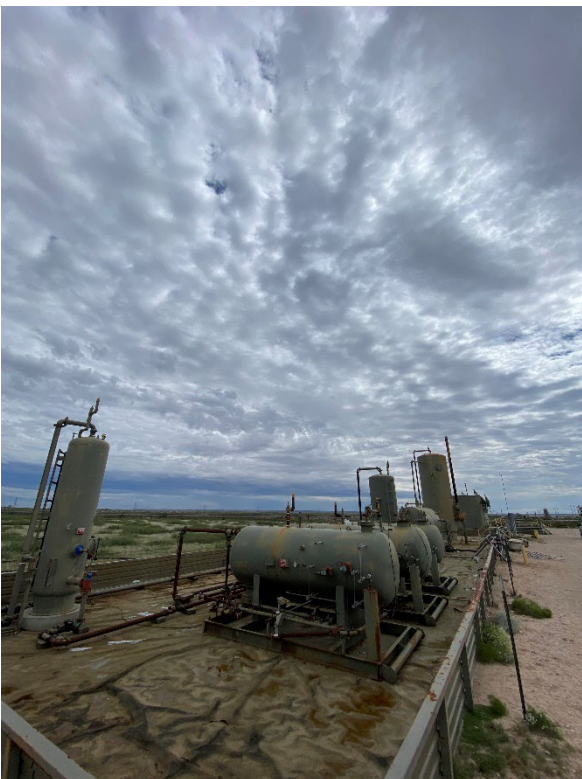
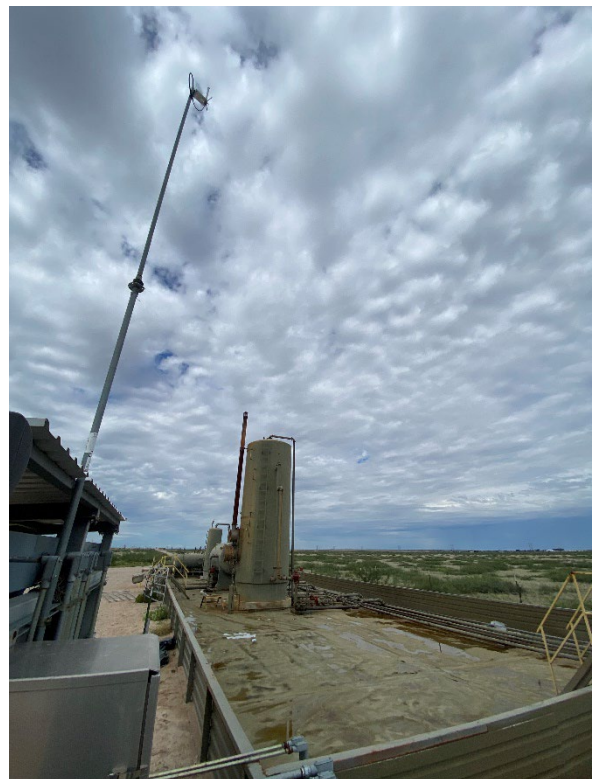
Liner Inspection

On August 6, 2022, Paragon returned to the site to conduct a liner inspection. A 48-hour notification was sent out to the NMOCD on August 3, 2022. The liner inspection concluded that the liner was all intact and in good condition. The integrity of the liner appears to have the ability to contain spills. See Appendix D for the email notification and liner report.

Visualization	Yes	No	Comments
Is there a tear in the liner?		x	
Are there holes in the liner?		x	
Is the liner retaining any fluids?		x	
Does the liner have integrity to contain a leak?	x
