PHASE II ENVIRONMENTAL SAMPLING ASSESSMENT

EnerVest Operating, LLC

Abalone “AMB” State #1 Tank Battery
(Saltwater and oil release from separator)

February 24TH, 2012

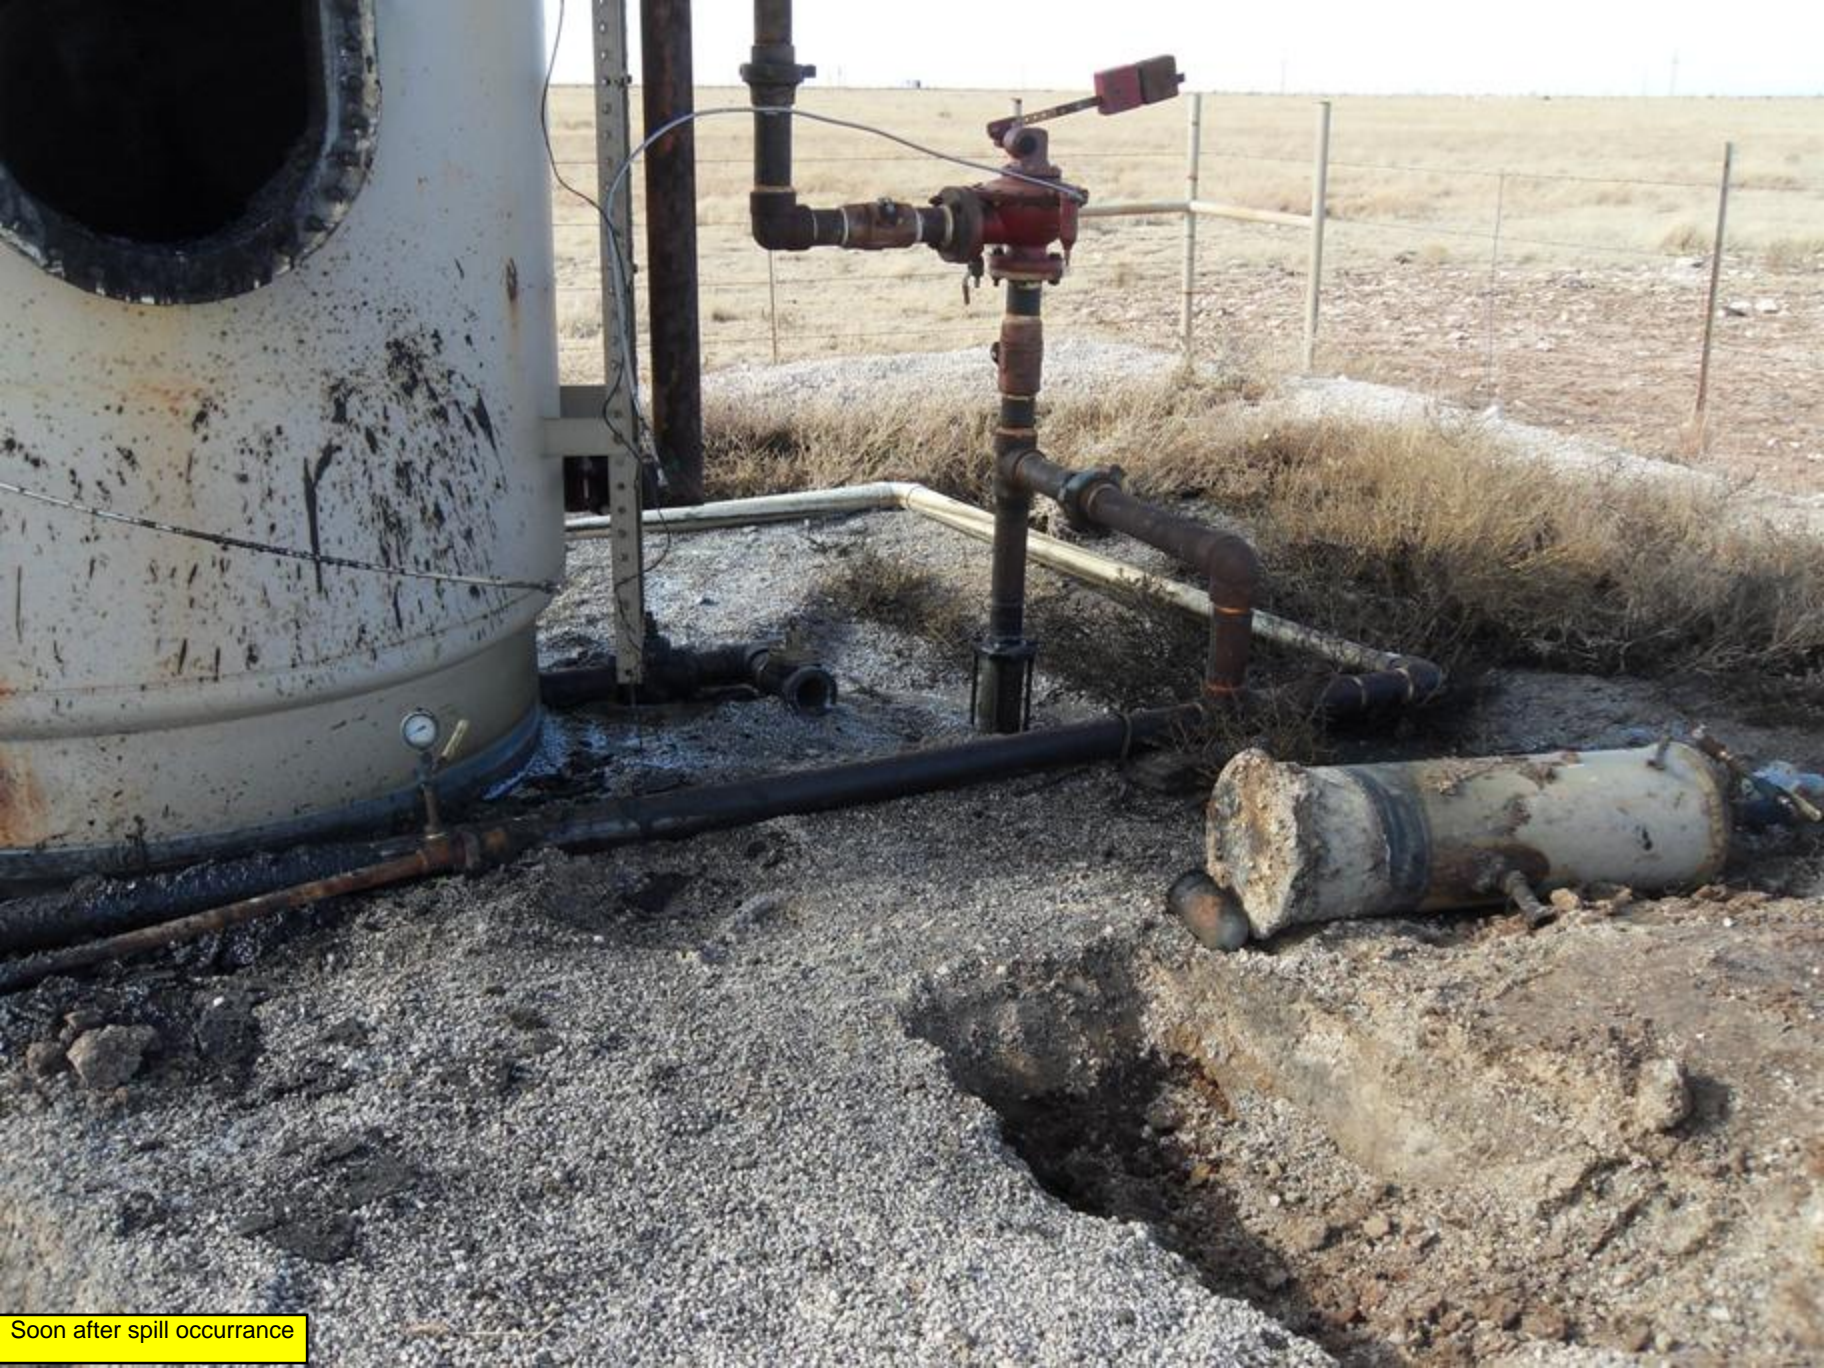
Soon after spill occurrence

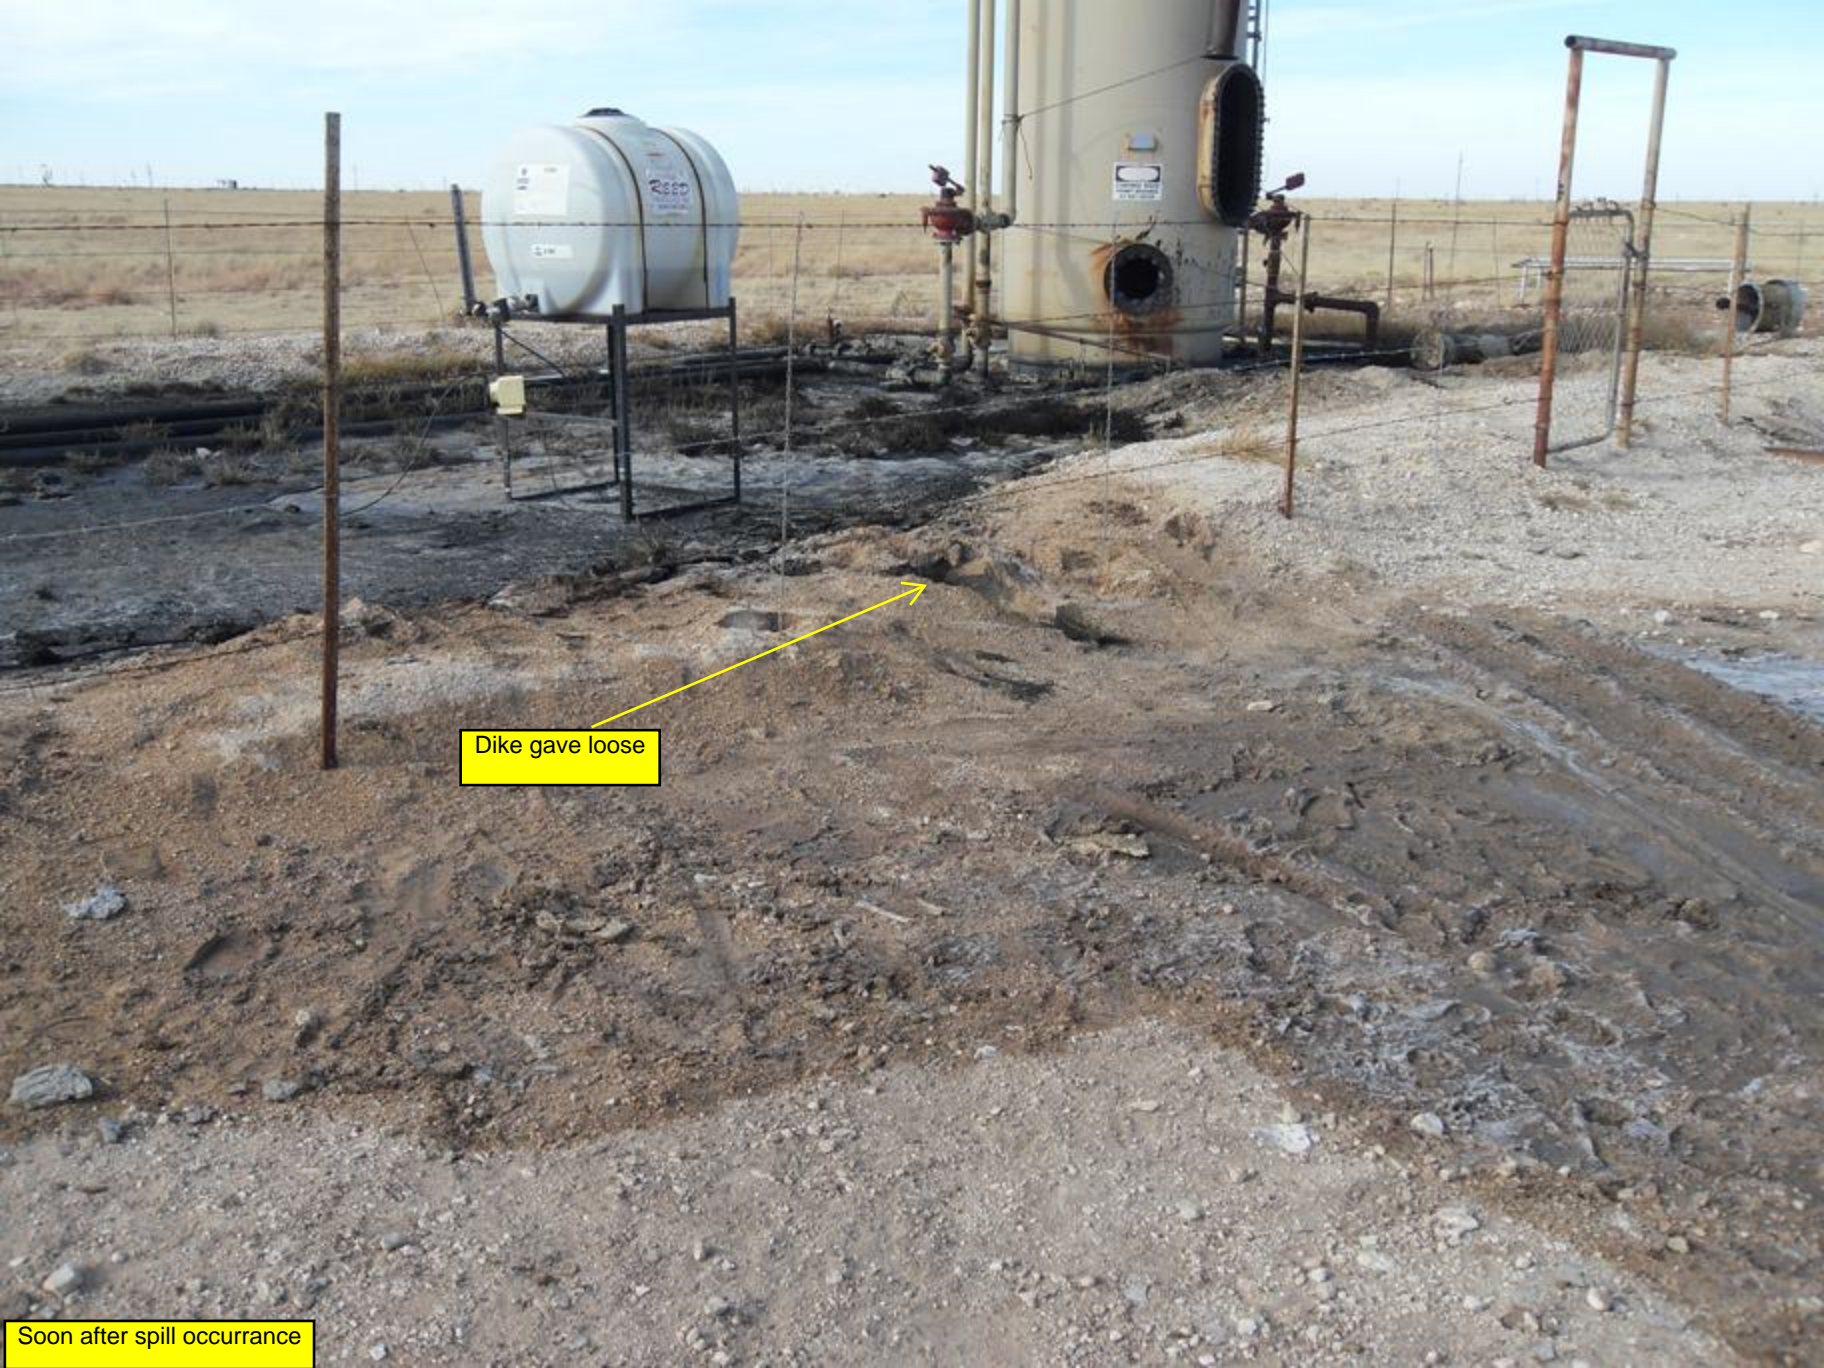
Dike gave loose

Soon after spill occurrence

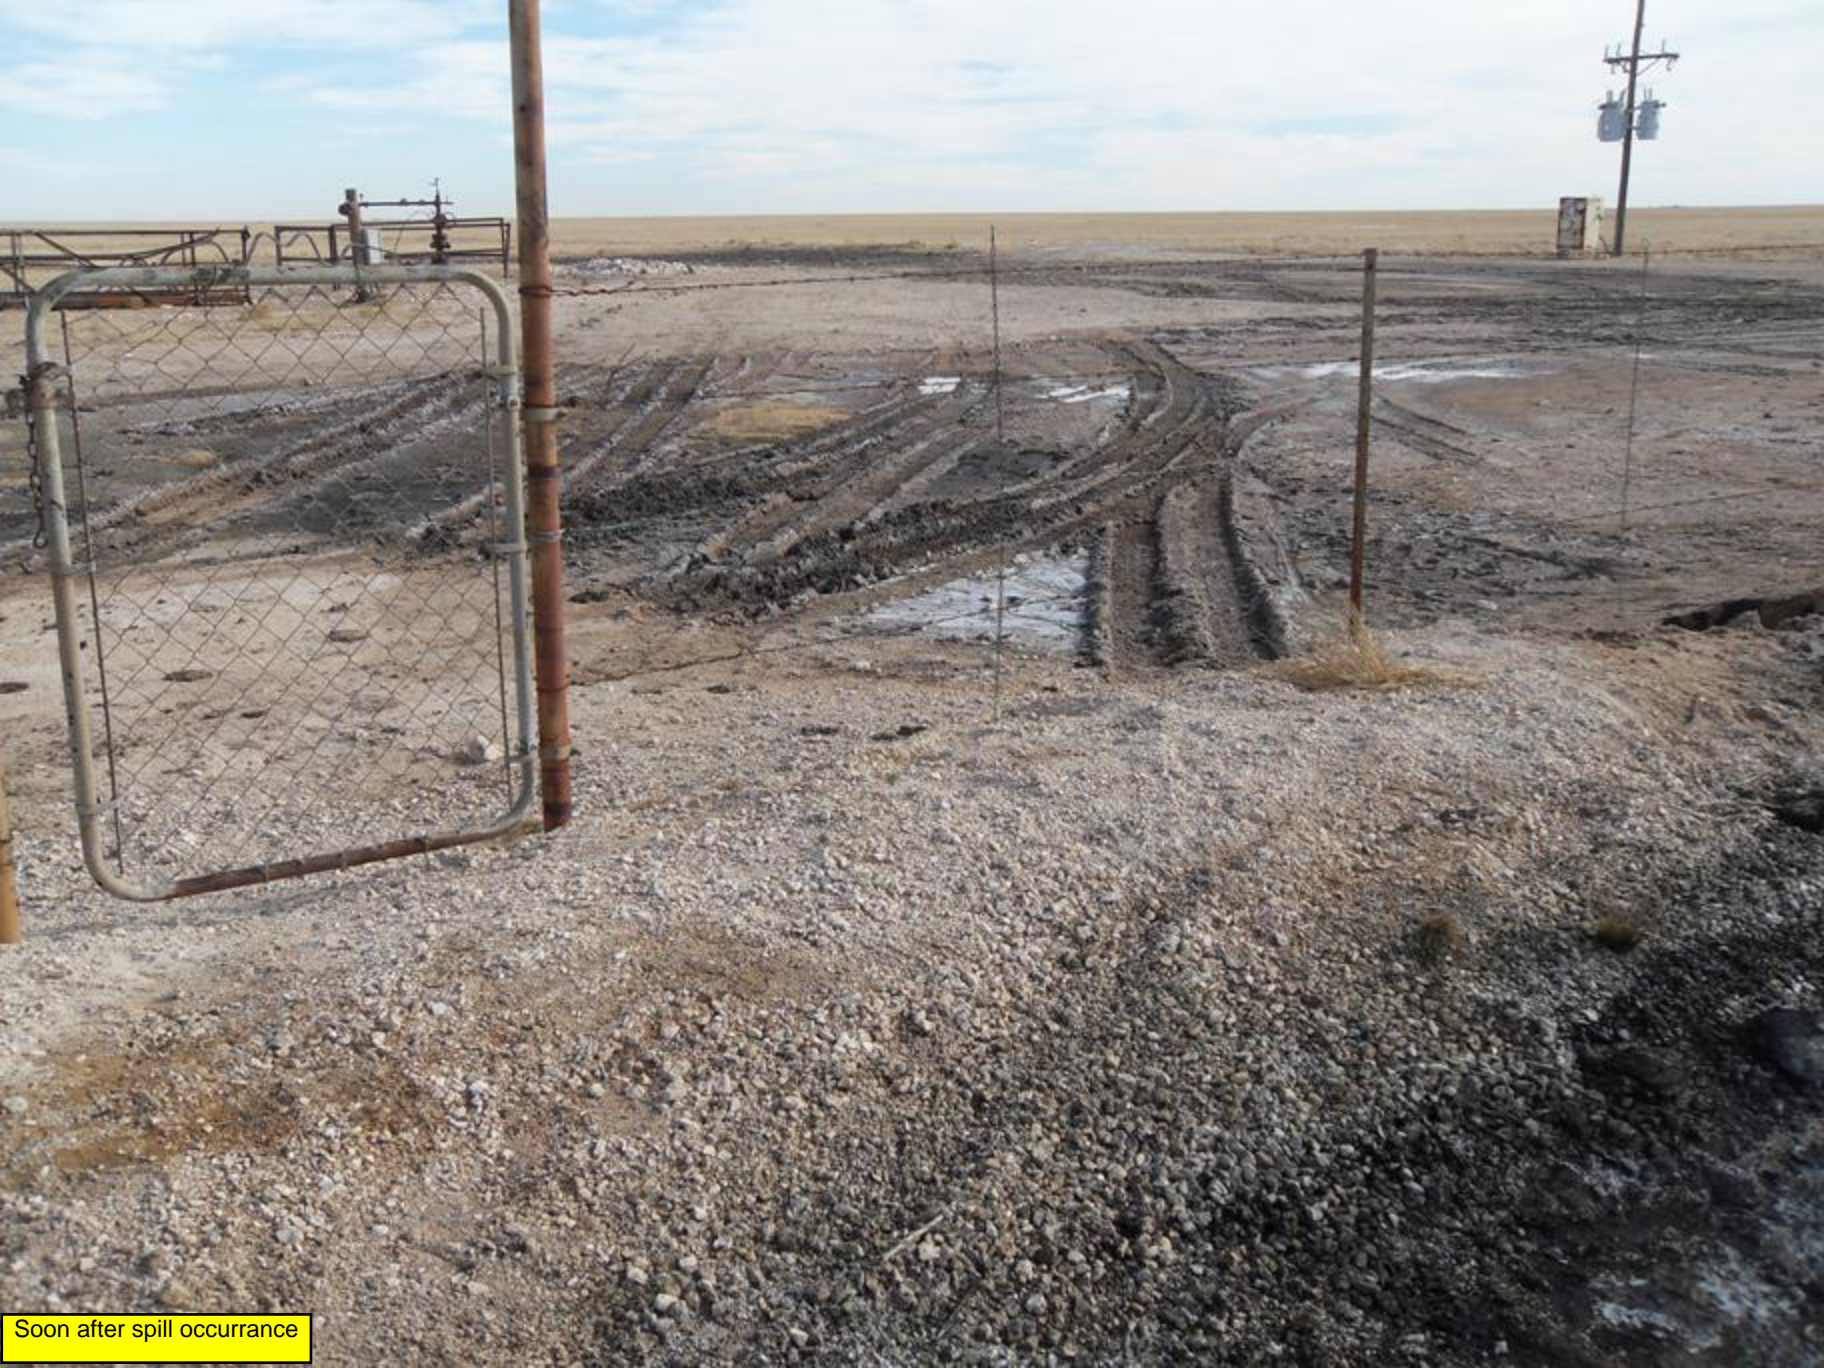
Soon after spill occurrence

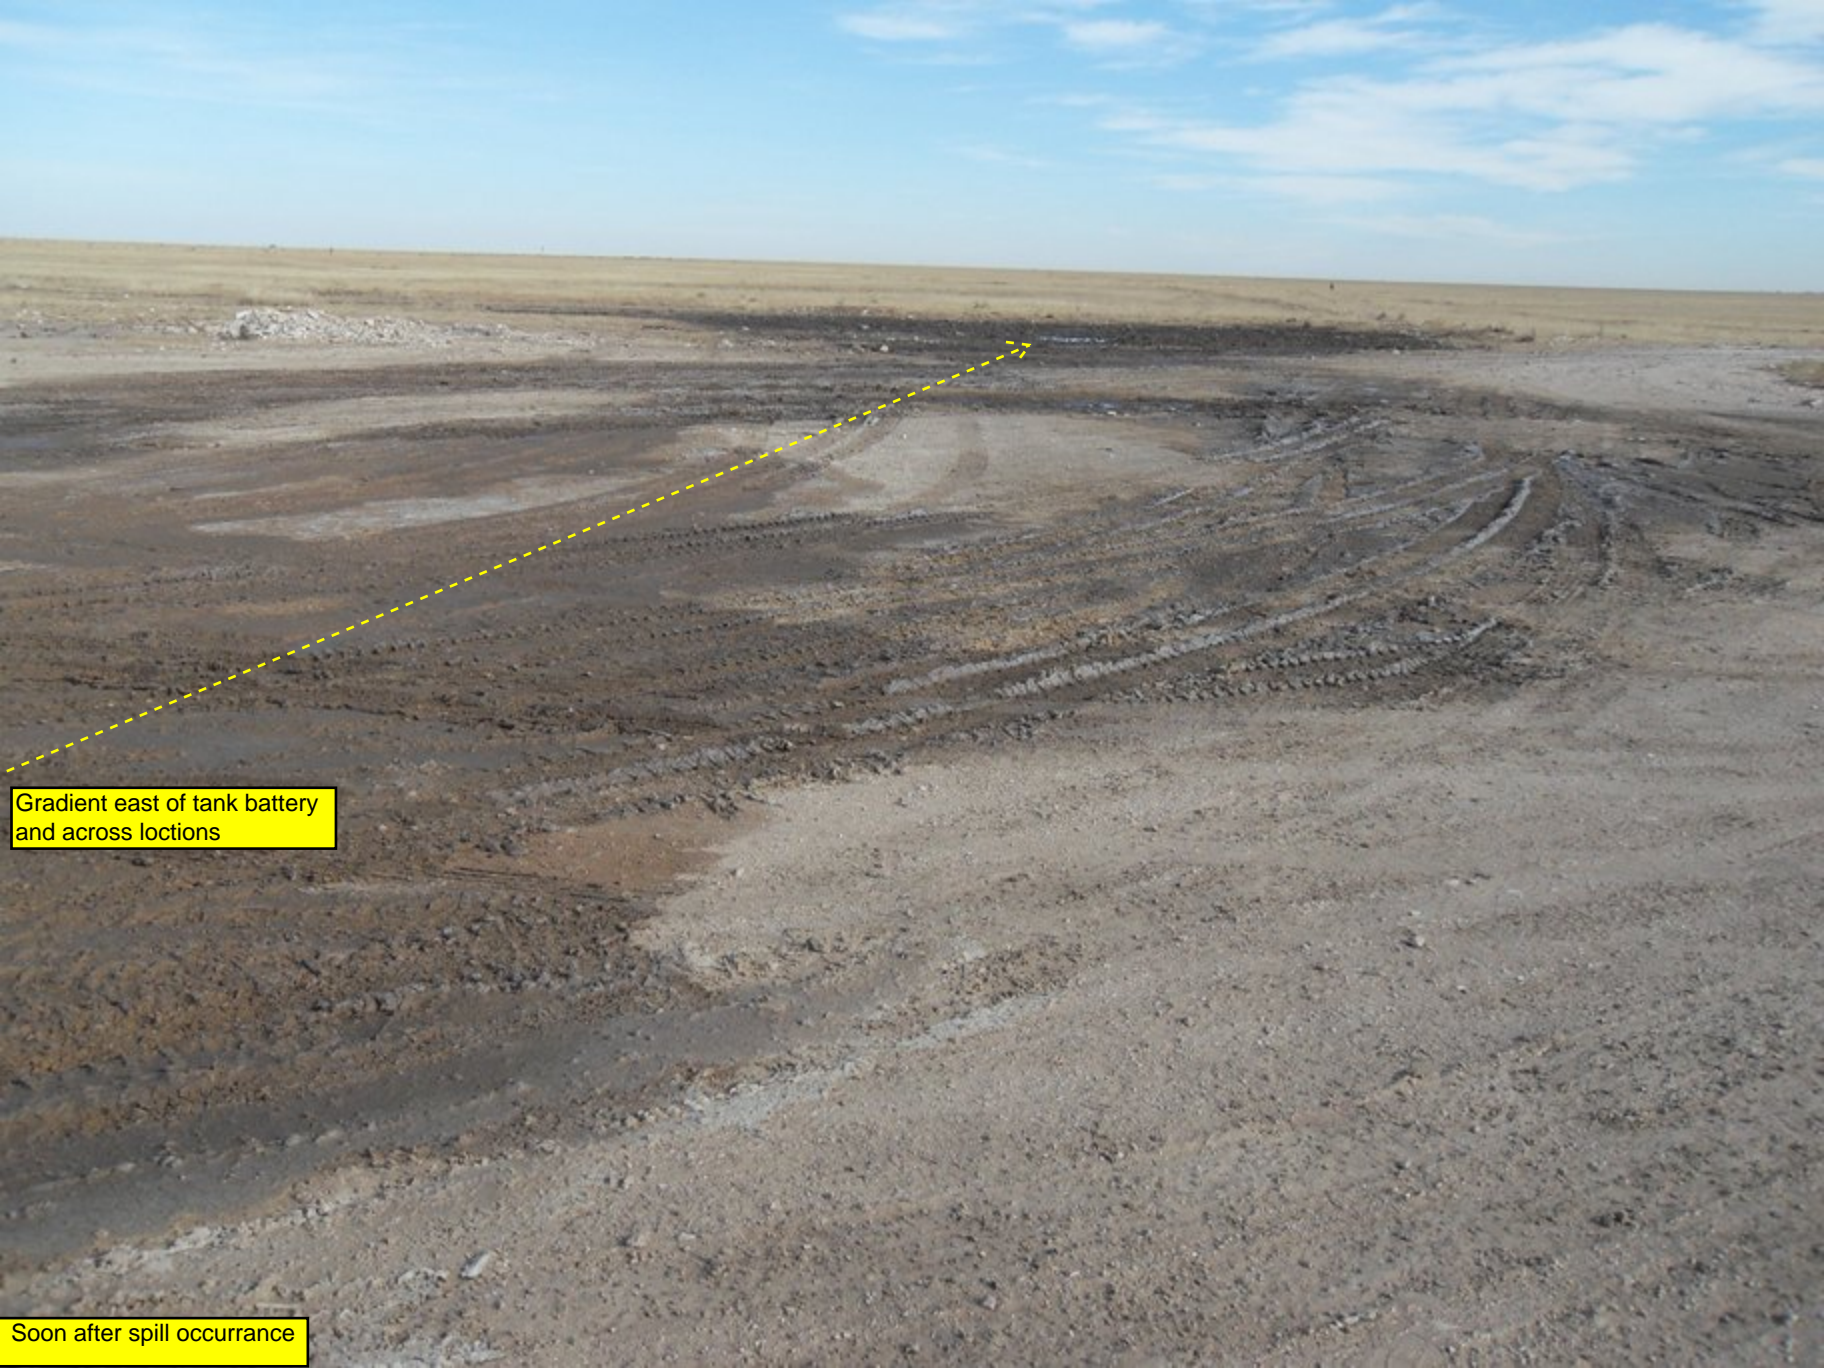
Gradient east of tank battery
and across locations

Soon after spill occurrence

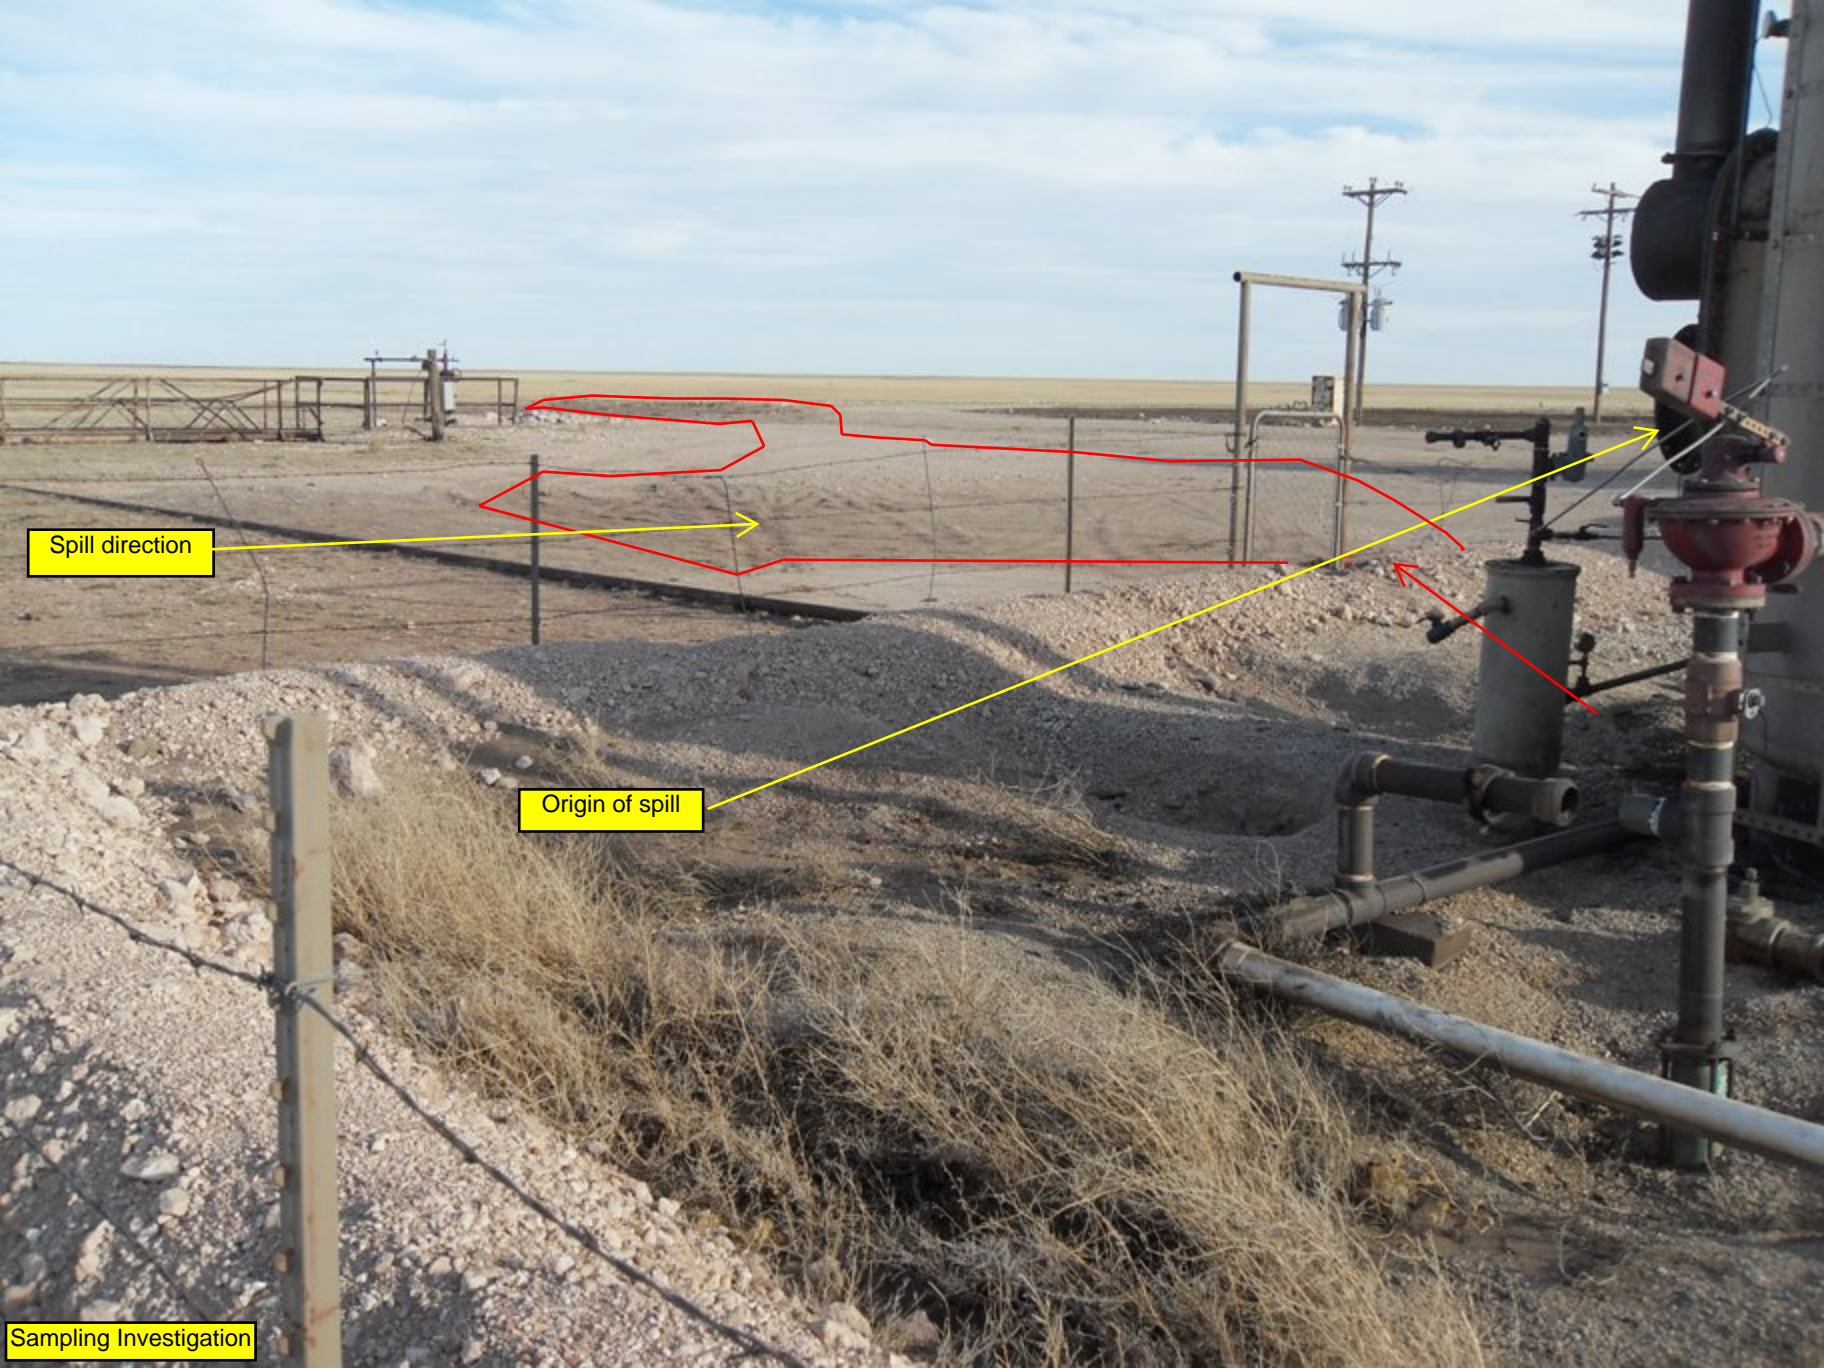
Spill direction

Origin of spill

Origin of spill - separator developed a leak. The dike and separator were repaired immediately.
