**RE: EnerVest Operating, LLC**

Field evaluation for spill occurrence  
on 7/24/14  
Blue Quail Federal #1  
Sharbro Federal #1

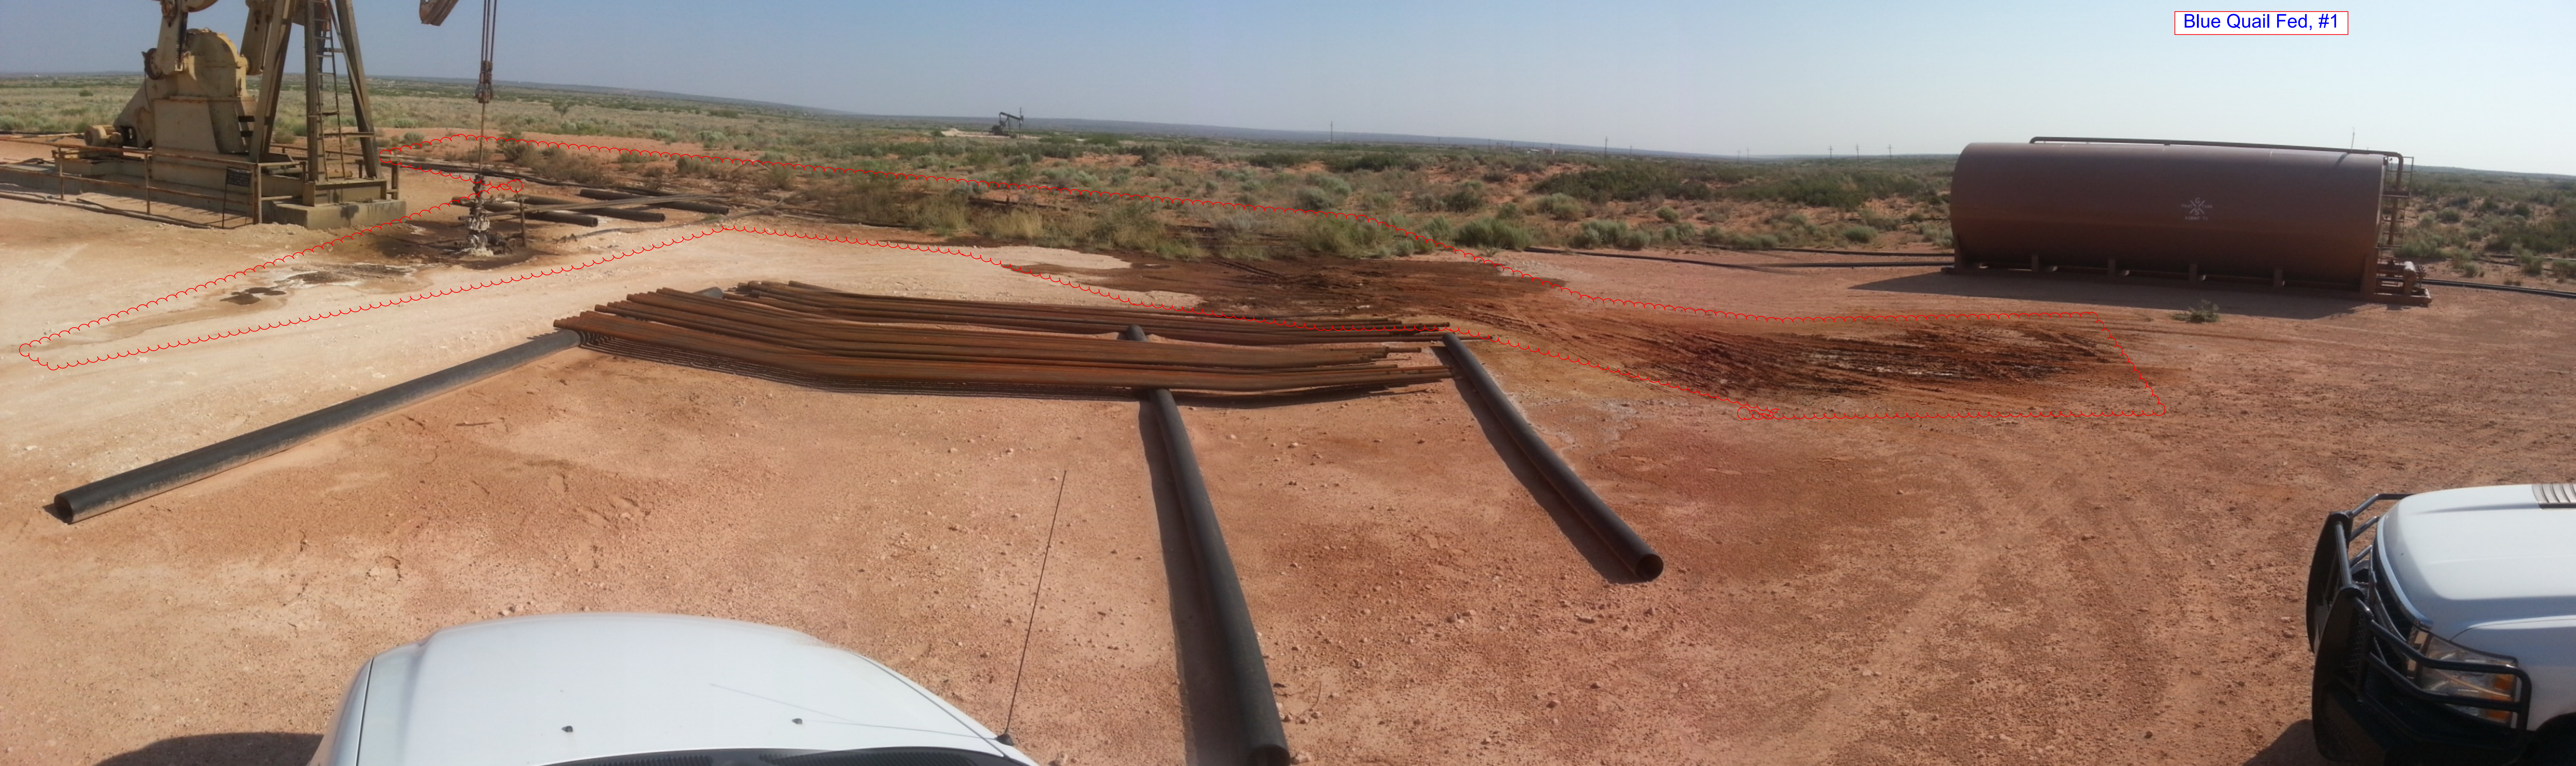
East side of spill area

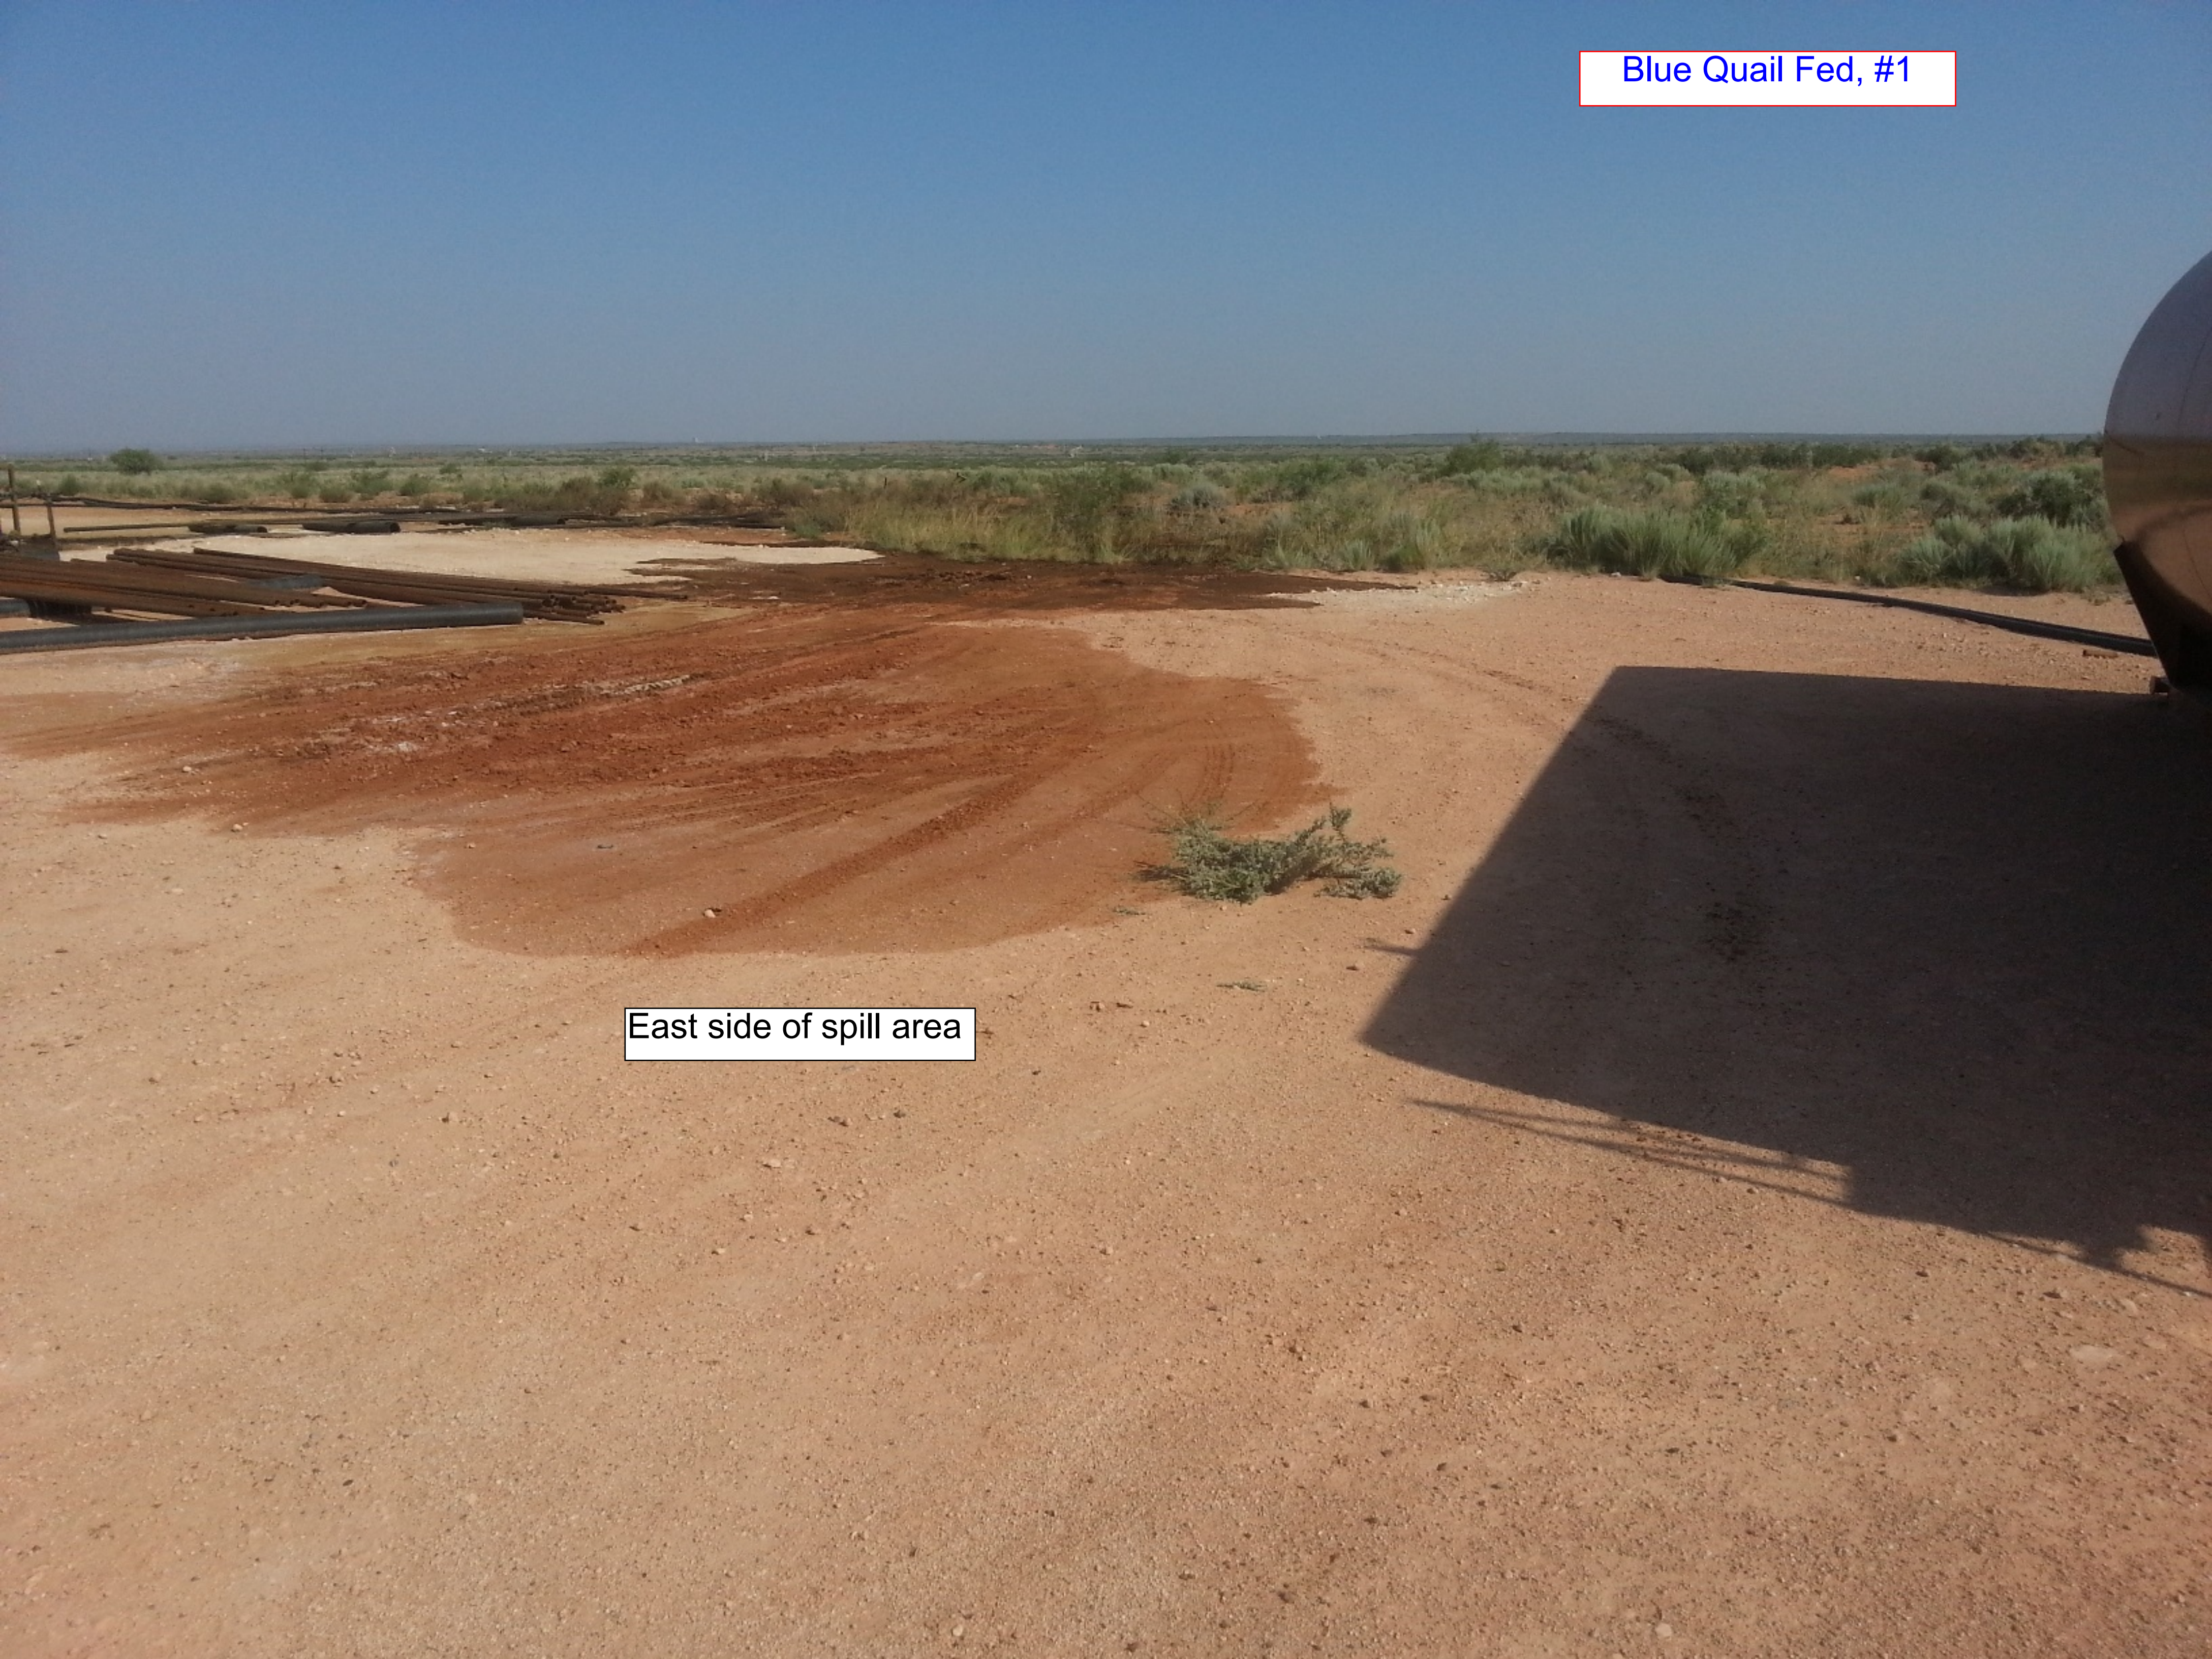
North of location spill area.  
Approximately 45' off caliche  
pad and 100' long.

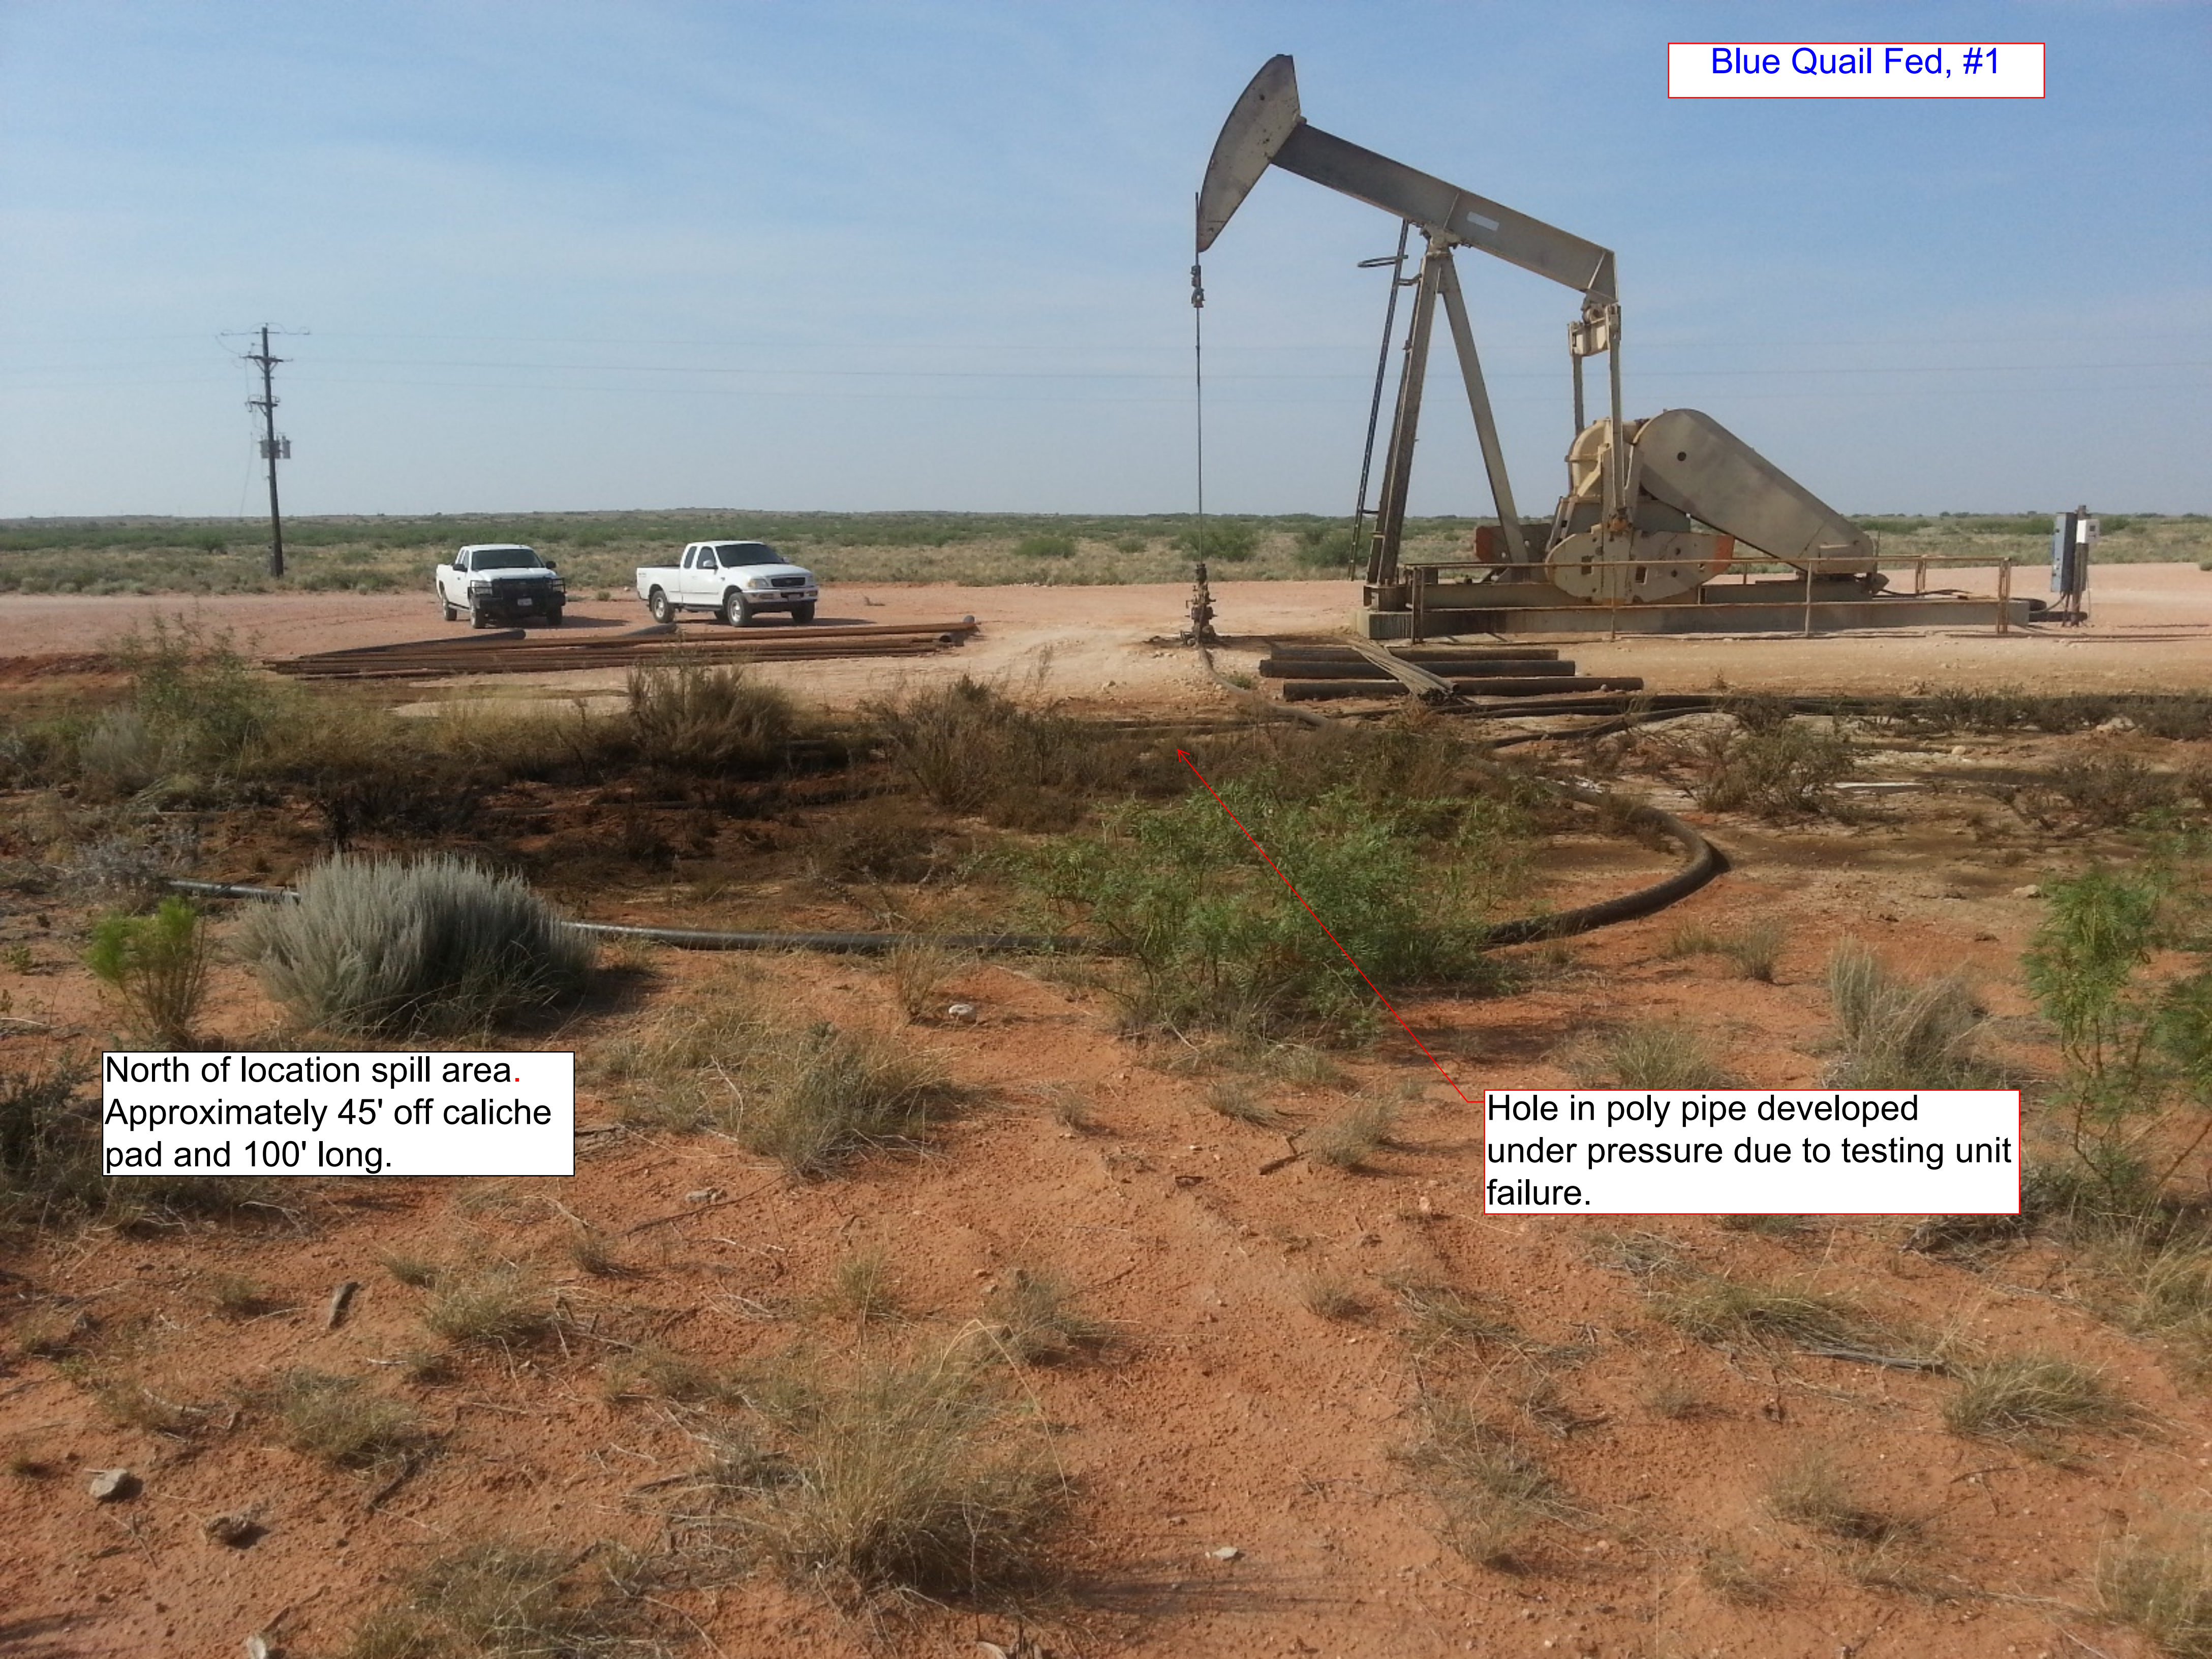
Hole in poly pipe developed  
under pressure due to testing unit  
failure.

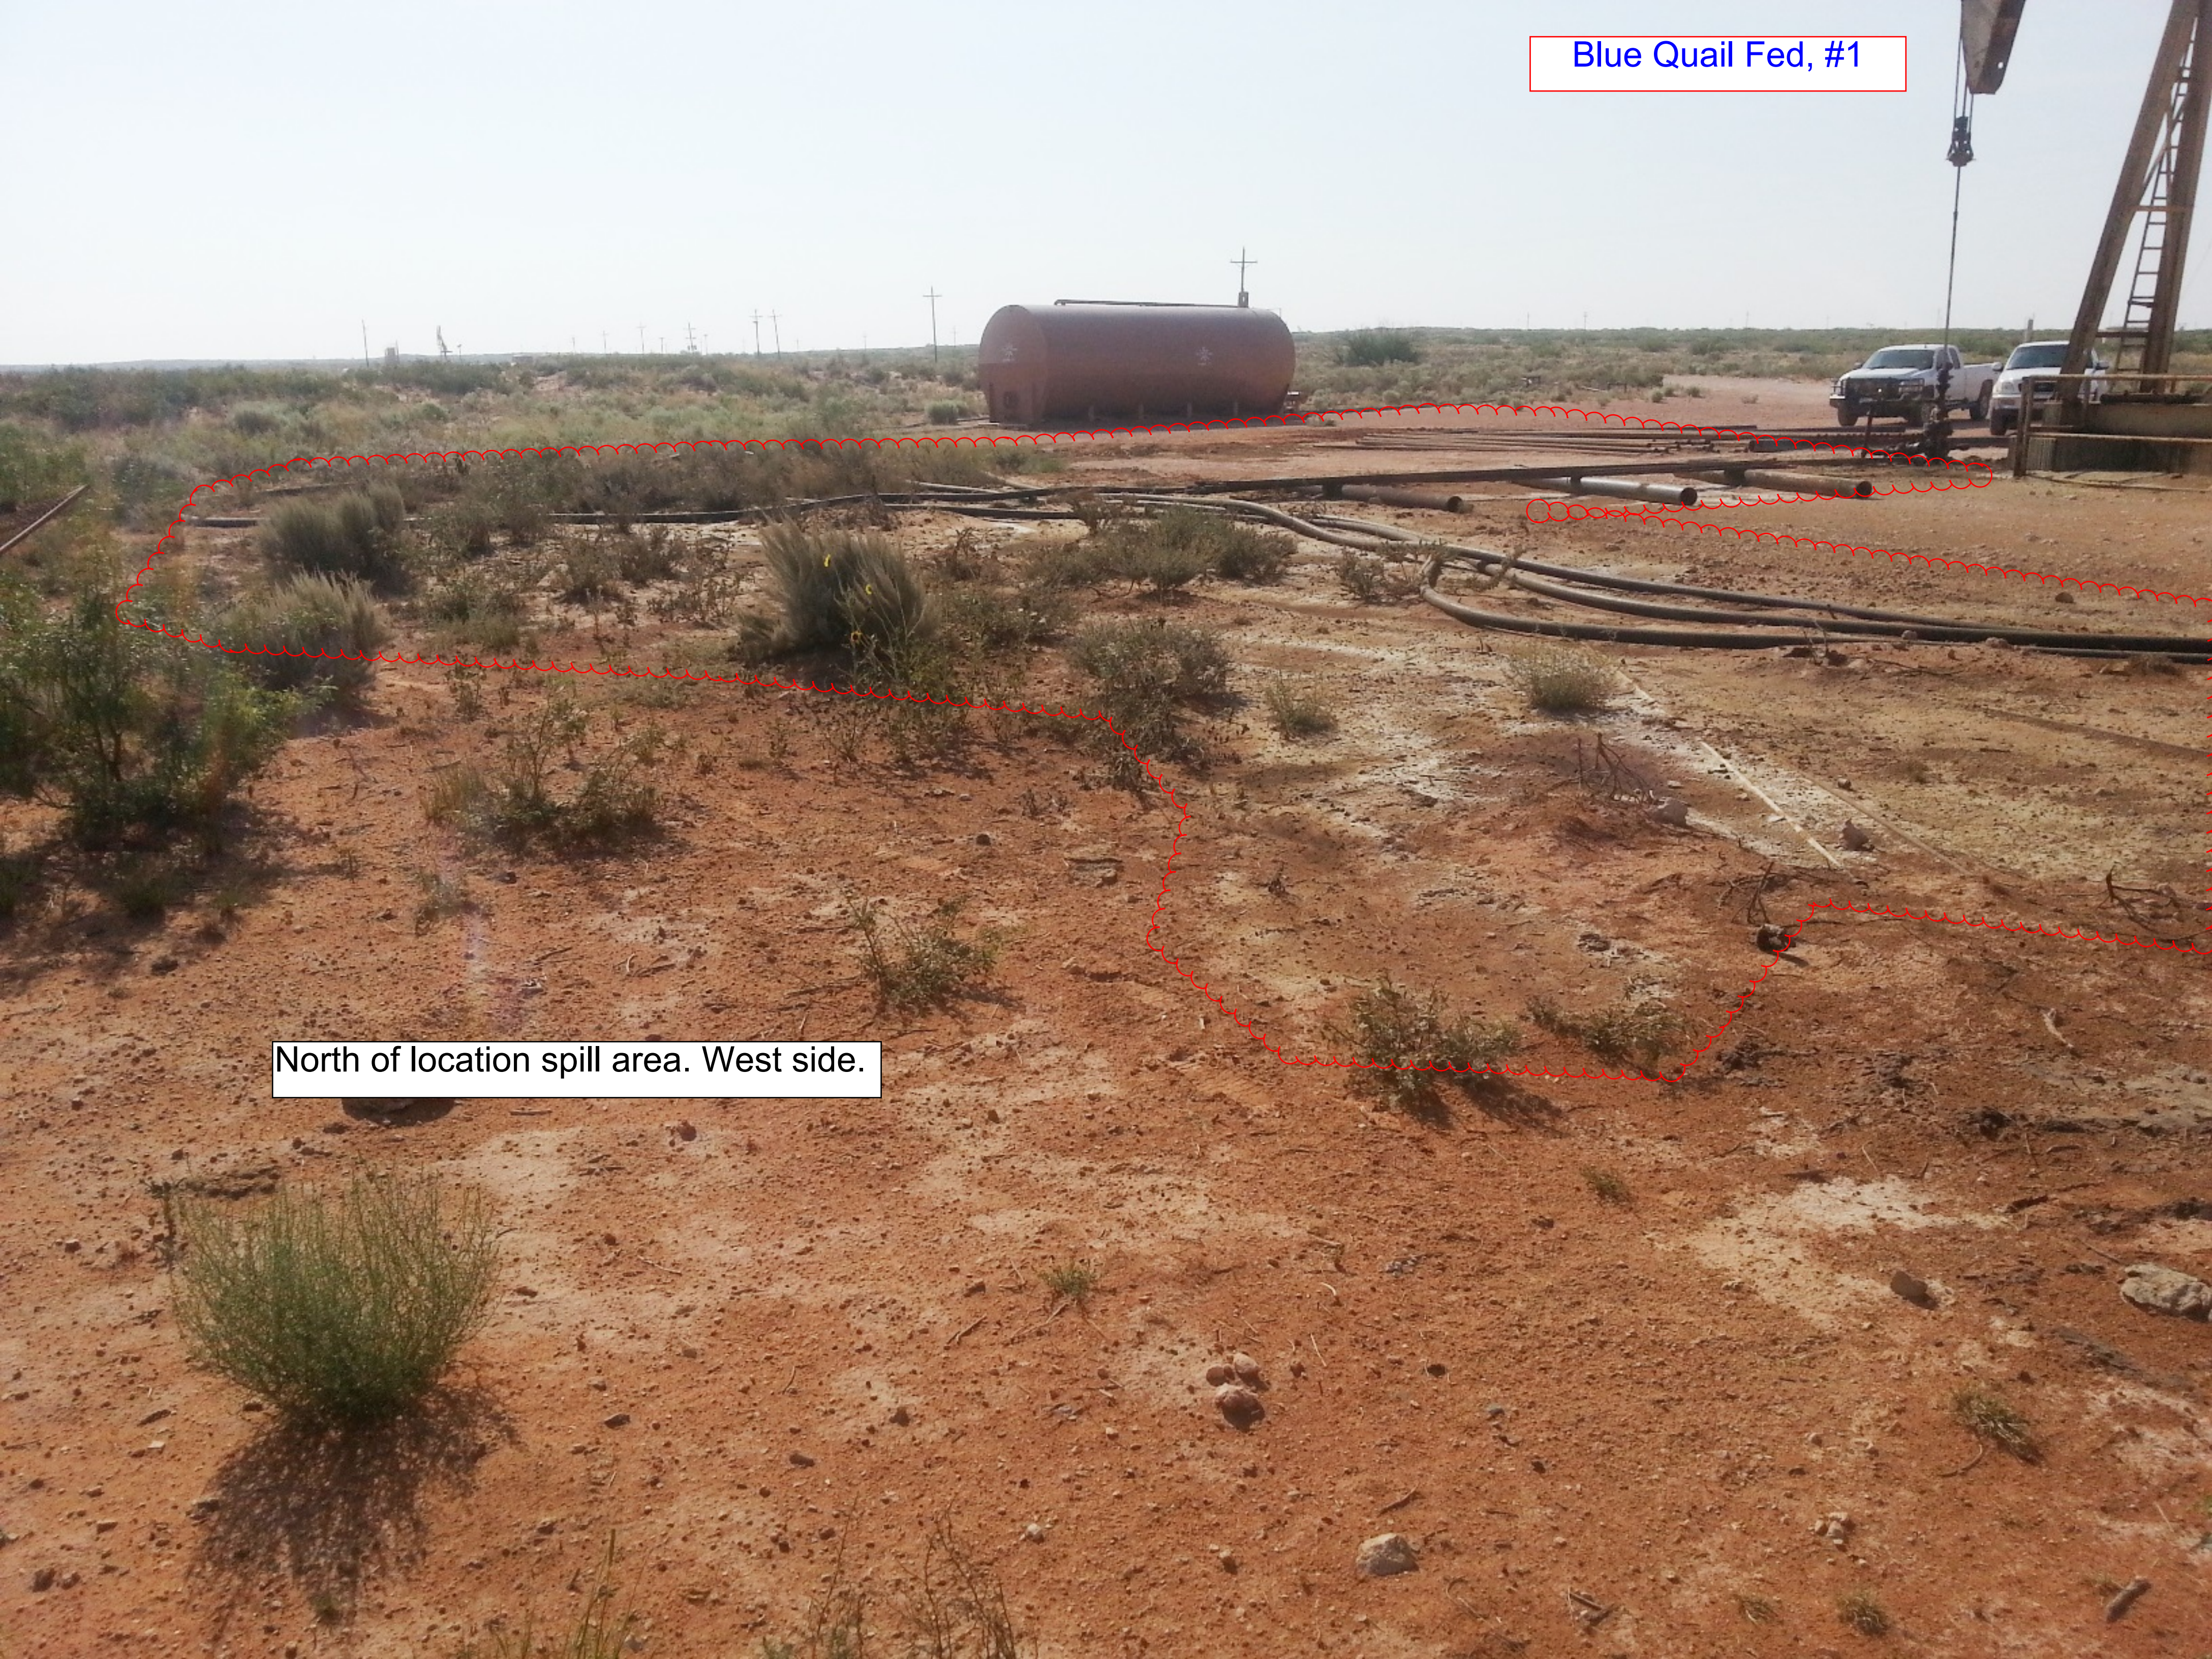
North of location spill area. West side.

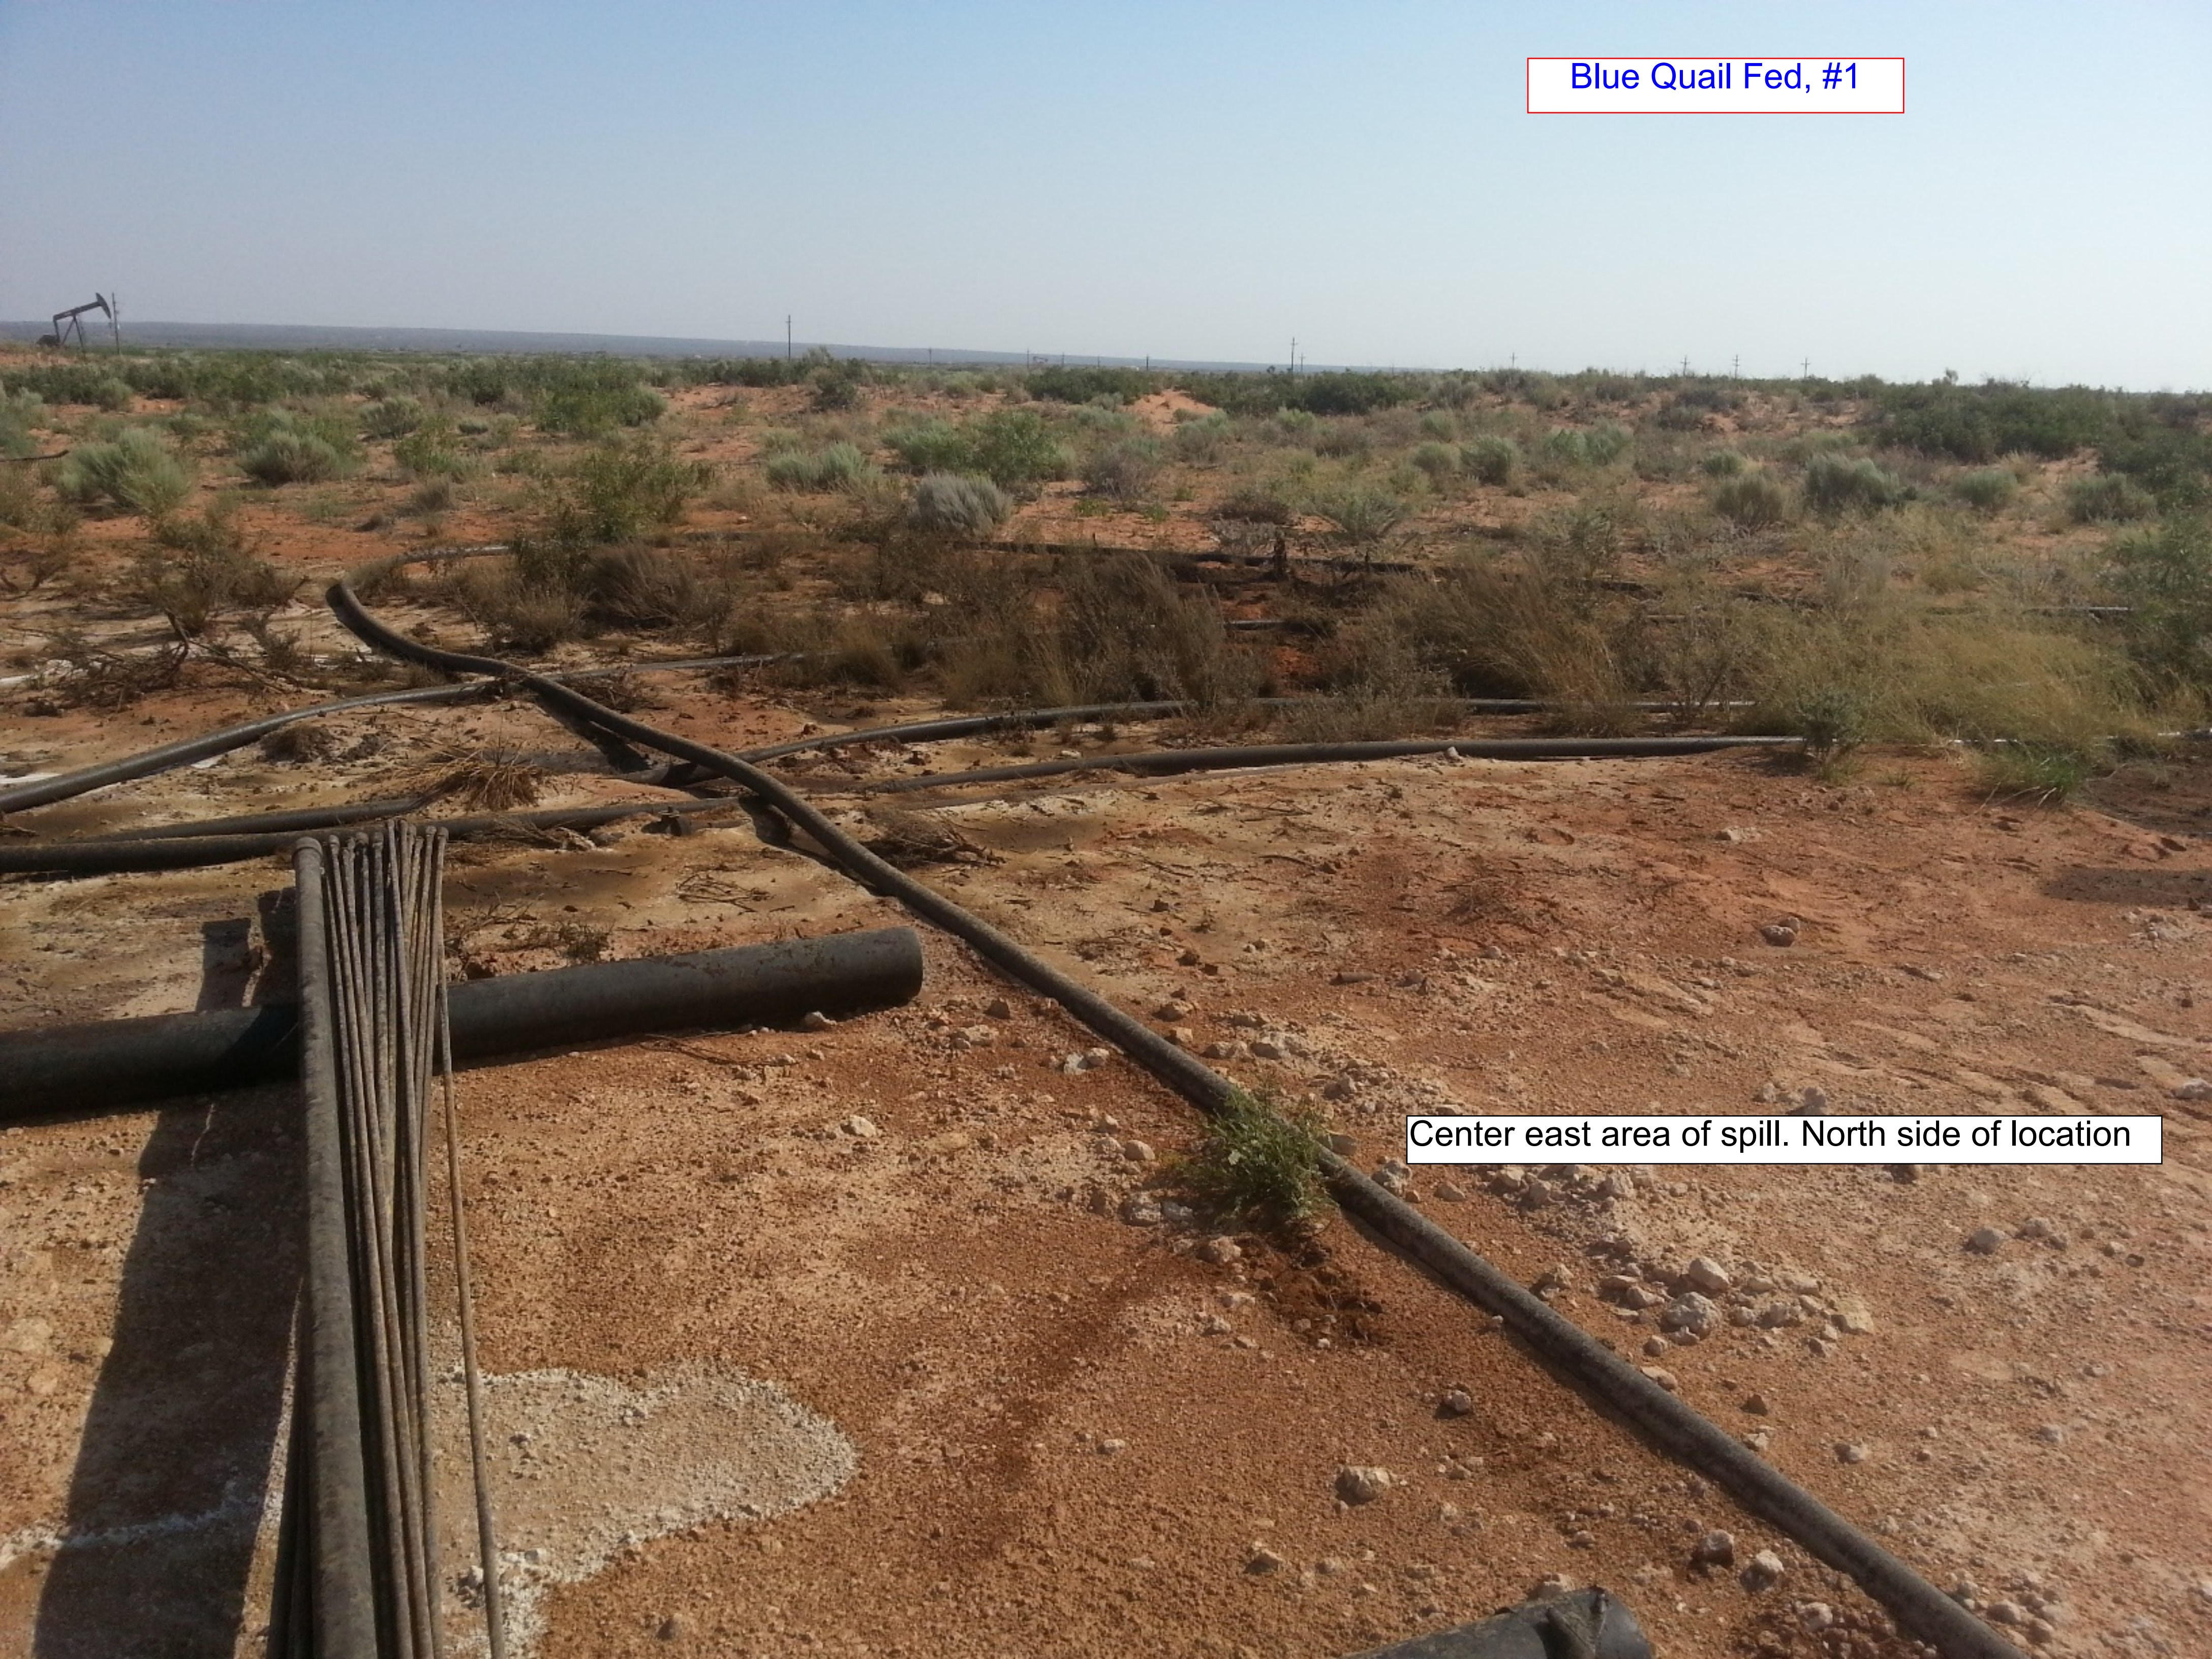
Well head developed leak under pressure.

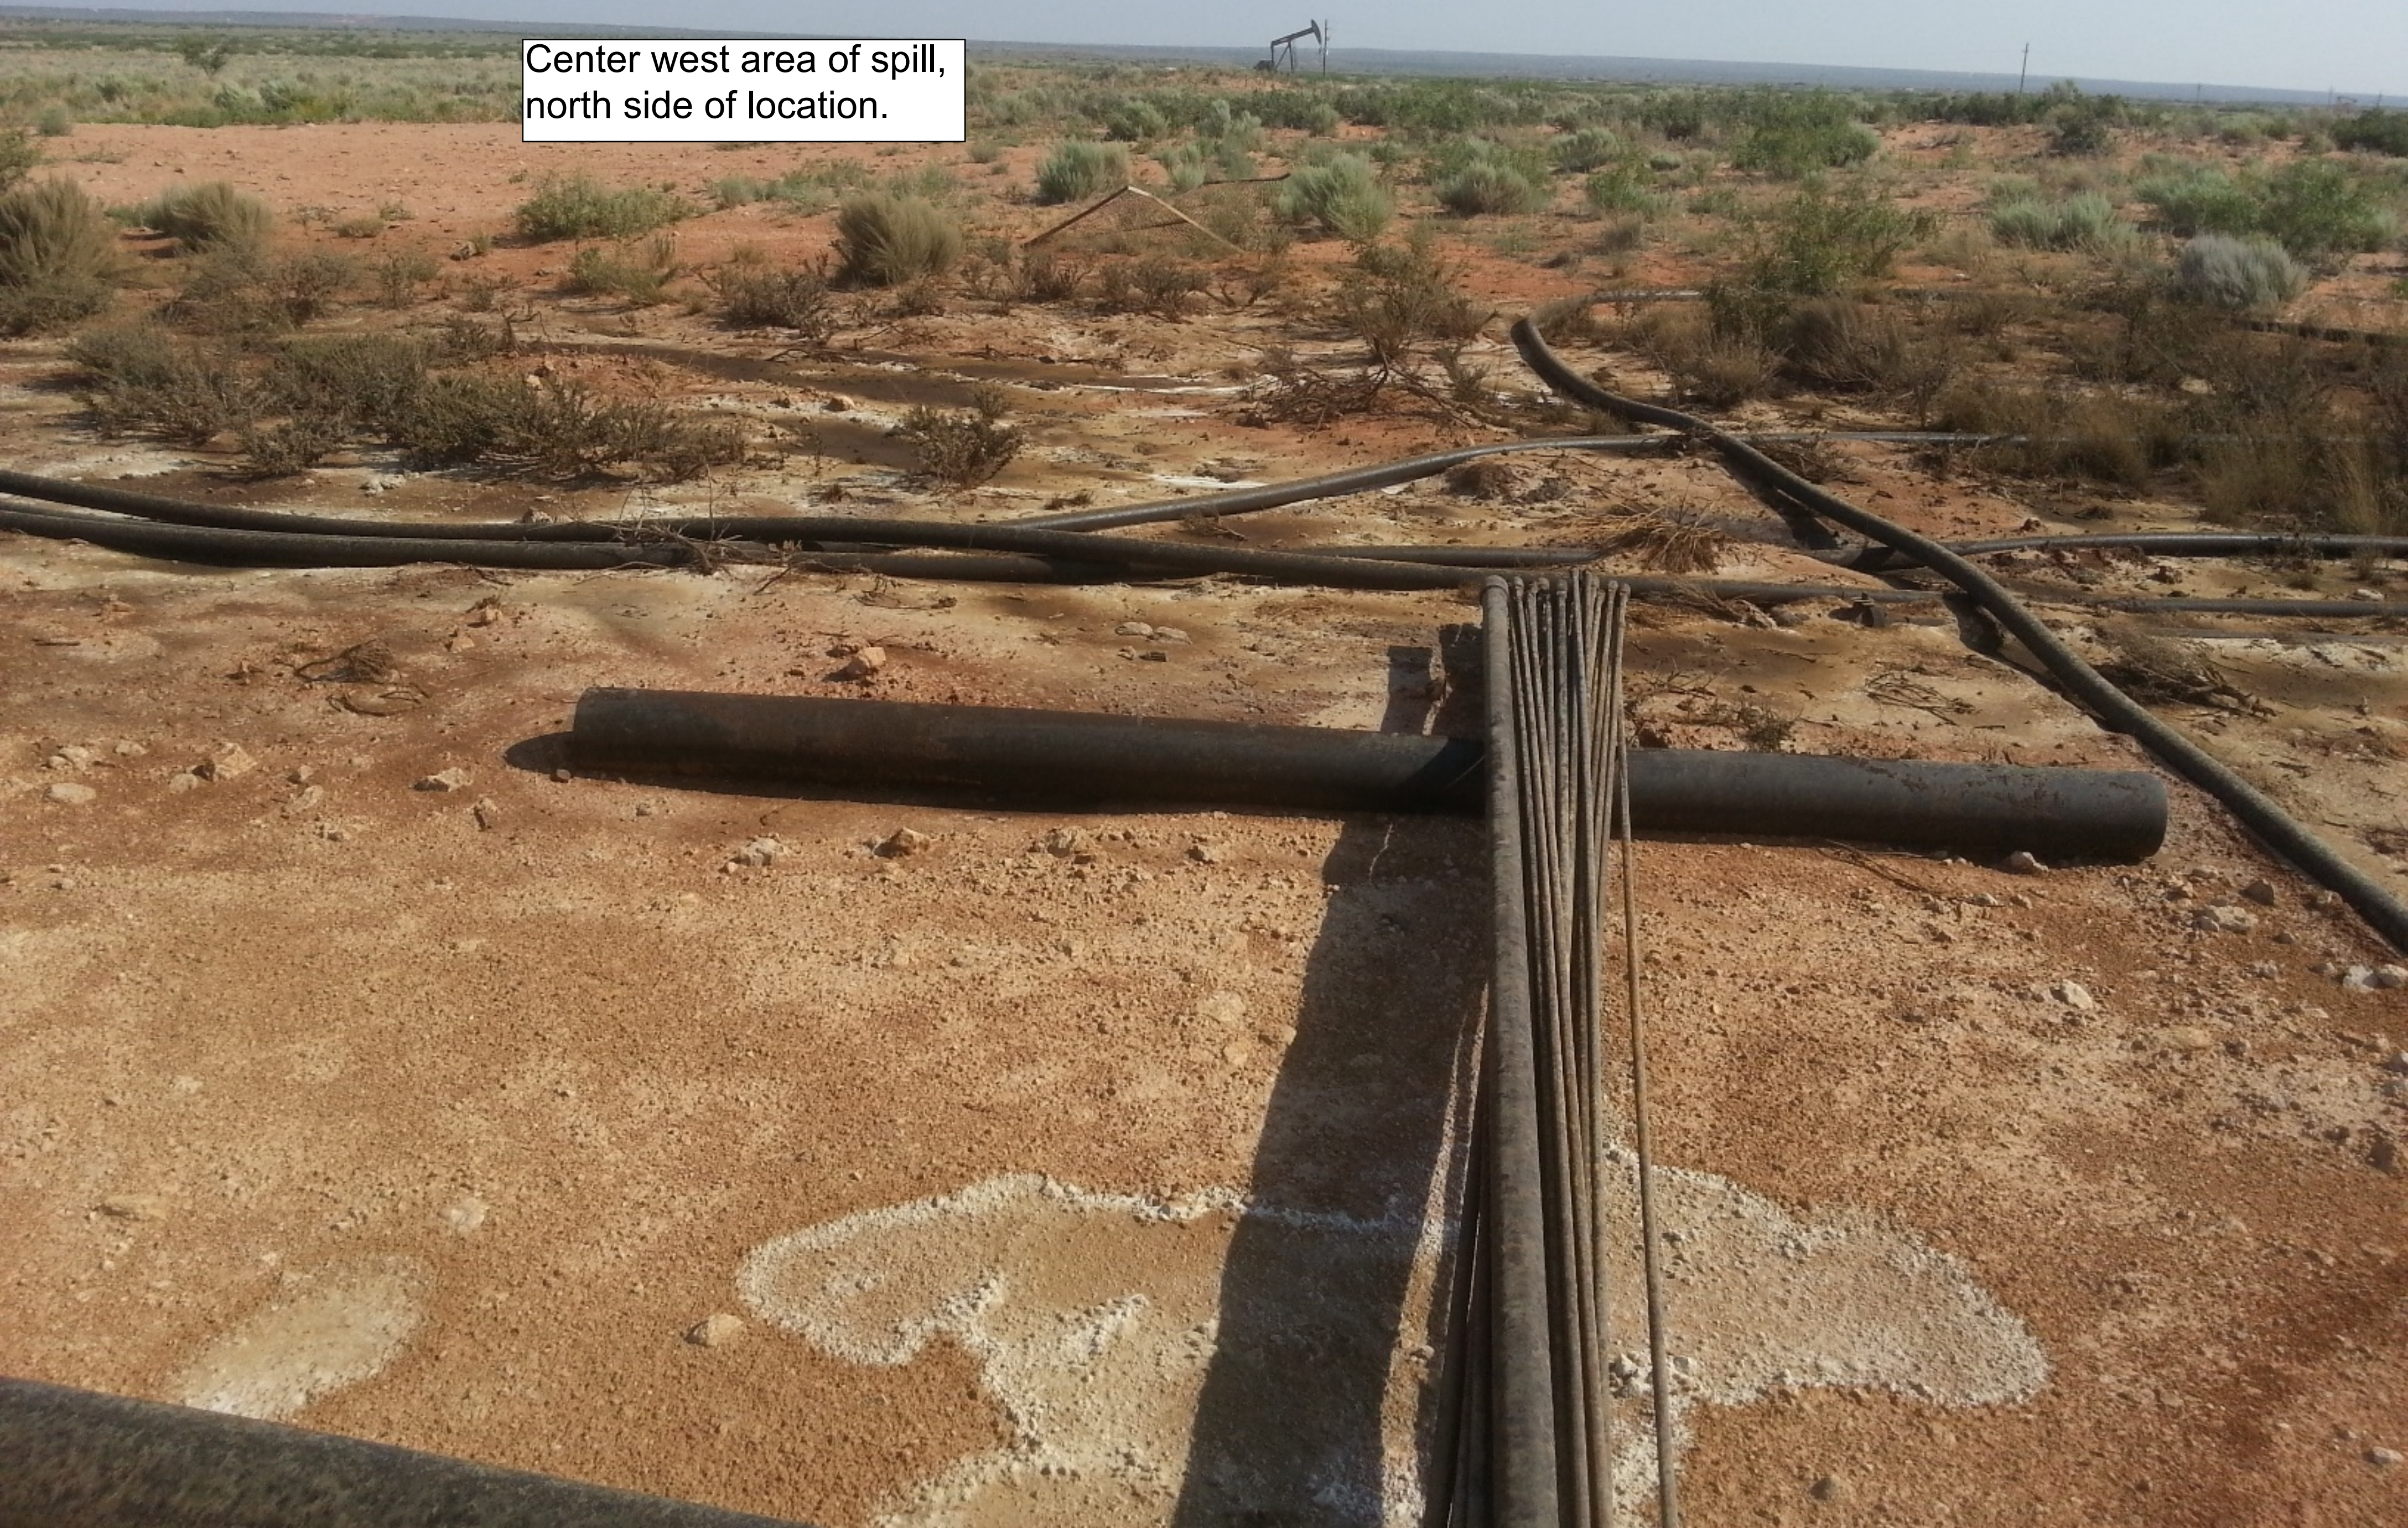
Center east area of spill. North side of location

Center west area of spill,  
north side of location.
