**RE: EnerVest Operating, LLC**

Field evaluation for spill occurrence  
on 7/24/14  
Blue Quail Federal #1  
Sharbro Federal #1

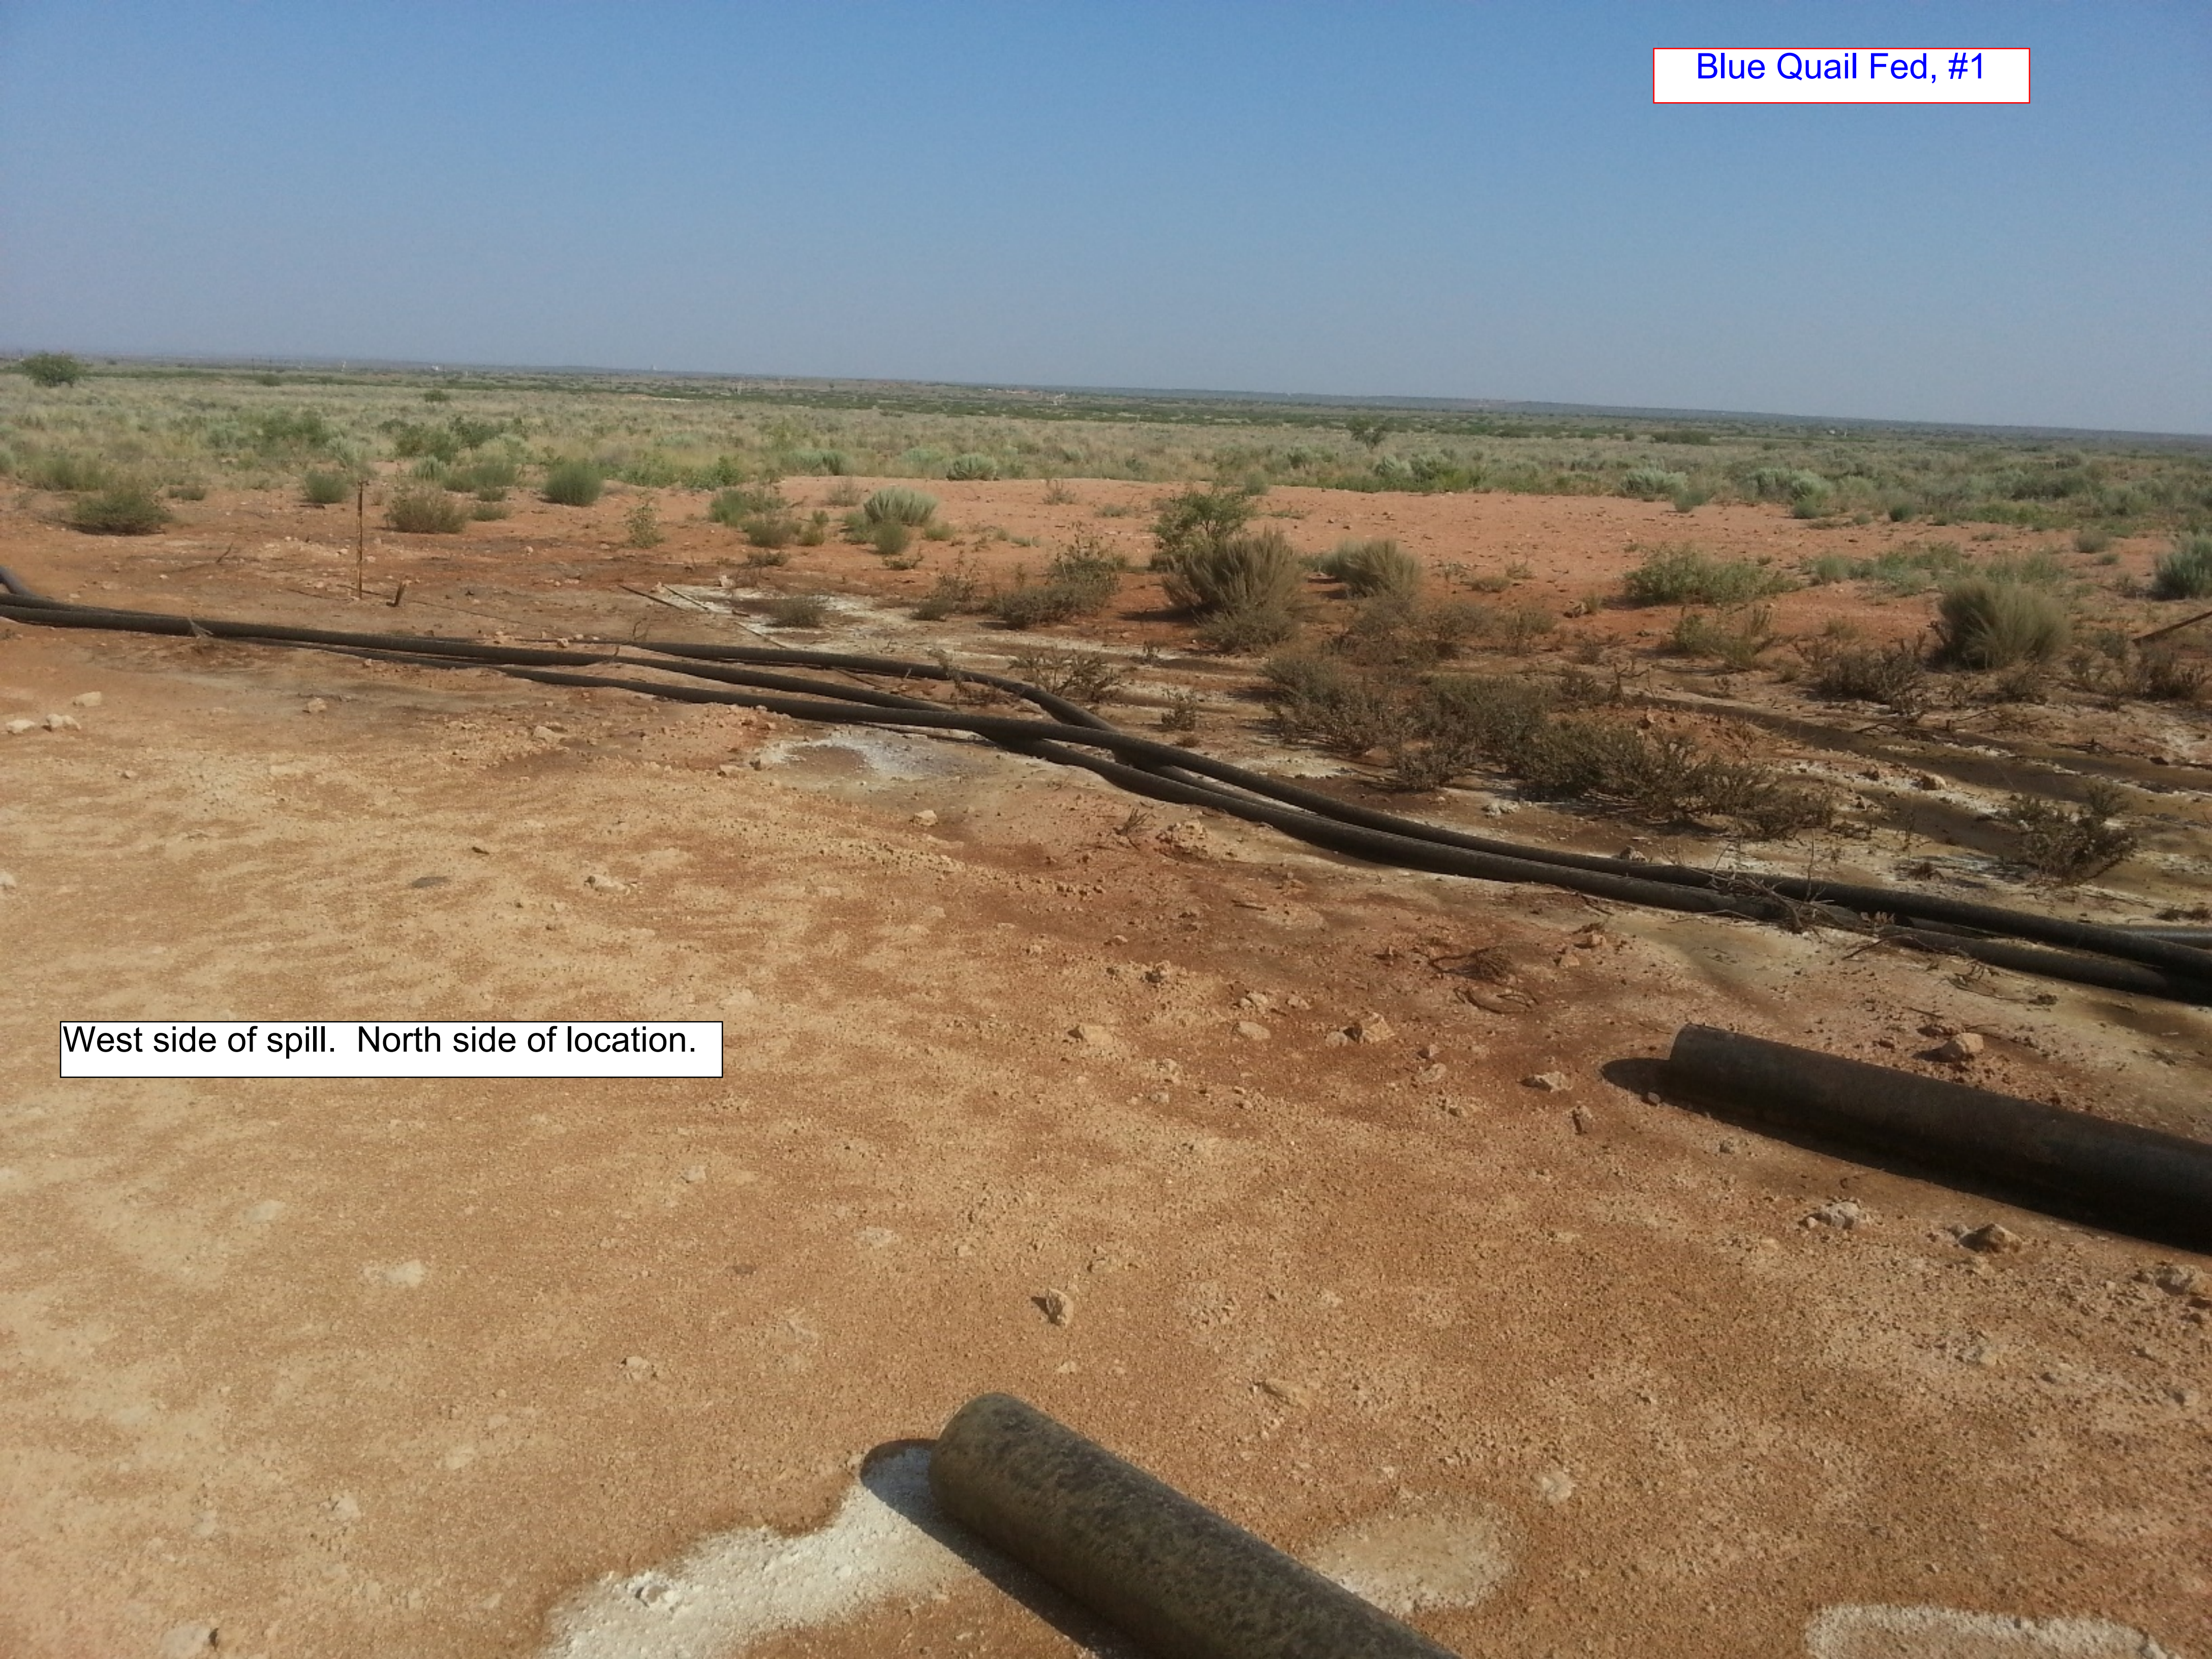
West side of spill. North side of location.

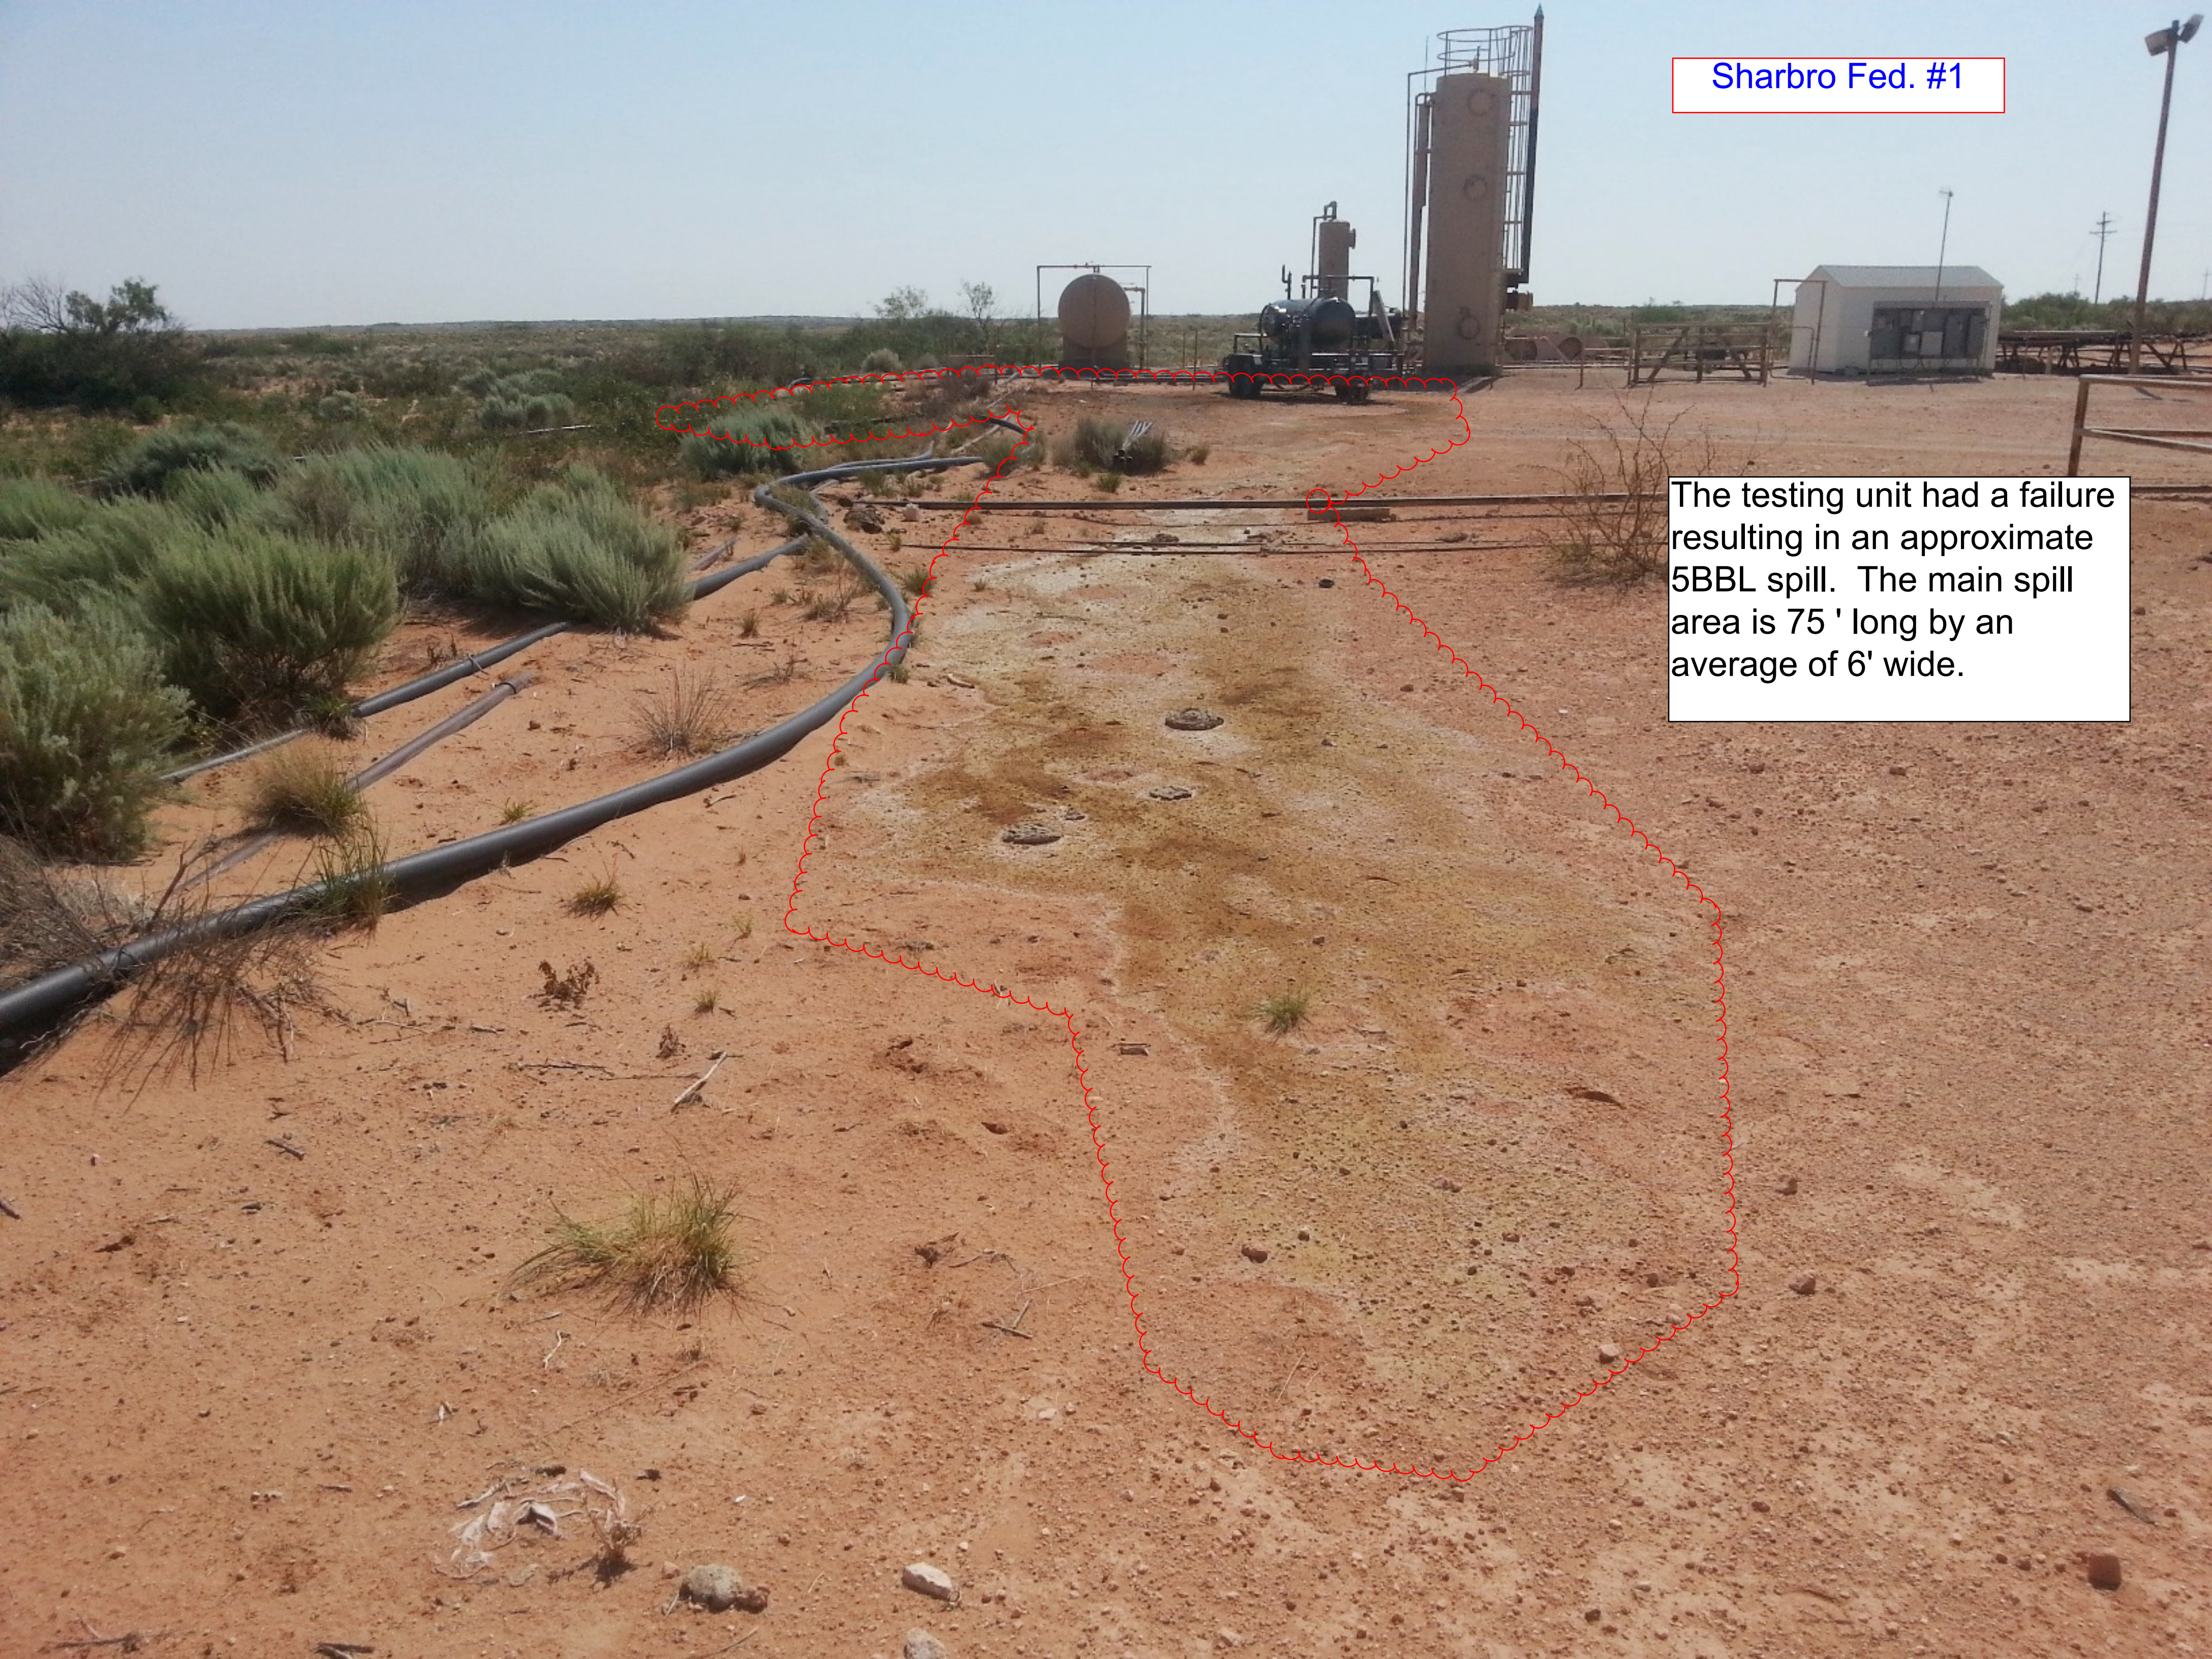
Sharbro Fed. #1

The testing unit had a failure resulting in an approximate 5BBL spill. The main spill area is 75 ' long by an average of 6' wide.

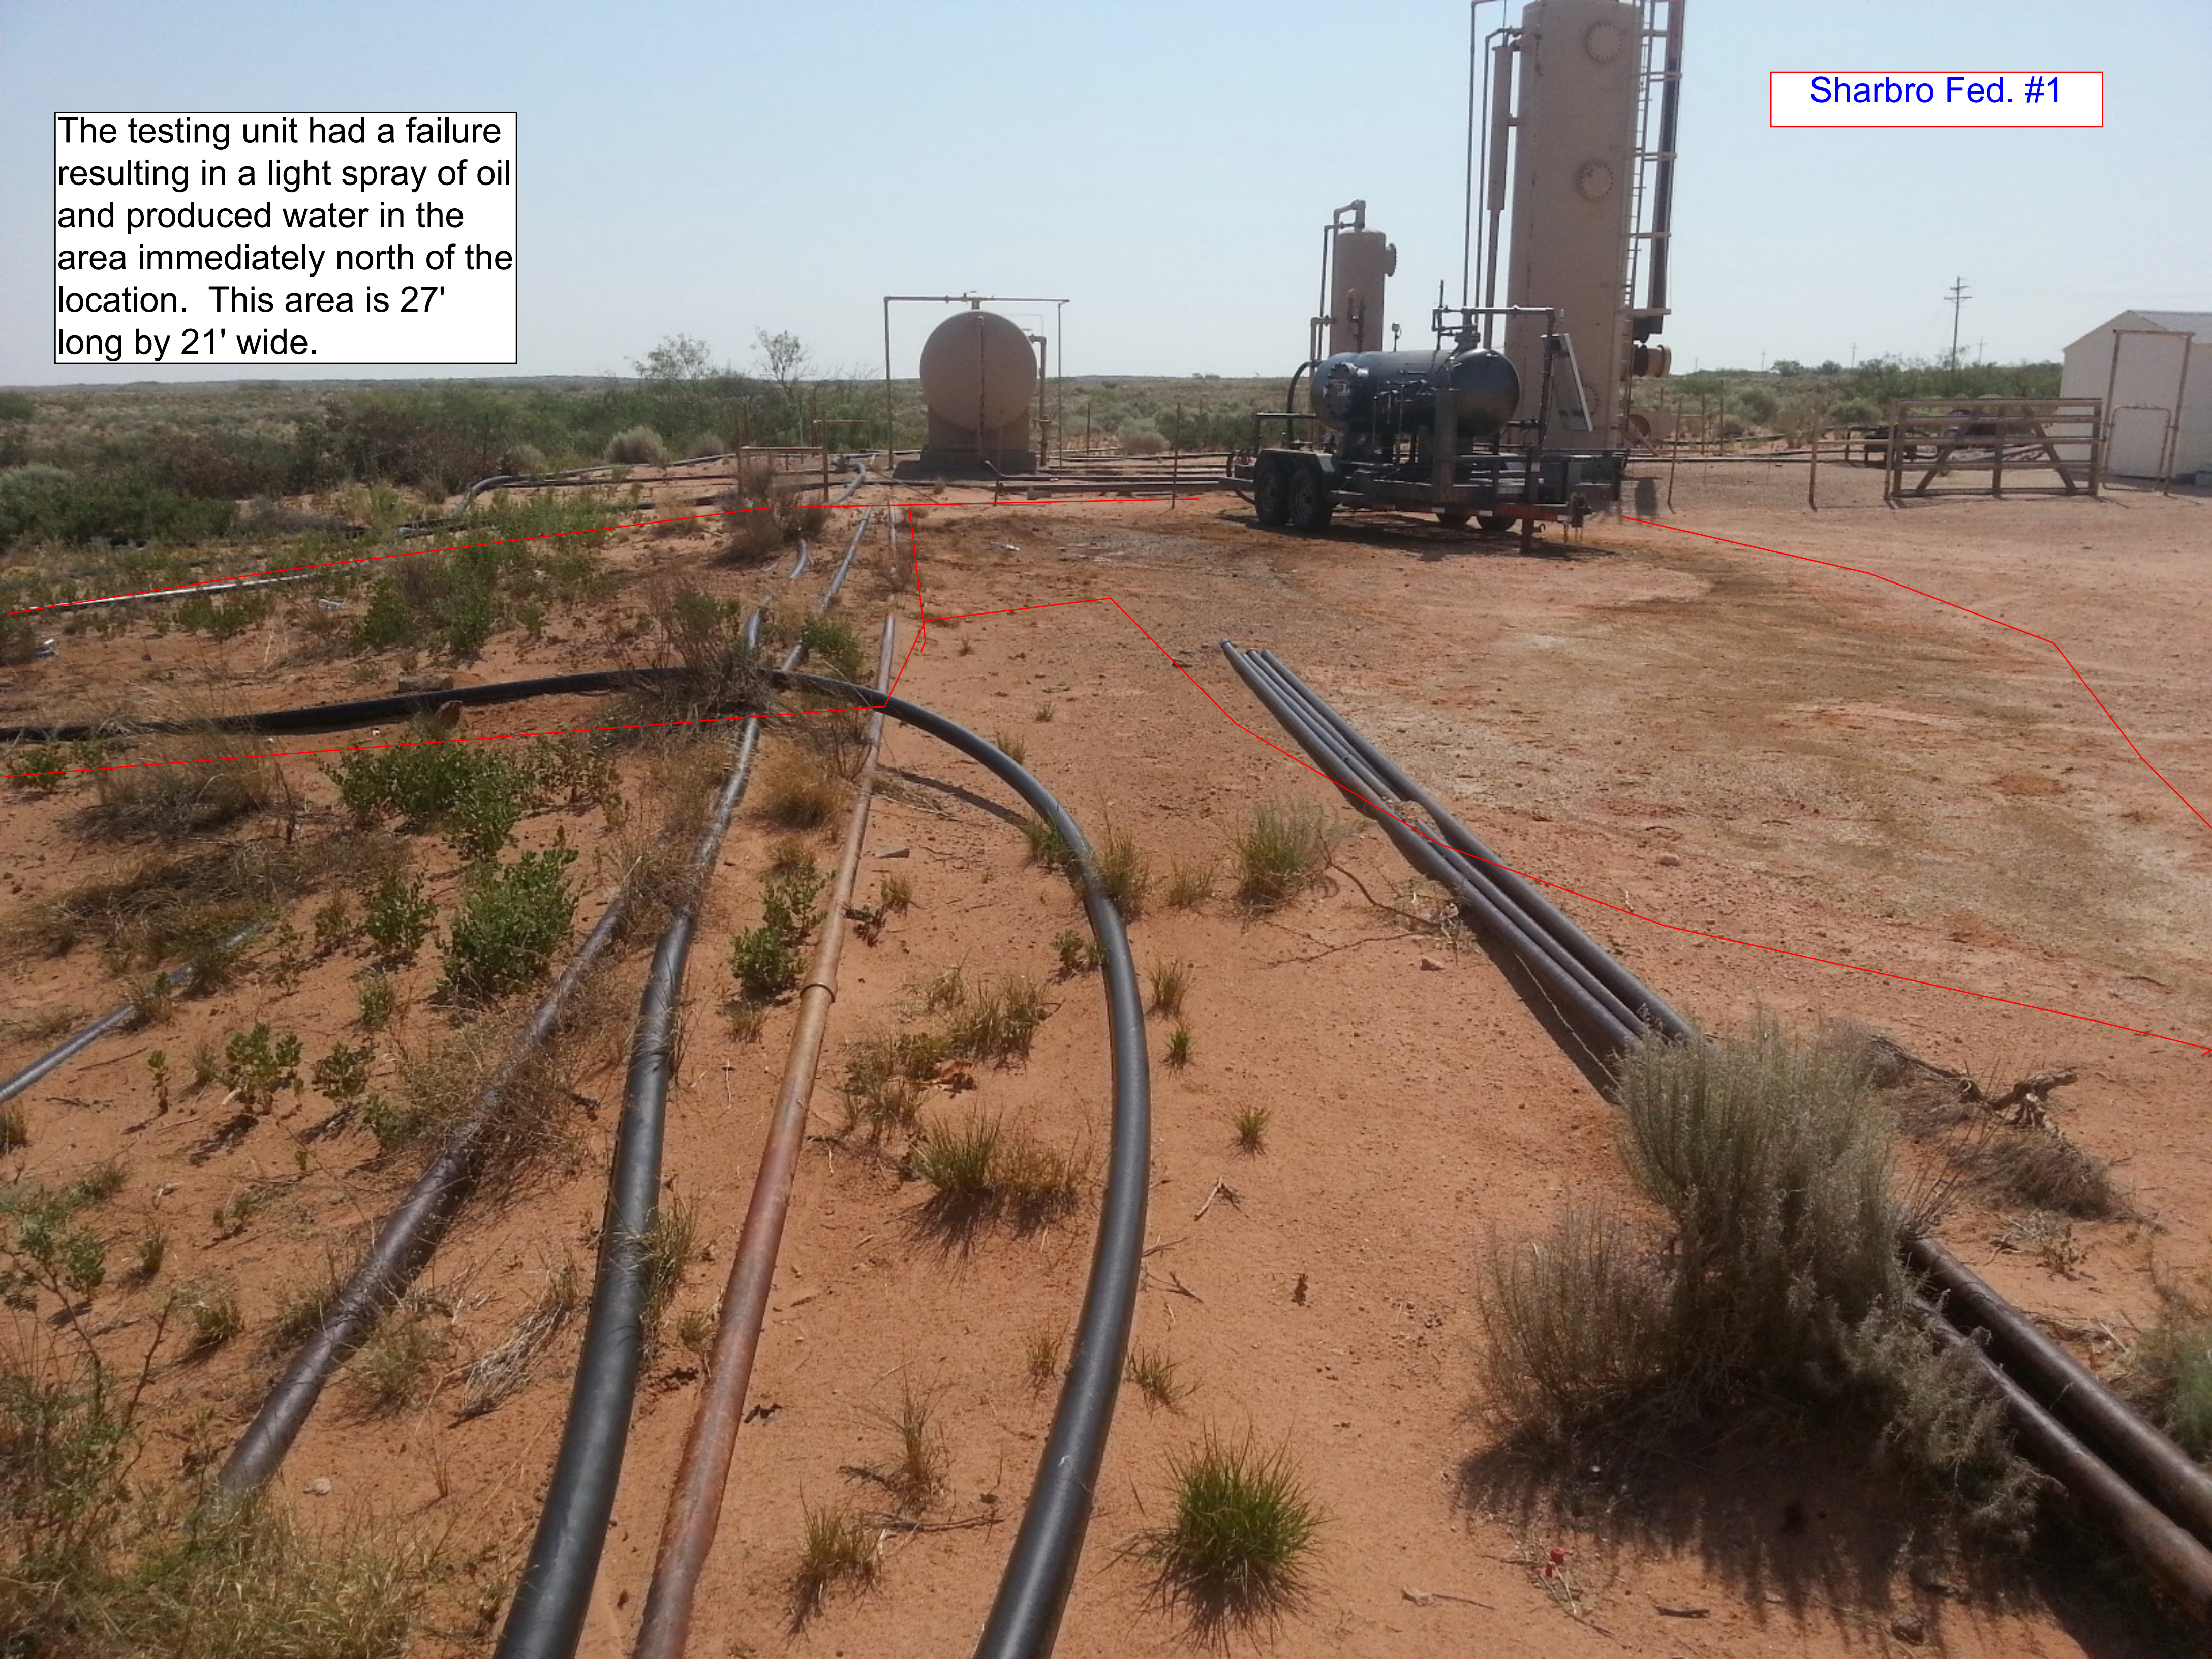
The testing unit had a failure resulting in a light spray of oil and produced water in the area immediately north of the location. This area is 27' long by 21' wide.

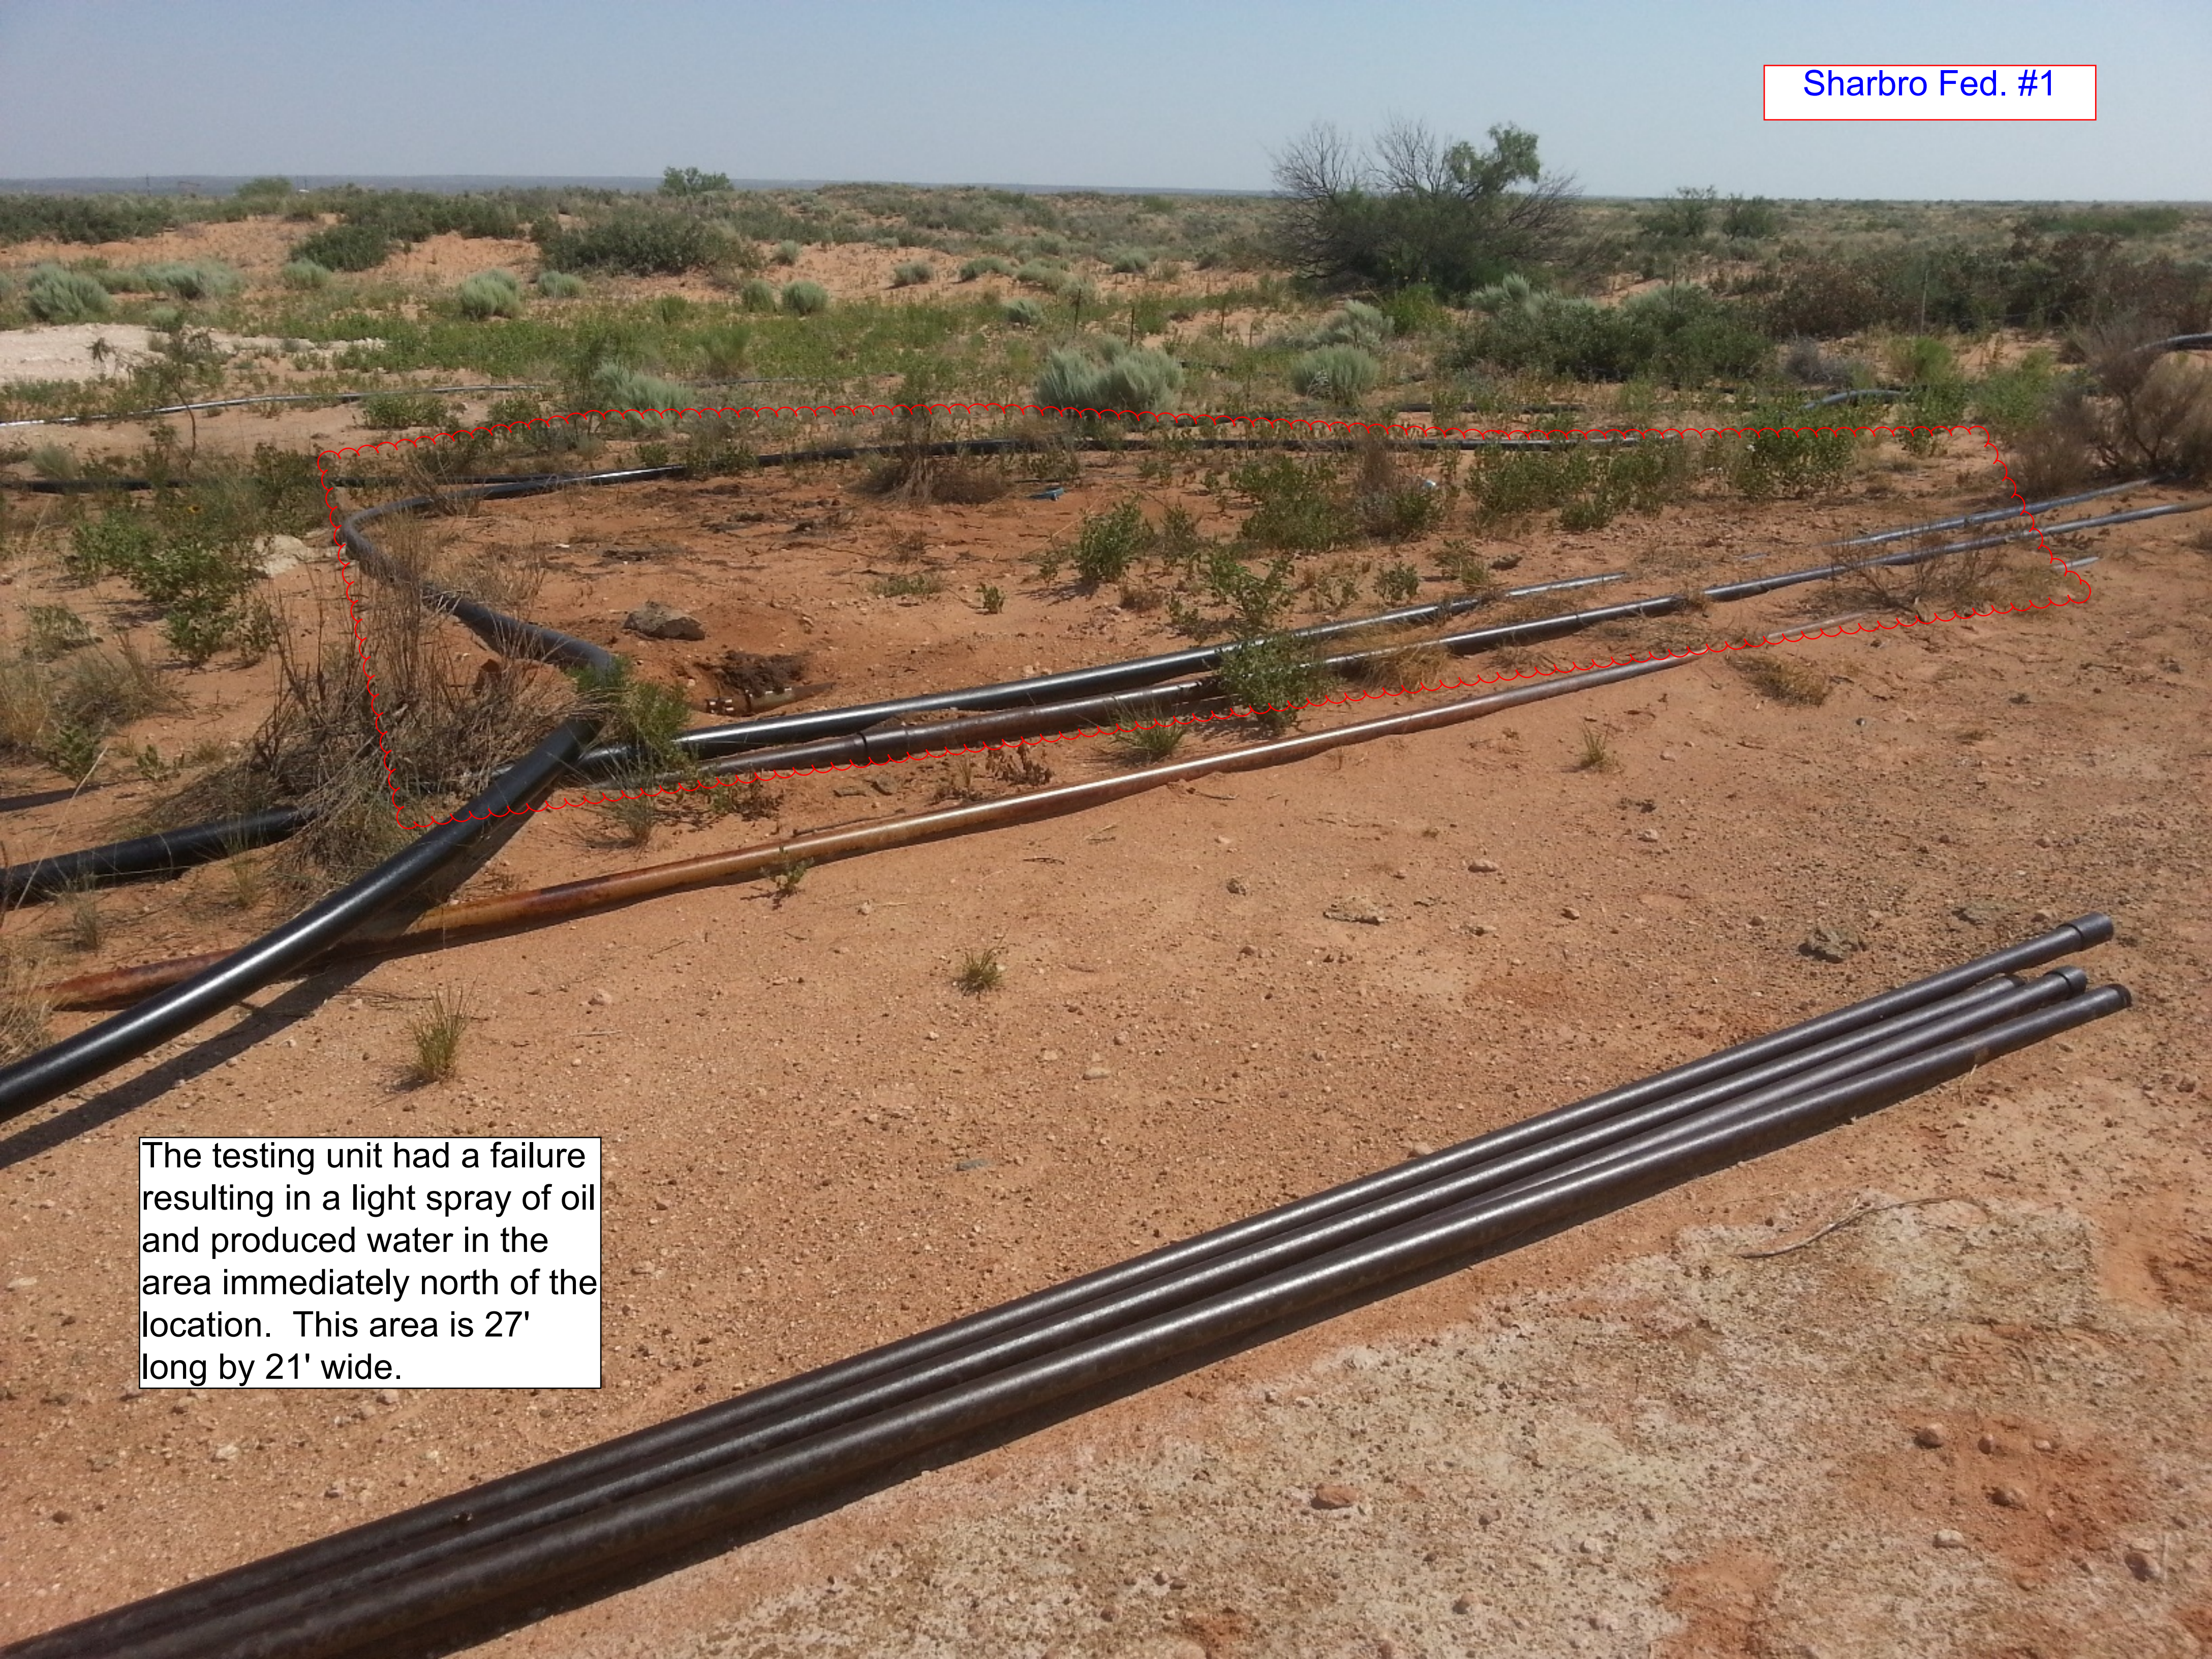
The testing unit had a failure resulting in a light spray of oil and produced water in the area immediately north of the location. This area is 27' long by 21' wide.

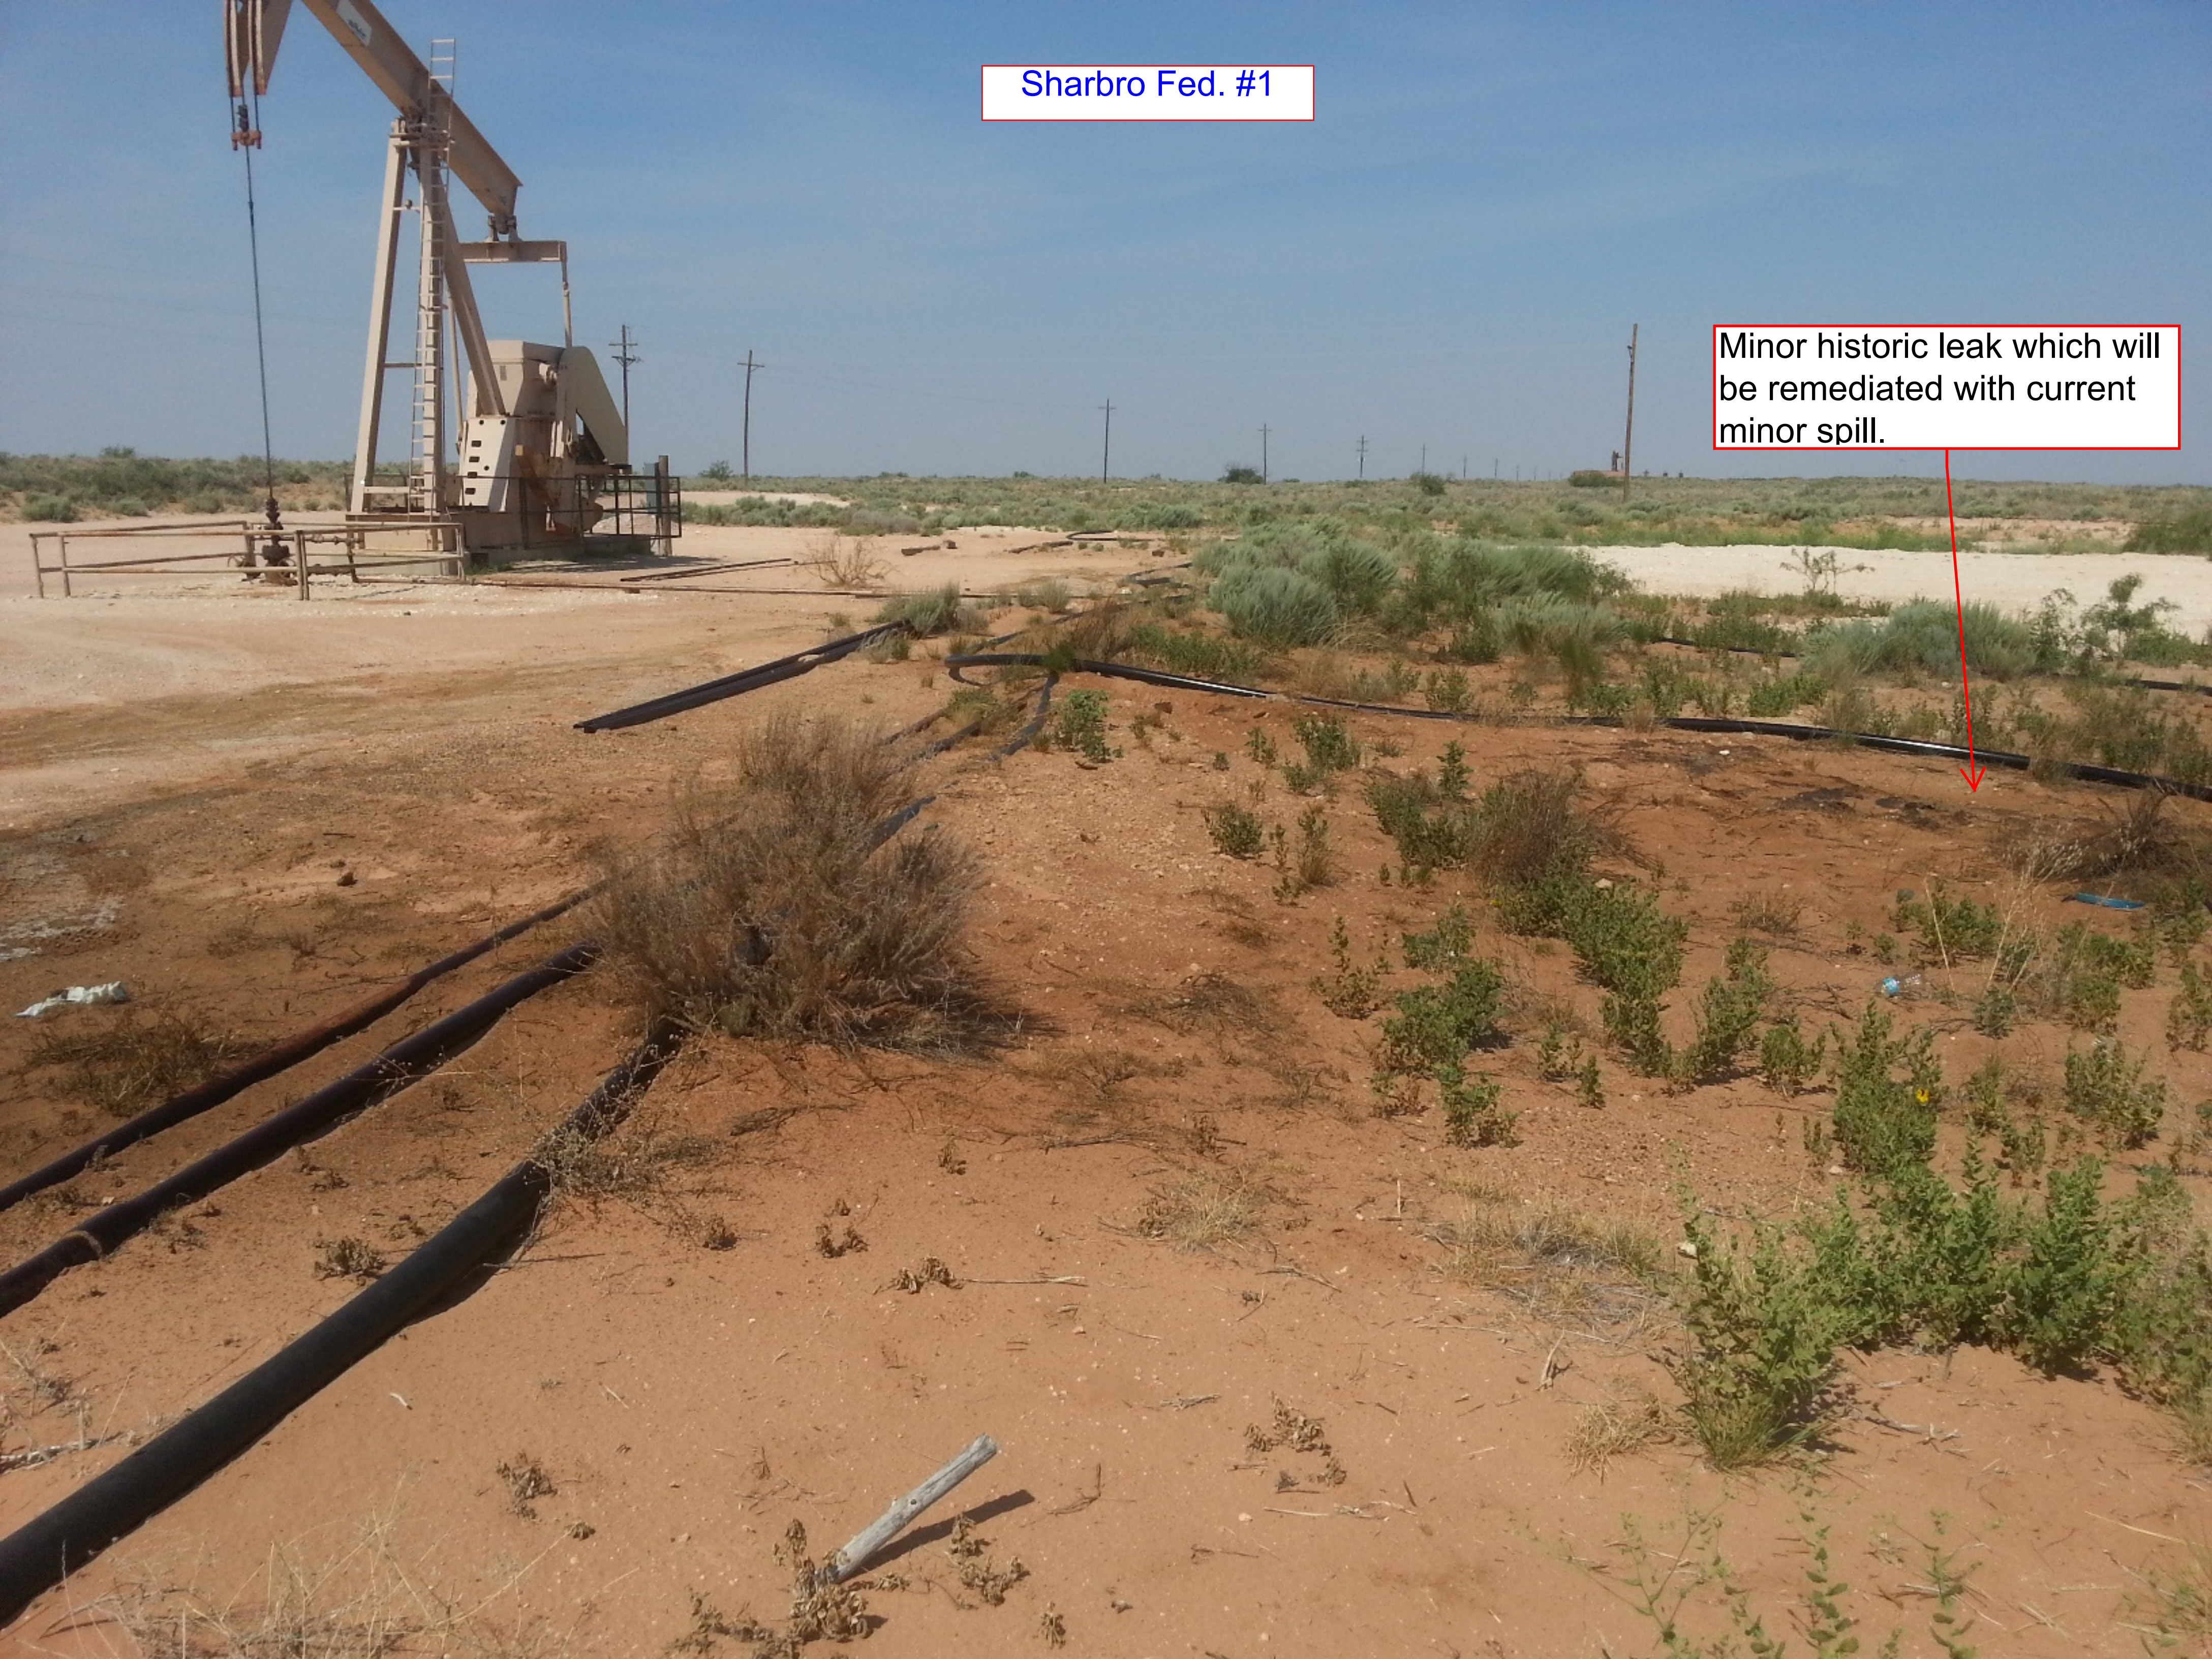
Sharbro Fed. #1

Minor historic leak which will  
be remediated with current  
minor spill.
