# PANTHER ENERGY SERVICES, LLC

Lease Name: South Langlie Jal Unit Injection Station

RP # 3831

## Work Plan

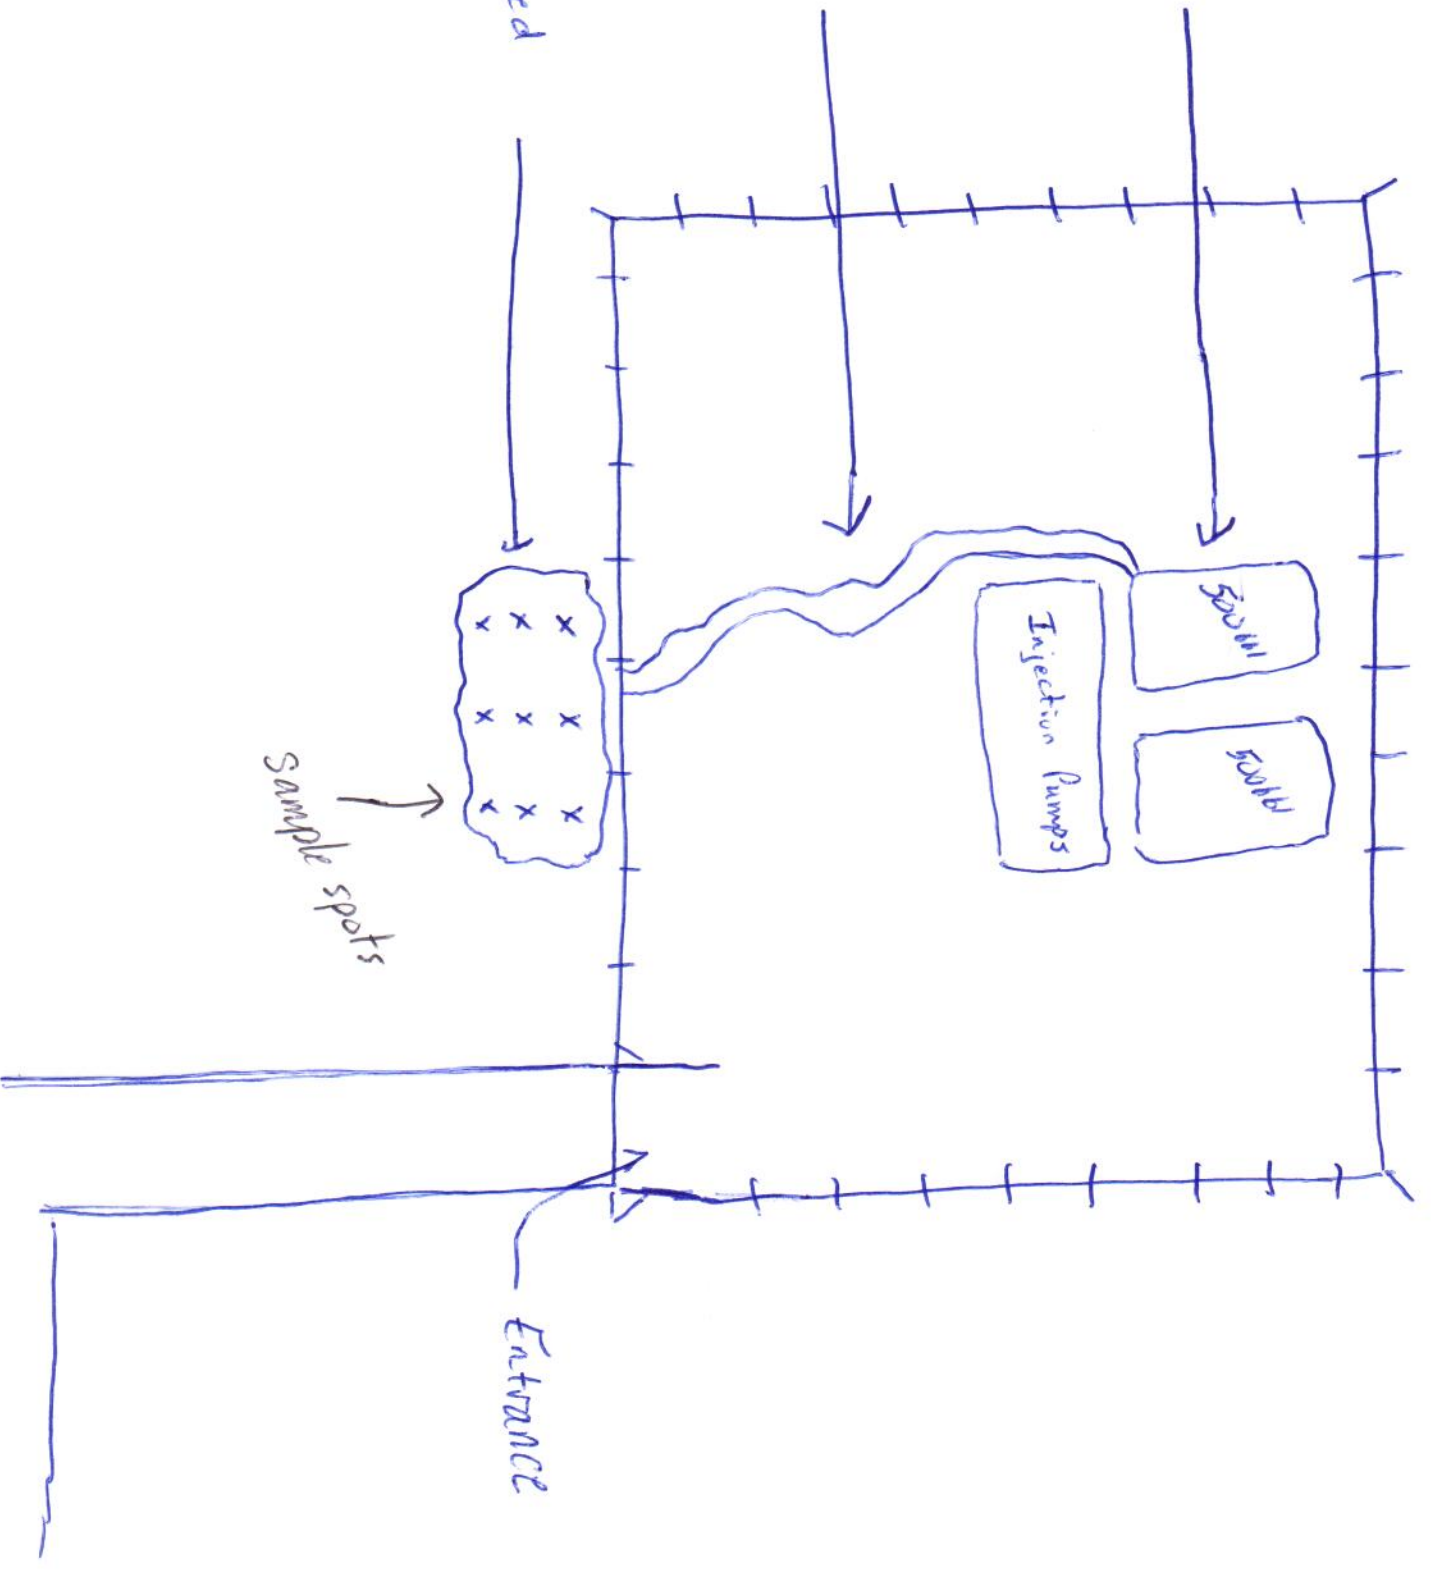
Tank that was  
hit by lightning

Spill Path

where spill stopped  
in pasture.

Sample spots

Entrance

500 bbl fiberglass tank was struck by lightning causing the spill. The affected area is approximately 50' x 50' outside battery. No remedial activities have taken place. One call has been submitted. We will push up top soil of affected area. Then we will take PIS samples of area to find and clean up any hot spots left. Finally, we will take a composite sample of the area to see if clean. Sample will be taken to lab for verification. If clean we will backfill area.
