## Release Notification and Corrective Action

Name of Company: Nadel and Gussman Permian, LLC	Contact: Bill Dougherty
Address: 601 N. Marienfeld, Suite 508, Midland, TX 79707	Telephone No. 325-998-7107
Facility Name: Raptor West 3 State #1	Facility Type: Oil Well

Re: Raptor West 3 State No. 1 Corrective Action Plan/ Final Remediation Report  
U/L J S3 T19S R34E 1650' FSL 1650' FEL, Lea County, New Mexico  
**API No. 30-025-36680**

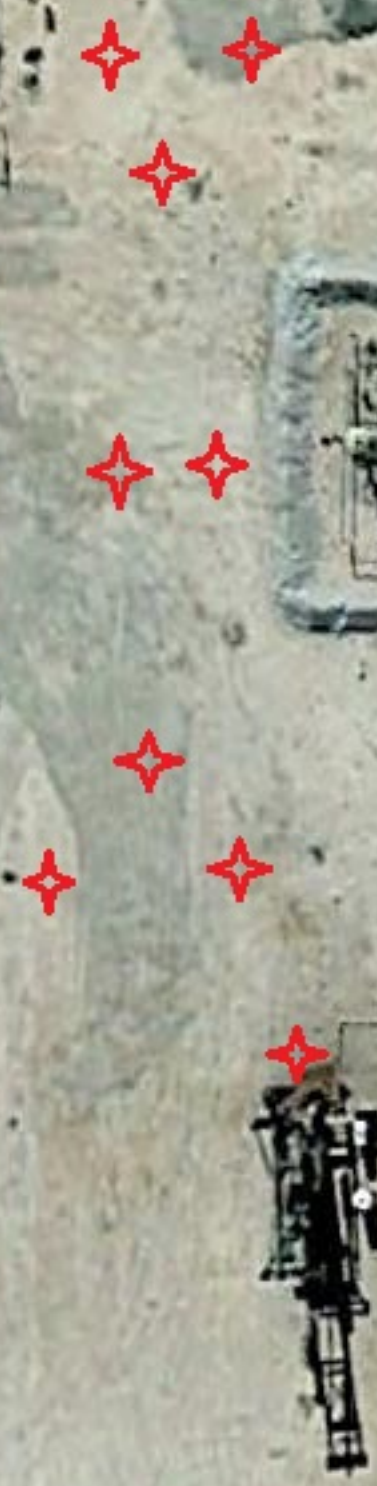
**RAPTOR WEST 3 STATE #1**  
\*\*NOT TO SCALE\*\*

SAMPLE DEPTHS ~ 3'
