To: Kellie Jones, New Mexico Oil Conservation Division, Dist. I  
Reference: Remediation Work Plan  
Operator: Apache Corporation  
Location: WBDU #137  
API: 30-025-39574  
Legals: UL. O, Sec. 4, T21S, R37E, Lea County, New Mexico  
GPS: 32.5024 -103.1701 (Point of Release)

### Release Notification and Corrective Action

Apache Corporation-WBDU #137

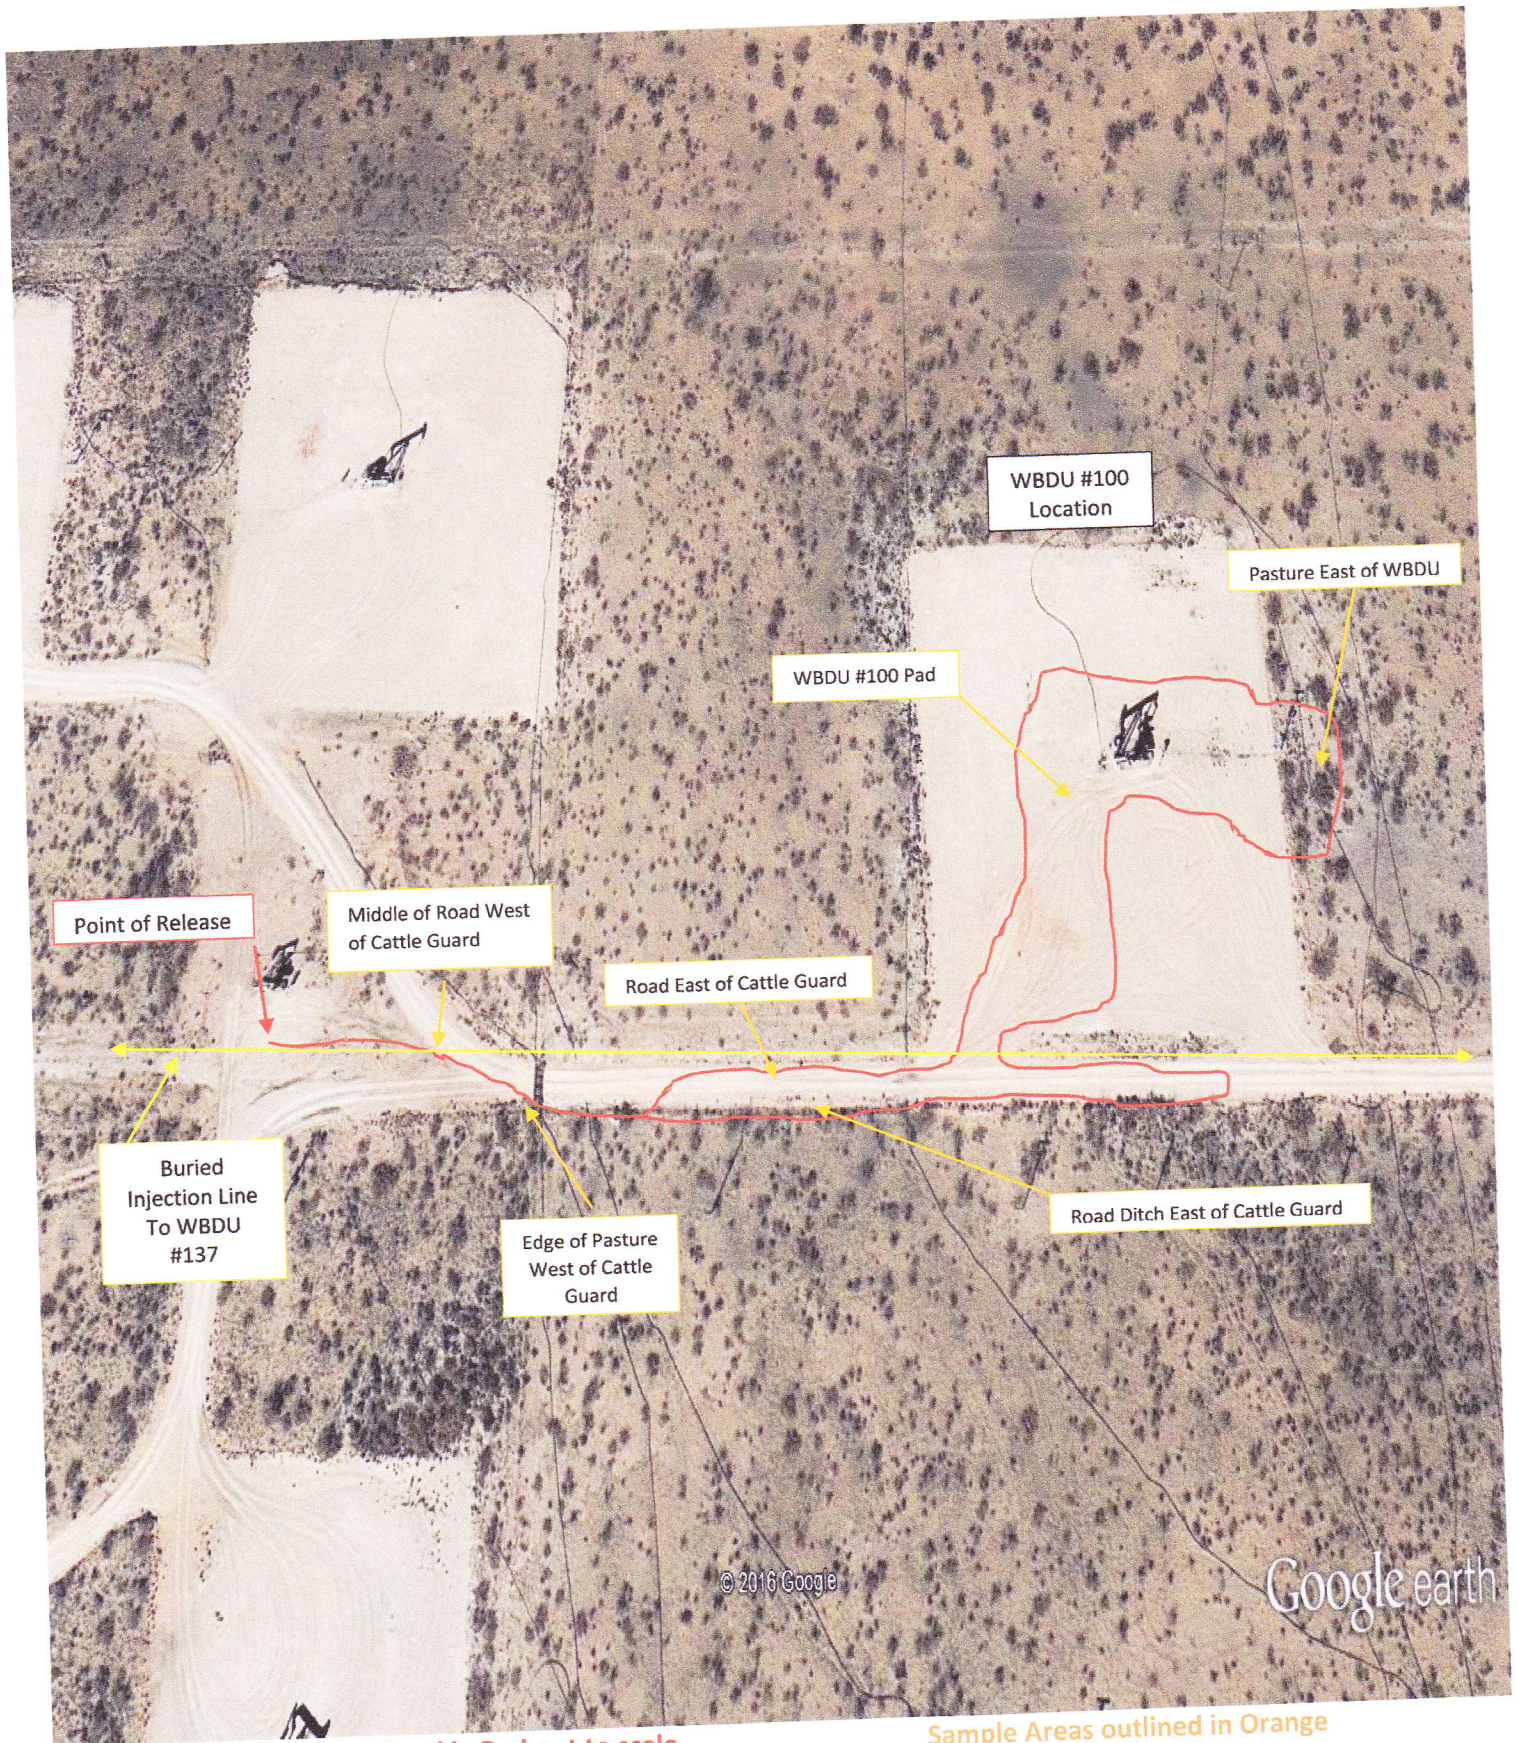
Apache Corporation- WBDU #137 Site Map

Based upon the lab results, there are three of the seven impacted areas that need additional work; the pasture east of the WBDU #100 pad, the road ditch east of the cattle guard, and the edge of the pasture west of the cattle guard.

Impacted area outlined in Red-not to scale

Sample Areas outlined in Orange

- 1) Pasture East of the WBDU #100 Pad-I propose to excavate this area to a depth of 3' BGS and install a 20 mil synthetic liner. The area will then be backfilled, contoured to match the surrounding terrain, and seeded.
- 2) Road Ditch East of the Cattle Guard-I propose to excavate an additional 6" of impacted soil from the ditch and backfill to grade.
- 3) Edge of the Pasture West of the Cattle Guard-I propose to excavate an additional 2' of impacted soil, backfill back to grade and seed.
