Release Notification and Corrective Action

Name of Company	Targa Midstream Services	Contact	Ralph England
Address	P.O. Box 1689, Lovington, NM 88260	Telephone No.	575-441-4653
Facility Name	David Bilbrey 8" Pipeline - Site #1	Facility Type	Natural Gas Pipeline
Surface Owner	David Bilbrey	Mineral Owner	API No.

Soil Sample Analytical Data Summary
Targa Midstream Services, LLC, David Bilbrey 8" Pipeline Release Investigation Site #1
Lea County, New Mexico
N33° 31' 50.1276" W103° 05' 23.5860"

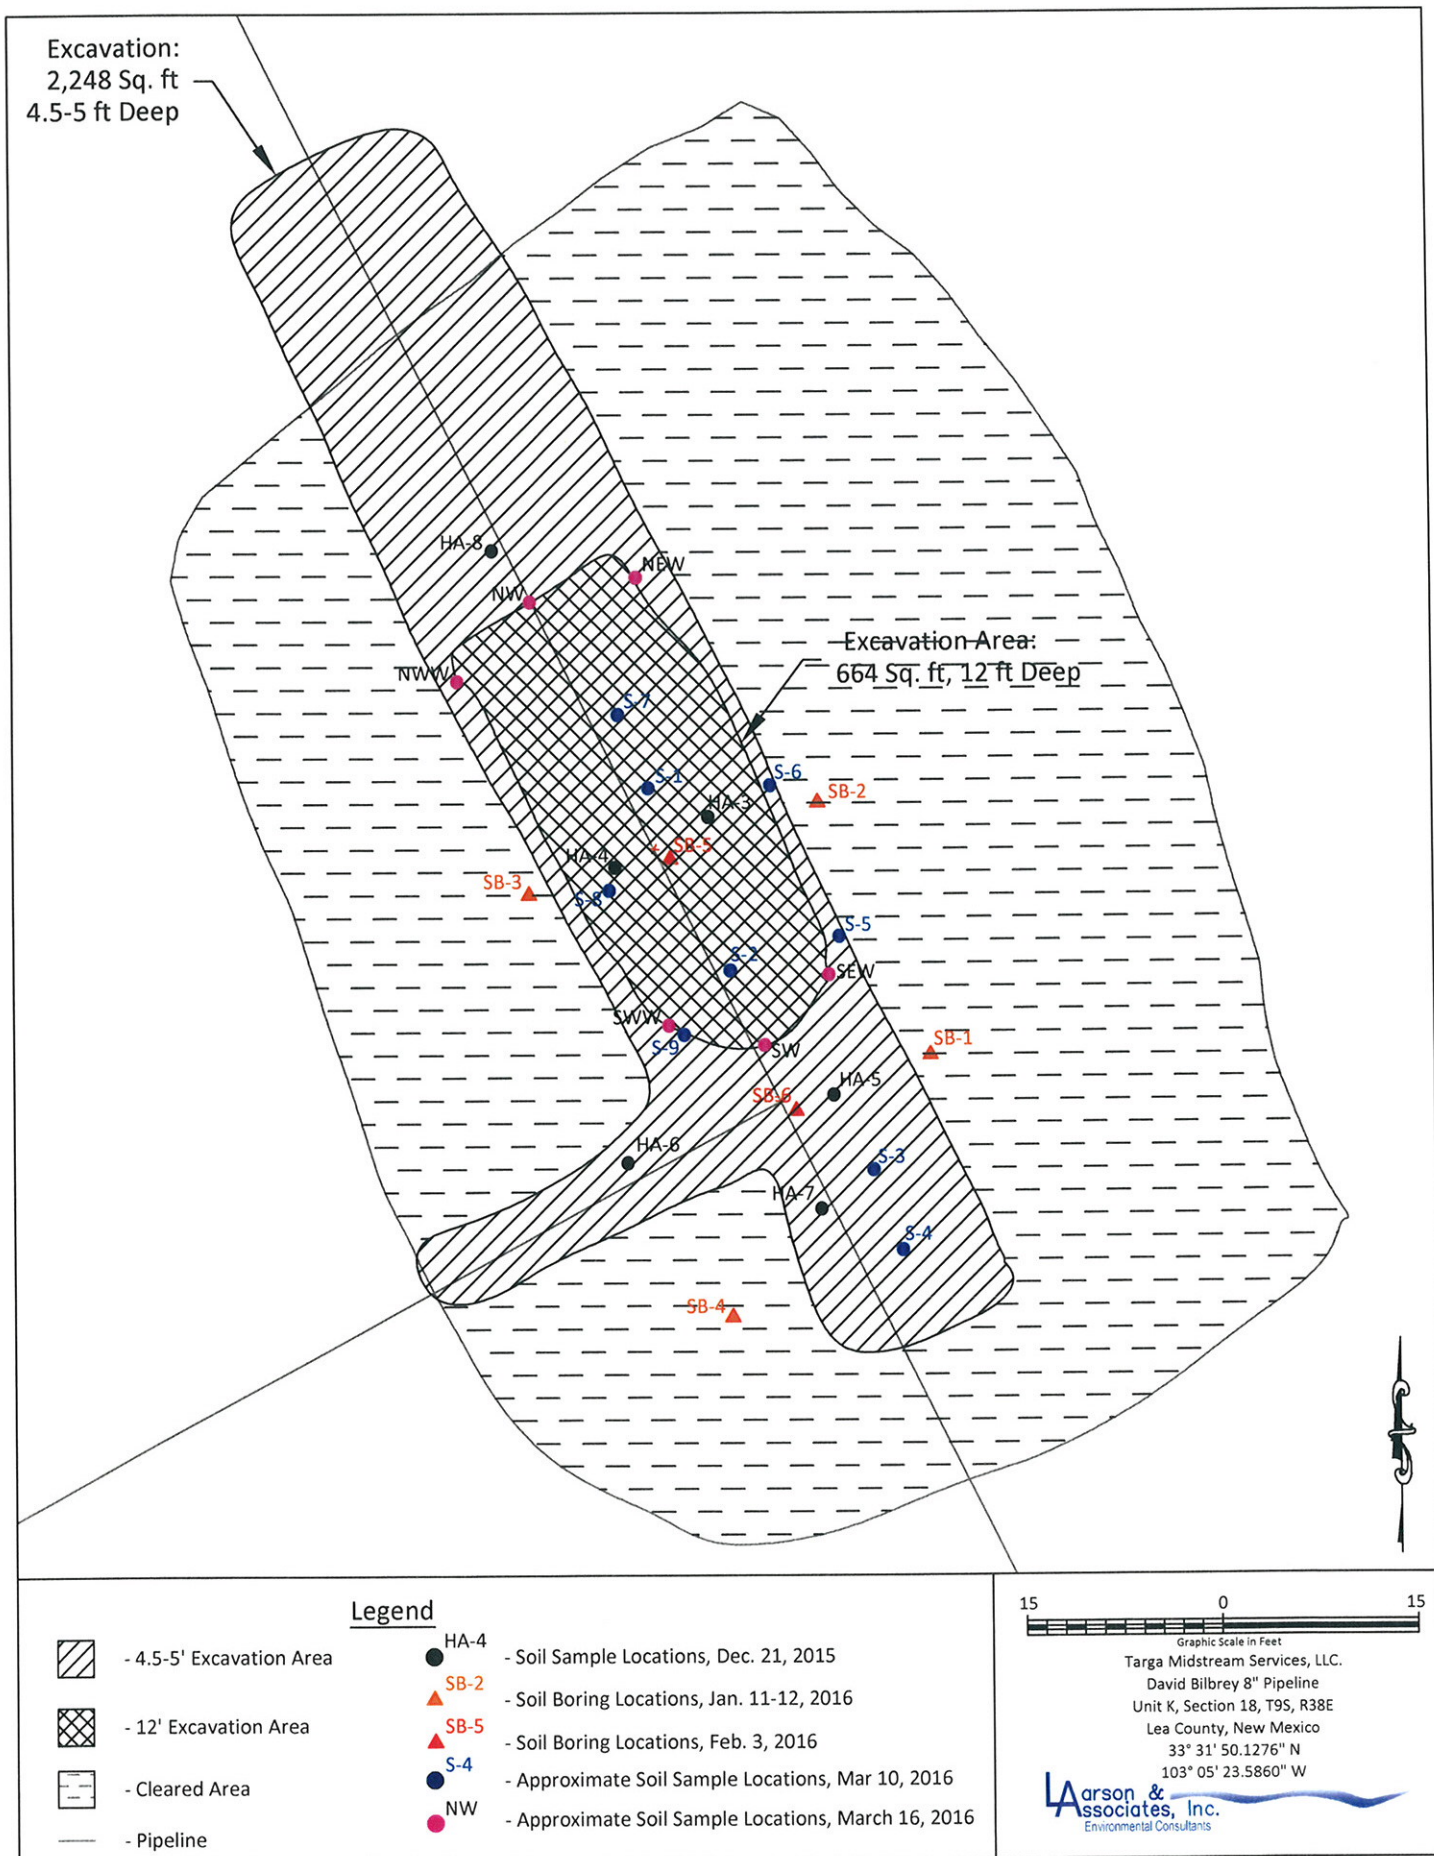
Figure 3 - Site Map Showing Initial Excavation and Soil Samples, March 16, 2016

The release was caused by corrosion of an 8" steel line transporting natural gas. Release area was sampled on December 21, 2015 by Larson & Associates, Inc. The horizontal and vertical extents were delineated with borings. Lab results indicated impact to about 15 feet bgs. Soil was excavated to about 23 feet bgs.

Soil was excavated to about 23 feet bgs and disposed at Gandy Marley Landfill (NM-711-1-0019). Please see attached lab results from samples collected on March 16 and 24, 2016 and samples location map (Figure 3).
