Release Notification and Corrective Action

Name of Company	Targa Midstream Services	Contact	Ralph England
Address	P.O. Box 1689, Lovington, NM 88260	Telephone No.	575-441-4653
Facility Name	David Bilbrey 8" Pipeline - Site #3	Facility Type	Natural Gas Pipeline
Surface Owner	David Bilbrey	Mineral Owner	API No.

Targa Midstream Services, LLC.
David Bilbrey 8" Pipeline Site # 3
Unit F, Section 18, T9S, R38E
Lea County, New Mexico
33° 32' 04.816" N
103° 05' 32.604" W

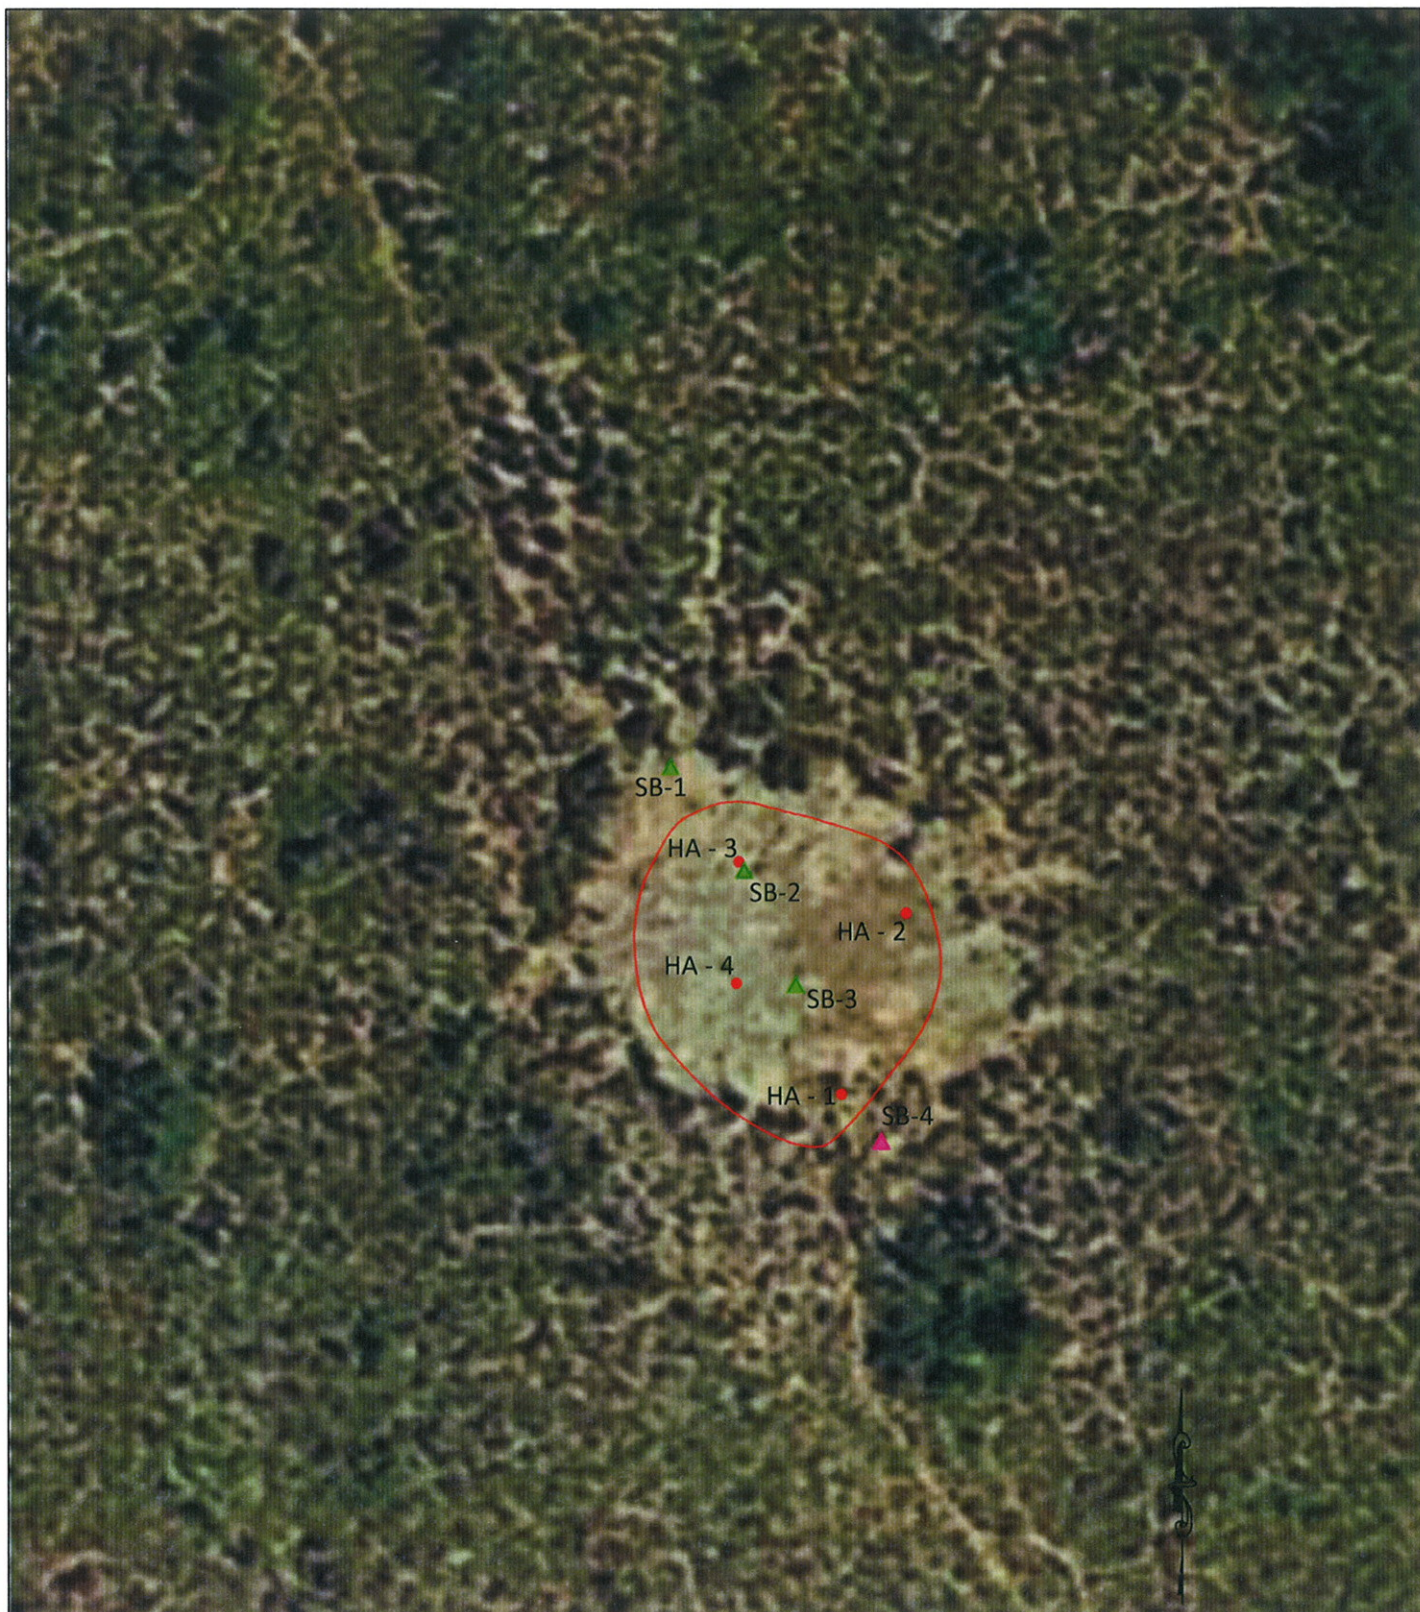
Figure 2 - Aerial Map

The release was caused by corrosion of an 8" steel line transporting natural gas. Release area was sampled on March 9, 2015 by Larson & Associates, Inc. Borings were drilled to about 25 feet bgs to delineate horizontal and vertical impacts. Soil samples were collected every 5 feet. Lab results indicated impact to about 10 feet bgs. Soil was excavated to about 13 feet bgs.

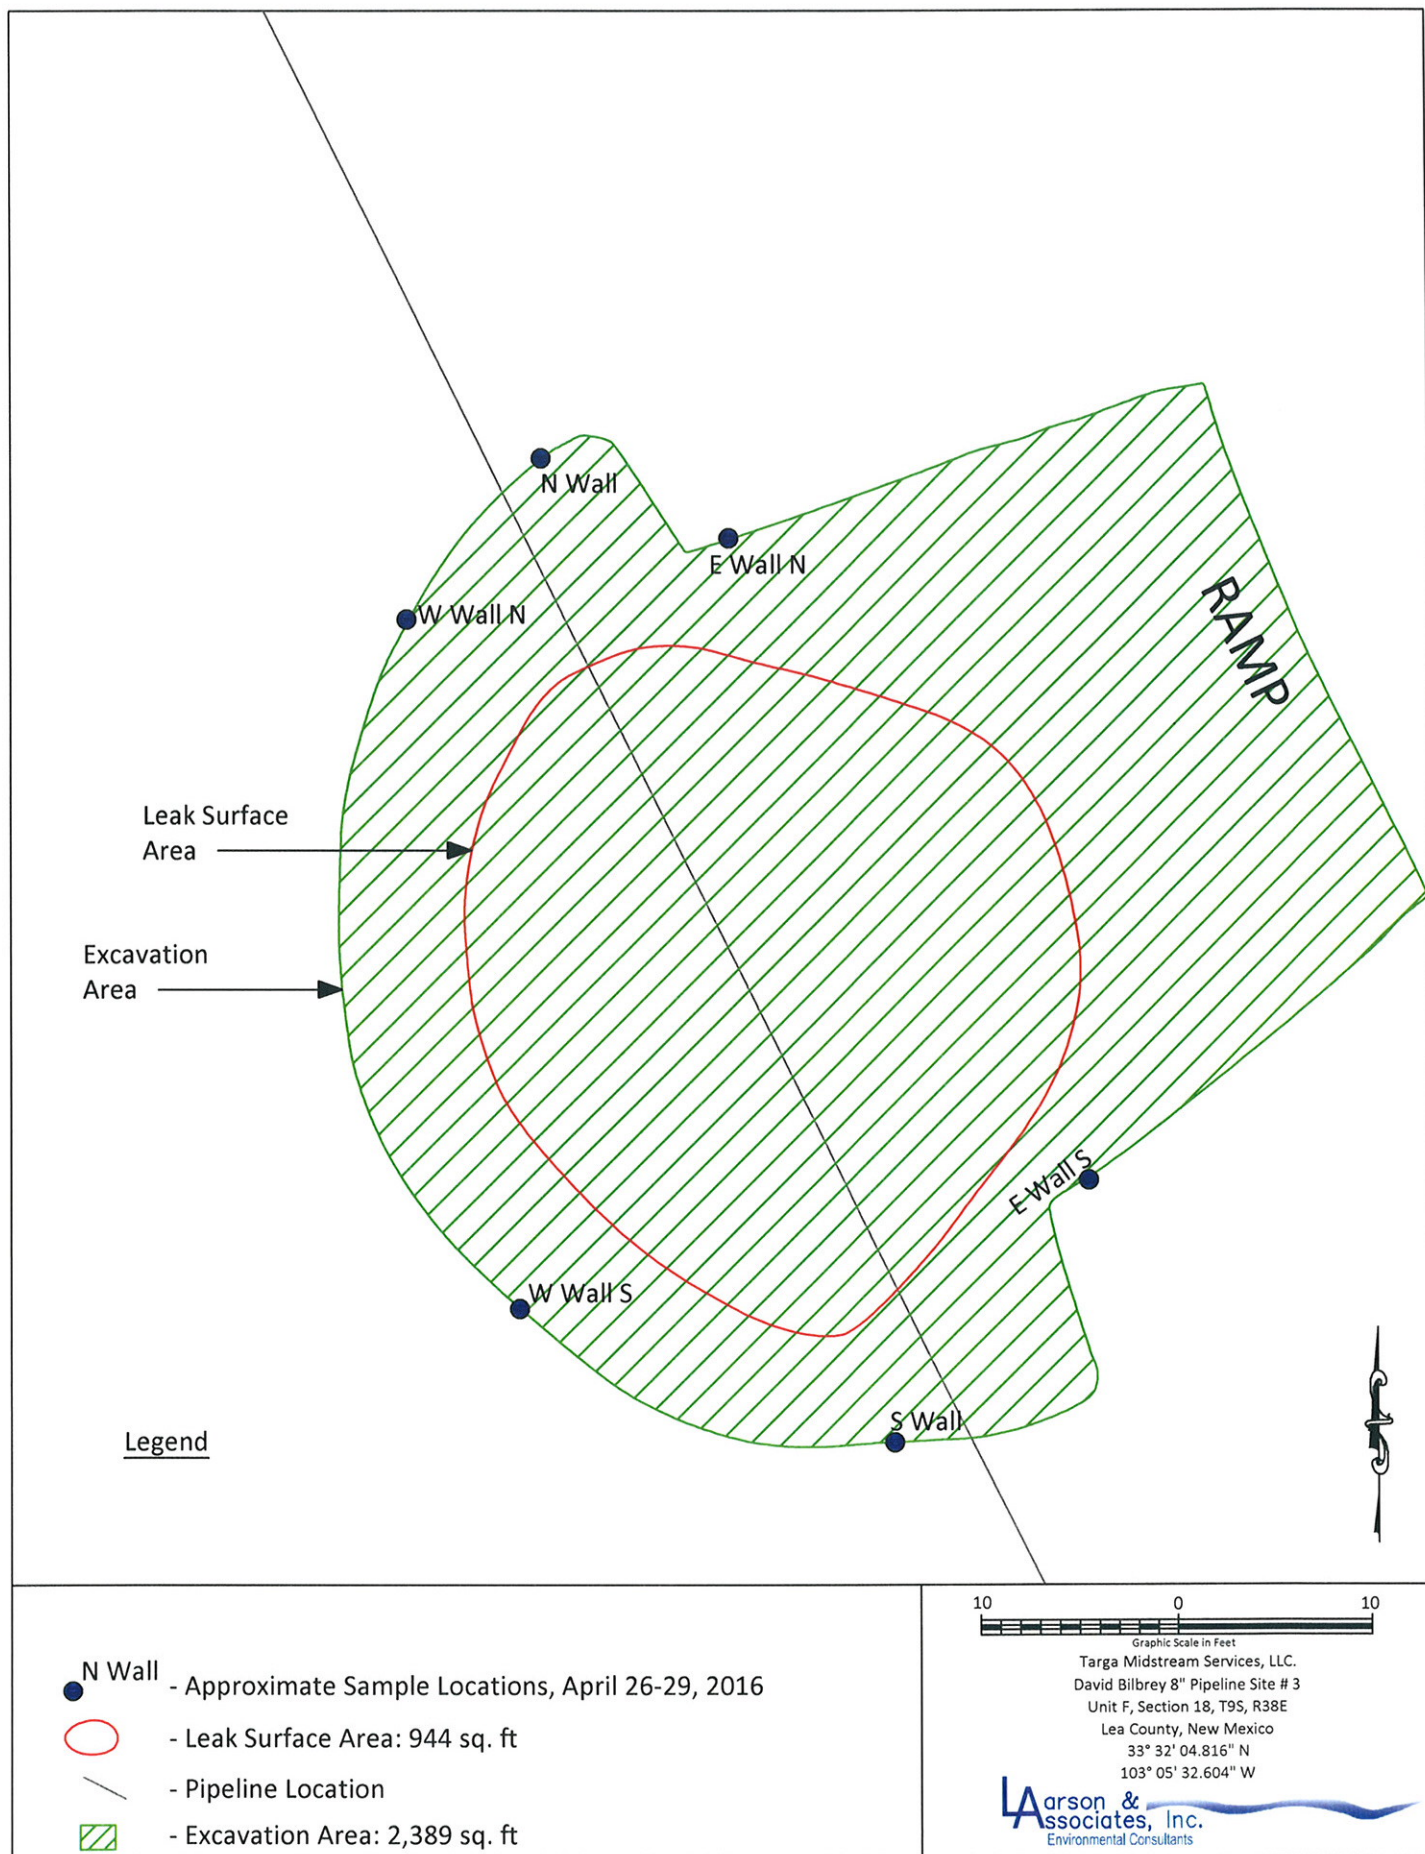
Figure 4 - Site Map Showing Excavation Area and Soil Sample Locations

Impacted soil was excavated to approximately 13 feet bgs and disposed at Gandy Marley Landfill (NM-711-1-0019). Please see attached lab results from samples collected on March 16 and 24, 2016 and samples location map (Figure 3).
