Release Notification and Corrective Action

Name of Company: Jay Management Company	Contact: Jim Foster
Address: 2425 W Loop South, Ste. 810, Houston, Texas 77027	Telephone No.: 979-324-2139
Facility Name: Enfield No. 1	Facility Type: Well with Tank Battery

Photographic Documentation
Enfield No. 1 Release
Jay Management Company, Lea County, New Mexico

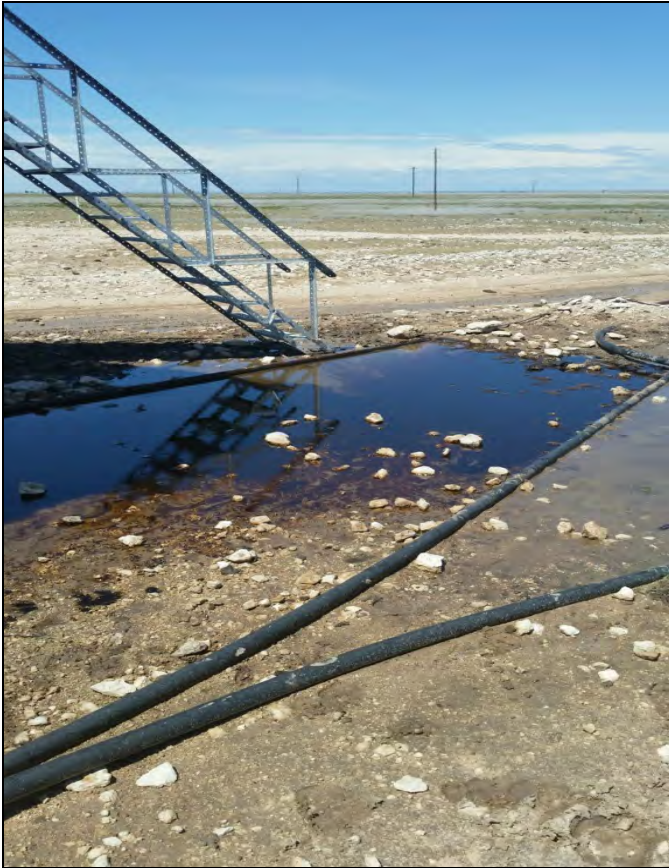
Release occurred within the secondary containment area of the tank battery. None of the released fluids left the site. Approximately 22 bbls of fluid was recovered with a vacuum truck for off-site disposal.

Photograph 1 - A view looking at the released fluids within tank battery secondary containment.

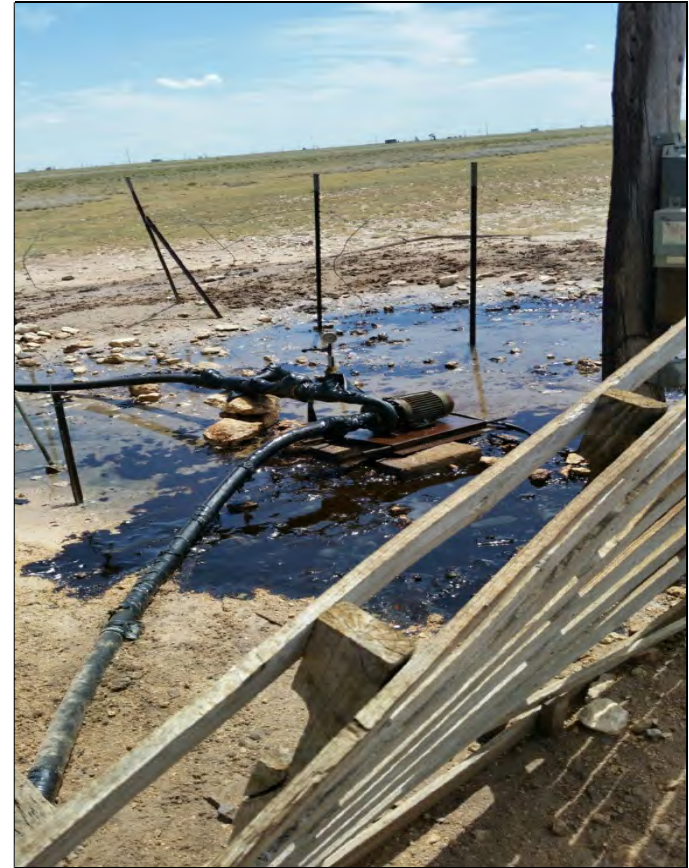
Photograph 2 - A second view looking at the released fluids within tank battery secondary containment.
