Penroc Oil Corporation
Langlie Jal Unit #032
Producing Well - Flowline Failure

Preliminary Delineation Report Case Number: 1R-4617

Section 06, T25S, R37E
Detailed coordinates in report.

Date of Incident
02/15/2017

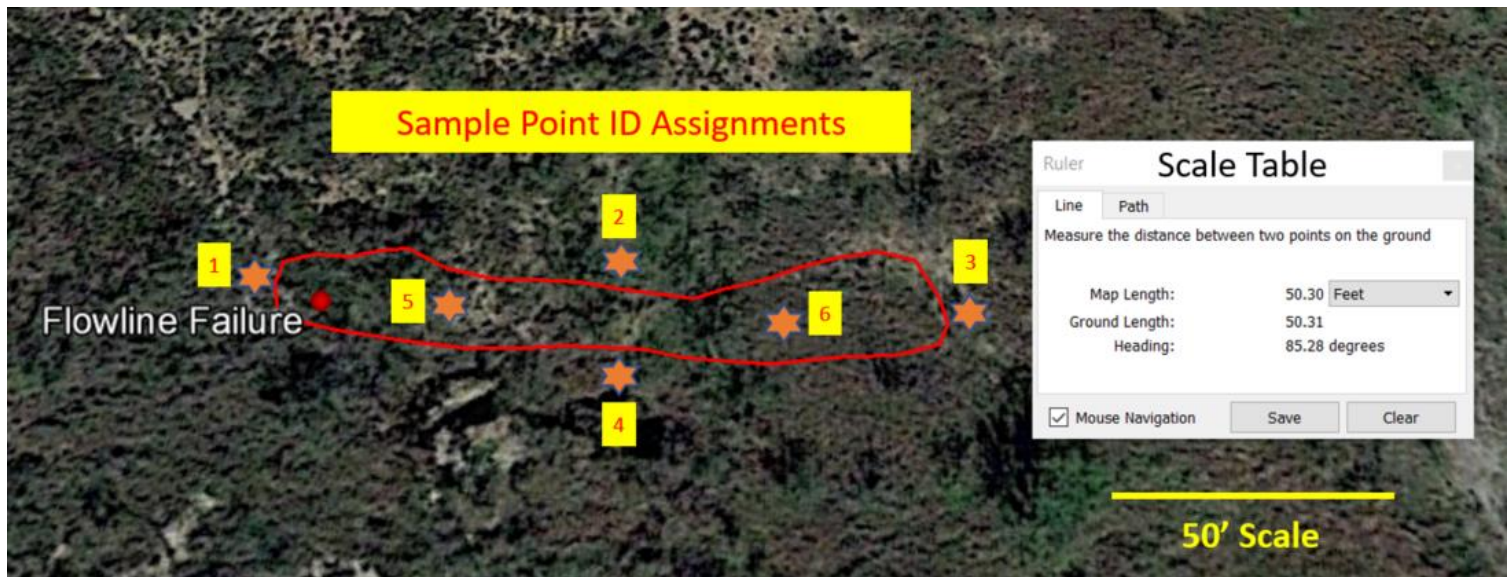
Sample Points ★

Flowline Failure

Red: Spill Outline
Red Dot: Flowline Failure Point
Orange: 130 Feet
Blue: 17 Feet
Green: 22 Feet

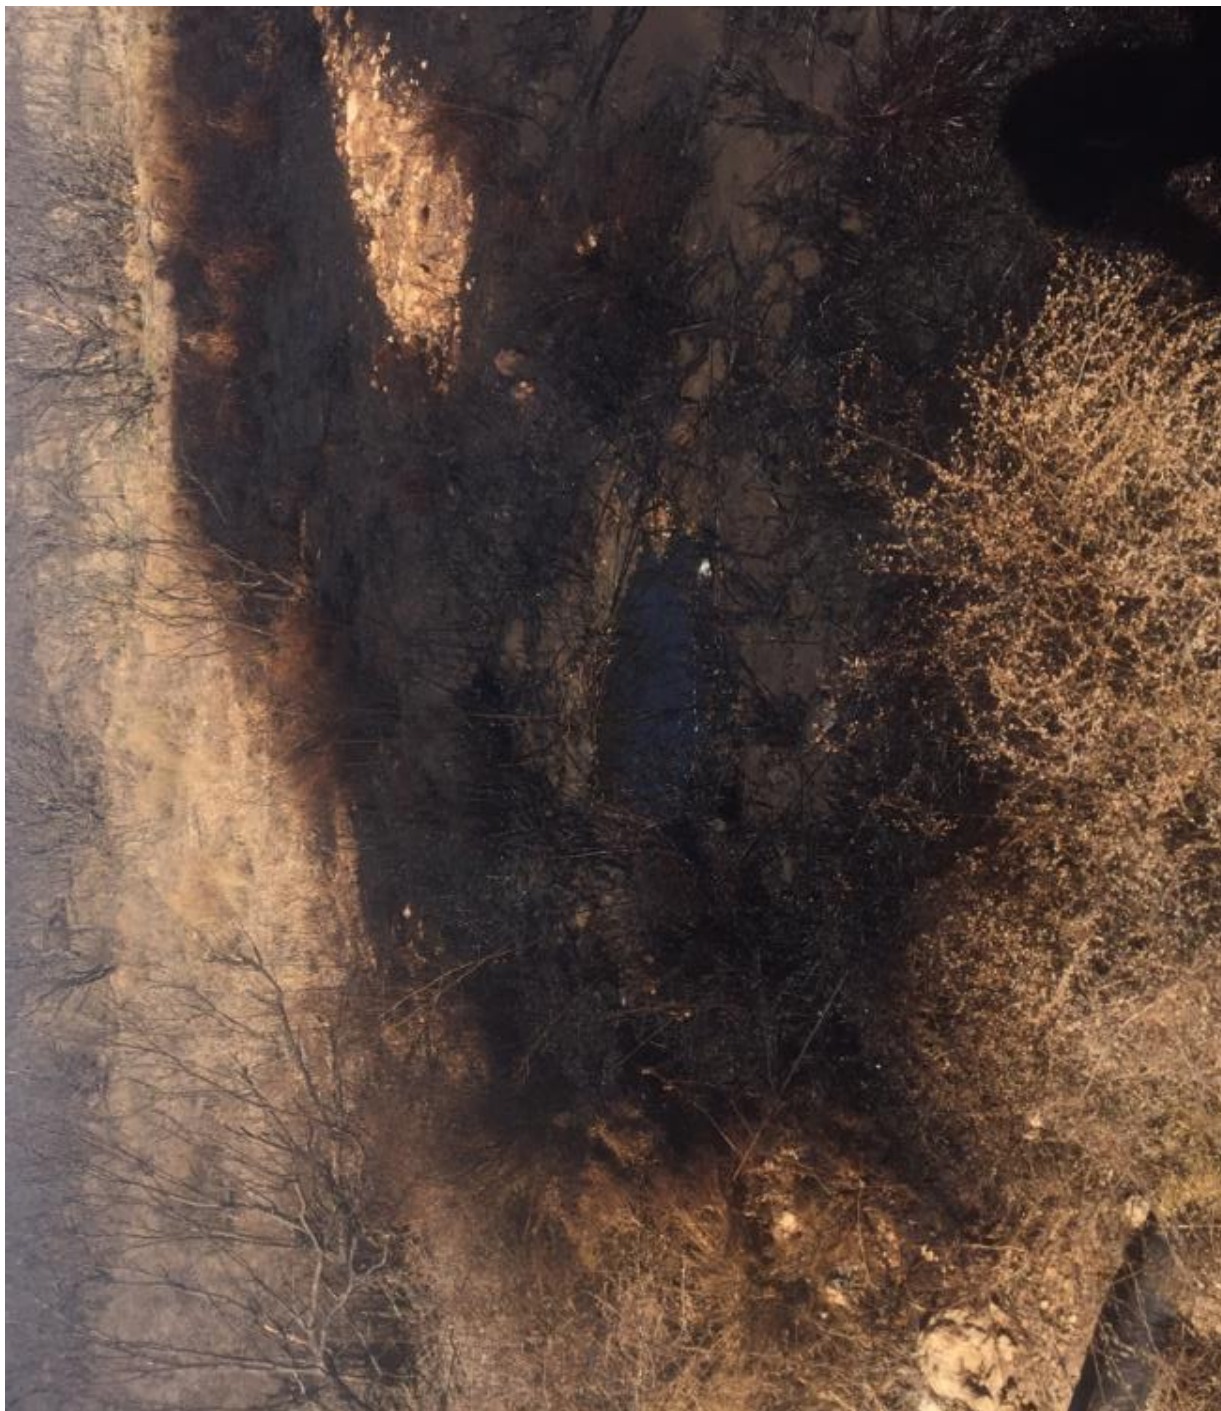
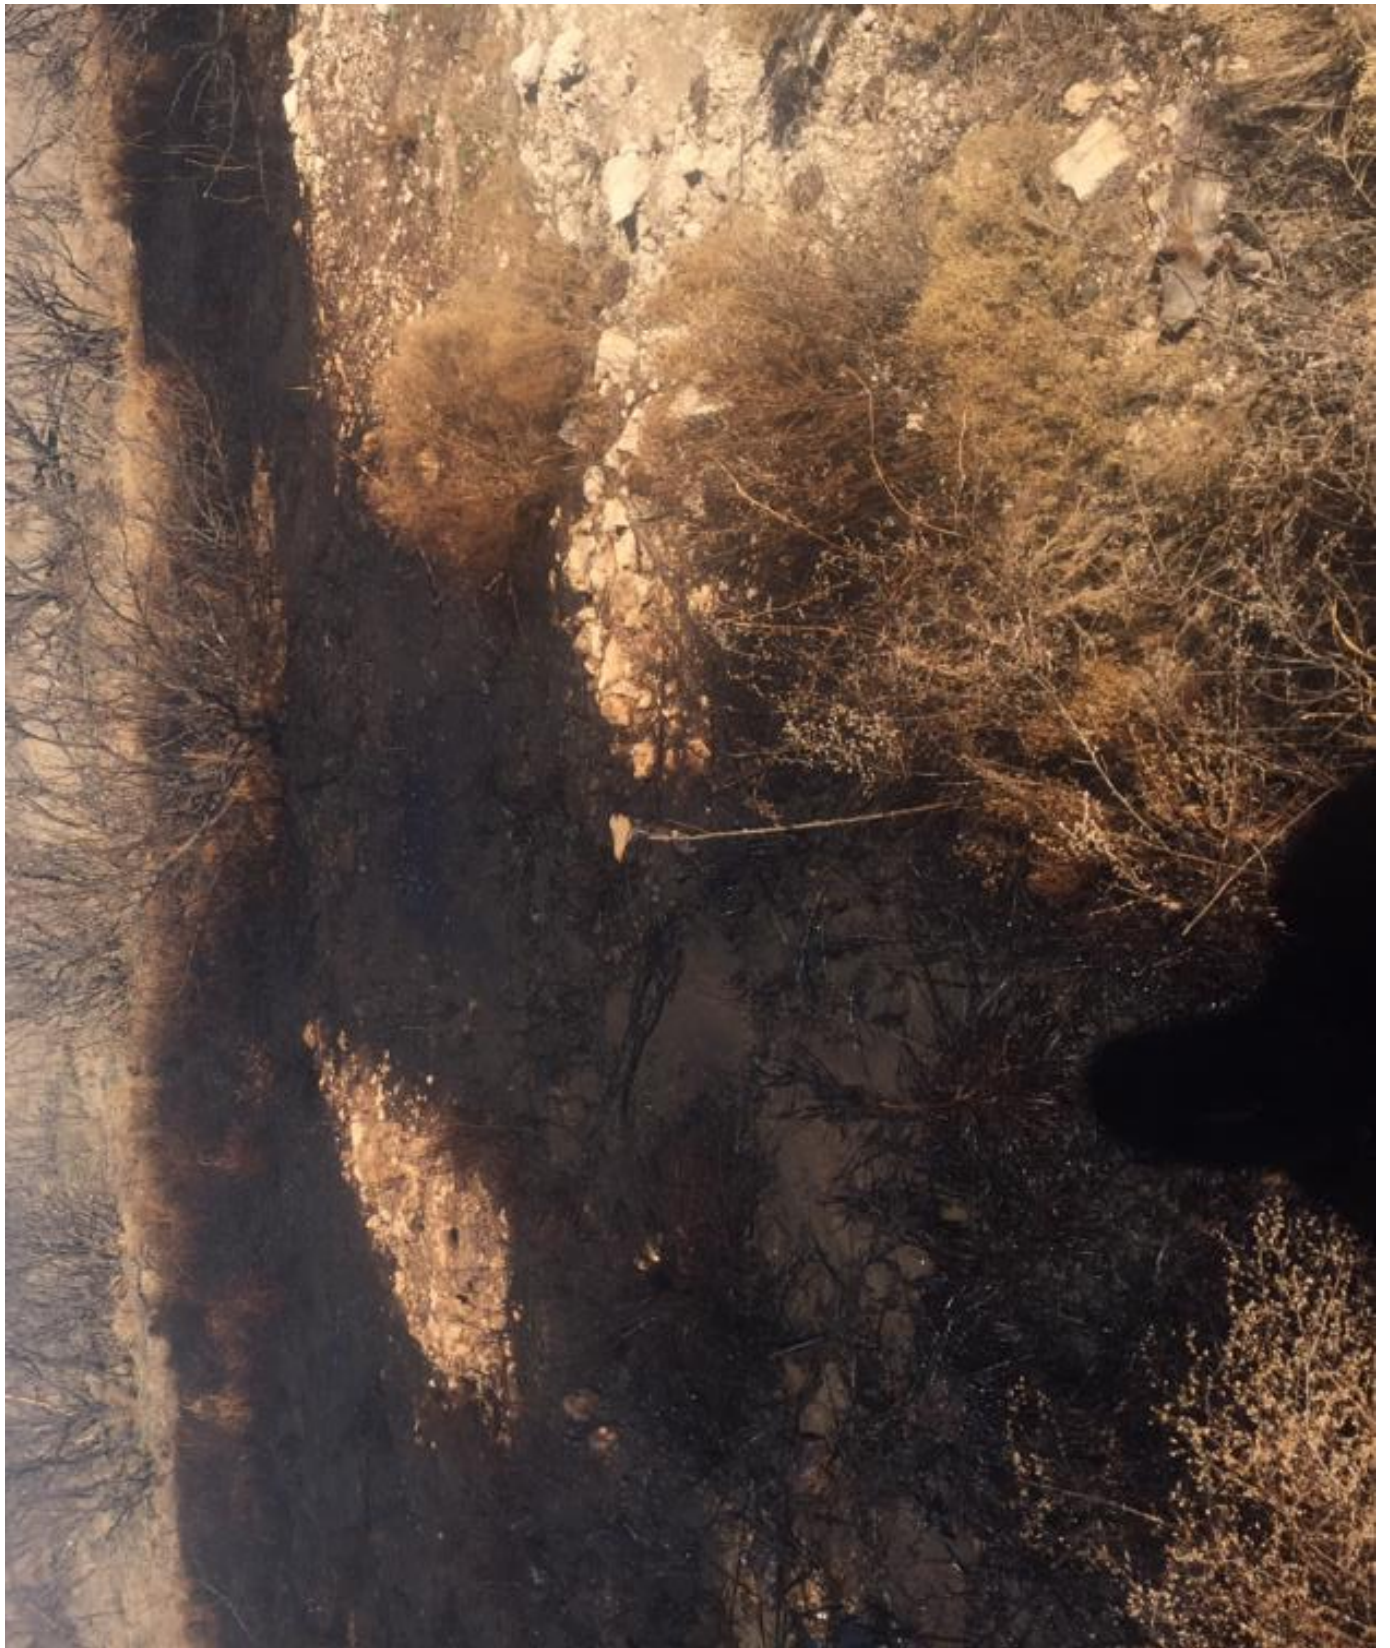
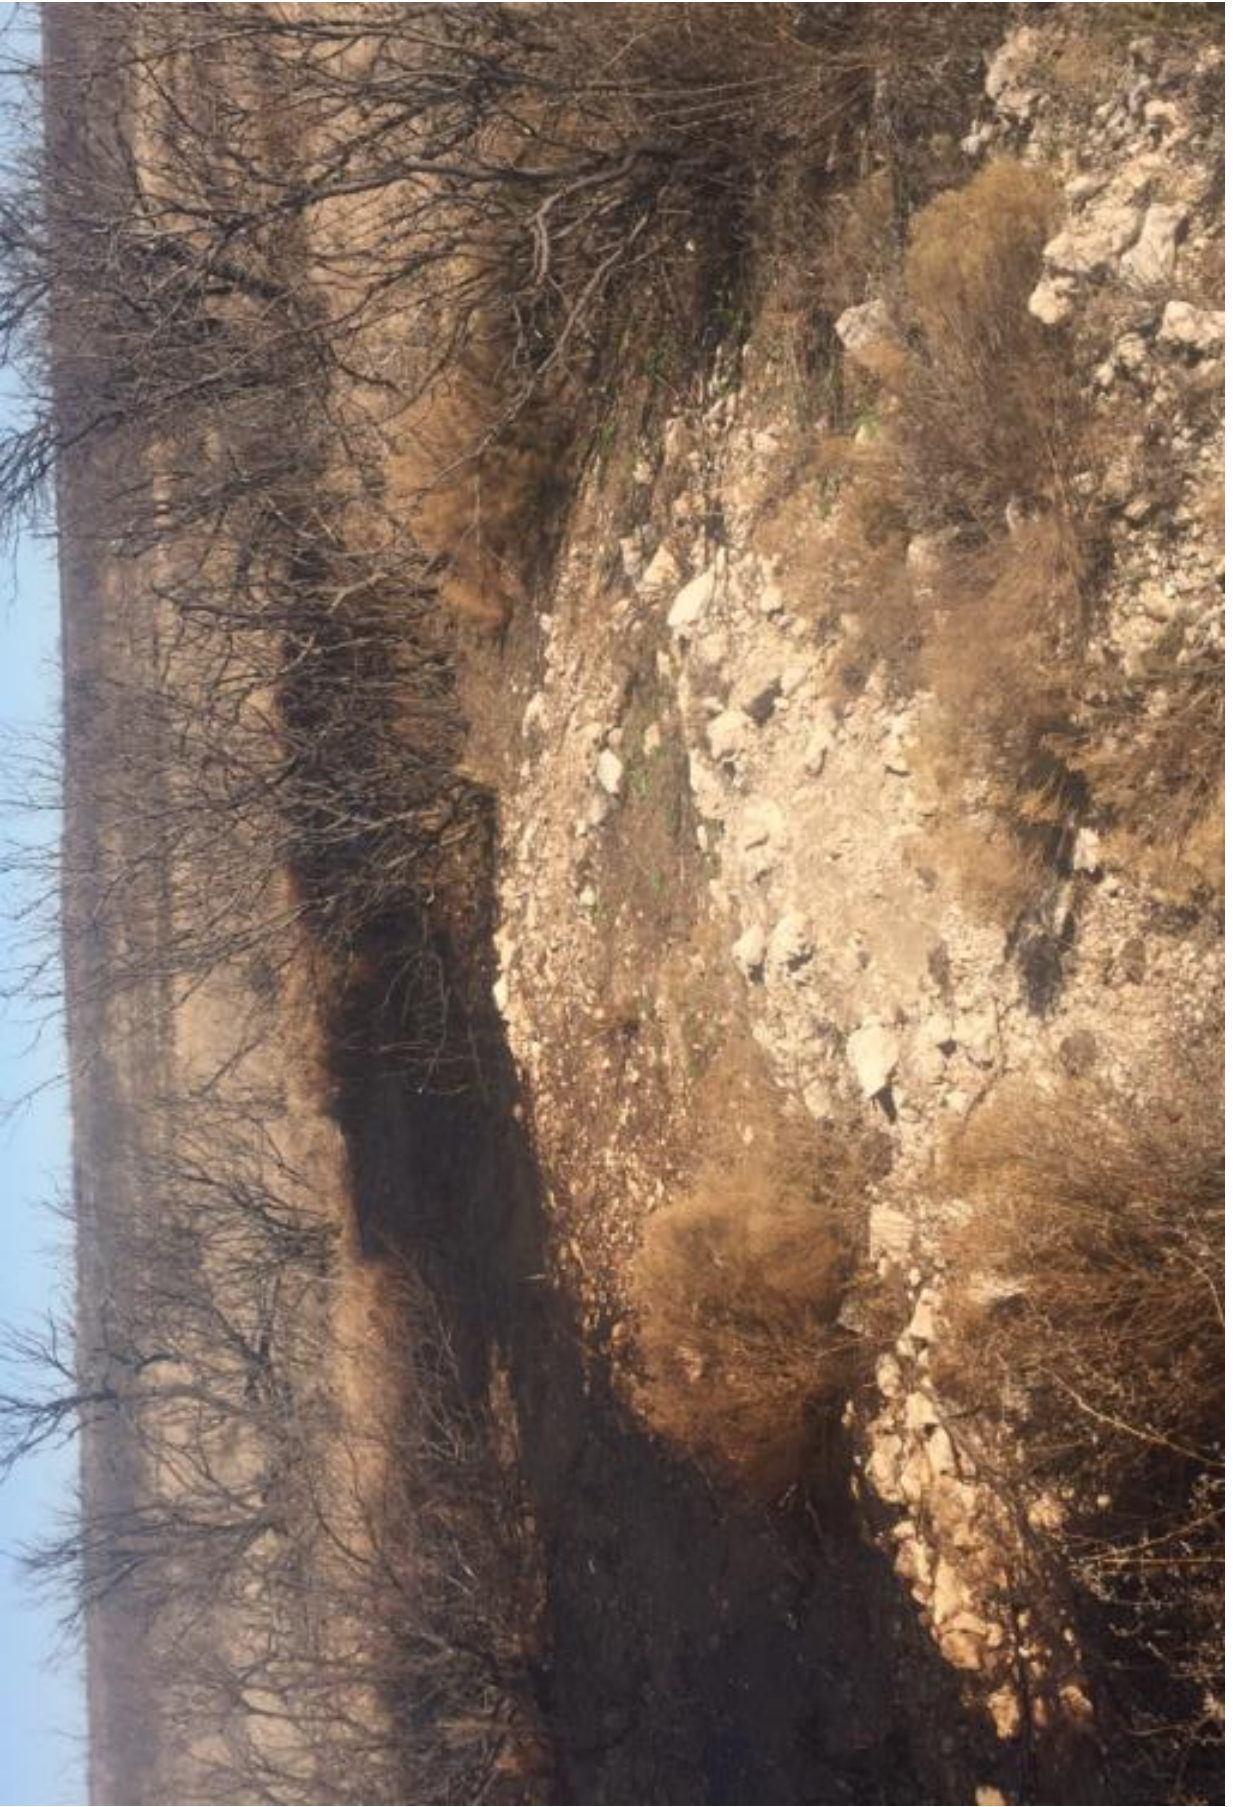
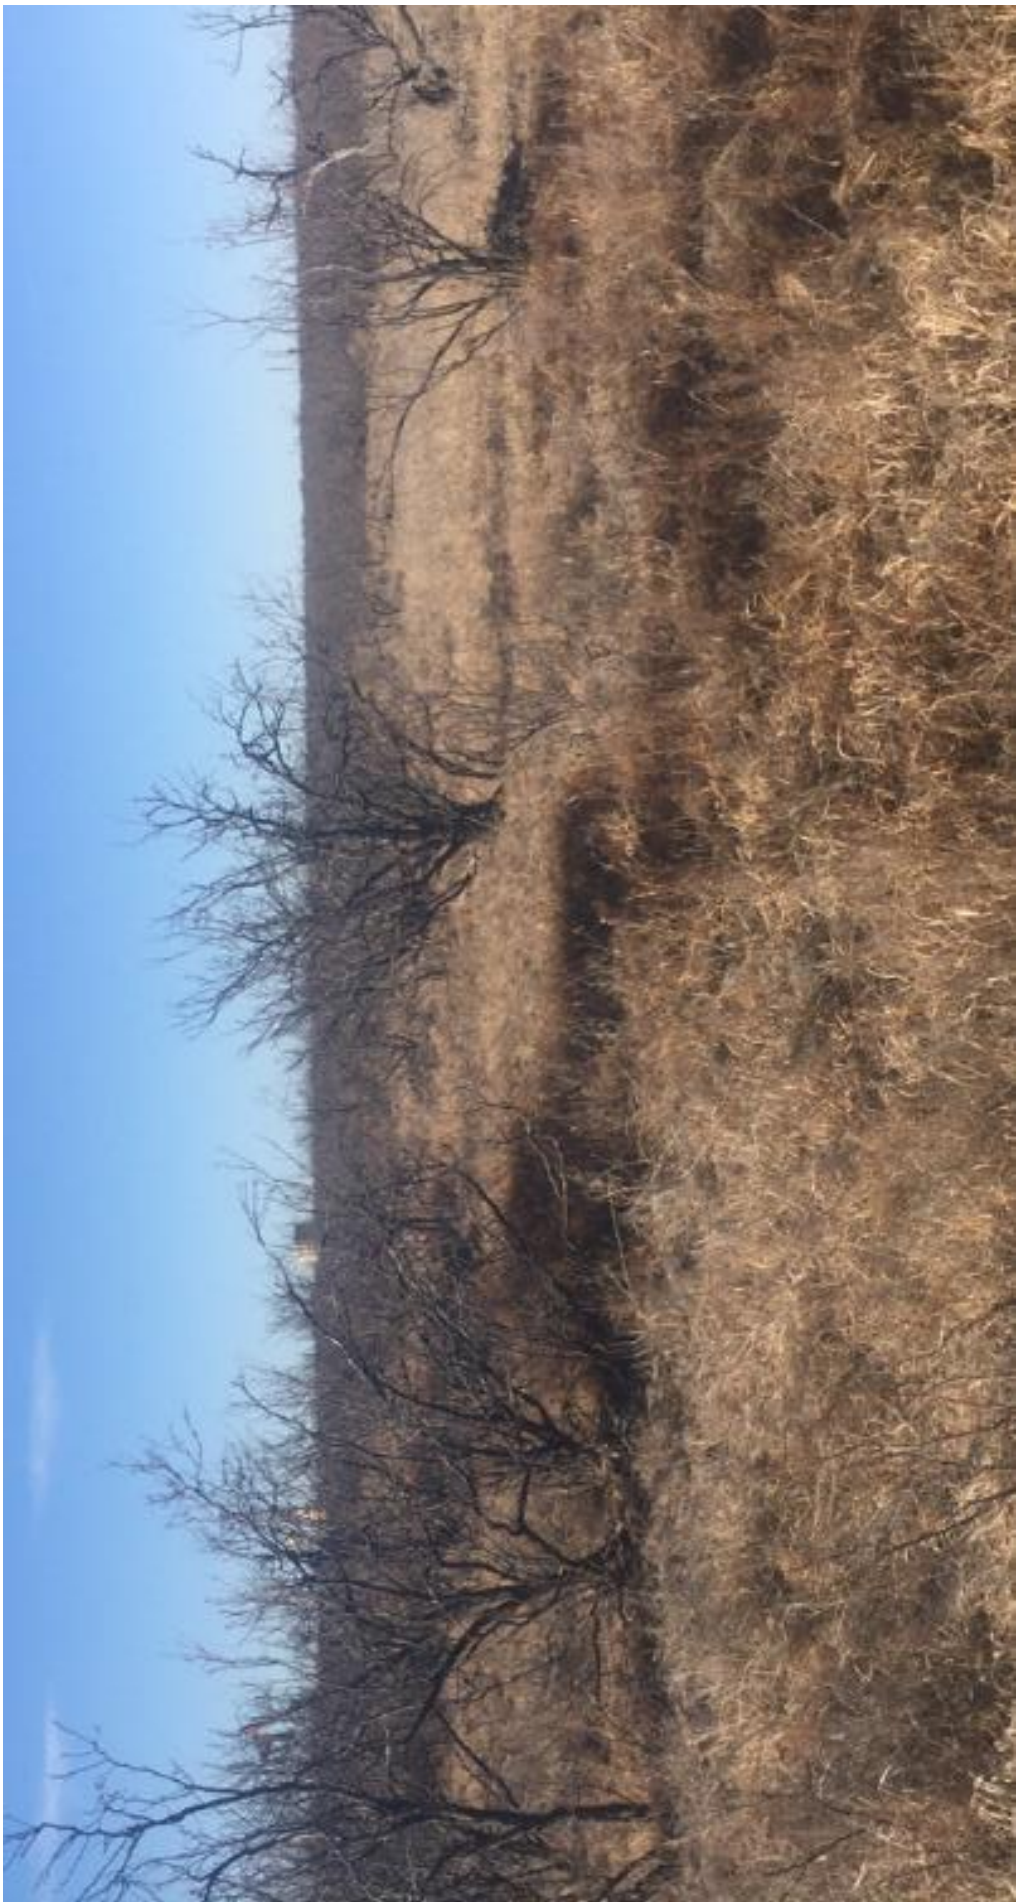
The following are photos taken immediately after the unauthorized release occurred and the wells in the area were shut in to prevent any further release of oil, produced water, or gas. Pictures are in order from west (where flowline failed) to east.
