**Re: Chevron Central Vacuum Unit 106/136
2017 Interim Remediation and Reclamation Report
Case No. 1RP-2642-0
Lea County, New Mexico**

2017 Interim Remediation and Reclamation Report

CVU 106/136

1R-2642-0

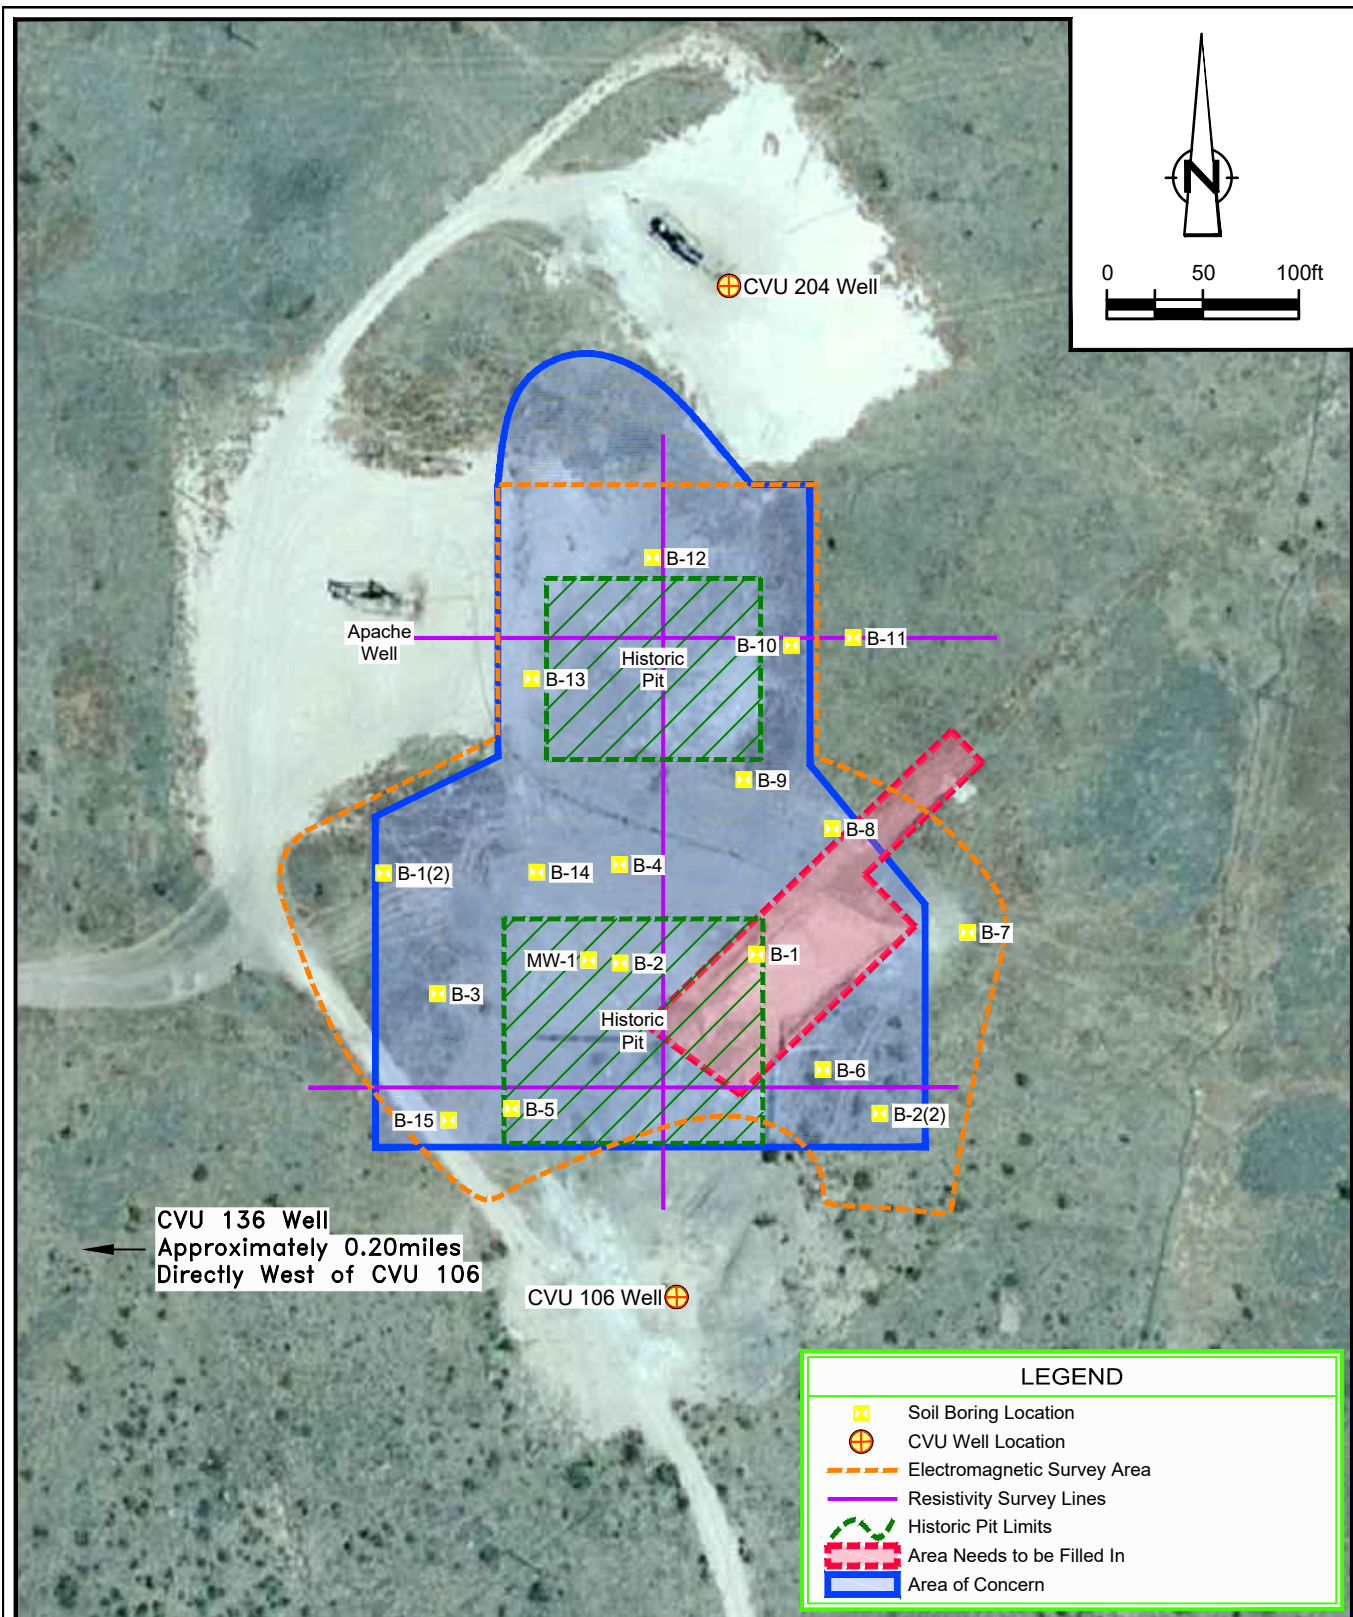
Figure 2

PROPOSED REMEDIATION ACTIVITY MAP
CVU No.136 AND CVU No.106
LEA COUNTY, NEW MEXICO
Chevron Environmental Management Company

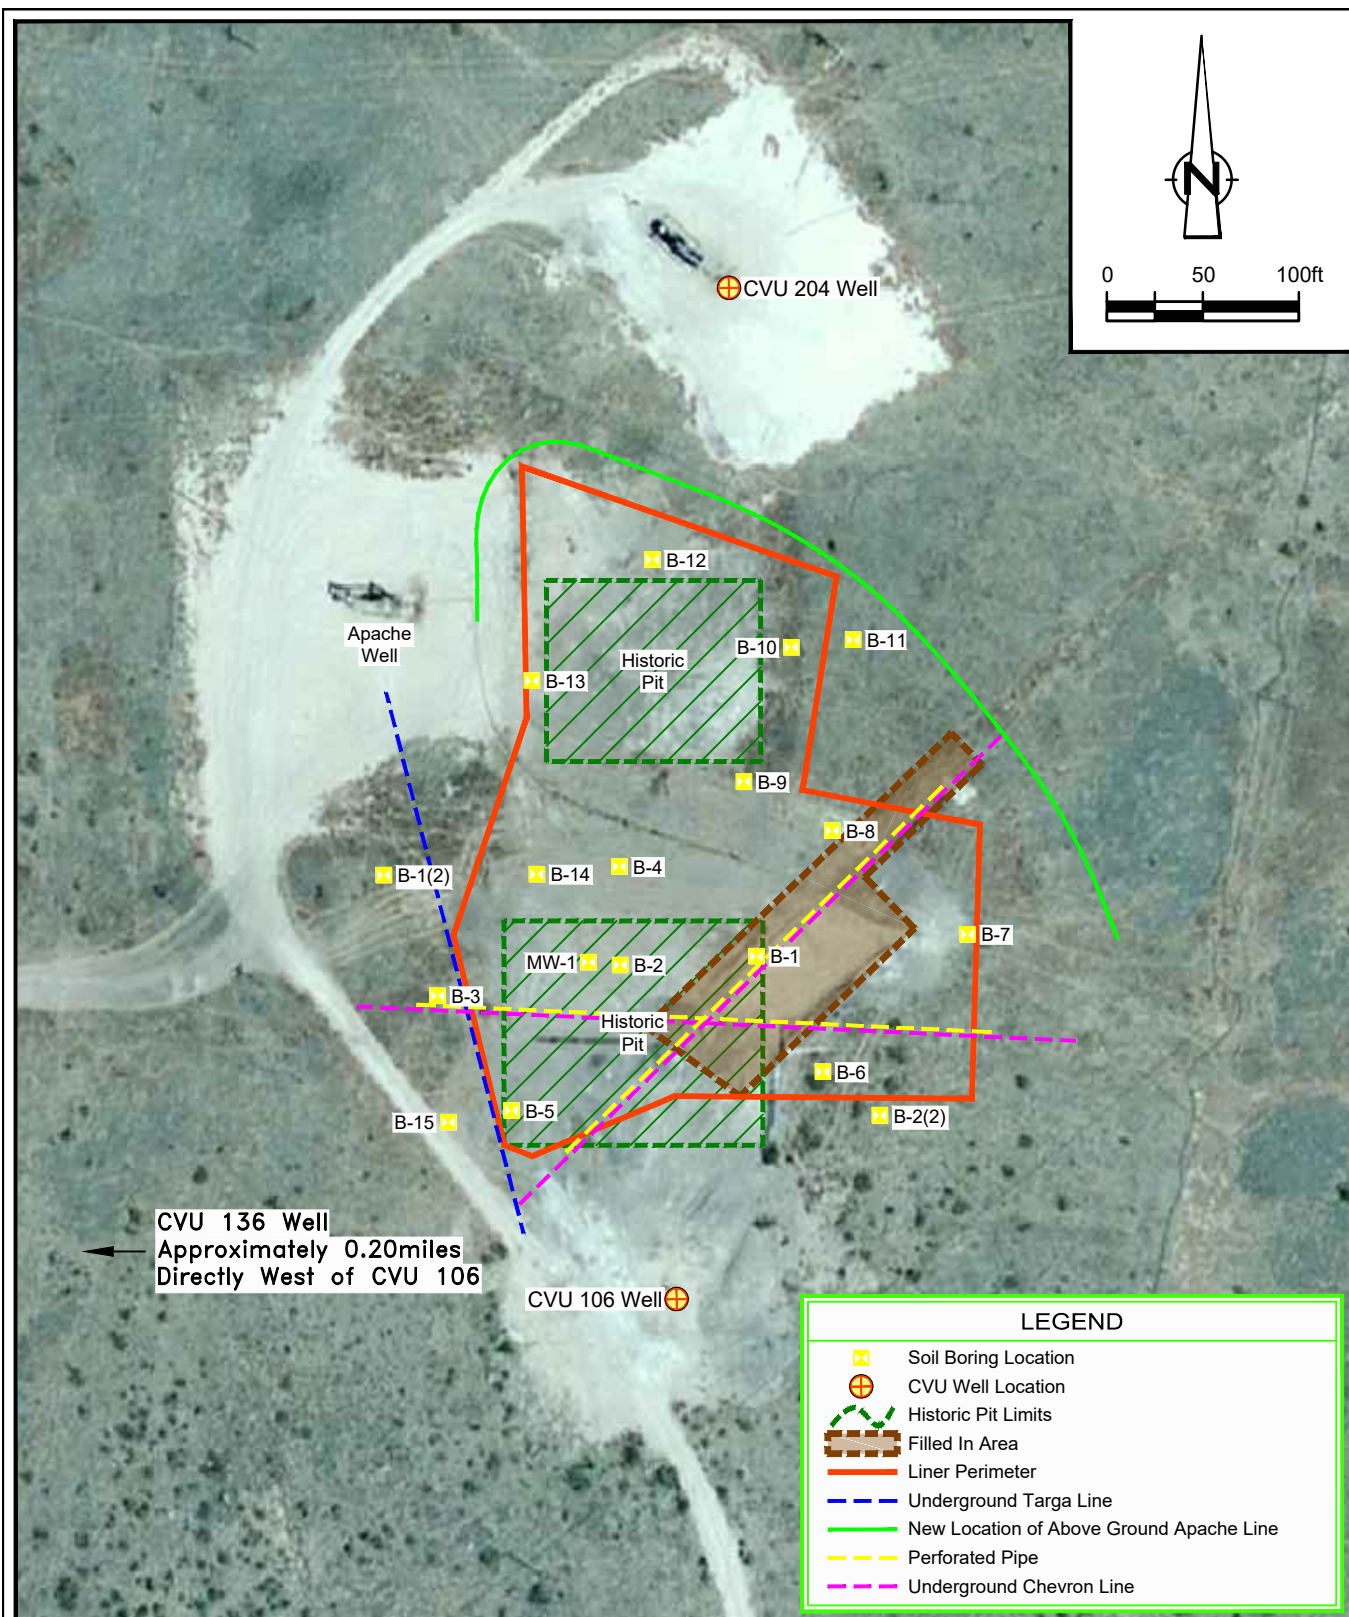
REMEDIATION ACTIVITY MAP
CVU No.136 AND CVU No.106
LEA COUNTY, NEW MEXICO

Soil sample and geophysical survey assessments provide evidence that chloride concentrations above the RRAL did not reach the groundwater table. Consequently, GHD recommended the installation of a liner to prevent further lateral and vertical migration of chlorides (see Figure 3 for liner location). After a discussion with the NMOCD on November 10, 2015, the agreed plan of action for the Site was the installation of a plastic liner in the area of impacted soil.

- An application for a Right of Entry (ROE) for Remediation permit to the NMSLO was completed and submitted prior to the start of work.
- The area to be lined (see Figure 3) was marked on the ground with flagging and NM811 was contacted to have underground utilities in the area pre-marked prior to physically locating the lines. Active lines in the vicinity were depressurized/shut down prior to being located by means of ground penetrating radar and day lighted by hydro excavation. Soils generated from hydro excavation were thin spread on site. Located lines can be referenced on Figure 3. All physical line locating was completed by September 14, 2017.

- The identified area of impact was lined with 20 mil polyethylene. The liner was placed to overlap the impacted area approximately ten feet at the edges. Once the area was lined, approximately one foot of caliche was placed to hold the liner down. Approximately one foot of topsoil was placed above the caliche to allow for reseeding of the area. Approximately 2,680 yards of caliche and 1,720 yards of topsoil were placed on top of the liner. Placement of the cover soil was completed on September 22, 2017.

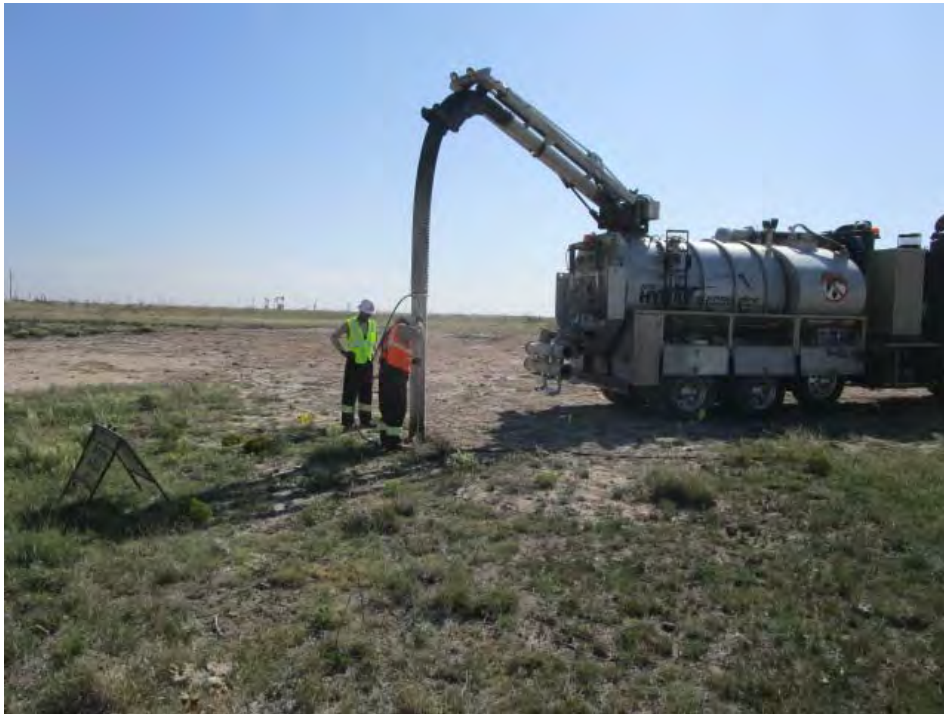
Photo 1 - Locating underground pipelines via hydrovac

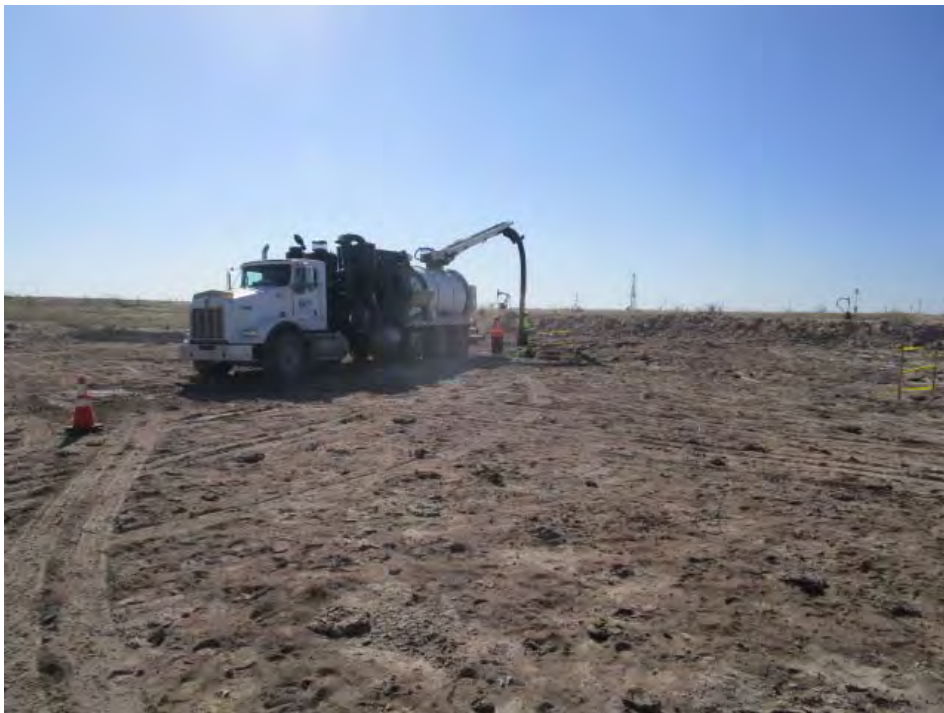
Photo 2 - Locating underground pipelines via hydrovac

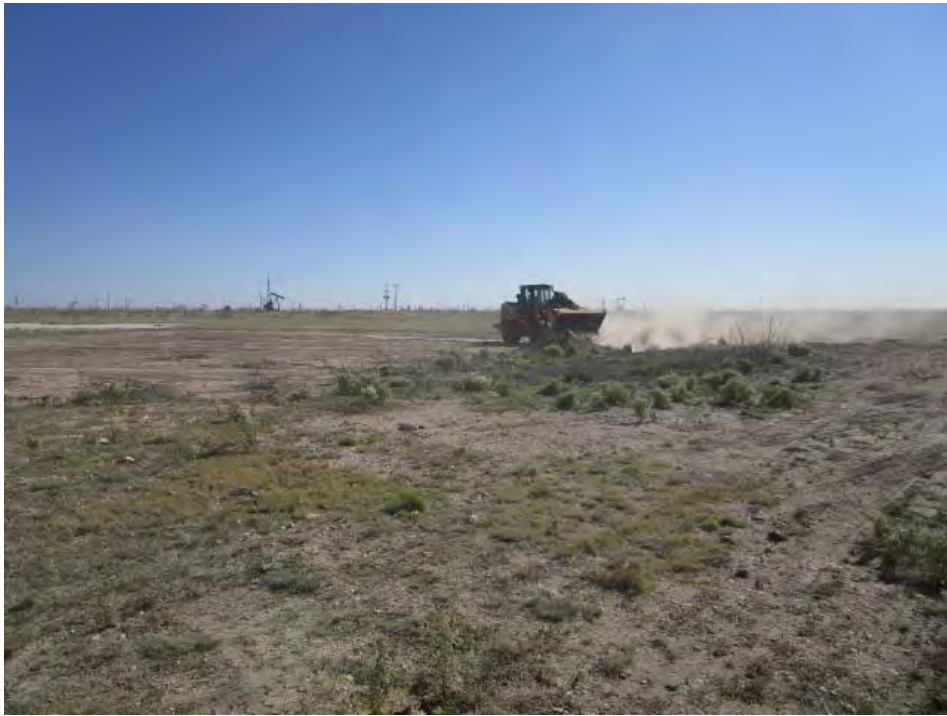
Photo 3 - Clearing, grubbing, and leveling the area to be lined

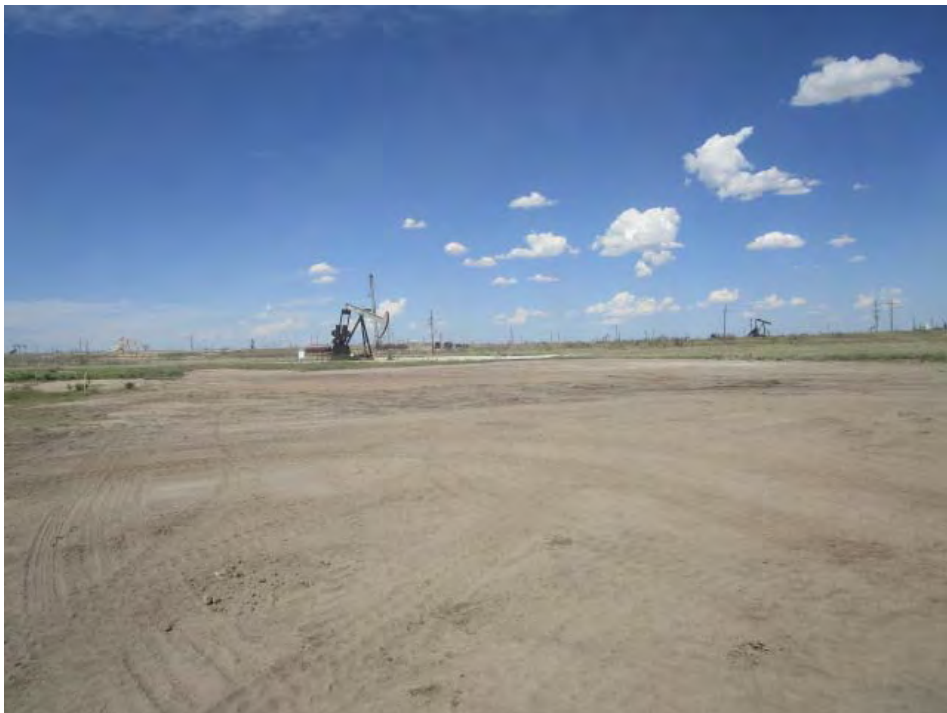
Photo 4 - Area to be lined is cleared and leveled

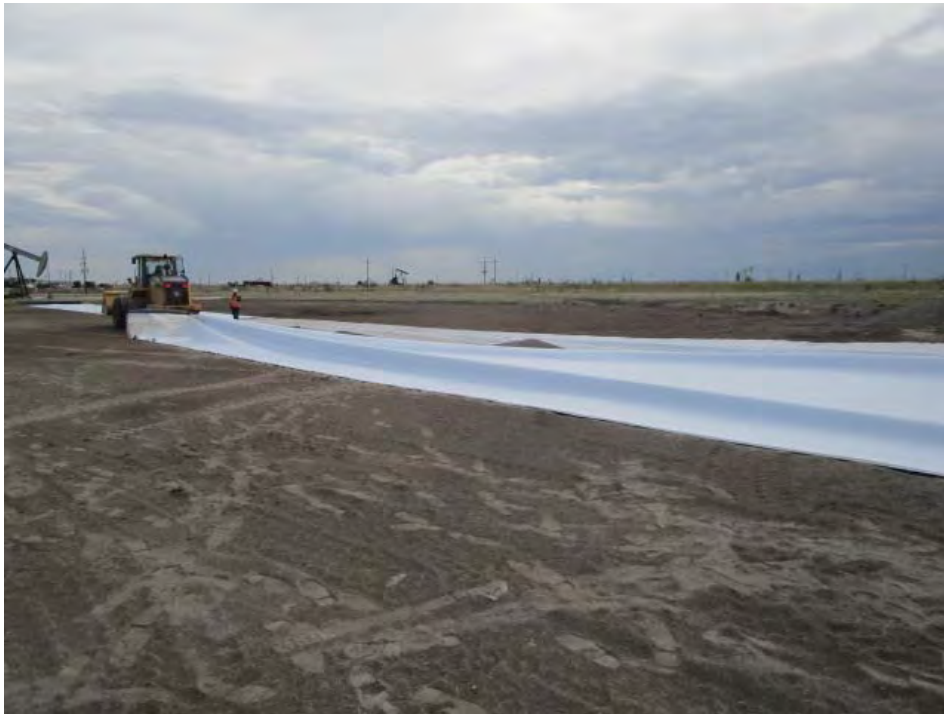
Photo 5 - Liner being placed

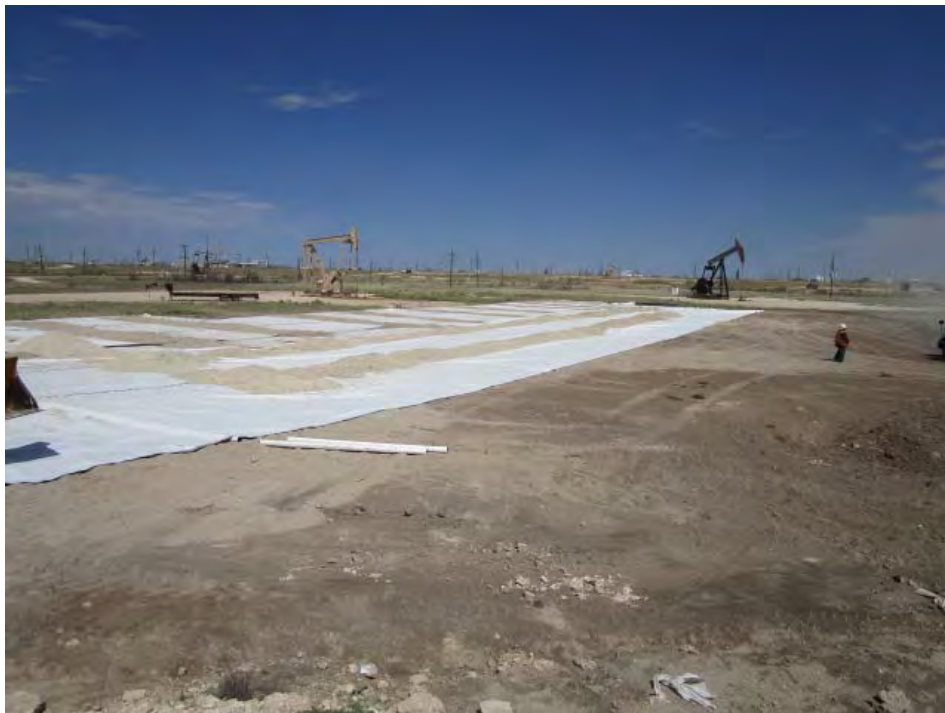
Photo 6 - Perforated pipe placed on top of underground pipelines and underneath the liner for leak detection

- The area that had been excavated in 2010 was backfilled to grade with clean caliche.
- Prior to placement of the liner, perforated PVC pipe was placed at ground surface along the length of each buried pipeline and extended at least ten feet past the edge of the cap material. The perforated PVC pipe was installed at the request of the NMOCD to act as leak detection. In the event that a release occurred from any of the buried pipelines, the perforated pipe would allow for leaking liquids to flow through the PVC to the edge of the cap where it could be observed. Signs were posted at the ends of the PVC pipe indicating that if liquids were present, Chevron should be contacted.

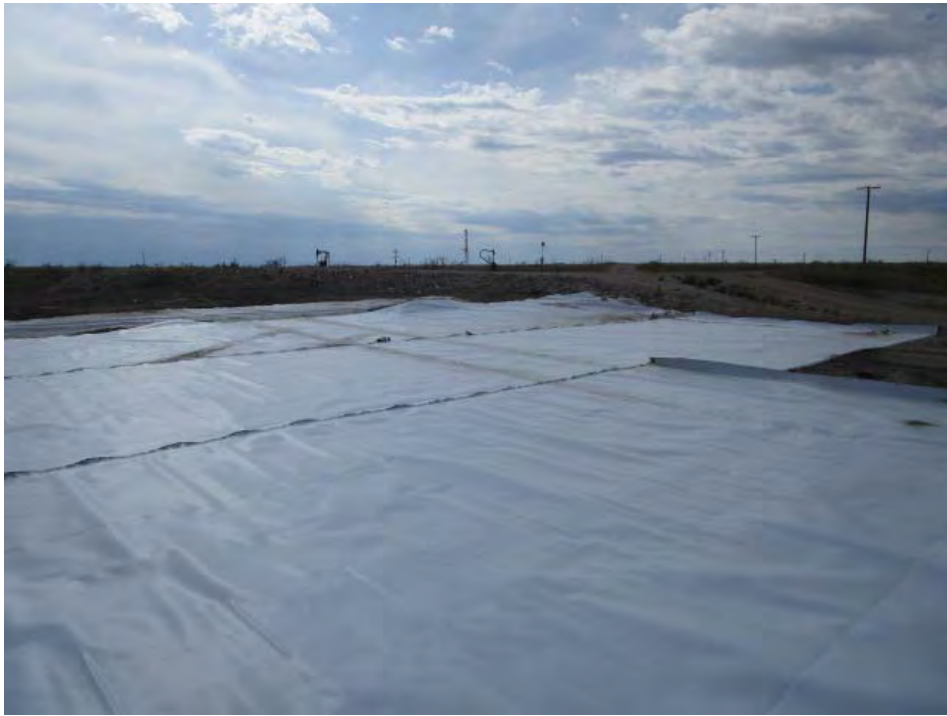
Photo 7 - Liner is placed over the entire cleared area

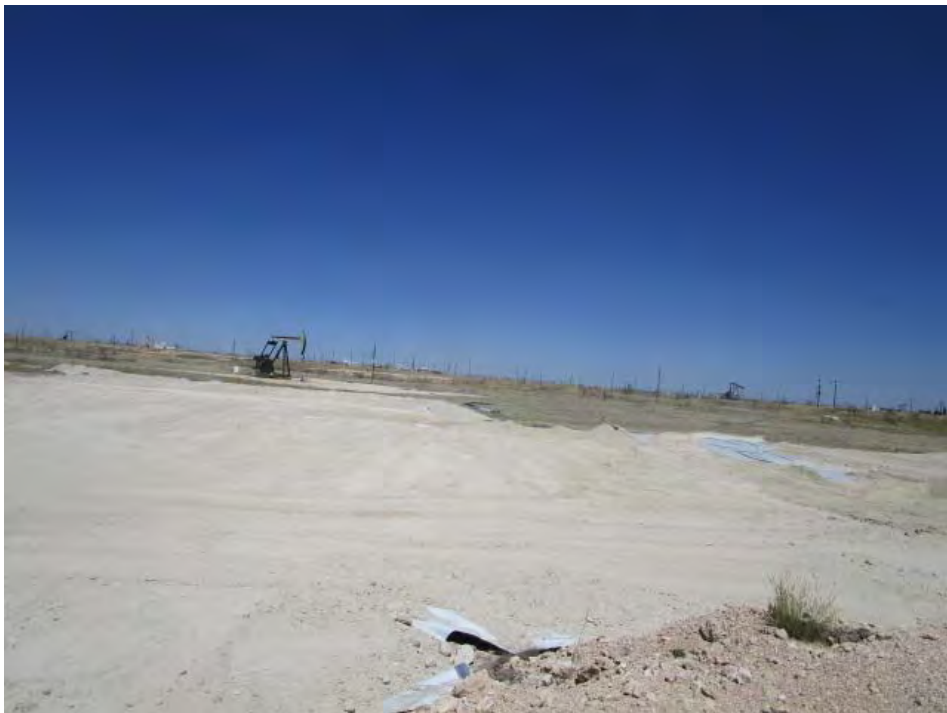
Photo 8 - Caliche placed on top of the liner to secure in place

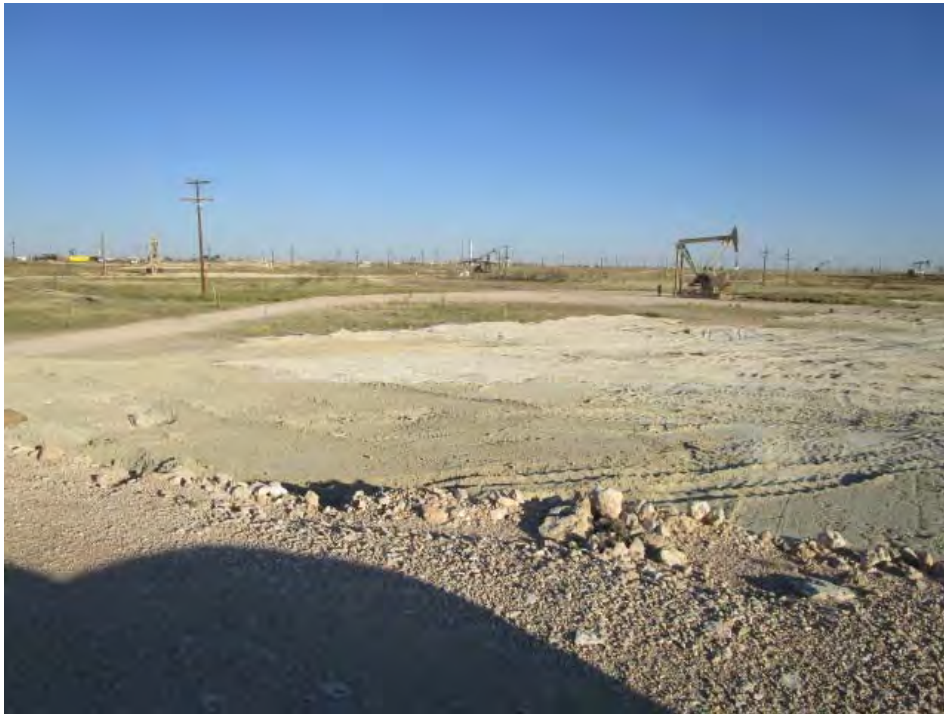
Photo 9 - Approximately one foot of caliche placement complete

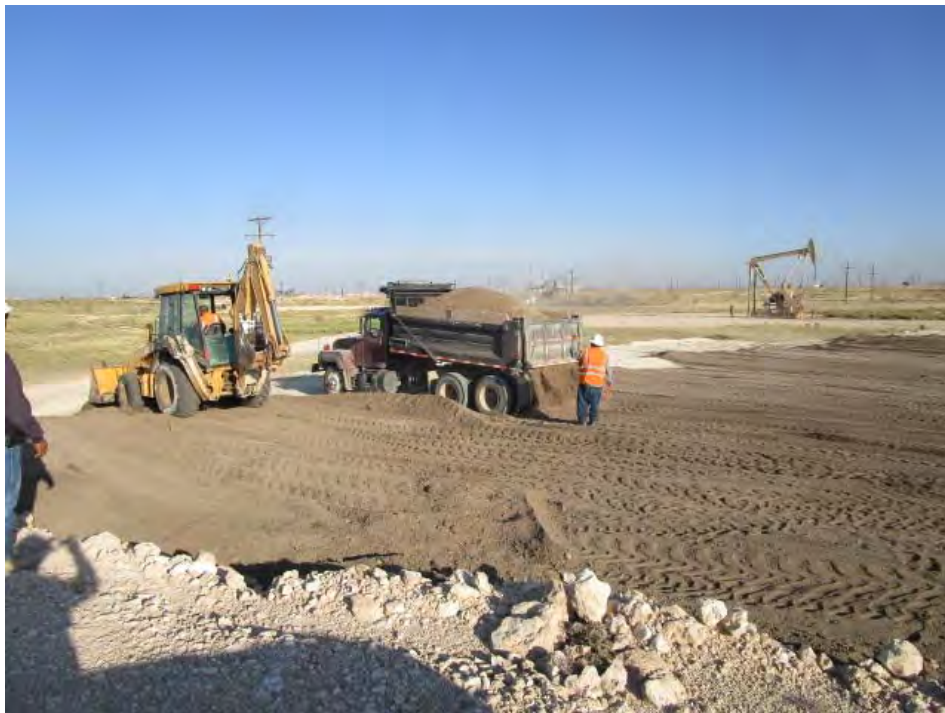
Photo 10 - Placement of topsoil on caliche

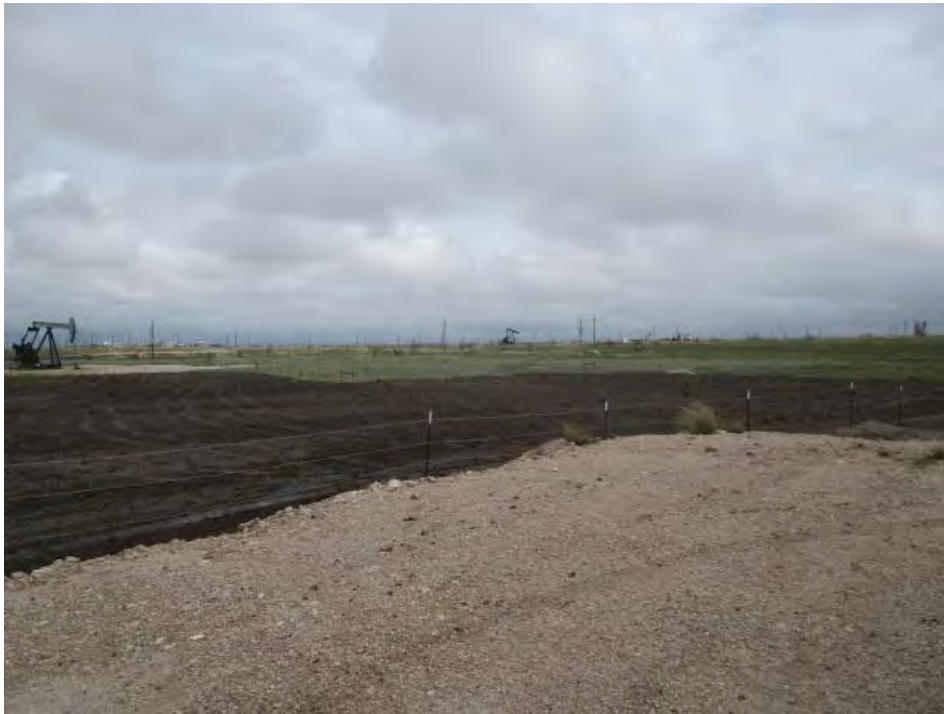
Photo 11 - A foot of topsoil placed and reclaimed area fenced off for seeding

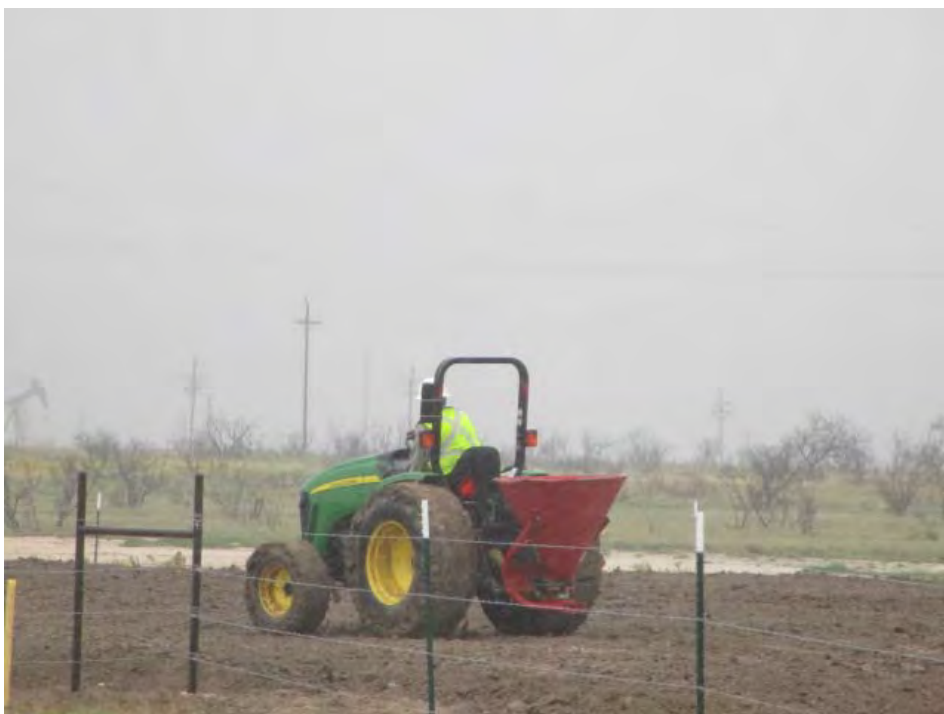
Photo 12 - Native seed mix BLM #2 broadcasted across the reclaimed area

- On October 3 and 4, 2017, the disturbed area associated with the remediation efforts was reseeded. A T-post and barbwire fence was put in place surrounding the seeded area. Seed was broadcast in the area and disked following spreading. The seed mix placed was BLM No. 2 without lovegrass. If after one growing season the vegetation has not taken hold, seeding may be repeated until revegetation is successful.
