RE: **Notice of Reclamation & Revegetation of Temporary Pit Closures**
Murchison Oil and Gas, Inc., Lea County

Table 1 - Temporary Pit Closure Requests

SUBJECT: *Reserve Pit Inspection: SI-173*
Murchison Oil & Gas, Inc.

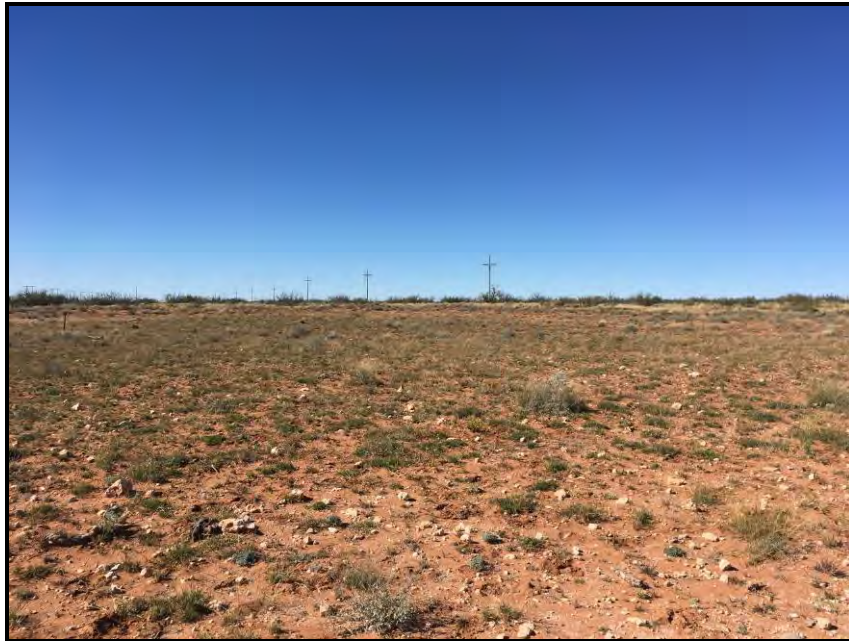
Photo A: View of reserve pit at Jackson Unit #23H facing west.

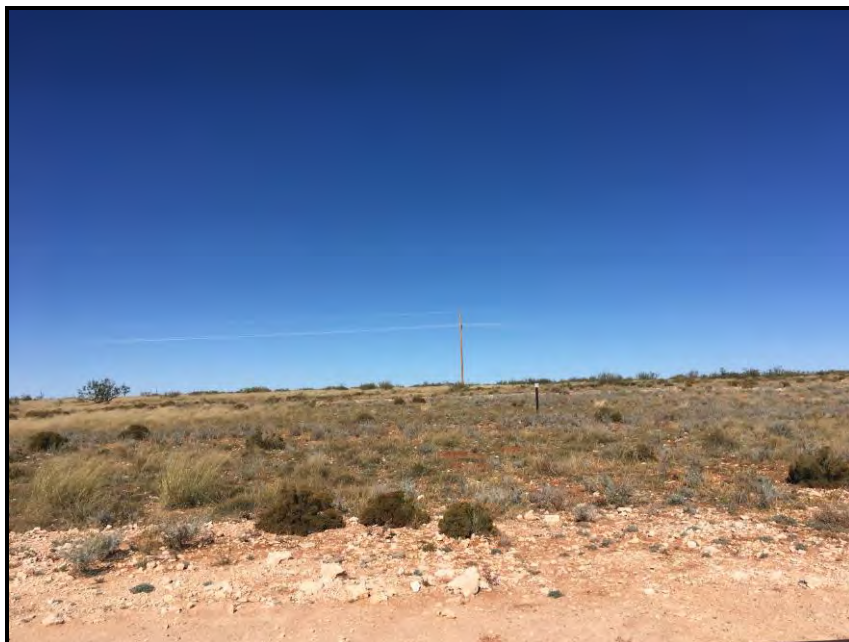
Photo B: View of reserve pit at Jackson Unit #24H facing north.

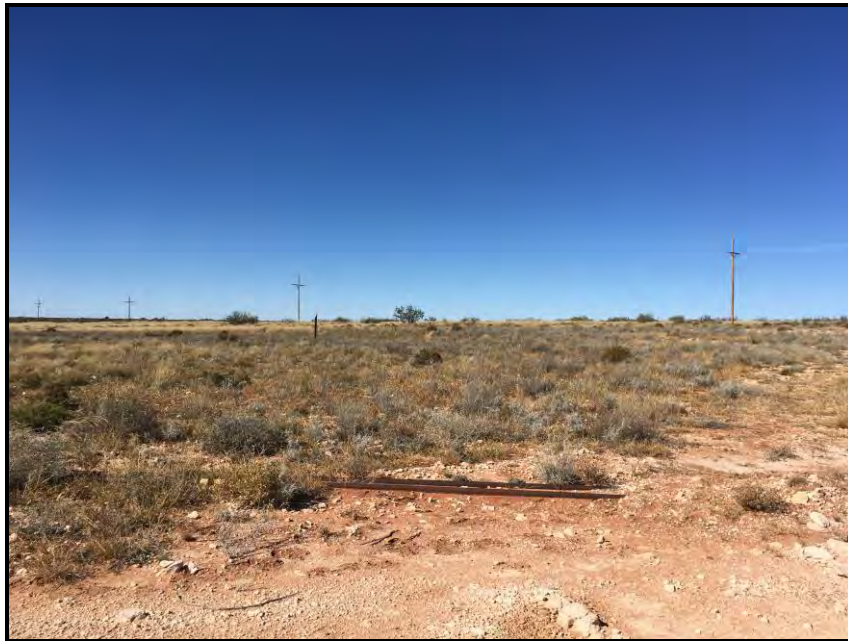
Photo C: View of reserve pit at Jackson Unit #25H facing west.

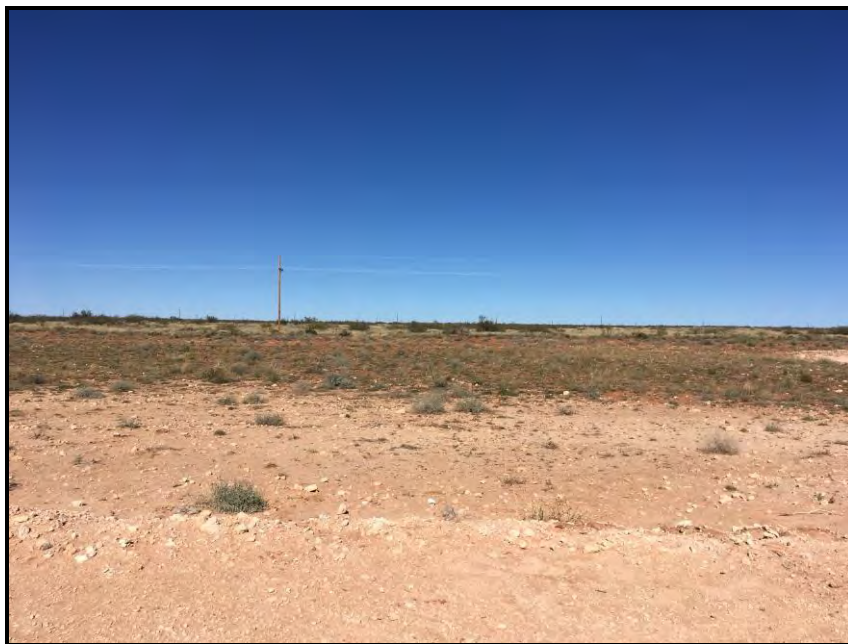
Photo D: View of reserve pit at Jackson Unit #22H facing north.

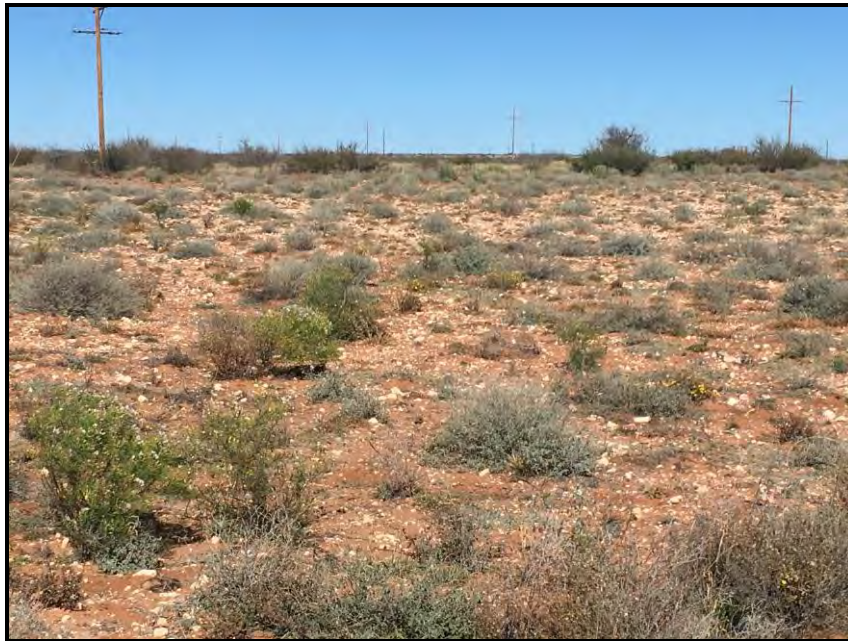
Photo E: View of reserve pit at Jackson Unit #21H facing north.

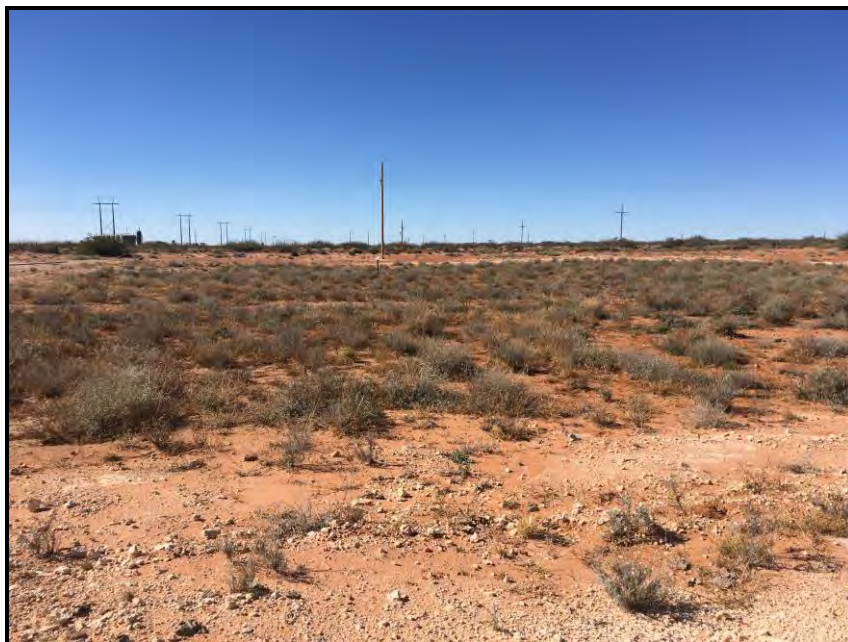
Photo F: View of reserve pit at Jackson Unit #19H facing west.

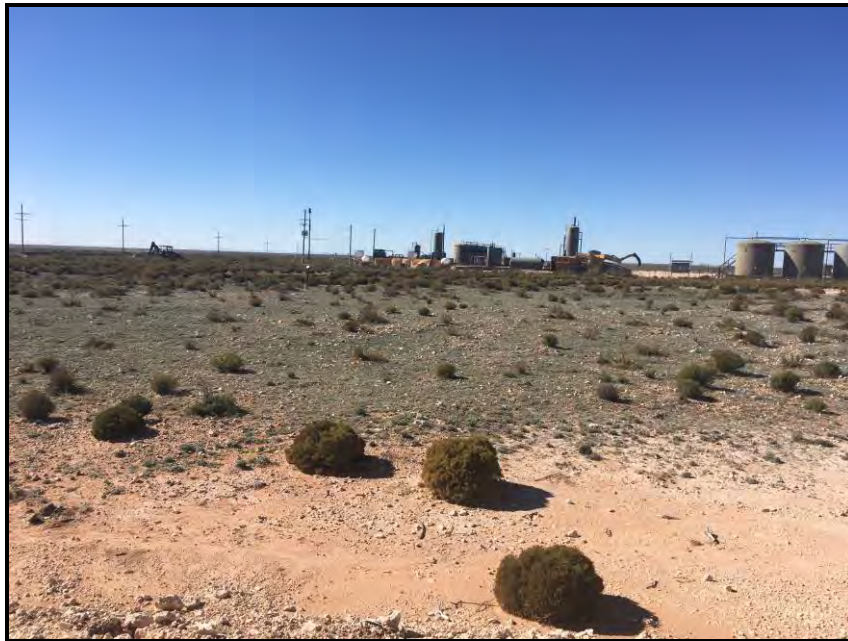
Photo G: View of reserve pit at Jackson Unit #12H facing west.

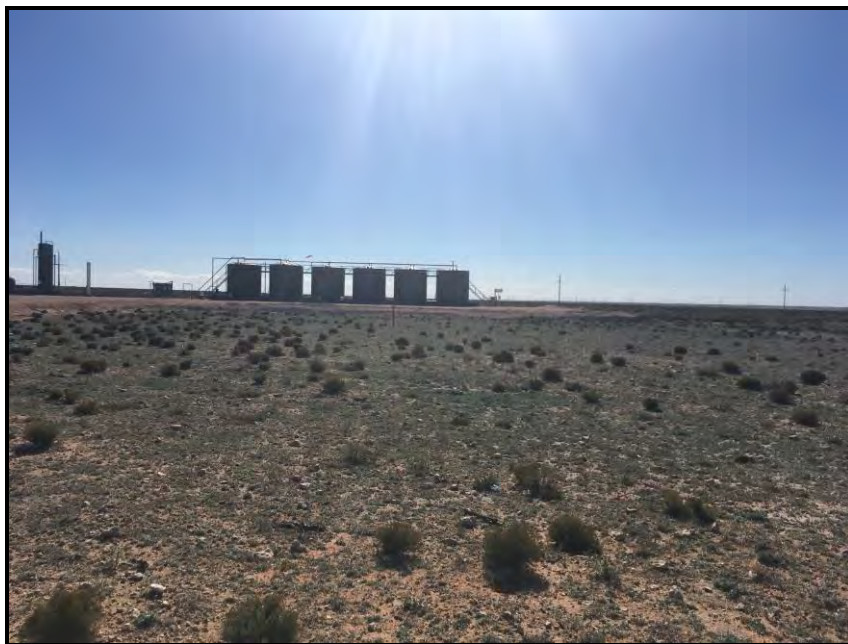
Photo H: View of reserve pit at Jackson Unit #11H facing south.

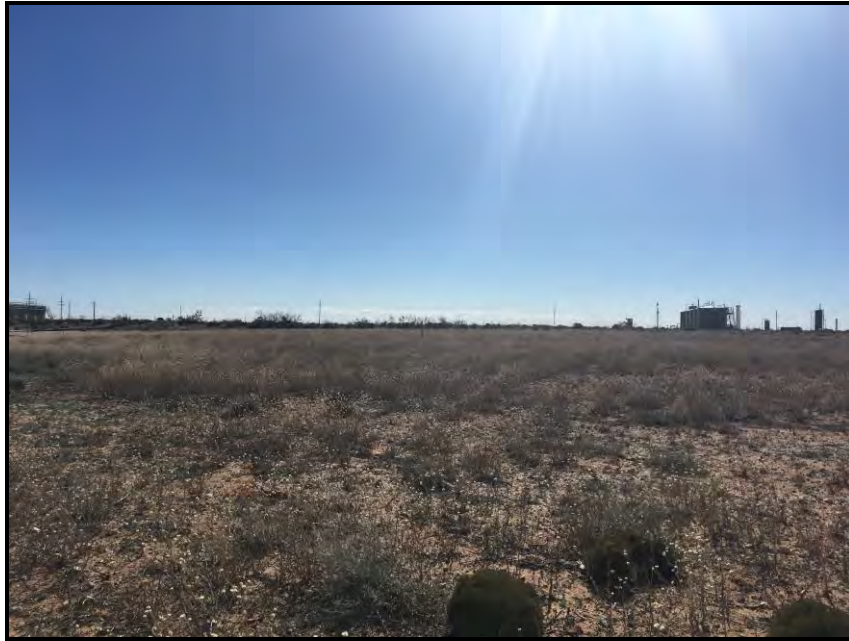
Photo I: View of reserve pit at Mogi 9 St Com #4H facing south.

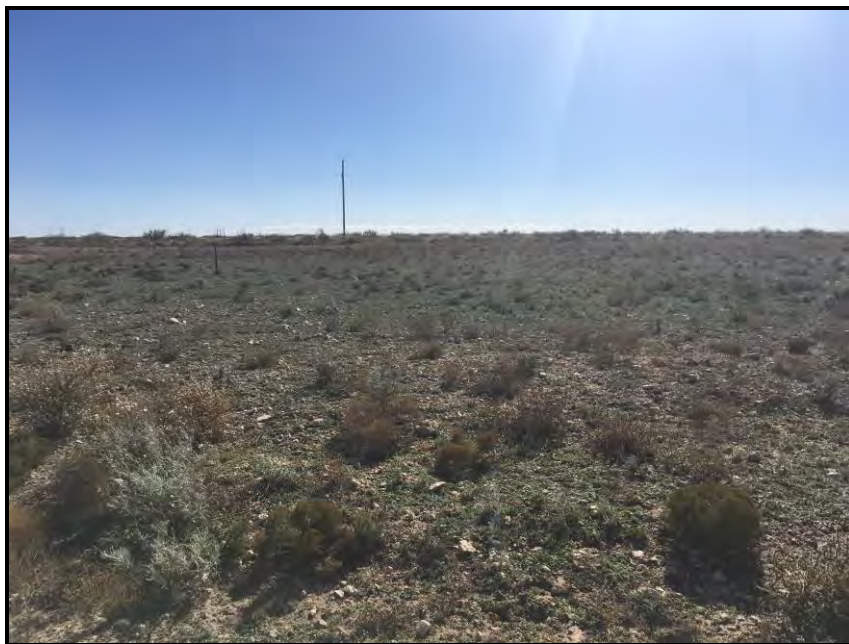
Photo J: View of reserve pit at Mogi 9 St Com #4H facing west.

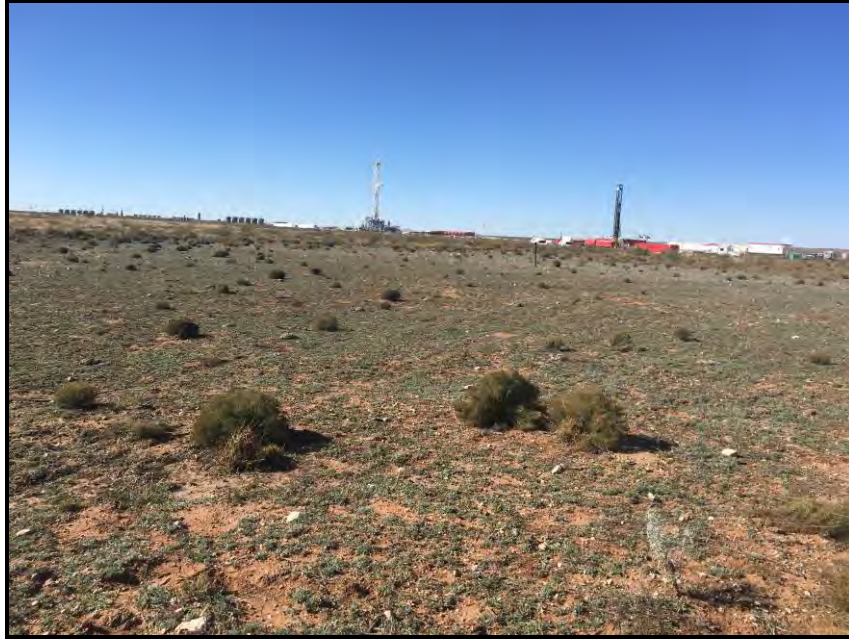
Photo K: View of reserve pit at Jackson Unit #15H facing west.

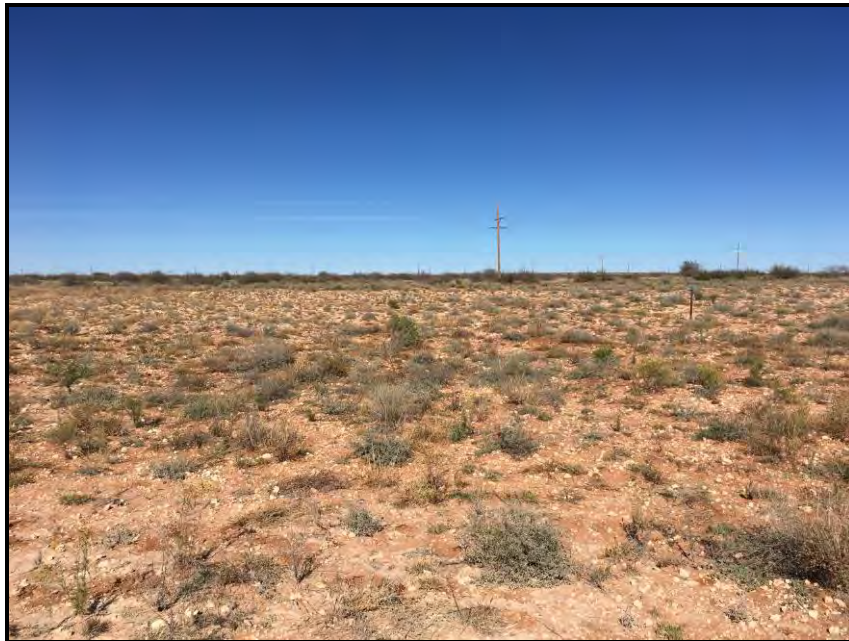
Photo L: View of reserve pit at Jackson Unit #17H facing north.
