*EOG Resources, Inc.
Artesia Division Office
104 S. 4th Street
Artesia, N. M. 88210*

Re: Waylon BMD State #8
30-025-38256
Section 14, T11S-R34E
Lea County, New Mexico
1RP-

EOG Y Resources, Inc. is submitting the enclosed CLOSURE REPORT and C-141 Final Report for the above captioned location. The report is being submitted in response to the C-141 Initial Report dated 12/18/2017.

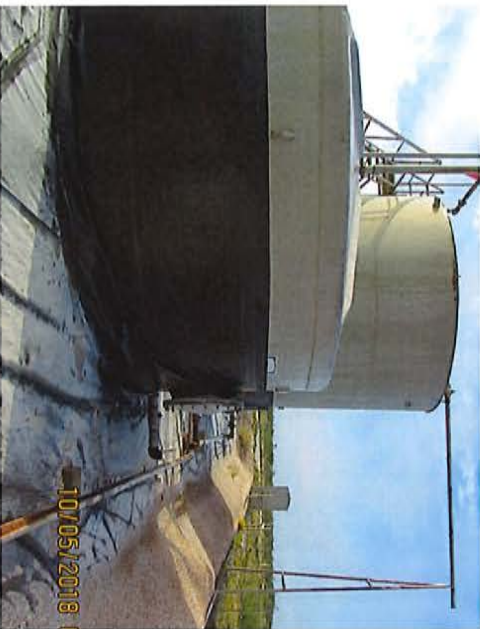
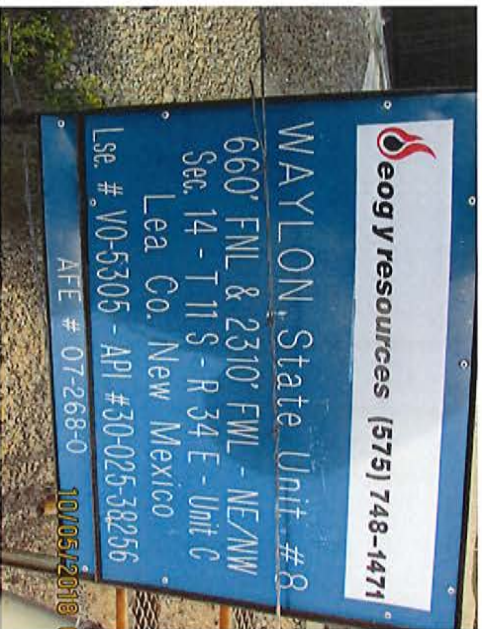
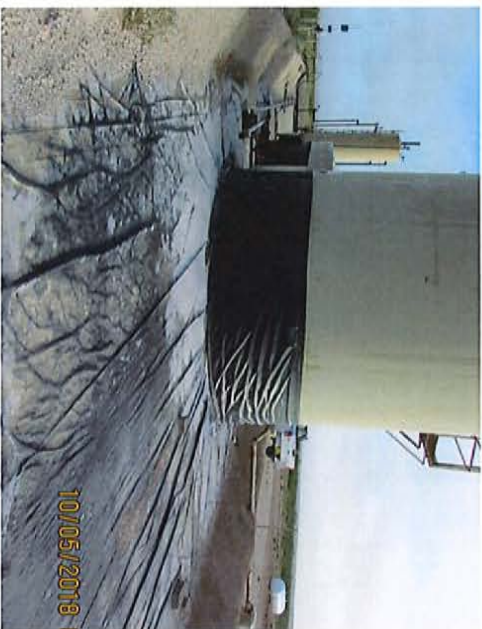
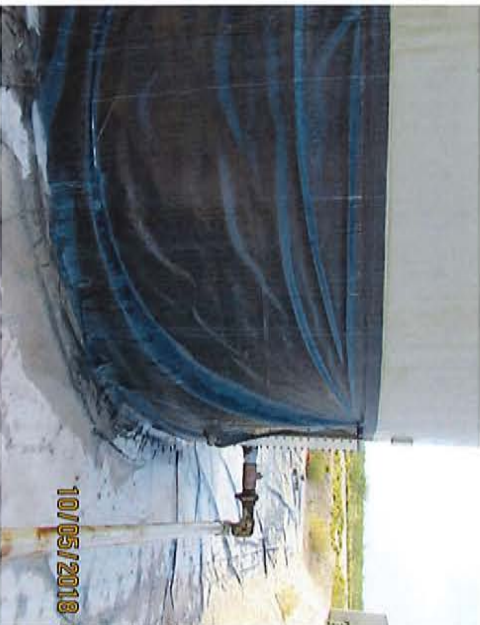
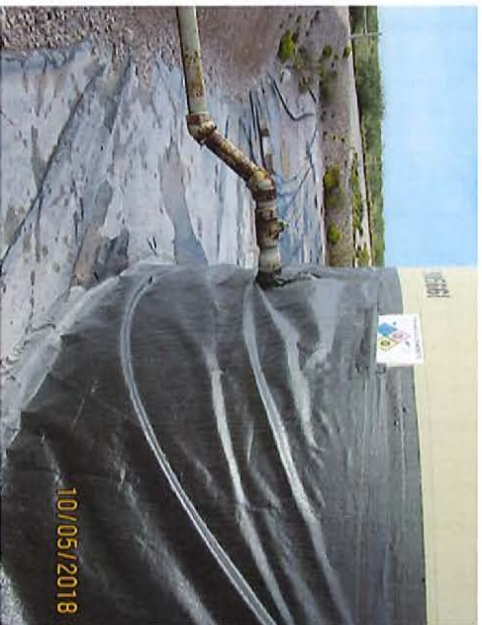
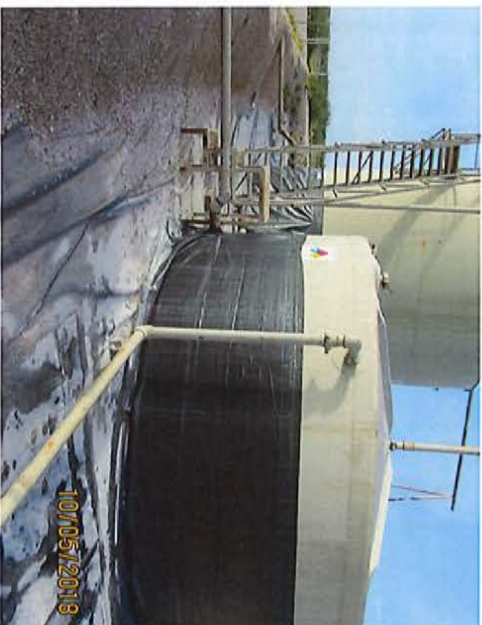
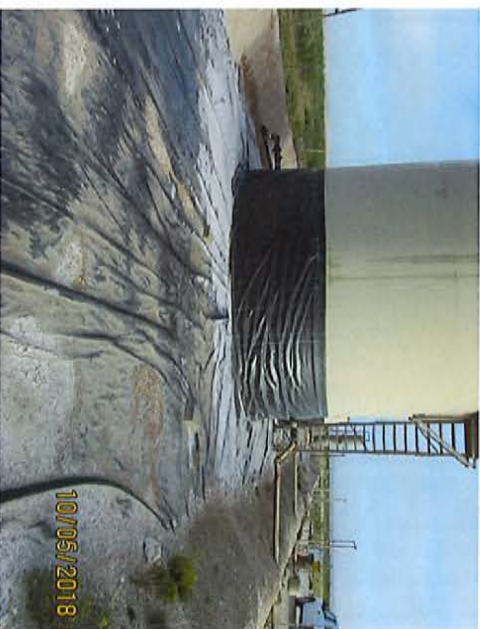
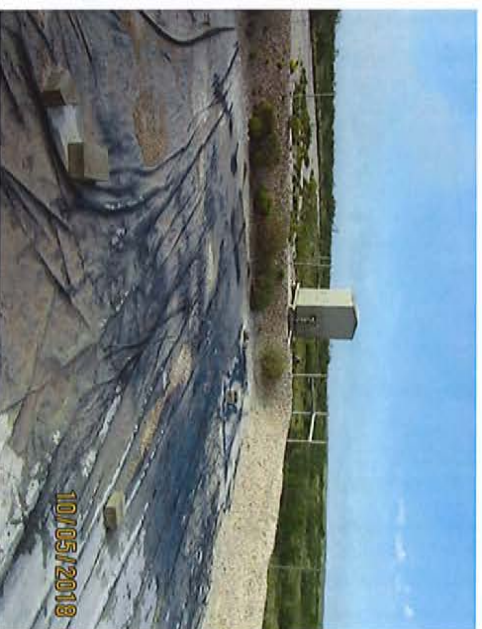
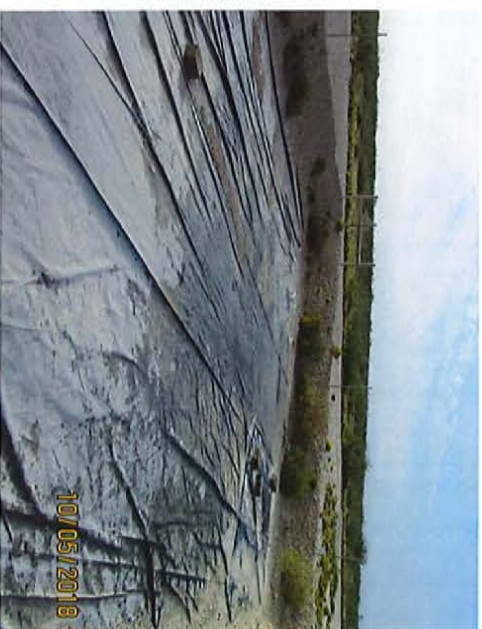
Photos

On December 15, 2017, EOG Y Resources, Inc. submitted to the NMOCD District I Office a Form C-141 for the release of 5 B/O with 4.5 B/O recovered (the remaining 0.5 B/O entrained within the gravel). The affected area is approximately 30' X 30' within the containment of the production facility and was contained within the bermed and lined battery. The release was caused by a production tank, a valve was left open causing the oil to equalize and overflow the tank. A vacuum truck was dispatched and recovered 90% of the released oil. A roustabout crew was dispatched and excavated the visibly impacted gravel. The impacted gravel excavated was hauled to an NMOCD approved disposal facility.

With the battery being bermed and lined with a 20 millimeter liner, Per the Conditions of Approval on the C-141 Initial Report, the NMOCD requested the liner to be inspected and provide a concise report of the inspection with affirmation the liner has and will continue to contain liquids.

An approximate area of 10'X 30', this battery is bermed and has a synthetic liner. Vacuum truck recovered 4.5 B/O, remaining 0.5 B/O entrained within gravel material on top of liner. Roustabout crews removed impacted gravel, that gravel was disposed at an NMOCD approved facility. EOG Y will inspect liner and attest to liner integrity. Depth to Ground Water: <50' (approximately 33.85', per NMOSE & USGS Groundwater Levels), Wellhead Protection Area: No, Distance to Surface Water Body: >1000', SITE RANKING IS 20. Based off of the liner inspection/enclosed photos, EOG Y requests closure.
