**Internal Incident Report – Spill/Release****HOBBS OCD****AUG 02 2012****RECEIVED****Location: WBDU #138****Production Area: Eunice North****District: New Mexico****Date: 08/01/12****Time: 7:55pm****One Line Summary: Internal corrosion deteriorated the 2" line in the middle of the Victaulic clamp groove.**

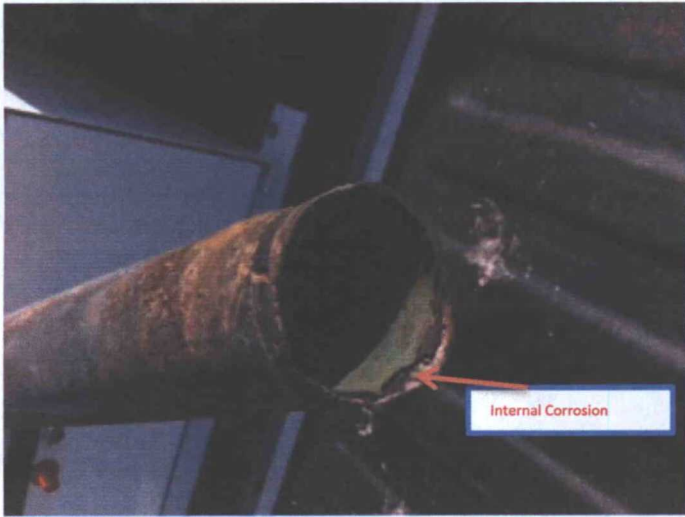
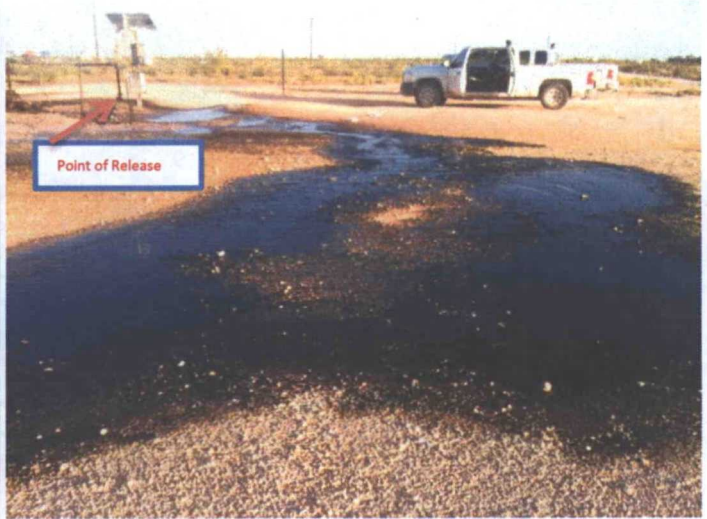
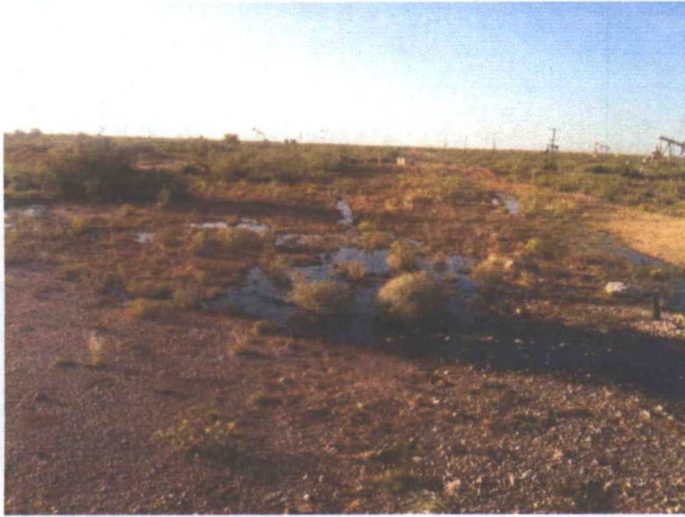
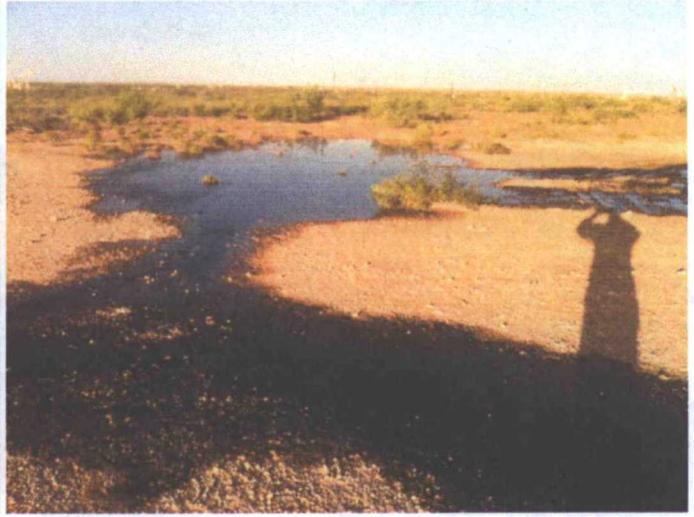
**Full summary:** As the pumper was going around his wells to shut them in due to gas plant shut-in, he spotted the leak on the WBDU #138. This morning the mechanic disconnected the corroded pipe and will be replacing with stainless steel pipe. This corroded pipe was plastic coated with tongue and groove. A vacuum truck was dispatched to the location to remove all standing fluid. Approximately 80bbls of produced water was released and approximately 70bbls of produced water was recovered. The release affected the location pad and the pasture area. The total affected area was 14,583 square feet. A backhoe was dispatched immediately to spread out clean soil to cover the remaining fluid on the ground. A one-call has been placed and the initial assessment is being conducted at this time.

- All piping will be replaced with stainless steel pipe on all injection wells within the WBDU Unit.
