30-025-03646

Well Name: State AC #1
Location: Crossroads Field. Lea Co, NM
Job Description: H5 Failure

AFE# or LOE: LOE
Lease #: NM 0008
Well Site Supervisor: L.A. Spittler, Jr.

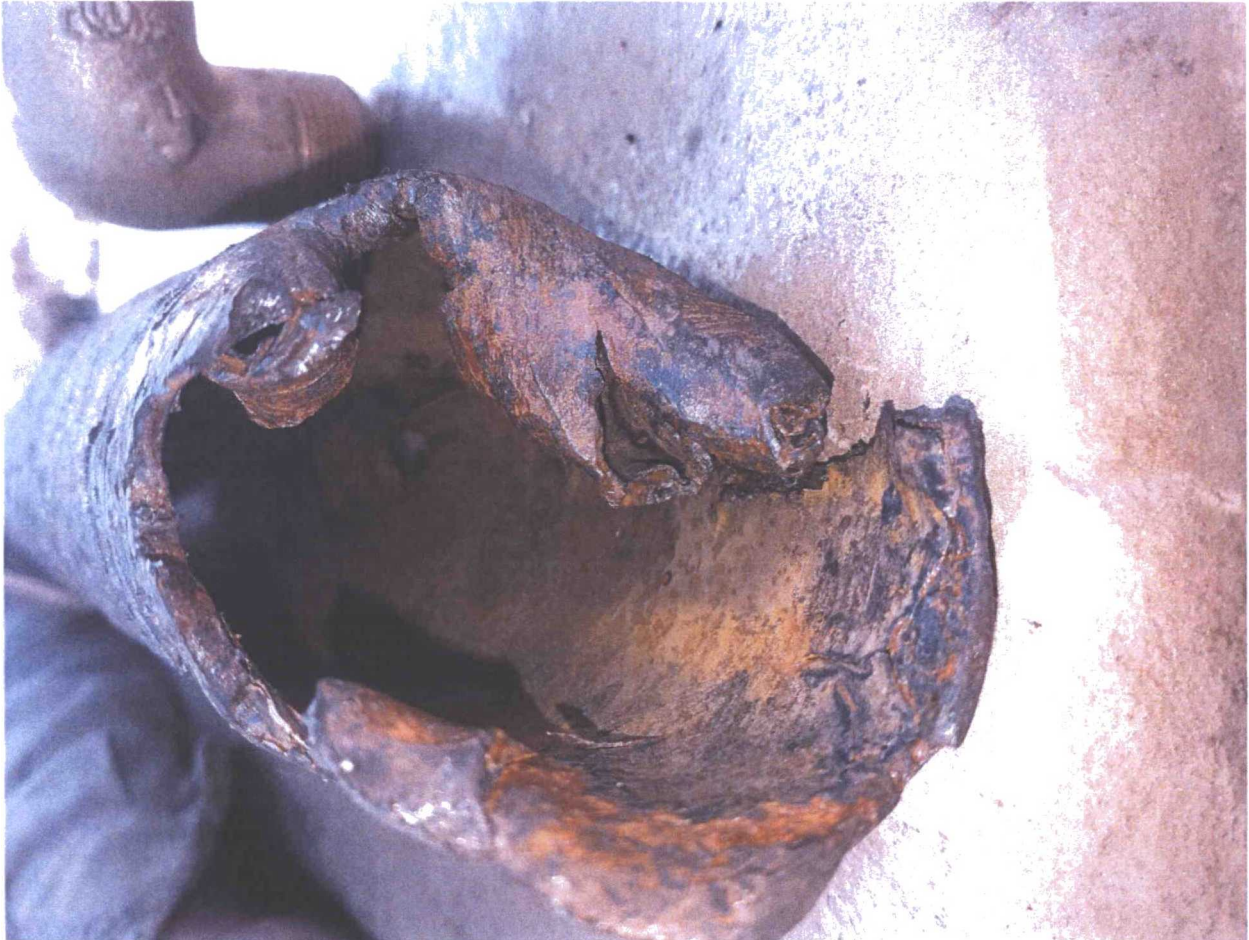
9/20/17
Conducted pre-job tail gate safety meeting. TOH, standing back in the derrick with 1000' of 2 7/8" kill string. Assemble, picked up and TIH with (BHA#1. New 5 3/4" csg shoe, w/5" ID, on 30' of 5 3/4" wash pipe, 5 3/4" top bushing w/ cut right 2 3/8" ID, with 4 5/8" x 2 7/8" x-over sub w/ 2 1/2" ID. 34.6" long). Re-tally the 2 7/8" work string. Tagged the top of the fish @ 3005'. Rig up the power swivel. Broke circulation with produced water. Took 25 bbl's of water. Washed over top of fish circulating out scale with some iron sulfide. Washed over approximately 9', down to 3014'. The wash pipe stalled out, plugging off the work string and losing circulation. TOH w/ BHA#1. Cleaned out fill from tools. Assemble, picked up and TIH with (BHA#2. New 5 3/4" over shot w/ 2 7/8" grapple, 2' x-over sub on 30' of 5 3/4" wash pipe, 5 3/4" top bushing w/ cut right 2 3/8" ID, with 4 5/8" x 2 7/8" x-over w/ 2 1/2" ID. 36.6" long). Tagged top of fish @ 3007'. Wash over top of fish 4'. Picked up with no tension. TOH w/a collar and a 2' piece of 2 7/8" tbg. Body break. The bottom of the tbg fished out was mangled and twisted. TIH with (BHA#1). Tagged the top of the fish @ 3007'. Rig up the power swivel. Broke circulation with produced water. Milled down and over top of fish to 3041'. Lost circulation. TOH with (BHA#1). Did not recover anything. Recovered a total of 2' of 2 7/8" tbg today. Top of the fish @ 3007'. Secured the wellsite. SIWFN. Tomorrow morning, the plan is to run BHA#2 over shot first trip in hole.

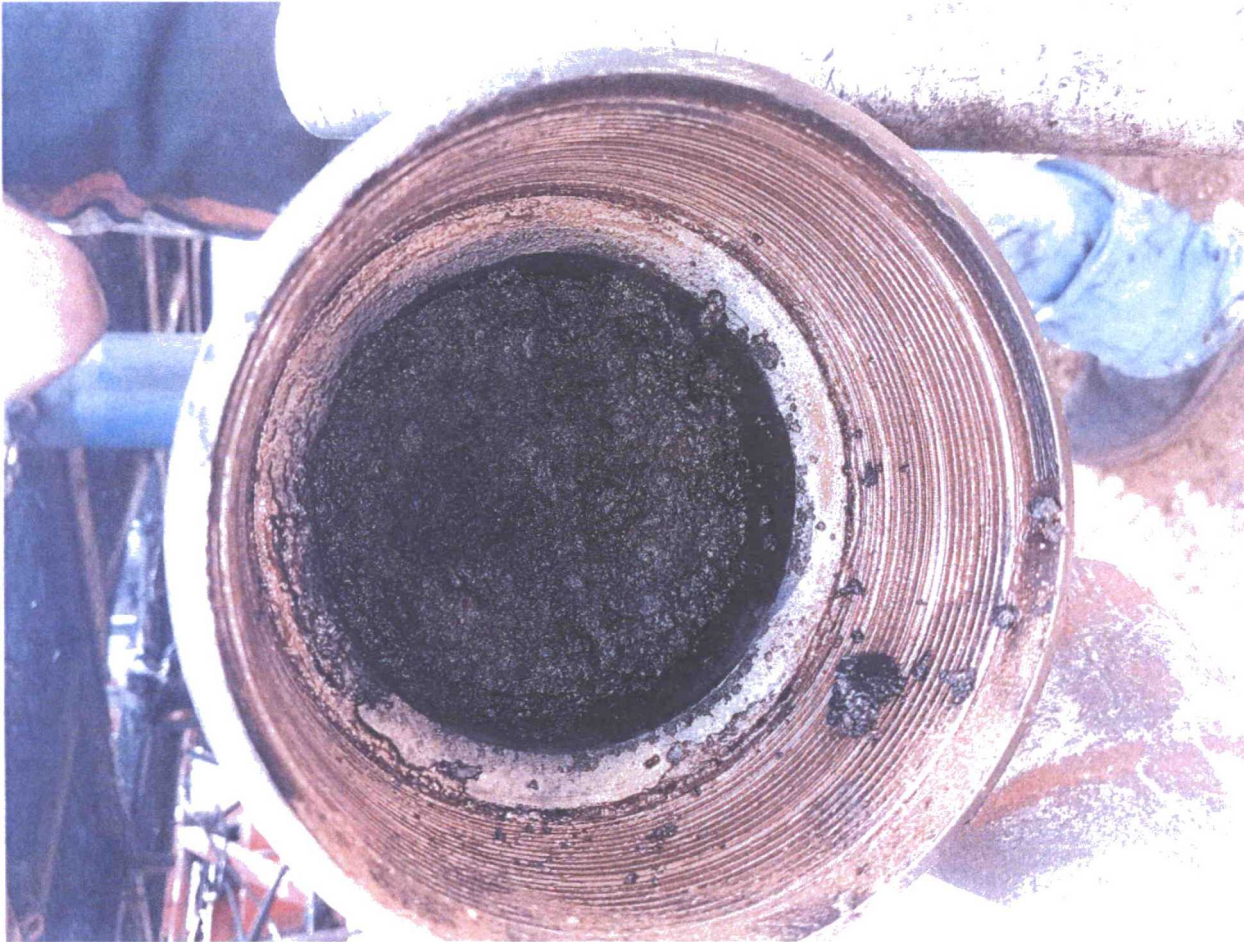
Conducted pre-job tail gate safety meeting. Assemble, picked up and TIH with (BHA#4). 5 3/4" csg shoe w/new Shark-Tooth mill, w/5" ID, on 4 jts of 30' of 5 3/4" wash pipe, 5 3/4" top bushing w/ cut right 2 3/8" ID, with 4 5/8" x 2 7/8" x-over sub w/ 2 1/2" ID. 124.6" long). <Added 3 extra jts of 5 3/4" wash pipe to the BHA#3> Tagged up at 3066'. Unable to break circulation. The (BHA#4) got stuck. Unable to rotate BHA, go up or down. Worked the (BHA#4) free by pulling 92k. TOH w/ (BHA#4). Visually inspecting the BHA tools for scaring, cuts, or jagged edges. The (BHA#4) looked new. We believe the reason for getting the (BHA#4) stuck. The (BHA#4) was too stiff and scale build up inside the 7" casing. Laid down 2 jts of 5 3/4" wash pipe. TIH with (BHA#5). 5 3/4" csg shoe w/new Shark-Tooth mill, w/5" ID, on 2 jts of 30' of 5 3/4" wash pipe, 5 3/4" top bushing w/ cut right 2 3/8" ID, with 4 5/8" x 2 7/8" x-over sub w/ 2 1/2" ID. 64.6" long). Set down @ 3066'. Rigged up the power swivel. Broke circulation with produced water. Took 180 bbl's of produced water. Washed down to 3195'. Approximately 9' over top of the fish. Lost circulation. Rigged down the power swivel. TOH with (BHA#5). Had 5 1/2 jts of the 2 7/8" work string tbg packed full of scale cuttings. Clean out work string tbg and BHA tools. TIH with (BHA#5) to 2900'. Did not recover any 2 7/8" tbg today. Top of the fish is @ 3184'. Secured the wellsite. SIWFN. Tomorrow morning, the plan is to finish TIH with (BHA#5) 5 3/4" csg shoe w/new Shark-Tooth mill, w/5" ID, on 2 jts of 30' of 5 3/4" wash pipe, 5 3/4" top bushing w/ cut right 2 3/8" ID, with 4 5/8" x 2 7/8" x-over sub w/ 2 1/2" ID. 64.6" long).

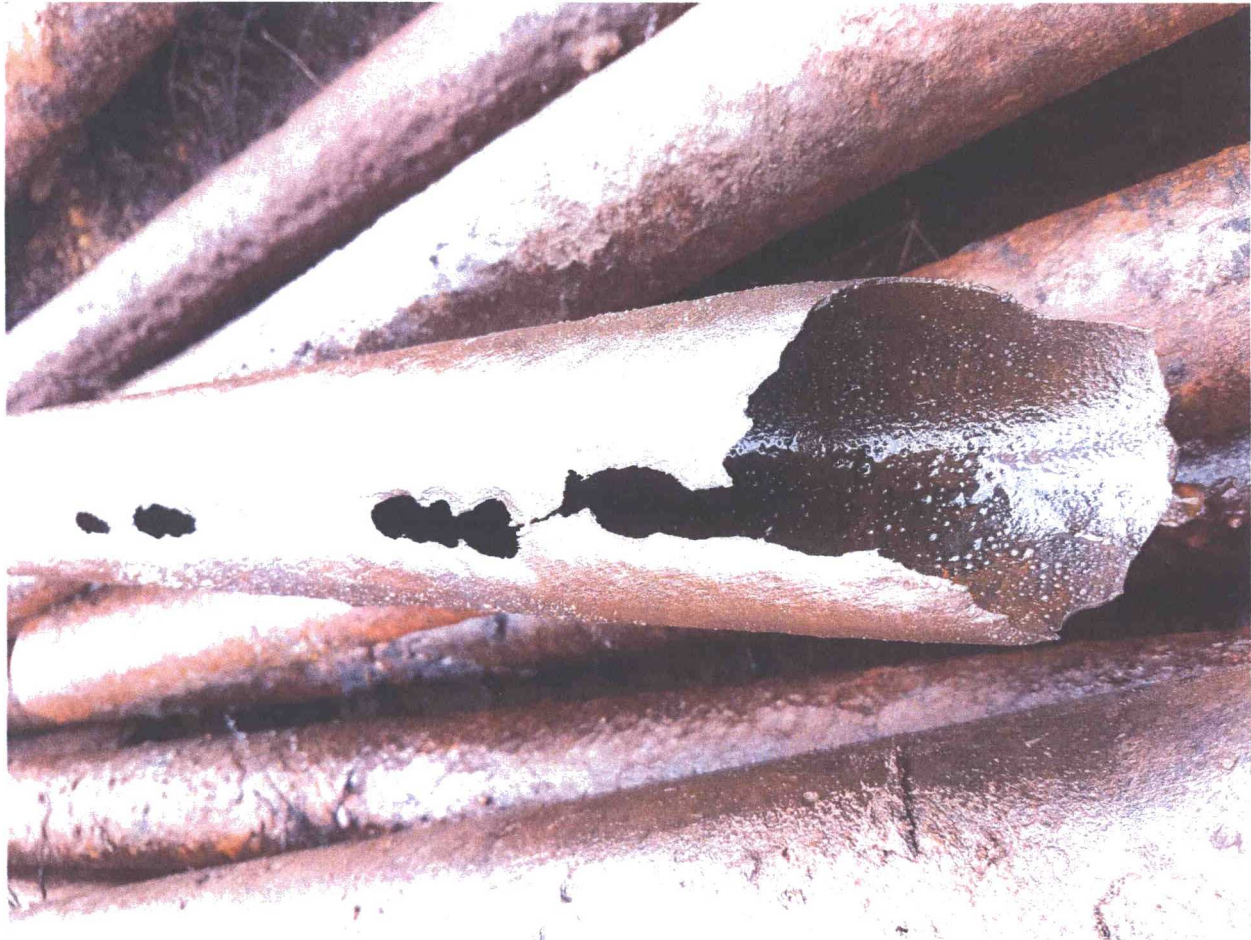
Conducted pre-job tail gate safety meeting. Finished TIH with (BHA#2). 5 3/4" over shot w/ 2 7/8" grapple, 2' x-over sub on 30' of 5 3/4" wash pipe, 5 3/4" top bushing w/ cut right 2 3/8" ID, with 4 5/8" x 2 7/8" x-over w/ 2 1/2" ID. 36.6" long). Engaged over the top of the fish @ 3501'. Slightly picked up on (BHA#2) with no tension. TOH with (BHA#2). Recovered 1 single 9' piece of 2 7/8" tbg. Body break. Removed and laid down the 9' of fished out tbg from the BHA. The tbg was severely corroded, pitted holes, extremely thin wall and mostly rust color. Top of the fish @ 3510'. Assemble and TIH with a condition 1 used Baker 5 3/4" tri-cone bit, new 7" casing scraper, x-over sub and 2 7/8" work string. TIH to the top of the fish @ 3510. Did not hit any build ups while tripping in the hole. Rigged up the power swivel. Broke circulation with 200 bbl's of produce water. Circulated the hole clean. Rigged down the power swivel and rigged up the revers unit hose to the tbg. Closed the BOP's and conducted an injection rate test while @ top of the fish @ 3510'. Initial injection rate was 2.75 BPM @ 500 psi. With 50 bbls pumped away the rate dropped to 2 BPM @ 500 psi. ISDP-0 psi. Pumped a total of 200 bbls. Rigged down the reverse unit hose from the tbg. TOH with bit and casing scraper. Picked up and TIH with (BHA#6) 5 3/4" csg shoe w/new Star Carbon Tipped mill, w/5" ID, on 2 jts of 30' of 5 3/4" wash pipe, 5 3/4" top bushing w/ cut right 2 3/8" ID, with 4 5/8" x 2 7/8" x-over sub w/ 2 1/2" ID. 64.6" long). Stopped at 3000'. Used a total of 450 bbls of produced water today. Secured the wellsite. SIWFN. Recovered a total of 9' of 2 7/8" tbg in 1 piece today. Top of the fish is @ 3510'. Tomorrow, the plan is to finish TIH with wash pipe. Then run over-shot.
