RE: Heat Exchanger Bundle Pad Investigation Work Plan
Marathon Gallup Refinery
(dba Western Refining Southwest LLC)
EPA ID# NMD000333211

Heat Exchanger Bundle Pad Investigation Work Plan

Heat Exchanger Bundle Pad Soil Sampling Investigation Work Plan

Remote Visual and Cleaning Inspection

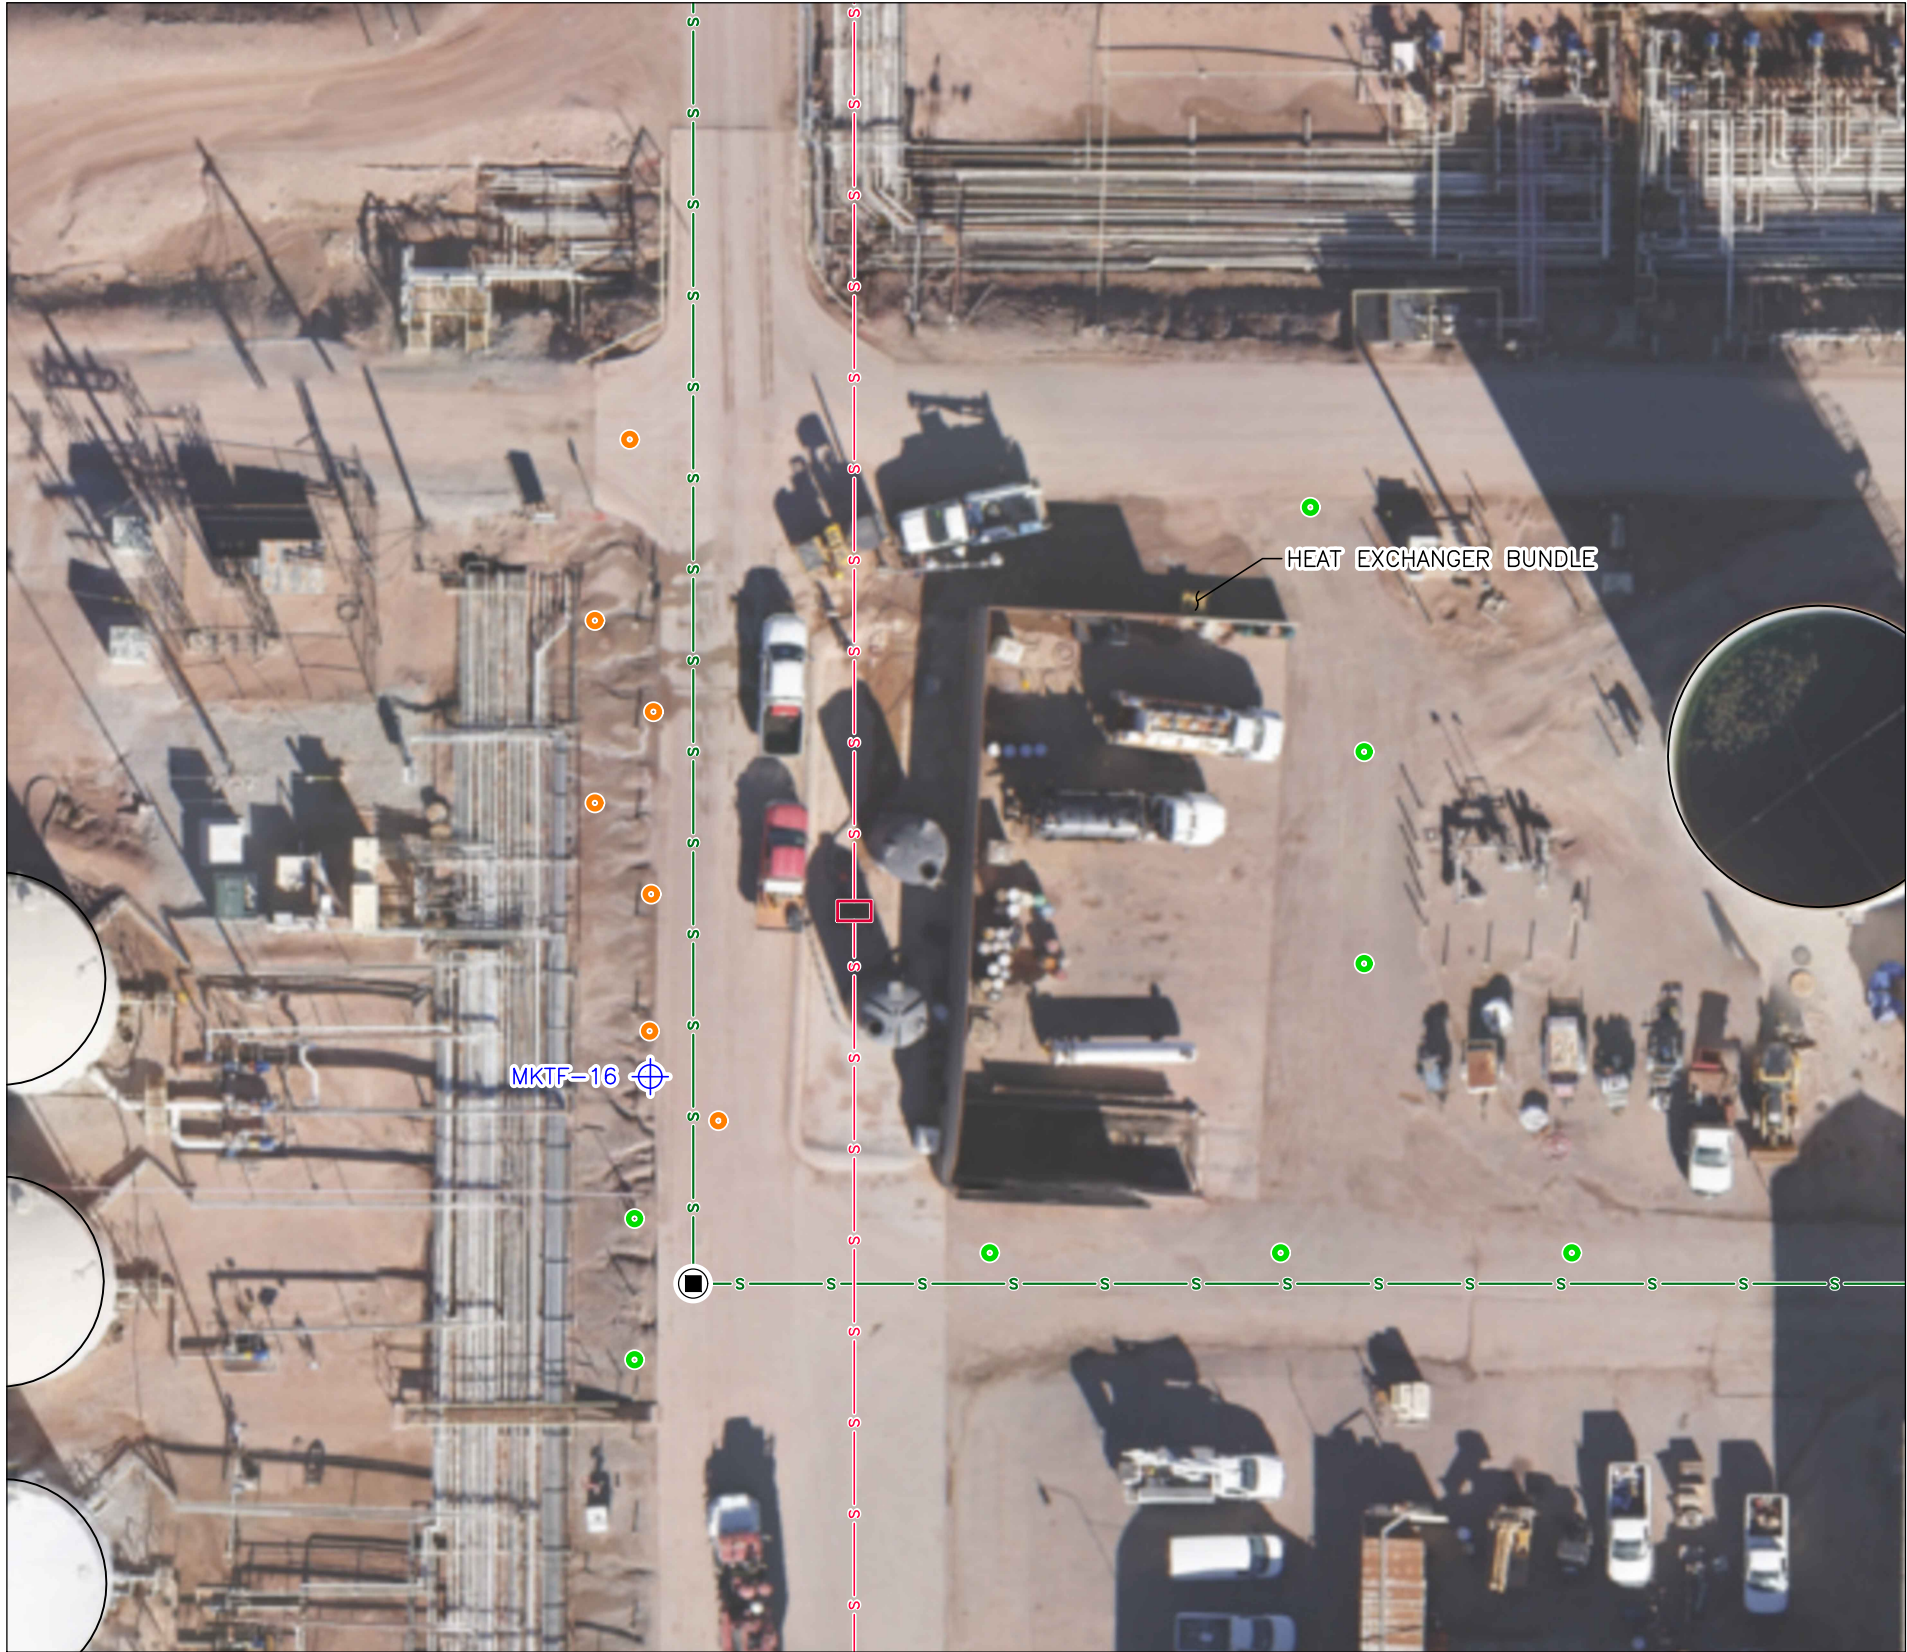
2 PROPOSED SOIL BORING LOCATIONS
SCALE: 1" = 30'

Soil borings will be completed with a geoprobe direct-push drill rig at eight locations around the Bundle Pad to a total depth of 15 ft bgs (Figure 2). Soil borings will be screened in the field for presence of volatiles using a photoionization detector (PID). The total depth of the Bundle Pad sump and process sewer line in this area is approximately 12 ft bgs. Soil samples will be collected from 12 ft bgs, the bottom of the boring, and at depths where field screening indicates potential impacts. Soil samples will be analyzed for benzene via Method 8260B. Analytical results will be compared to NMED Industrial Soil Screening Levels (SSL).

Figure 2 also includes the proposed soil boring/sample locations for the Sour Naphtha Release Investigation. There are seven proposed borings from the intersection northwest of the Bundle Pad to MKTF-16. These sample locations have been proposed in the *Sour Naphtha Release Investigation Work Plan* to determine if the elevated benzene concentrations found in MKTF-16 are related to the 2017 Sour Naphtha release. The samples collected in the Sour Naphtha Investigation will include benzene and pertinent results will be reported alongside the Bundle Pad investigation results.

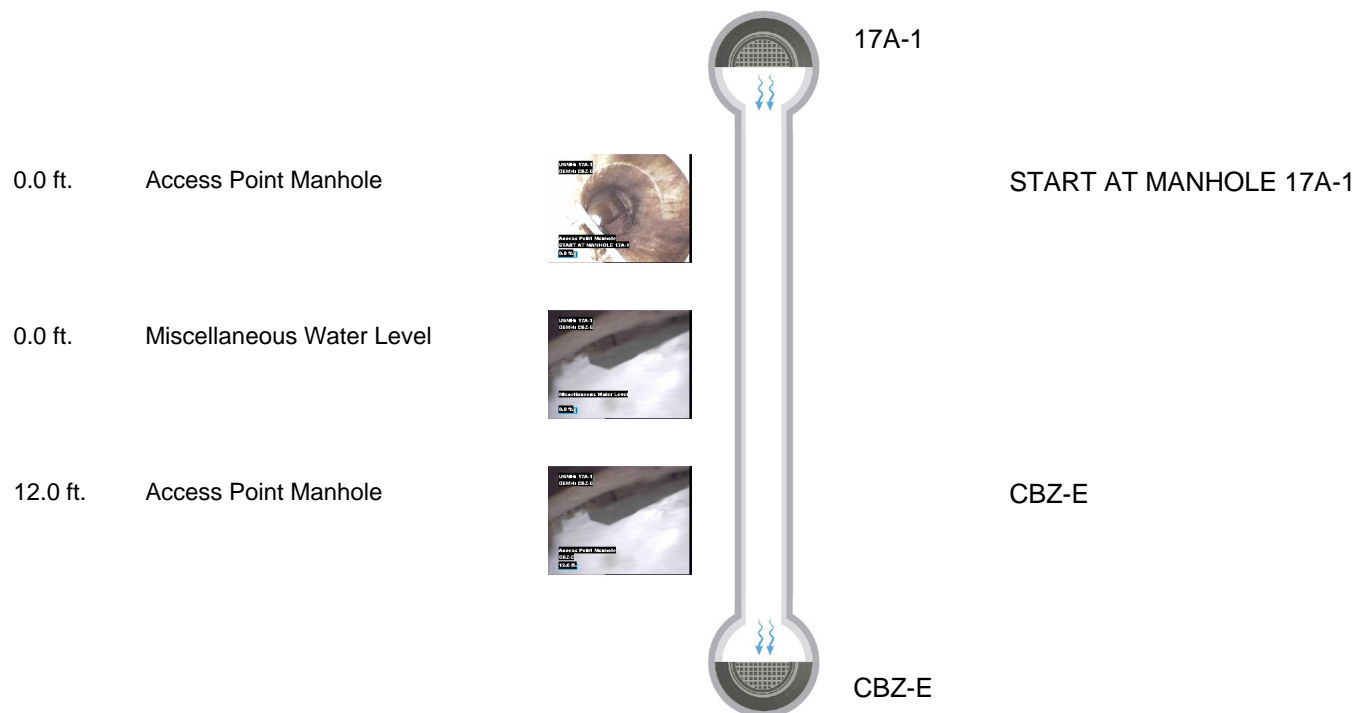
Pipe Segment Refere...	City GALLUP	Street BUNDLE PAD	Material PolyVinyl Chloride	Location C...	Pipe Use Stormwater
Upstream MH 17A-1	Total Length	Year Constructed	Shape Circular	Location Details	
Downstream MH CBZ-E	Length surveyed 12	Year Renewed	Height 16	Width 16	Pipe Joint...
SPR 0	MPR 0	PO Number		Customer	
SPRI 0	MPRI 0	Work Order Number		Purpose	
QSR 0000	QMR 0000				
OPR 0	Surveyed By BJAMES	Direction Downstream	Date 20200129	Media label	
OPRI 0	Certificate Number U-0317-07007227	Pre-Cleaning Light Cleaning	Time 11:40	Weather	
Date Cleaned			End Time 11:47	Additional Info

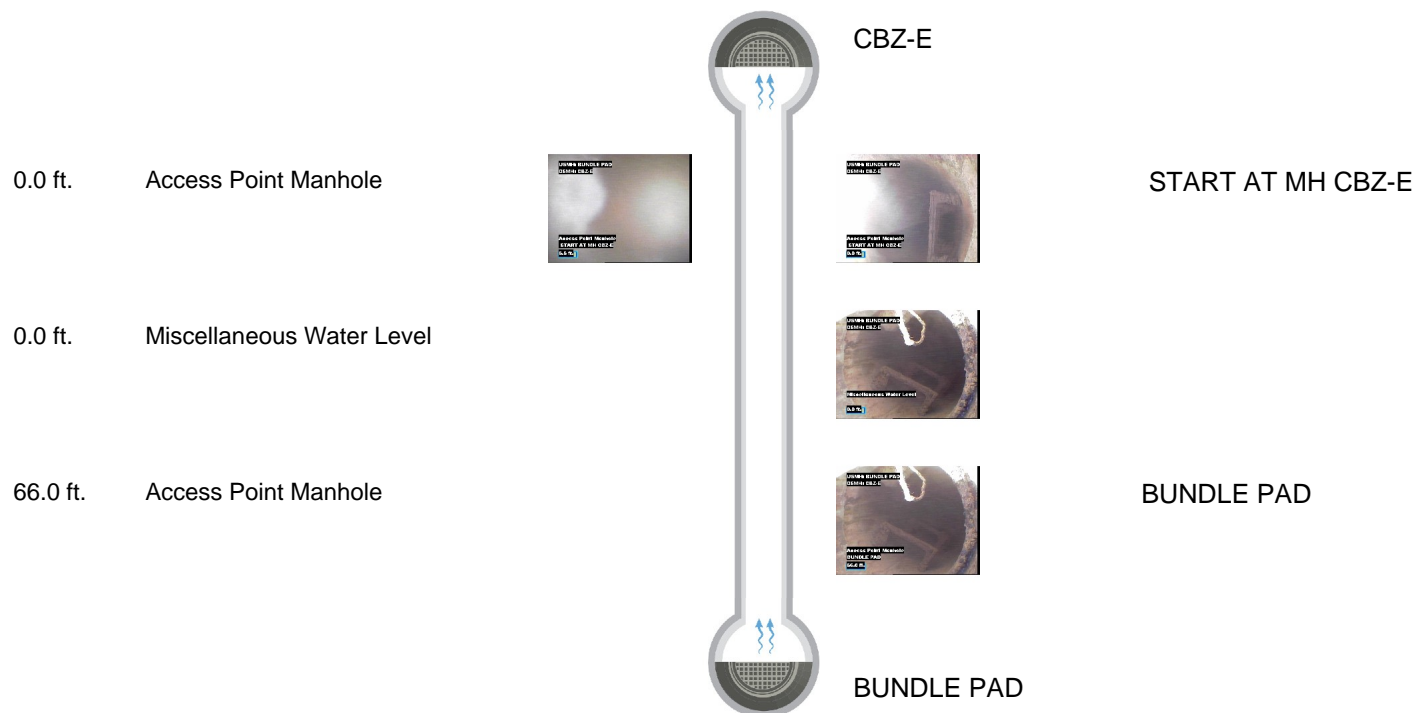
Pipe Segment Refere...	City GALLUP	Street BUNDLE PAD	Material Ductile Iron Pipe		Location C...	Pipe Use Stormwater
Upstream MH BUNDLE PAD	Total Length	Year Constructed	Shape Circular		Location Details	
Downstream MH CBZ-E	Length surveyed 66	Year Renewed	Height 8	Width 8	Pipe Joint...	
SPR 0	MPR 0	PO Number		Customer		
SPRI 0	MPRI 0	Work Order Number		Purpose		
QSR 0000	QMR 0000					
OPR 0	Surveyed By BJAMES	Direction Upstream	Date 20200128		Media label	
OPRI 0	Certificate Number U-0317-07007227	Pre-Cleaning No Pre-Cleaning	Time 11:04		Weather	
Date Cleaned			End Time 11:15		Additional Info

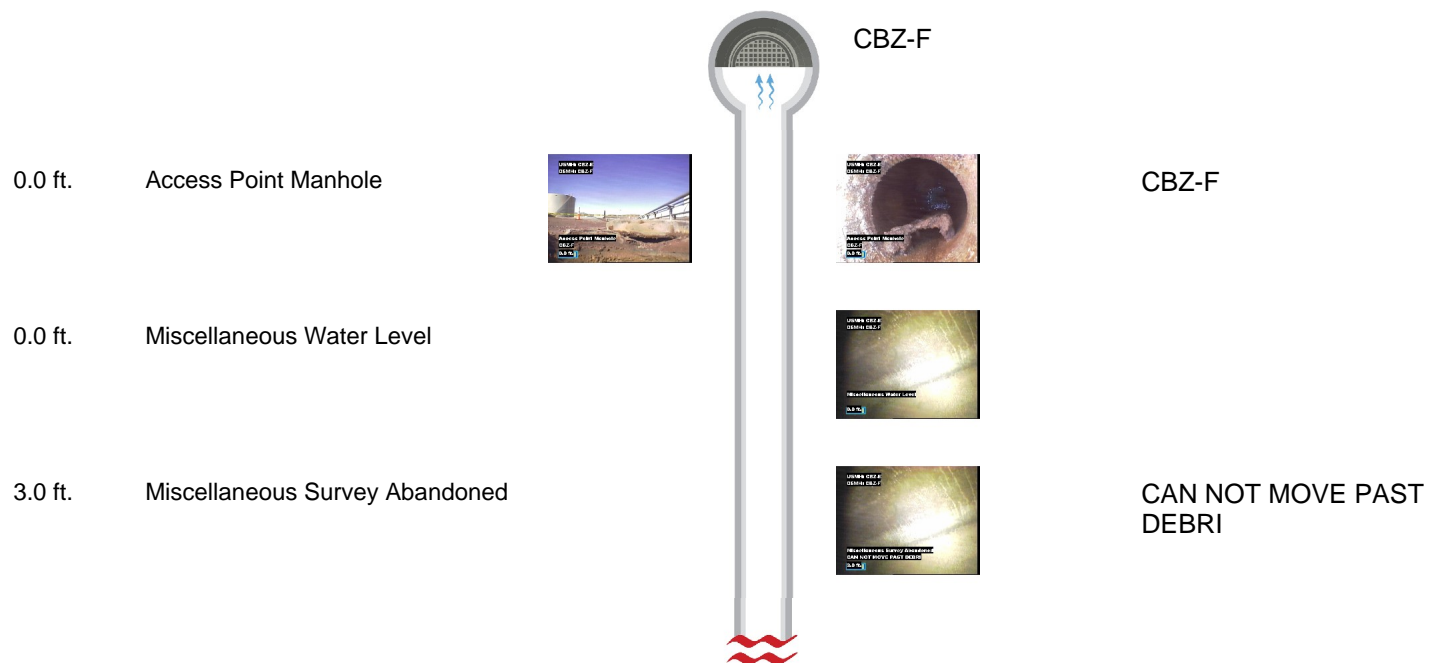
Pipe Segment Refere...	City GALLUP	Street BUNDLE PAD	Material PolyVinyl Chloride		Location C...	Pipe Use Stormwater
Upstream MH CBZ-E	Total Length	Year Constructed	Shape Circular		Location Details	
Downstream MH CBZ-F	Length surveyed 3	Year Renewed	Height 16	Width 16	Pipe Joint...	
SPR 0	MPR 0	PO Number		Customer		
SPRI 0	MPRI 0	Work Order Number		Purpose		
QSR 0000	QMR 0000					
OPR 0	Surveyed By BJAMES	Direction Upstream	Date 20200128		Media label	
OPRI 0	Certificate Number U-0317-07007227	Pre-Cleaning No Pre-Cleaning	Time 12:45		Weather	
Date Cleaned			End Time 12:51		Additional Info

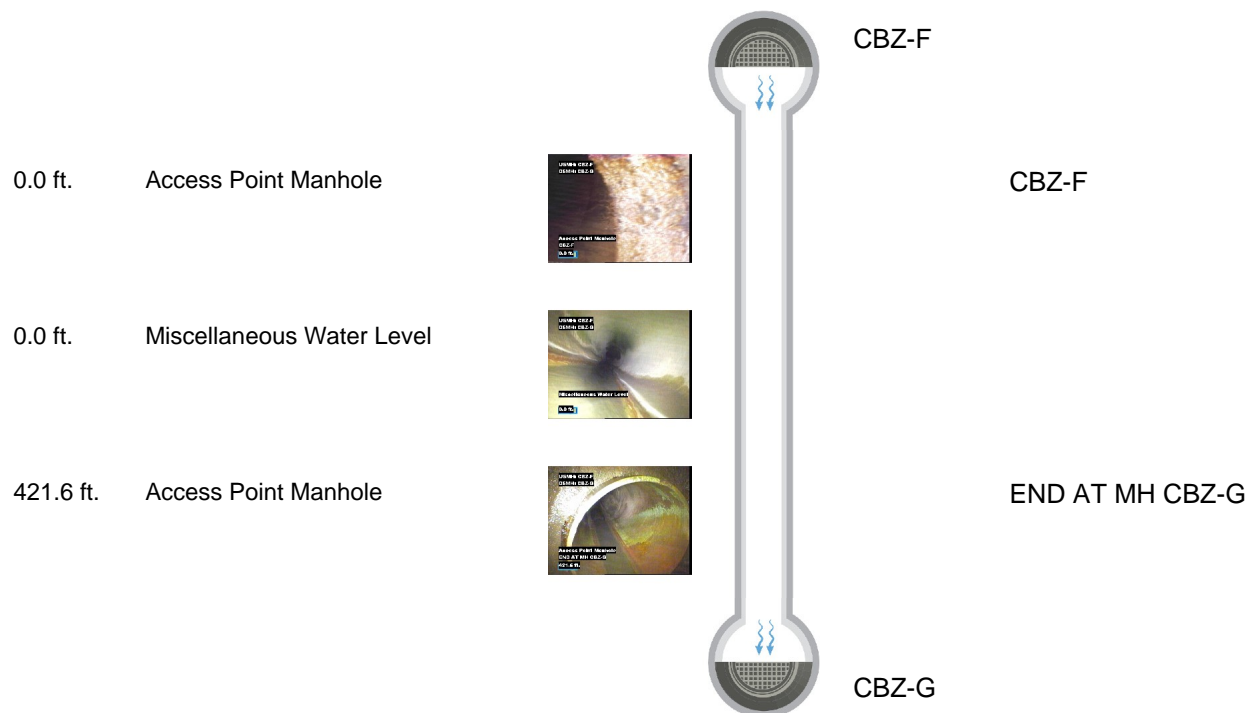
Pipe Segment Refere...	City GALLUP	Street BUNDLE PAD	Material PolyVinyl Chloride		Location C...	Pipe Use Stormwater
Upstream MH CBZ-F	Total Length	Year Constructed	Shape Circular		Location Details	
Downstream MH CBZ-G	Length surveyed 421.6	Year Renewed	Height 16	Width 16	Pipe Joint...	
SPR 0	MPR 0	PO Number		Customer		
SPRI 0	MPRI 0	Work Order Number		Purpose		
QSR 0000	QMR 0000					
OPR 0	Surveyed By BJAMES	Direction Downstream	Date 20200128		Media label	
OPRI 0	Certificate Number U-0317-07007227	Pre-Cleaning No Pre-Cleaning	Time 13:21		Weather	
Date Cleaned			End Time 13:41		Additional Info

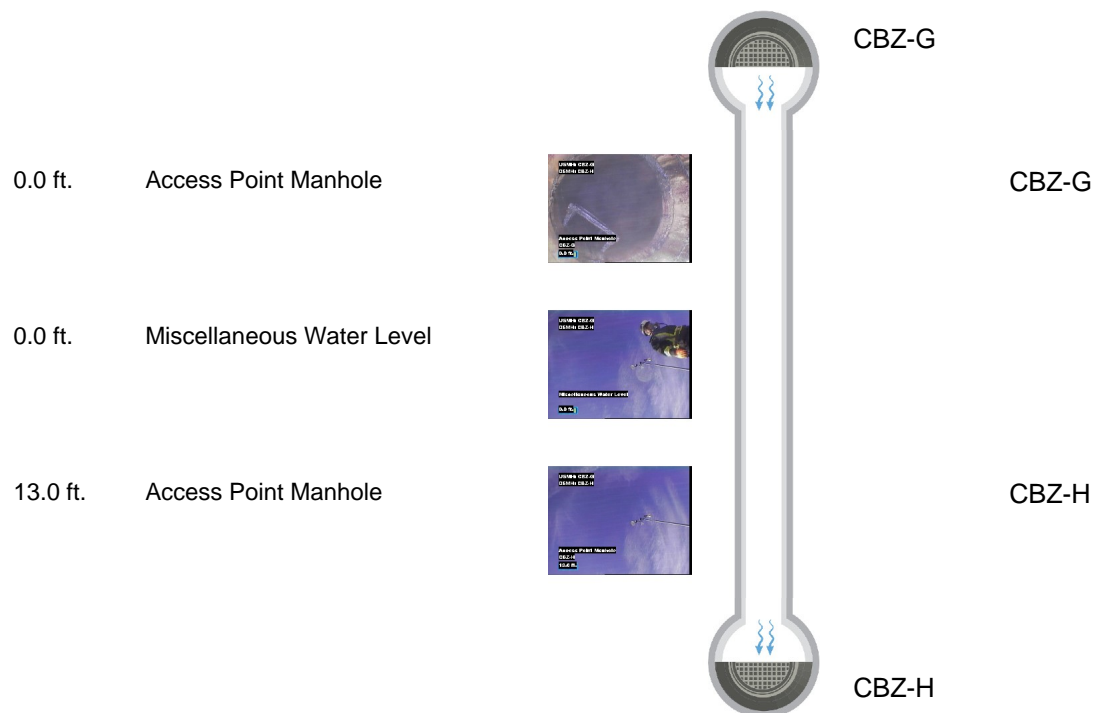
Pipe Segment Refere...	City GALLUP	Street BUNDLE PAD	Material Ductile Iron Pipe	Location C...	Pipe Use Stormwater
Upstream MH CBZ-G	Total Length	Year Constructed	Shape Circular	Location Details	
Downstream MH CBZ-H	Length surveyed 13	Year Renewed	Height 12	Width 12	Pipe Joint...
SPR 0	MPR 0	PO Number		Customer	
SPRI 0	MPRI 0	Work Order Number		Purpose	
QSR 0000	QMR 0000				
OPR 0	Surveyed By BJAMES	Direction Downstream	Date 20200130	Media label	
OPRI 0	Certificate Number U-0317-07007227	Pre-Cleaning No Pre-Cleaning	Time 09:12	Weather	
Date Cleaned			End Time 09:16	Additional Info

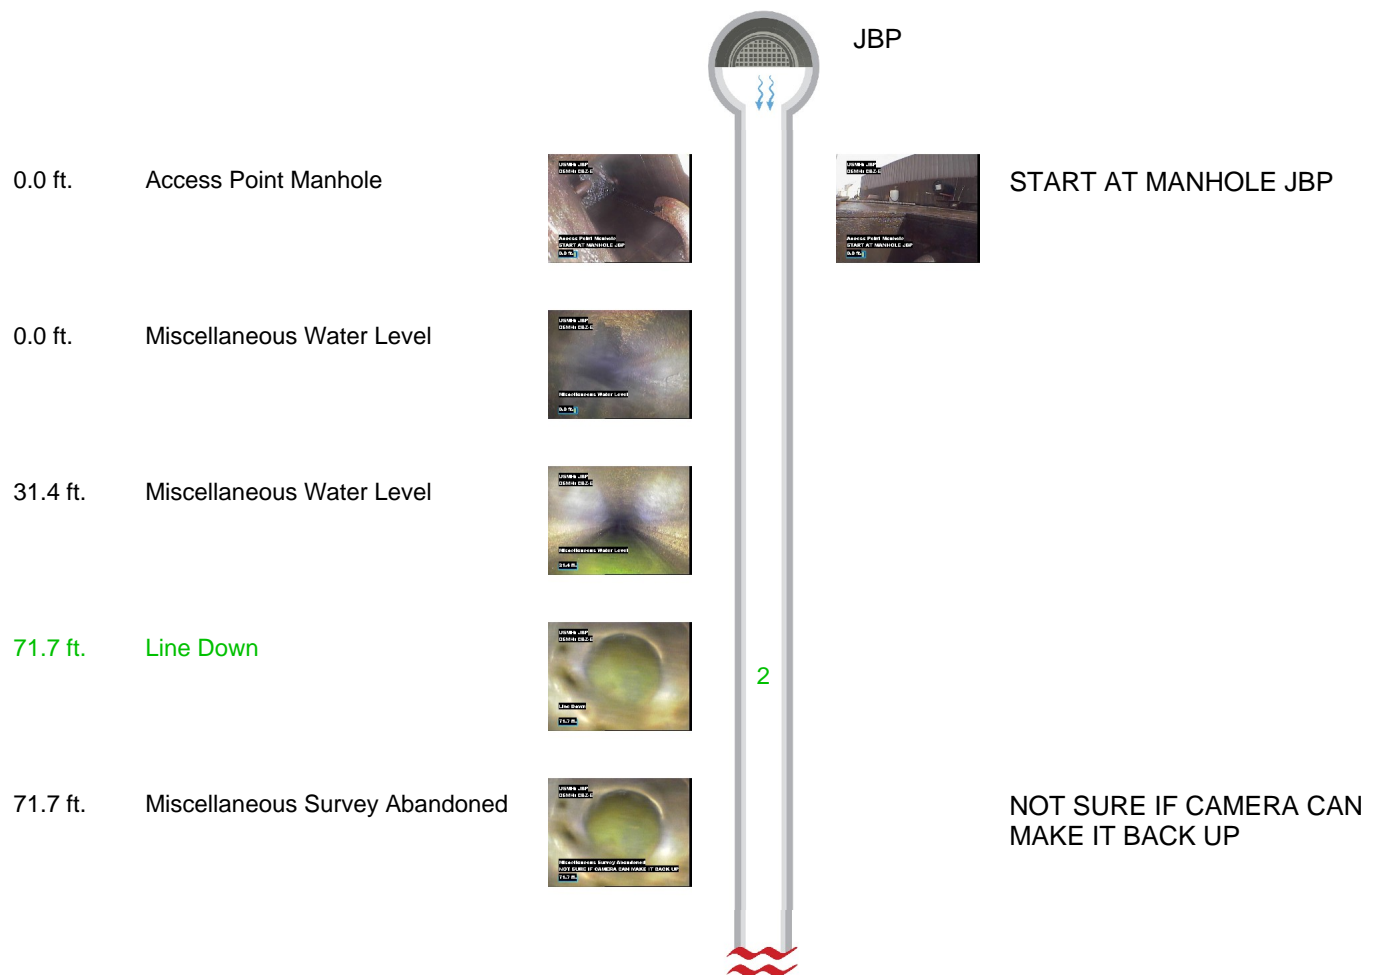
Pipe Segment Refere...	City GALLUP	Street BUNDLE PAD	Material Ductile Iron Pipe	Location C...	Pipe Use Stormwater
Upstream MH JBP	Total Length	Year Constructed	Shape Circular	Location Details	
Downstream MH CBZ-E	Length surveyed 71.7	Year Renewed	Height 8	Width 8	Pipe Joint...
SPR 0	MPR 2	PO Number		Customer	
SPRI 0	MPRI 2	Work Order Number		Purpose	
QSR 0000	QMR 2100				
OPR 2	Surveyed By BJAMES	Direction Downstream	Date 20200129	Media label	
OPRI 2	Certificate Number U-0317-07007227	Pre-Cleaning No Pre-Cleaning	Time 10:26	Weather	
Date Cleaned			End Time 10:36	Additional Info
