Vertex Project #: 21E-00087-012

Spill Closure Report: Black River SWD #1
Unit C, Section 31, Township 23 South, Range 28 East
County: Eddy
API: 30-015-43807
NMOCD Tracking Number: nAPP2111148844

Matador Production Company (Matador) retained Vertex Resource Services Inc. (Vertex) to conduct a spill assessment for the April 10, 2021, produced water release that occurred at Black River SWD #1, API: 30-015-43807 (hereafter referred to as “Black River”). Matador provided notification of the spill to New Mexico Oil Conservation Division (NMOCD) District 2 via submission of an initial C-141 Release Notification (Attachment 1) on April 21, 2021. The NMOCD tracking number assigned to this release is nAPP2111148844.

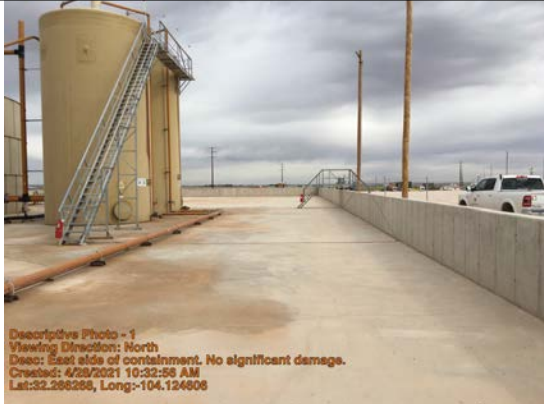
East side of containment. No significant damage.

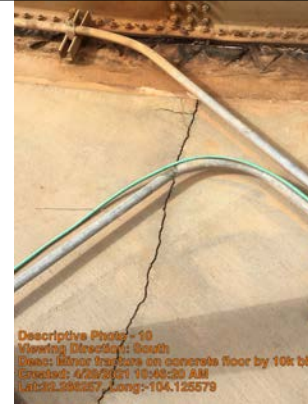
Minor fracture on concrete floor by 10k bbl west tank.

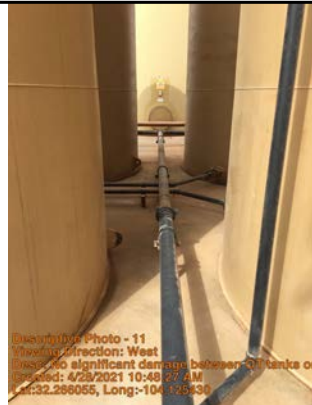
No significant damage between OT tanks on south side.

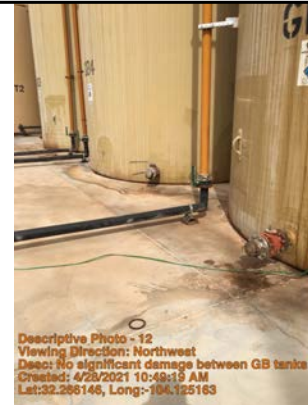
No significant damage between GB tanks on south side.

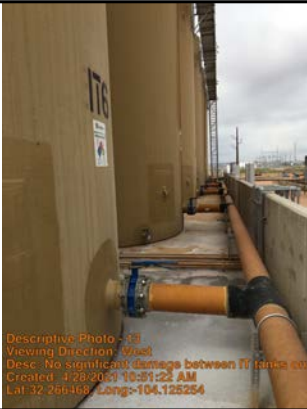
<p>Descriptive Photo - 13 Viewing Direction: West Desc: No significant damage between IT tanks on north side. Created: 4/28/2021 10:51:22 AM Lat:32.266468, Long:-104.125254</p> <p>No significant damage between IT tanks on north side.</p>	<p>Viewing Direction: South</p>

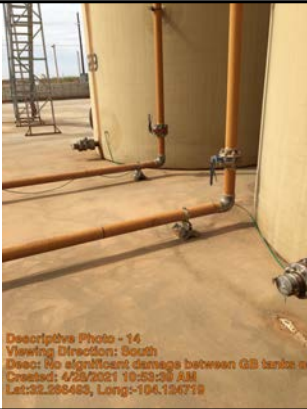
<p>Descriptive Photo - 14 Viewing Direction: South Desc: No significant damage between GB tanks on east side. Created: 4/28/2021 10:53:26 AM Lat:32.266468, Long:-104.124719</p> <p>No significant damage between GB tanks on east side.</p>
<p>Viewing Direction: Southwest</p>

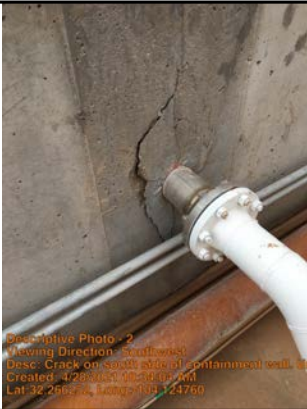
<p>Descriptive Photo - 2 Viewing Direction: Southwest Desc: Crack on south side of containment wall. Created: 4/28/2021 10:53:26 AM Lat:32.266468, Long:-104.124719</p> <p>Crack on south side of containment wall. Unable to tell how far it goes. May need repair.</p>	<p>Viewing Direction: South</p>

11:01 All fractures are minor and photographed. Will need sealing most likely.

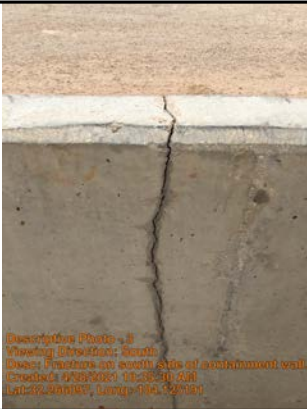
<p>Descriptive Photo - 3 Viewing Direction: South Desc: Fracture on south side of containment wall. Created: 4/28/2021 10:53:26 AM Lat:32.266468, Long:-104.124719</p> <p>Fracture on south side of containment wall.</p>

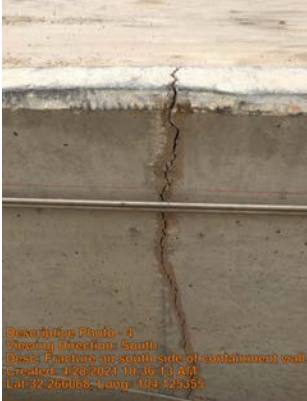
<p><small>Descriptive Photo - 4 Viewing Direction: South Desc: Fracture on south side of containment wall. Created: 4/28/2021 10:36:13 AM Lat:32.269068, Long: -104.125830</small></p>	<p>Viewing Direction: South</p>

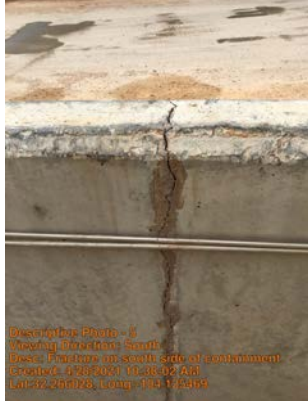
<p><small>Descriptive Photo - 5 Viewing Direction: South Desc: Fracture on south side of containment wall. Created: 4/28/2021 10:36:02 AM Lat:32.269068, Long: -104.125830</small></p>
Fracture on south side of containment wall.	Fracture on south side of containment wall.
<p>Viewing Direction: South</p>

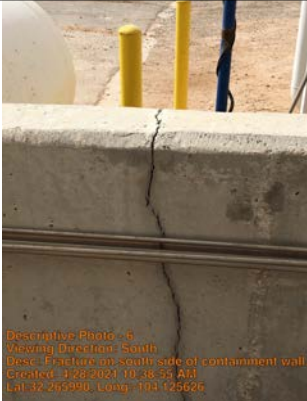
<p><small>Descriptive Photo - 6 Viewing Direction: South Desc: Fracture on south side of containment wall. Created: 4/28/2021 10:36:55 AM Lat:32.269068, Long: -104.125830</small></p>	<p>Viewing Direction: West</p>

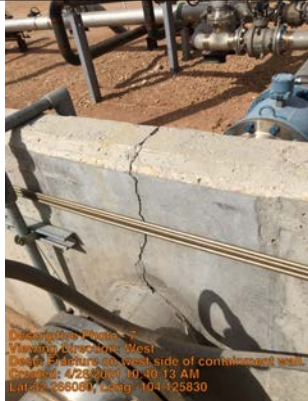
<p><small>Descriptive Photo - 7 Viewing Direction: West Desc: Fracture on west side of containment wall. Created: 4/28/2021 10:36:13 AM Lat:32.269068, Long: -104.125830</small></p>

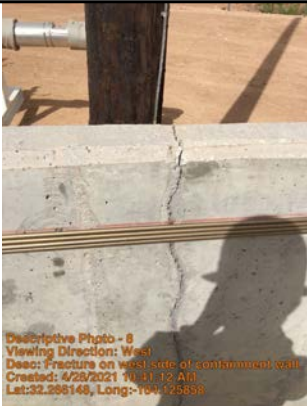
<p>Descriptive Photo - 8 Viewing Direction: West Desc: Fracture on west side of containment wall. Created: 4/28/2021 10:31:12 AM Lat:32.266148, Long:-104.125631</p>

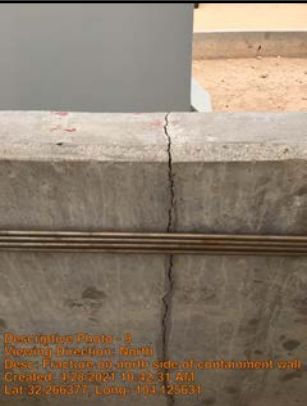
<p>Descriptive Photo - 9 Viewing Direction: North Desc: Fracture on north side of containment wall. Created: 4/28/2021 10:42:31 AM Lat:32.266377, Long:-104.125631</p>
Fracture on west side of containment wall.	Fracture on north side of containment wall.
