**Re: Liner Inspection and Closure Report
Pioneer Federal #1
API No. 30-015-24777
GPS: Latitude 32.46730 Longitude -104.22630
UL "G", Sec. 19, T21S, R27E
Eddy County, NM
NMOCD Ref. No. NRM1933049719 (2RP-5712)**

Liner Inspection Form

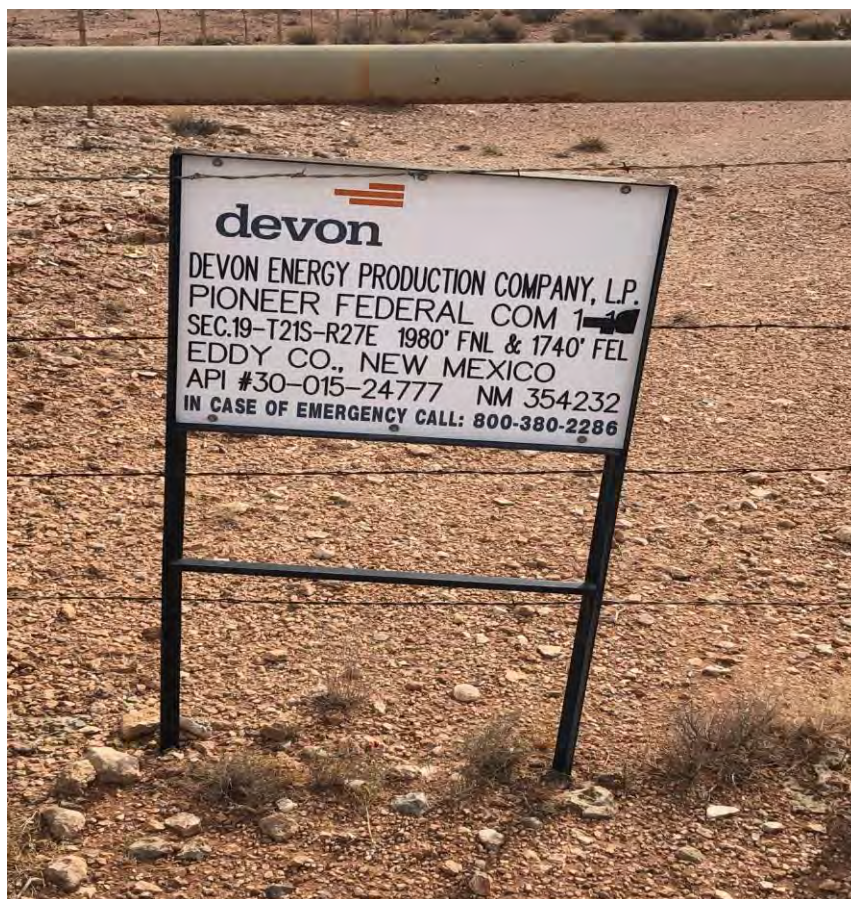
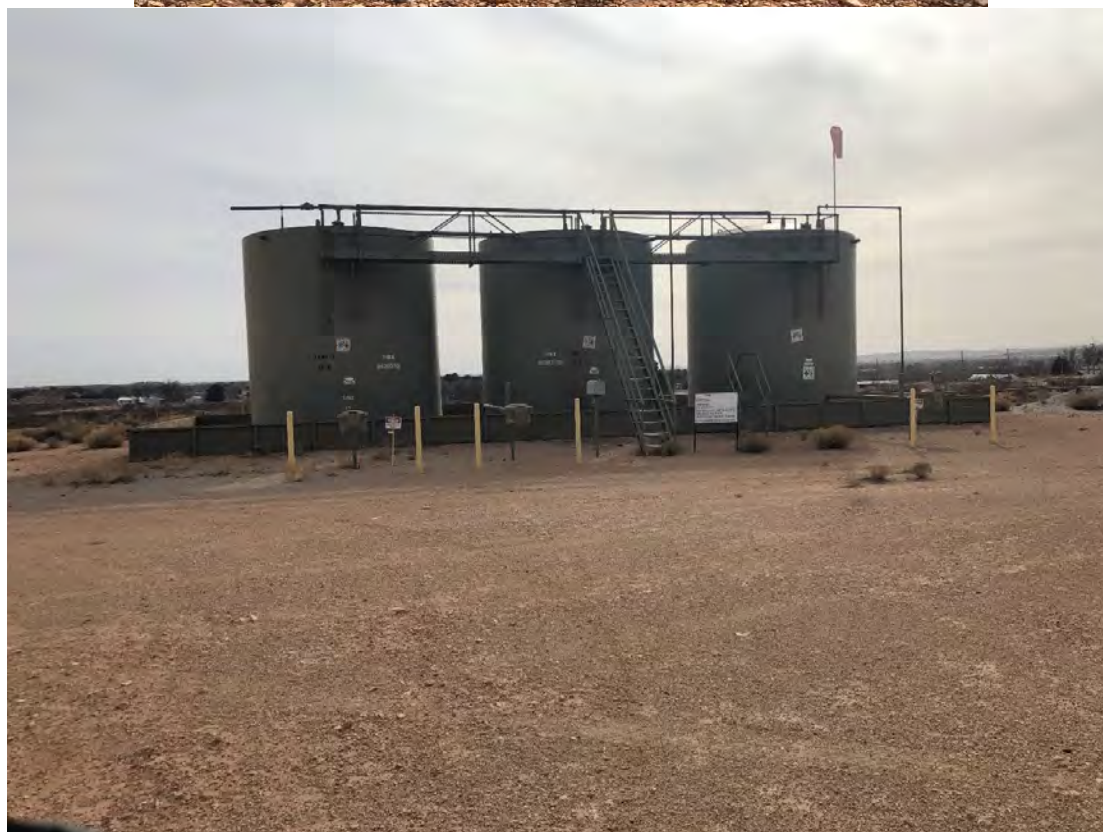
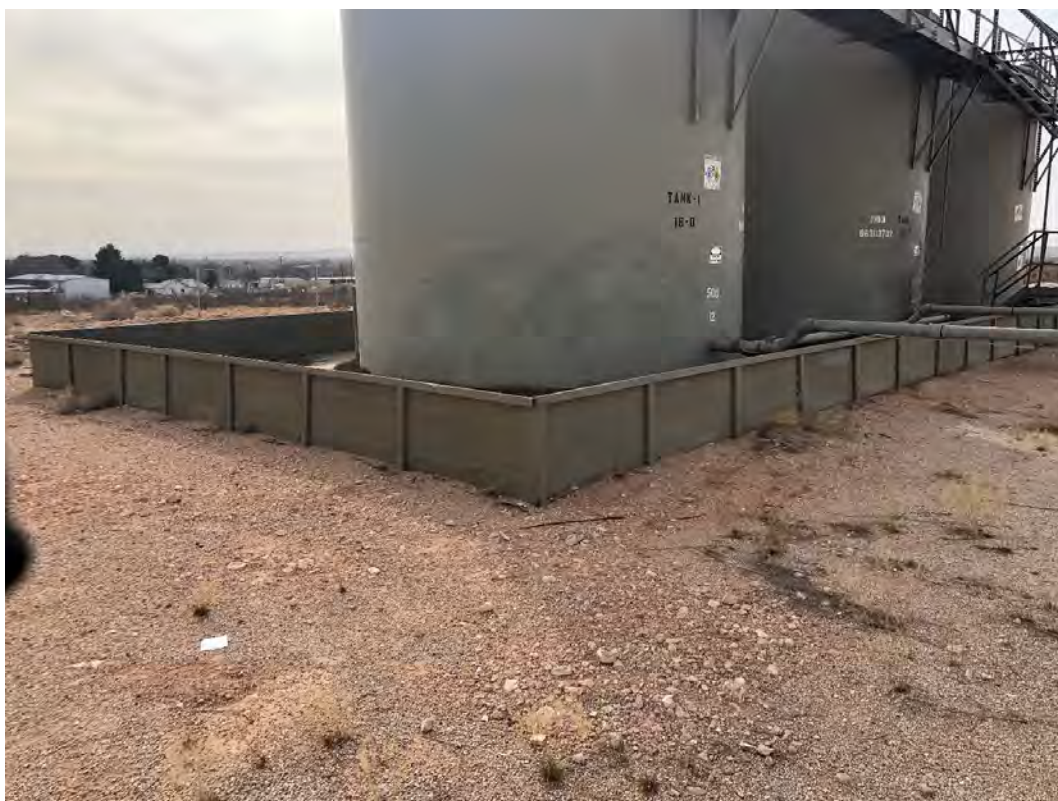
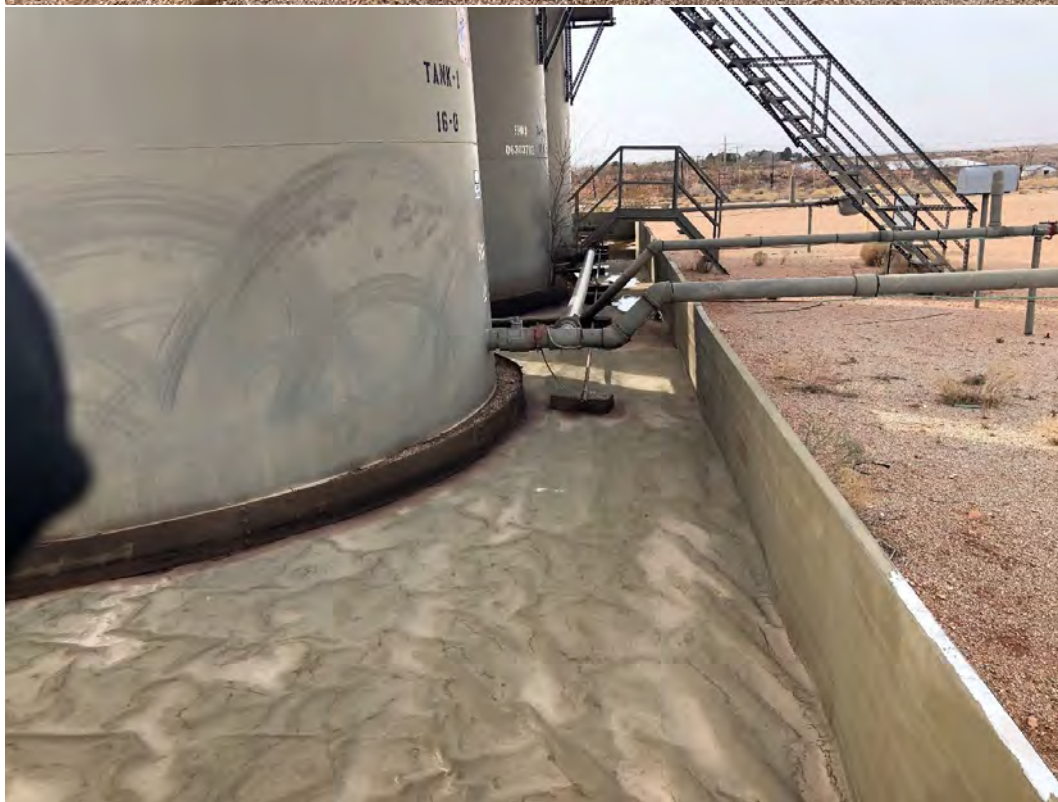
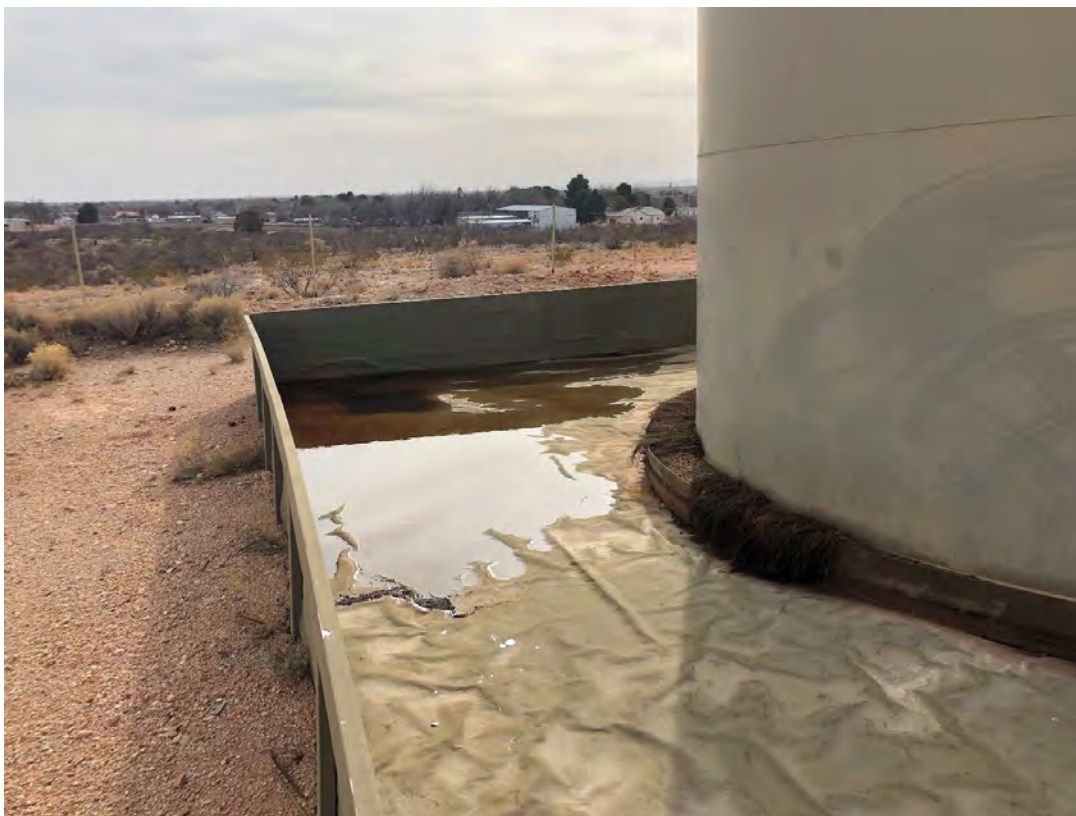
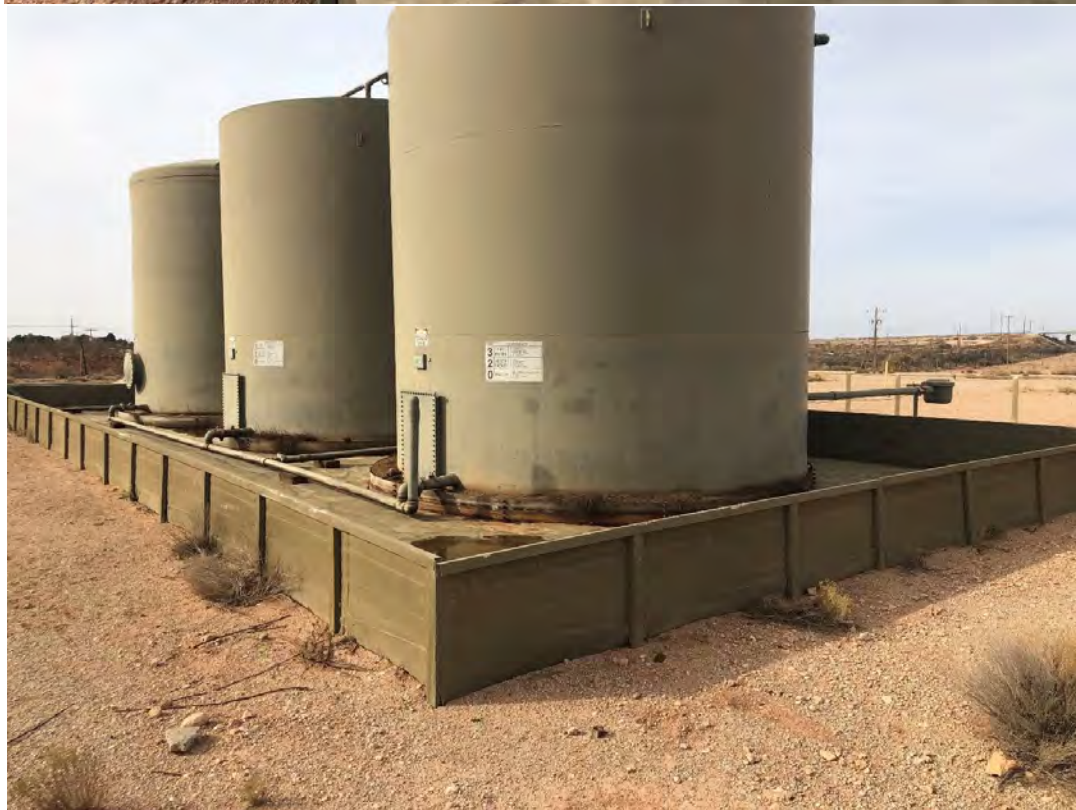
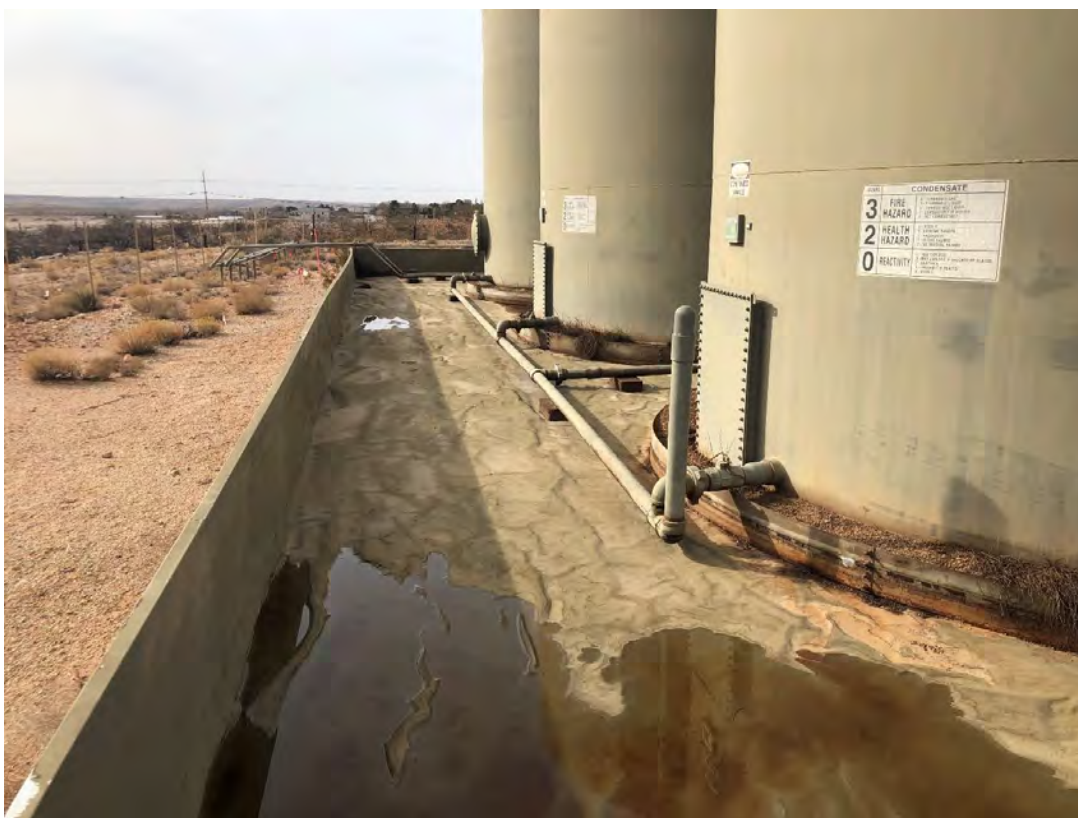
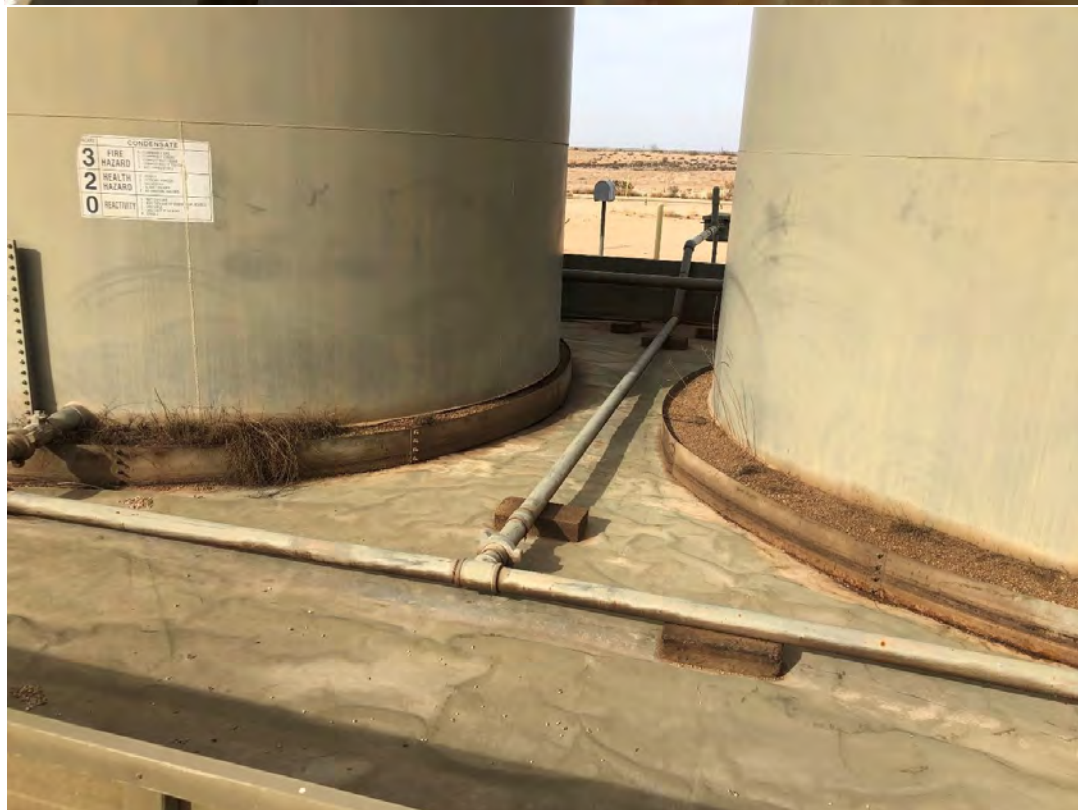
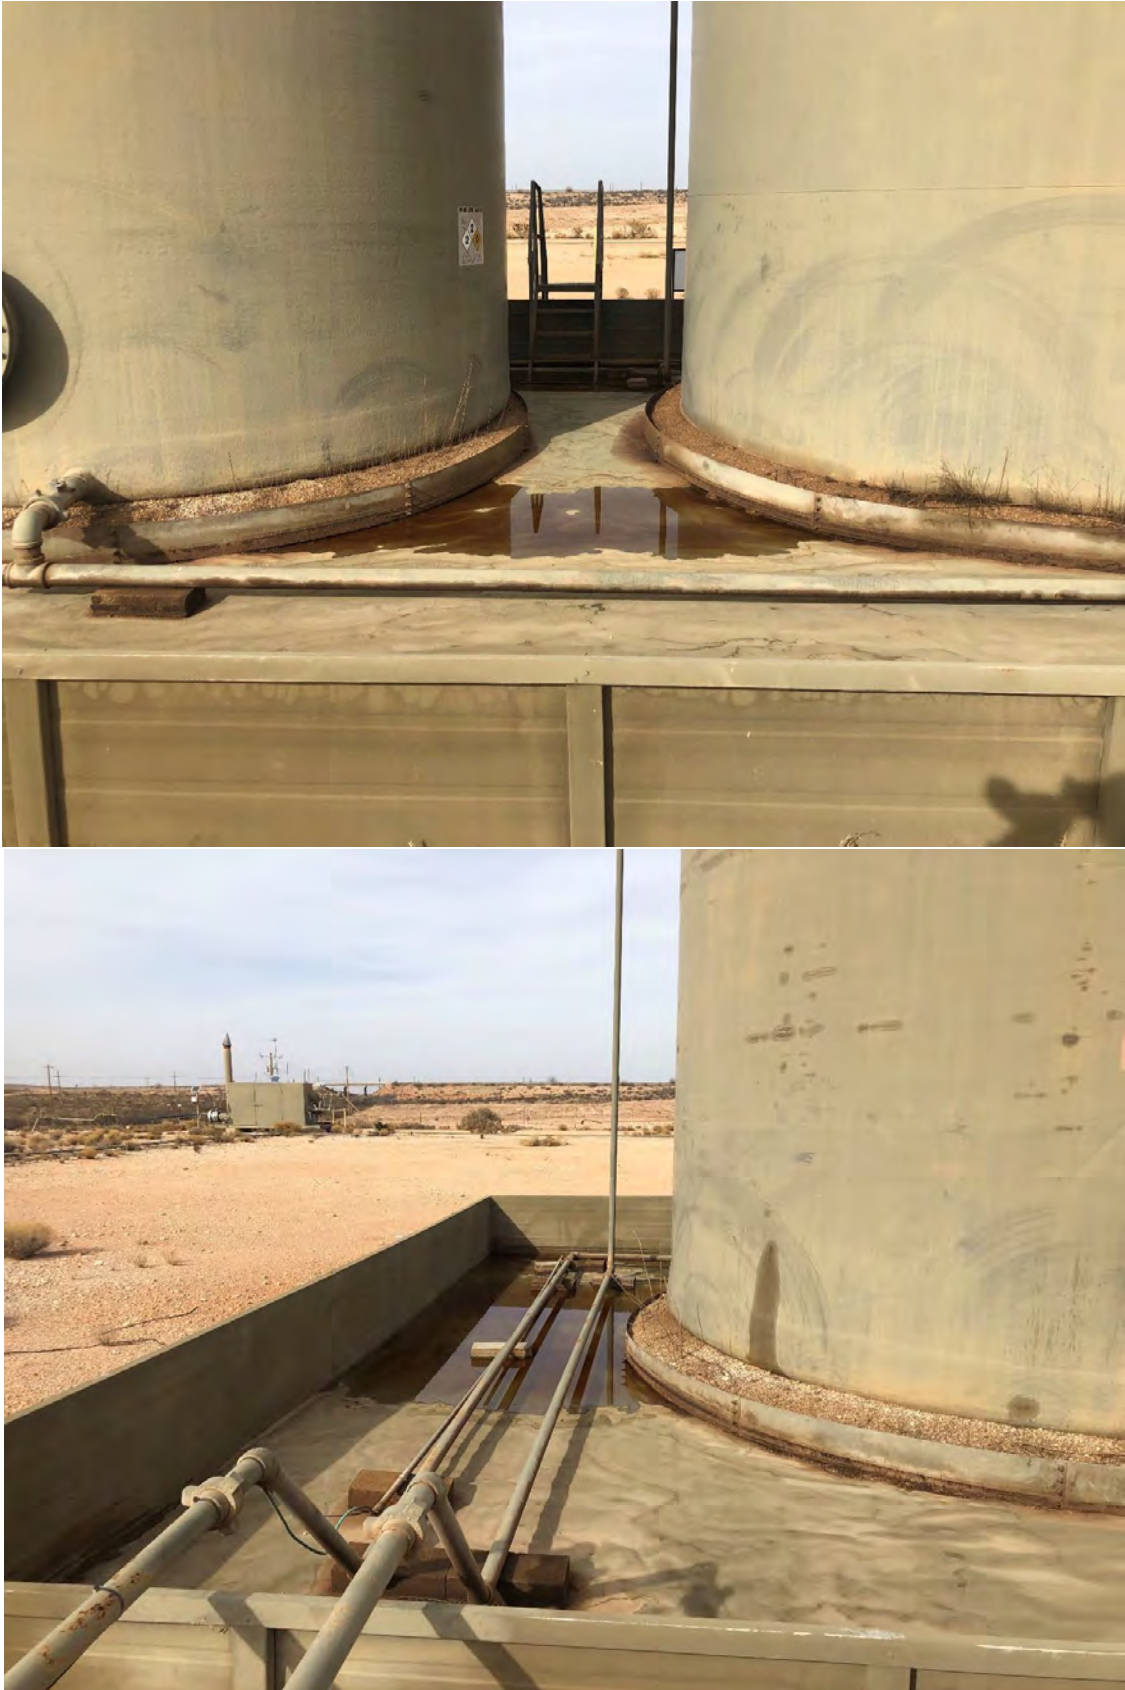
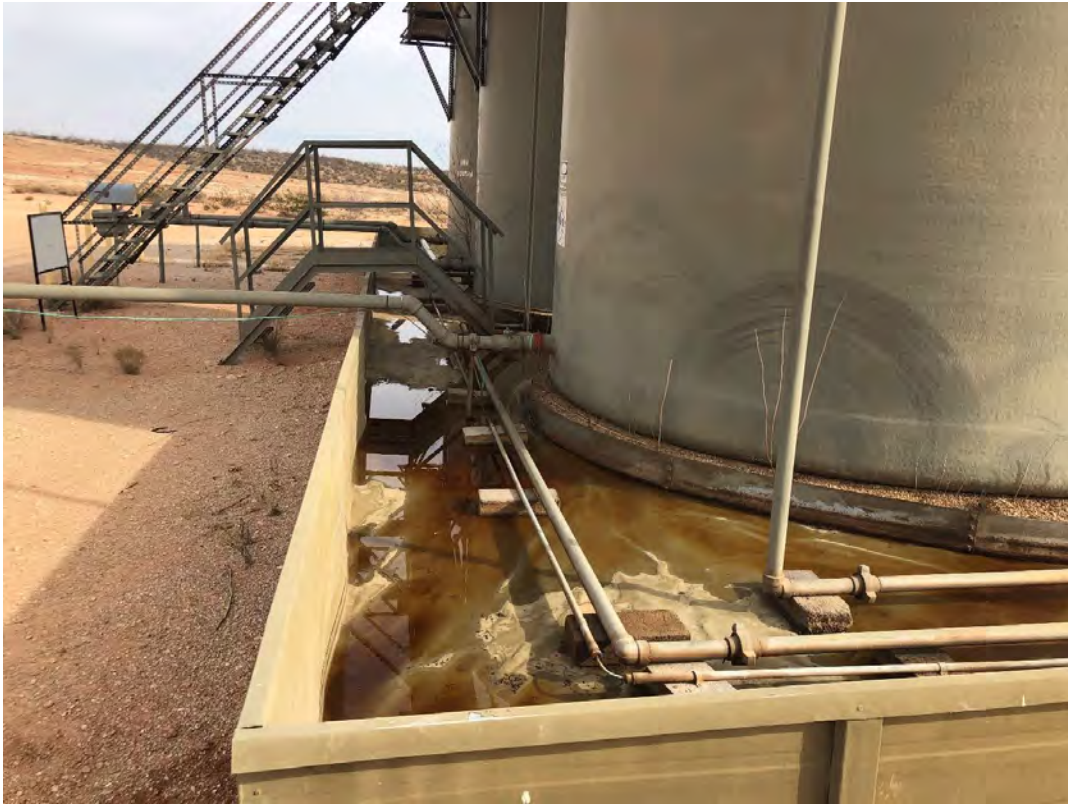
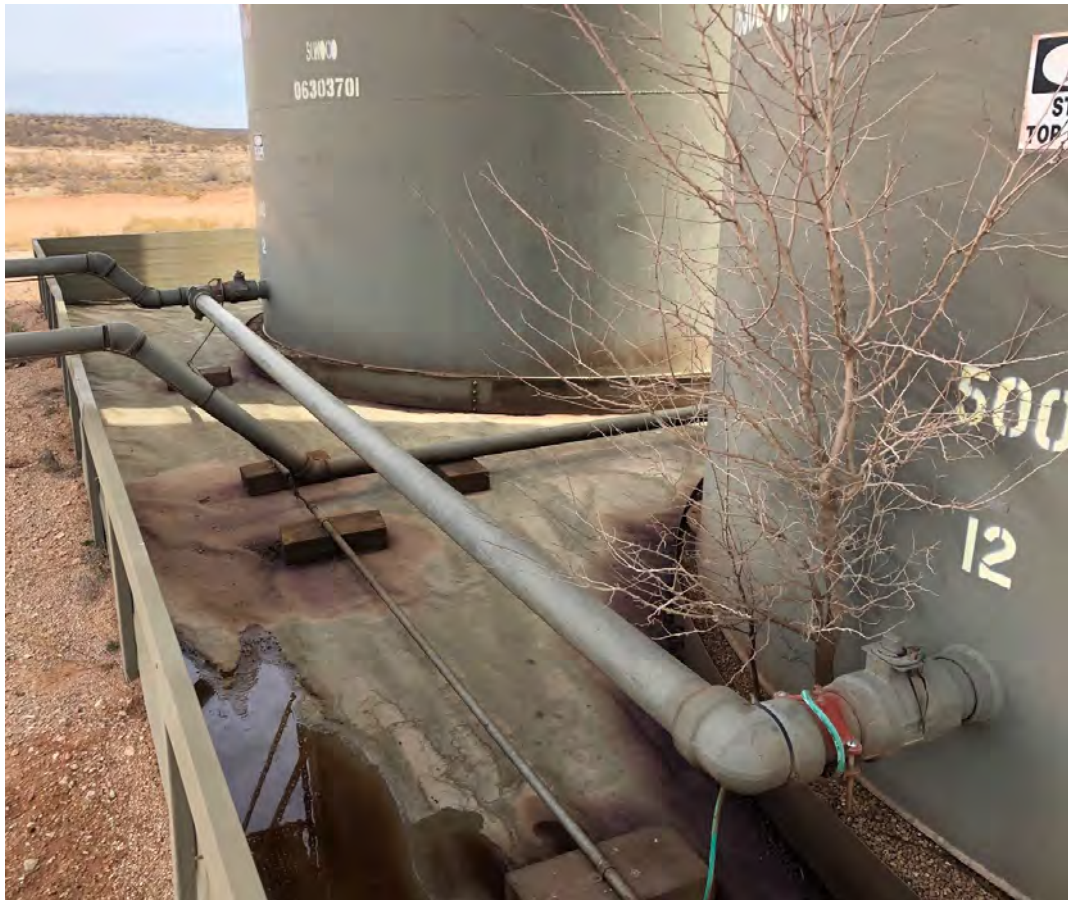
Photo Documentation

| Visualization | Yes | No | Comments |
|--|---|---|---|
| Is there a tear in the liner? | <input type="checkbox"/> | <input checked="" type="checkbox"/> | |
| Are there holes in the liner? | <input type="checkbox"/> | <input checked="" type="checkbox"/> | |
| Is the liner retaining any fluids? | <input checked="" type="checkbox"/> | <input type="checkbox"/> | Recent snow melt |
| Does the liner have integrity to contain a leak? | <input checked="" type="checkbox"/> | <input type="checkbox"/> | |
