February 18, 2020

Vertex Project #: 20E-00141-001

**Spill Closure Report:** Malachite 22 CTB  
Unit D, Section 22, Township 19 South, Range 33 East  
County: Lea  
API: 30-025-40318  
Tracking Number: nOY1722030579

2020 Spill Assessment and Closure  
February 2020

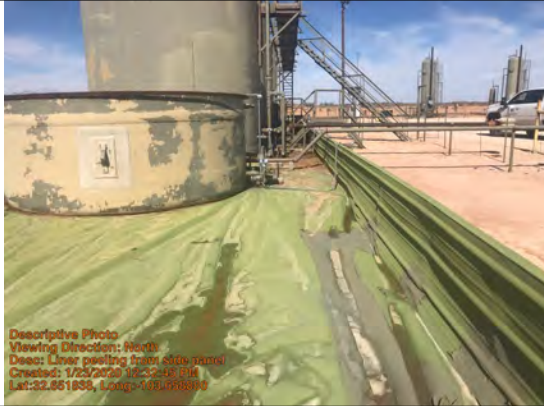
Descriptive Photo  
Viewing Direction: North  
Desc: Liner peeling from side of tank  
Created: 1/23/2020 10:32:18 PM  
Lat:32.661838, Long:-103.660949

Liner integrity

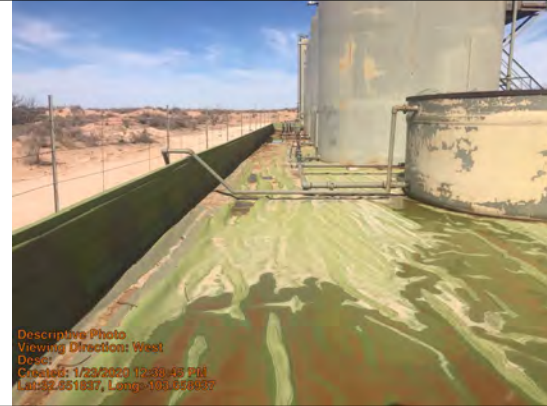
Liner integrity

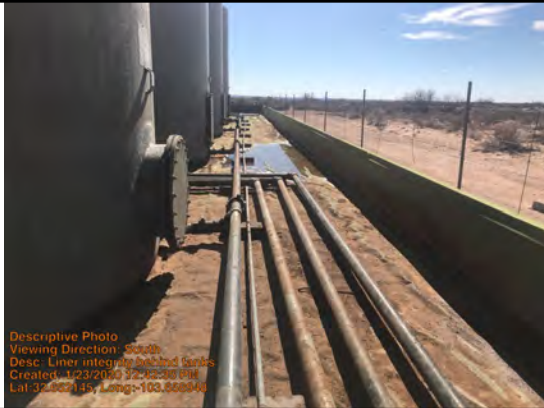
Descriptive Photo  
Viewing Direction: South  
Desc: Liner integrity behind tanks  
Created: 1/23/2020 3:24:30 PM  
Lat:32.662145, Long:-103.660949

Liner integrity behind tanks

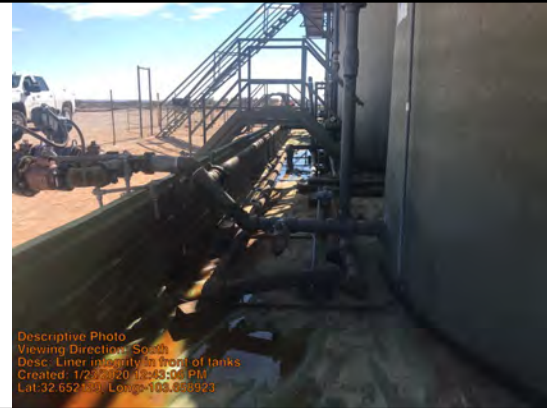
Descriptive Photo  
Viewing Direction: South  
Desc: Liner integrity in front of tanks  
Created: 1/23/2020 12:43:06 PM  
Lat:32.662330, Long:-103.660923

Liner integrity in front of tanks

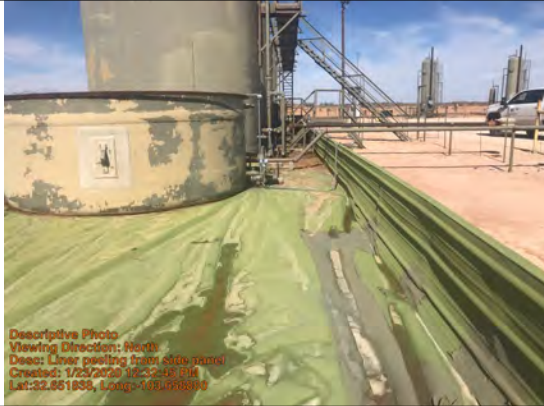
Descriptive Photo  
Viewing Direction: North  
Desc: Liner peeling from side of tank  
Created: 1/23/2020 10:32:18 PM  
Lat:32.661838, Long:-103.660949

Liner integrity

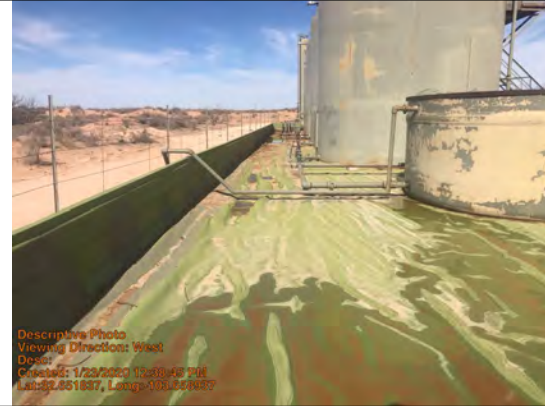
Liner integrity

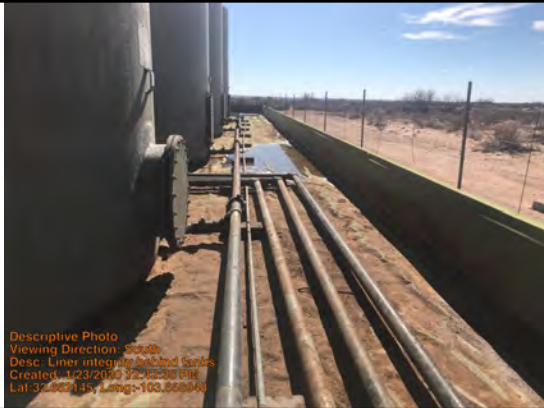
Descriptive Photo  
Viewing Direction: South  
Desc: Liner integrity behind tanks  
Created: 1/23/2020 3:24:30 PM  
Lat:32.662145, Long:-103.660949

Liner integrity behind tanks

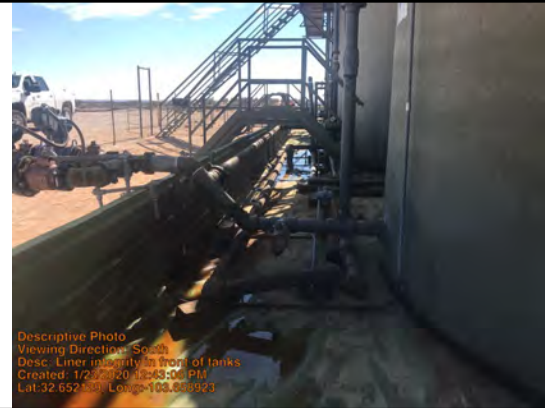
Descriptive Photo  
Viewing Direction: South  
Desc: Liner integrity in front of tanks  
Created: 1/23/2020 11:43:06 PM  
Lat:32.662330, Long:-103.660923

Liner integrity in front of tanks

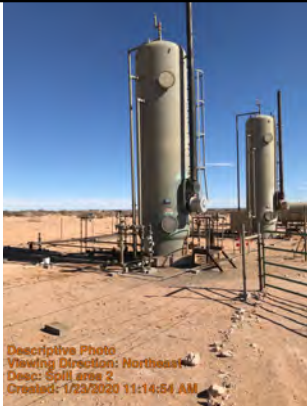
<p>Descriptive Photo Viewing Direction: Northeast Desc: Spill area 2 Created: 1/23/2020 11:14:54 AM</p> <p>Spill area 2</p>	<p><b>Viewing Direction: Southeast</b></p>

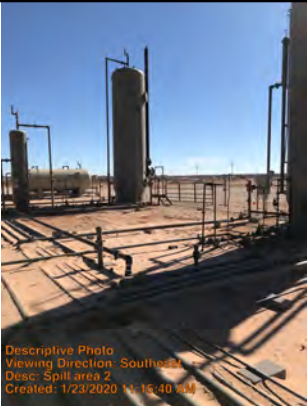
<p>Descriptive Photo Viewing Direction: Southeast Desc: Spill area 2 Created: 1/23/2020 11:15:40 AM</p> <p>Spill area 2</p>
<p><b>Viewing Direction: Northwest</b></p>

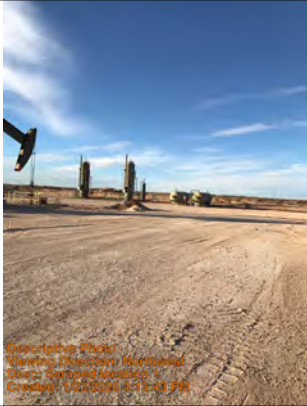
<p>Descriptive Photo Viewing Direction: Northwest Desc: Scraped location 1 Created: 1/23/2020 2:15:28 PM</p> <p>Scraped location 1</p>	<p><b>Viewing Direction: Southeast</b></p>

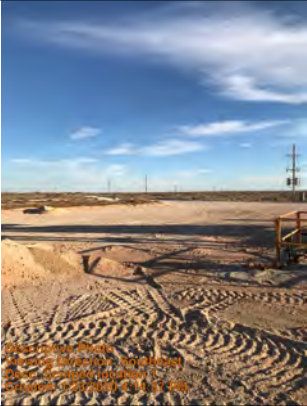
<p>Descriptive Photo Viewing Direction: Southeast Desc: Scraped location 1 Created: 1/23/2020 2:15:28 PM</p> <p>Scraped location 1</p>

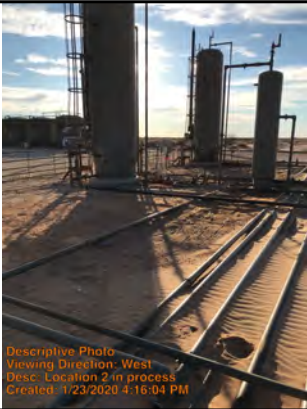
<p>Descriptive Photo Viewing Direction: West Desc: Location 2 in process Created: 1/23/2020 4:16:04 PM</p>

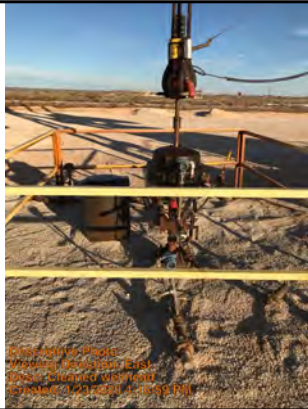
<p>Descriptive Photo Viewing Direction: East Desc: Cleaned wellhead Created: 1/23/2020 4:22:50 PM</p>
Location 2 in process	Cleaned wellhead
