Spill Closure Report:

Colonel R Howard 2 (Section 23, Township 23 South, Range 27 East)

Incident Report: nAPP2131555241

**Matador Production Company**

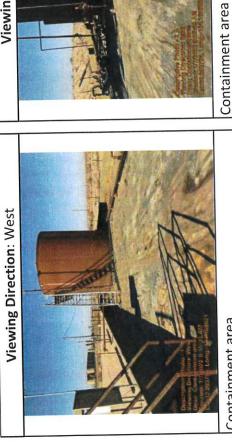
10:45 Upon completion of the liner inspection, no tears or imperfections where found.

Containment area

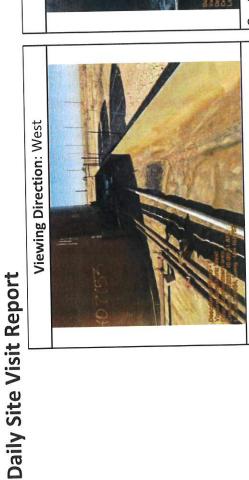
Liner between tanks
