RE: Liner Inspection and Closure Report

Thistle Unit 22 CTB 2

GPS: Latitude 32.295341 Longitude -103.554565 UL- A, Section 22, Township 23S, Range 33E NMOCD Reference No. NAPP2130051391

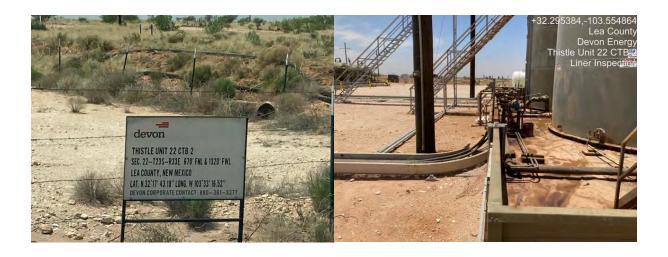
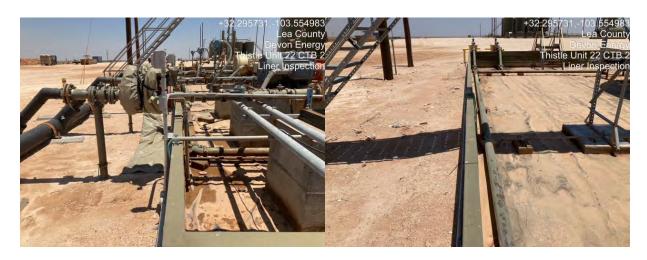
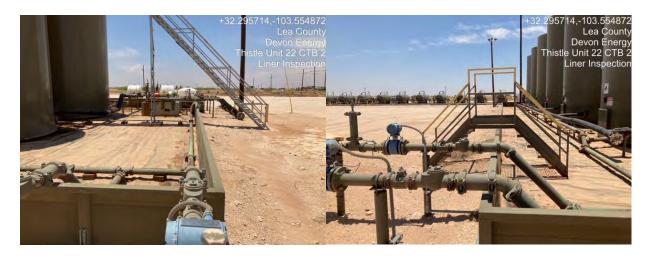
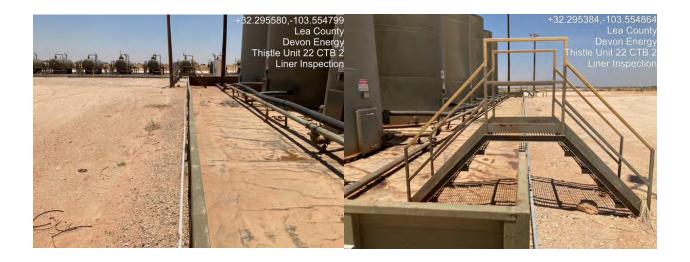
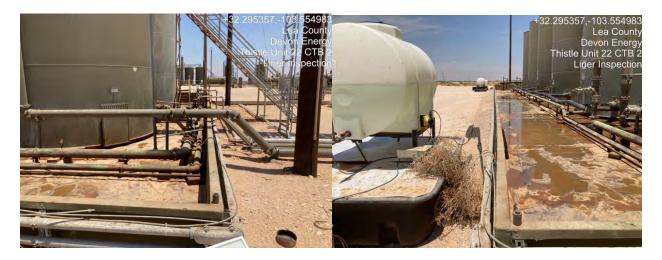
Photographic Documentation

On June 17, 2022, after sending the 48-hour notification via email, Pima Environmental conducted a liner inspection at this location. We concluded that this liner and containment maintained its integrity and was able to retain the fluids. The liner inspection form and photographic documentation can be found in Appendix C.
