# LINER INSPECTION AND CLOSURE REPORT REPORTABLE RELEASE

# **Spur Energy Partners**

Pinto 36 St Com #1
Incident ID: nAPP2216838692
API #30-015-39781
Eddy County, NM

Paragon Environmental LLC 225 Billy Walker Rd Hobbs, NM 88240 903-522-0833

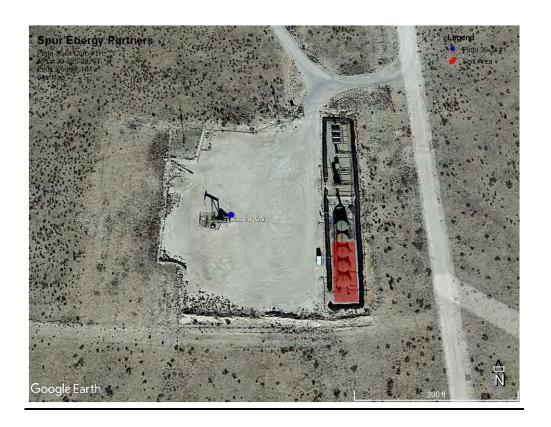
On July 20, 2022, Paragon went to the Pinto and conducted an initial assessment. There were obvious oil stains on the liner from the spill. There were no signs outside the containment that the liner had been breached. Therefore, no samples were taken. See the site map below showing the affected area.

On July 22, 2022, Paragon returned to the site with equipment and personnel to conduct cleanup activities. We initially sprayed the affected area with surface cleaner. We then power washed and squeegeed the runoff to where the vacuum truck could capture the fluids.

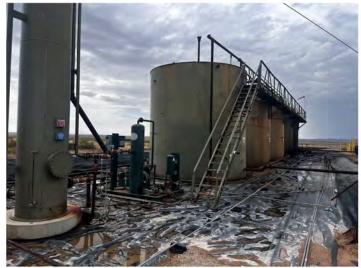
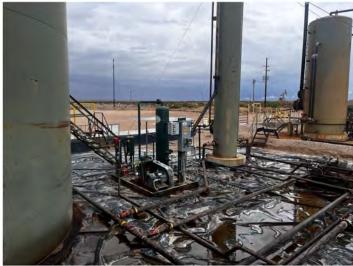
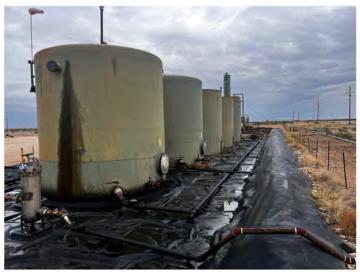
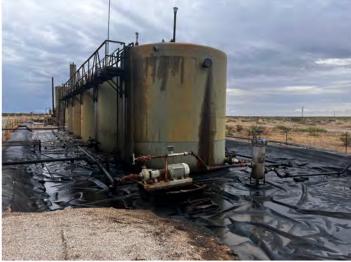
# Completed

On August 5, 2022, Paragon returned to the site to conduct a liner inspection. A 48-hour notification was sent out to the NMOCD on August 3, 2022. The liner inspection concluded that the liner was all intact and in good condition. See Appendix D for the email notification and liner report.
