LINER INSPECTION AND CLOSURE REPORT REPORTABLE RELEASE

Spur Energy Partners

Bradley 8 Fee #2H Incident ID: nRM2013953582 API #30-015-39811 Eddy County, NM

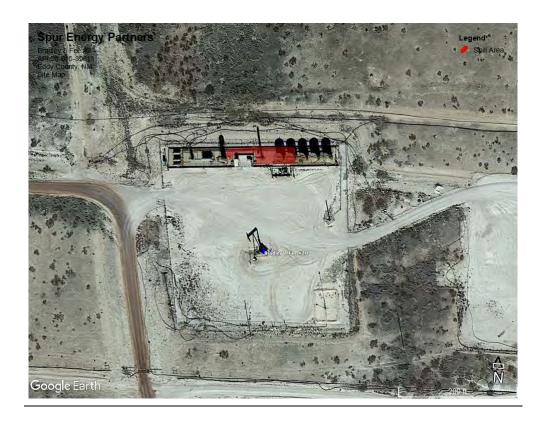
On May 23, 2022, Paragon went to the Bradley and conducted an initial assessment. There were noticeable oil stains on the liner from the spill. There were no signs outside the containment that the liner had been breached. Therefore, no samples were taken. See the site map below showing the affected area.

On June 9, 2022, Paragon returned to the site with equipment and personnel to conduct cleanup activities. We initially sprayed the affected area with surface cleaner. We then power washed and squeegeed the runoff to where the vacuum truck could capture the fluids.

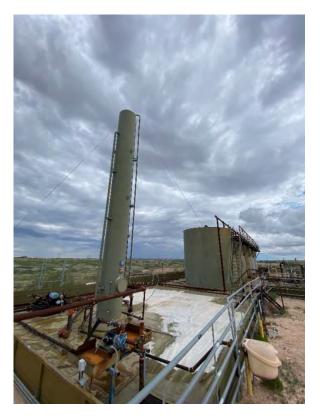
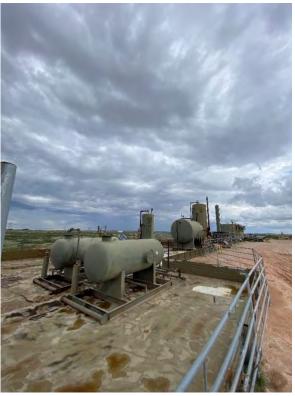
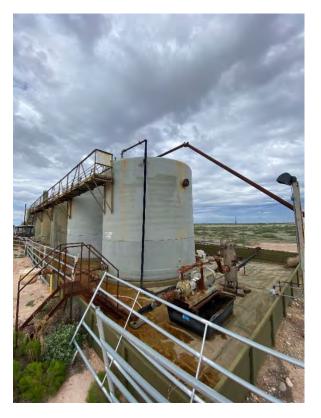
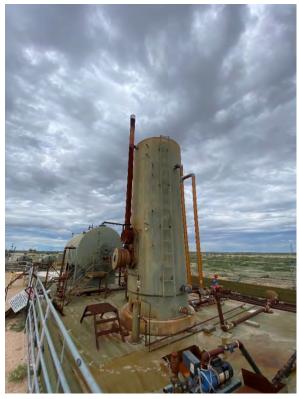
Liner Inspection

On July 20, 2022, Paragon returned to the site to conduct a liner inspection. A 48-hour notification was sent to the NMOCD on July 18, 2022. The liner inspection concluded that the liner was all intact and in good condition. The integrity of the liner appears to have the ability to contain spills. See Appendix D for the email notification and liner report.

Visualization	Yes	No	Comments
Is there a tear in the liner?		X	
Are there holes in the liner?		X	
Is the liner retaining any fluids?		X	
Does the liner have integrity to contain a leak?	X
