# **LINER INSPECTION AND CLOSURE REPORT**

## **REPORTABLE RELEASE**

**Spur Energy Partners**  
Clydesdale 1 Fee #6H Battery  
Incident ID: NAPP2130547657  
Eddy County, NM

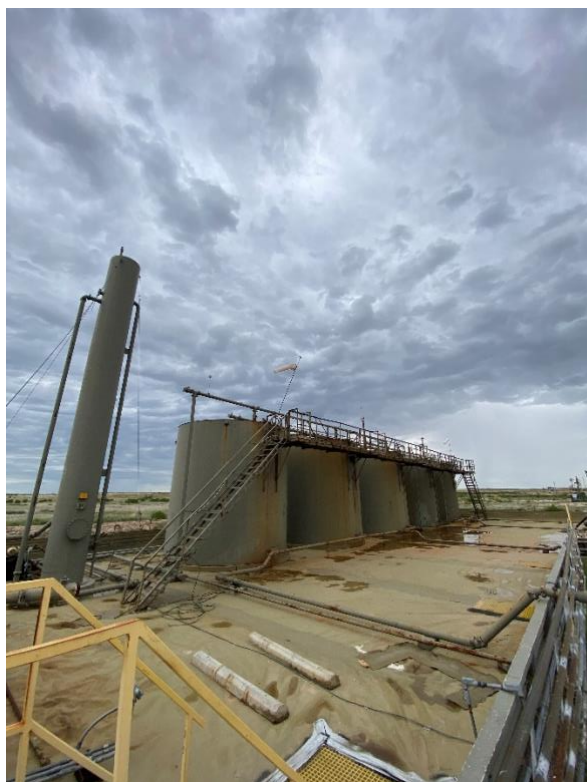
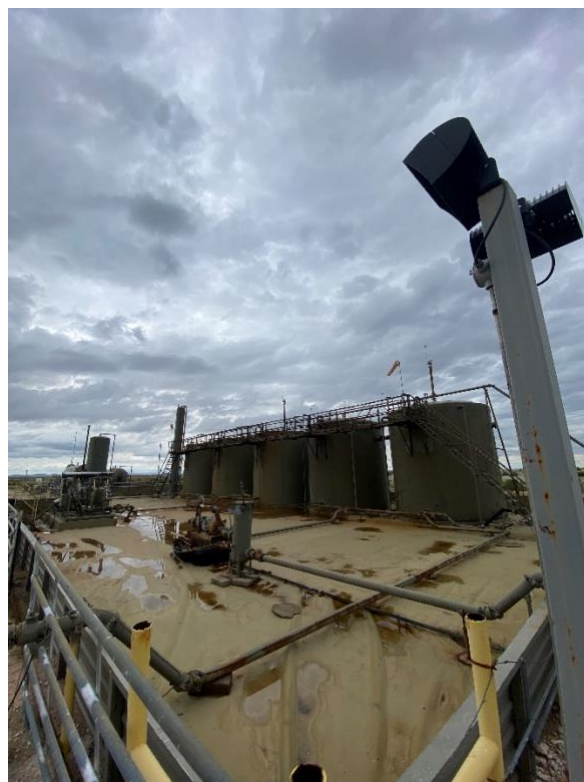
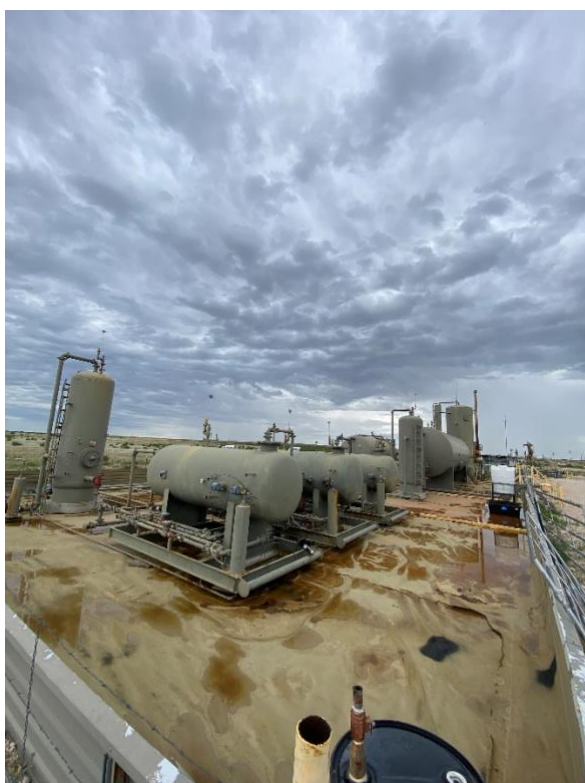
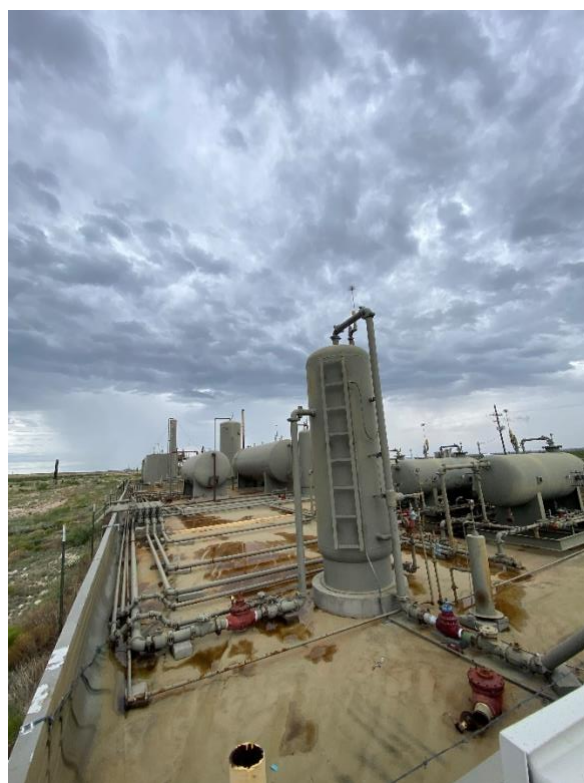
**Liner Inspection**

On July 20, 2022, Paragon returned to the site to conduct a liner inspection. A 48-hour notification was sent out to the NMOCD on July 18, 2022. The liner inspection concluded that the liner was all intact and in good condition. The integrity of the liner appears to have the ability to contain spills. See Appendix D for the email notification and liner report.

| Visualization | Yes | No | Comments |
|--|---|---|---|
| Is there a tear in the liner? | | x | |
| Are there holes in the liner? | | x | |
| Is the liner retaining any fluids? | | x | |
| Does the liner have integrity to contain a leak? | x | | |
