# **LINER INSPECTION AND CLOSURE REPORT** **REPORTABLE RELEASE**

**Spur Energy Partners**  
Shelby 23 Tank Battery  
Incident ID: NAPP2202848888  
Eddy County, NM

This report was prepared by Paragon Environmental LLC (Paragon) in response to the release for Spur Energy Partners (Spur) at the **Shelby 23 Tank Battery (Shelby)**.

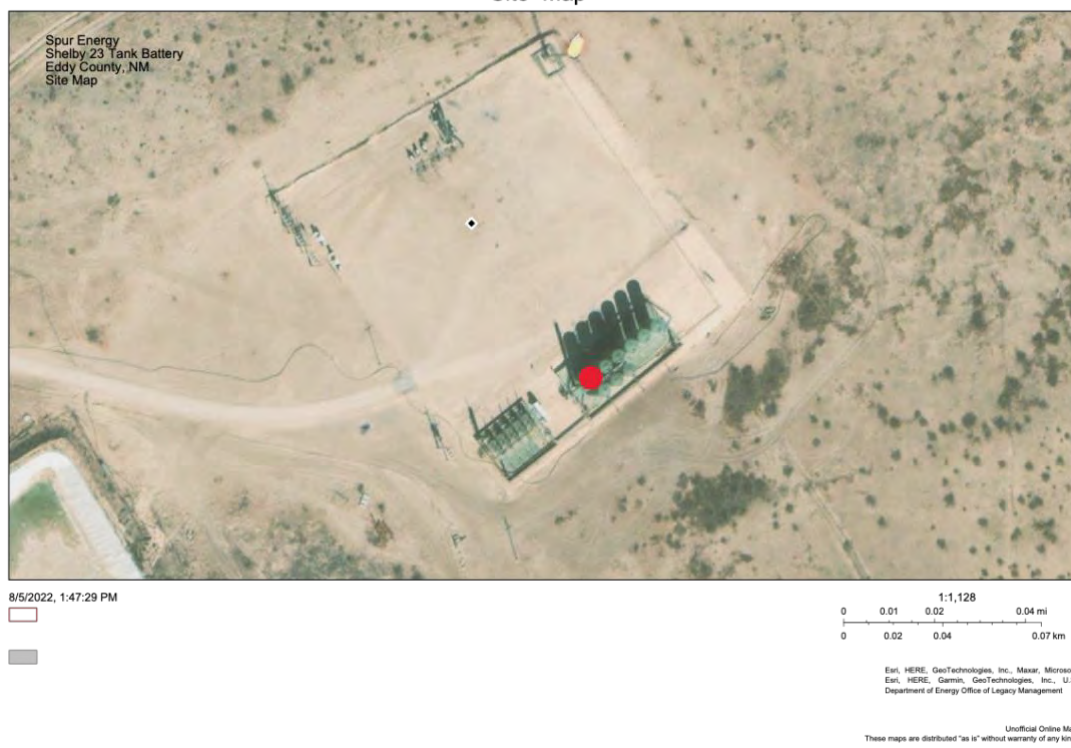
Site Map

On July 12, 2022, Paragon went to the Shelby and conducted an initial assessment. There was obvious staining on the liner from the spill. There was nothing outside the containment that showed any signs that the liner had been breached. Therefore, no samples were taken. See the site map below showing the affected area.

On July 18, 2022, Paragon returned to the site with equipment and personnel to conduct cleanup activities. We initially sprayed the affected area with surface cleaner. We then power washed and squeegeed the runoff to where the vacuum truck could capture the fluids.

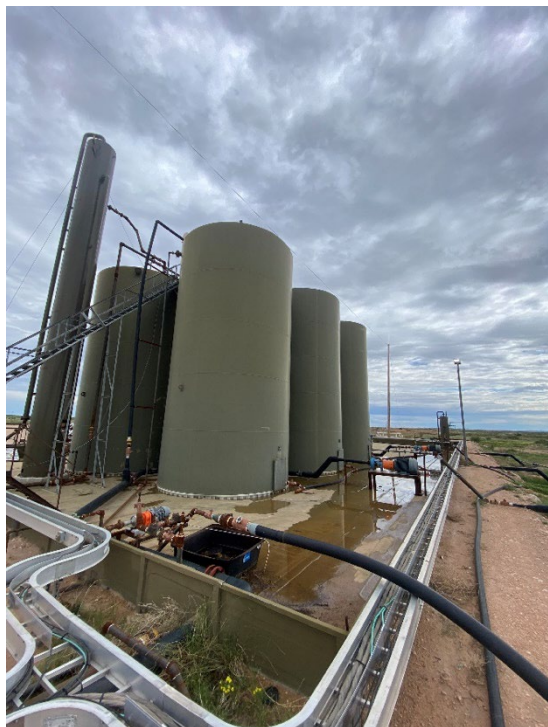
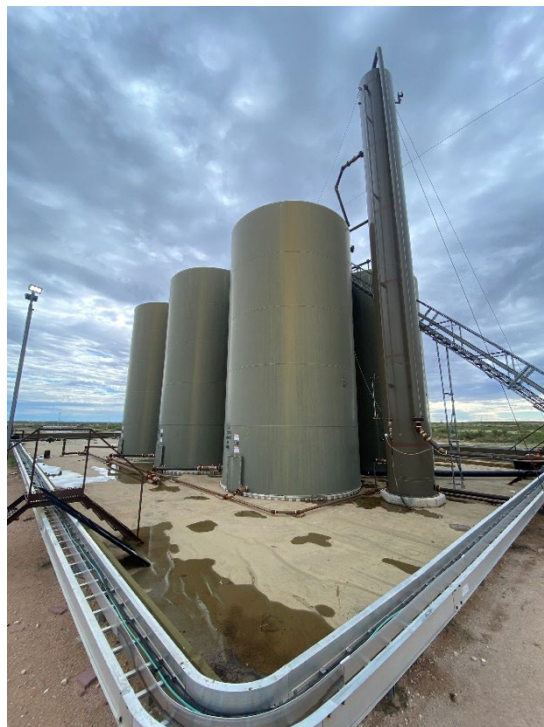
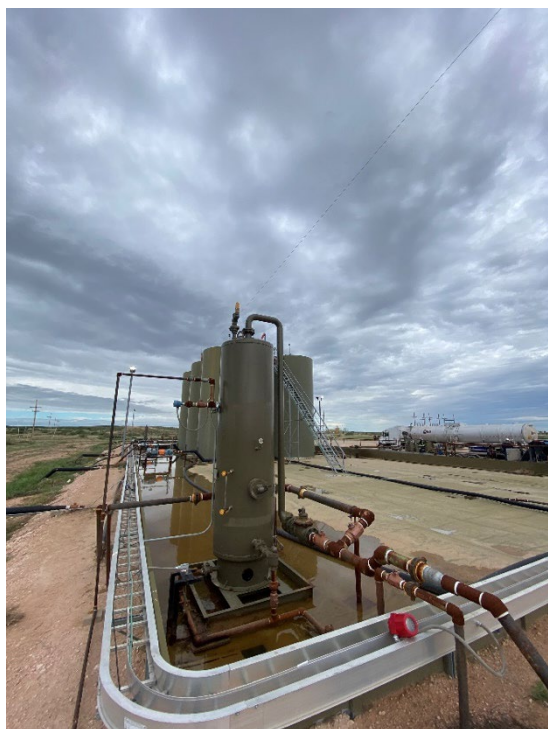
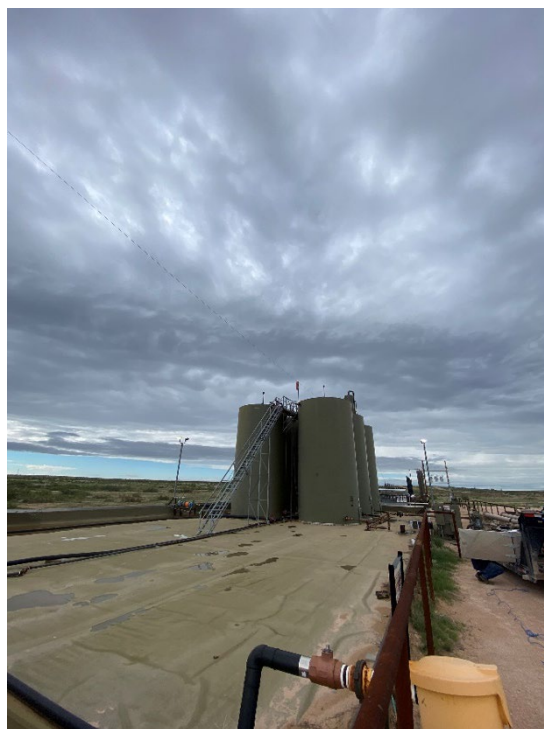
**Liner Inspection**

On July 20, 2022, Paragon returned to the site to conduct a liner inspection. A 48-hour notification was sent out to the NMOCD on July 18, 2022. The liner inspection concluded that the liner was all intact and in good condition. The integrity of the liner appears to have the ability to contain spills. See Appendix D for the email notification and liner report.

Visualization	Yes	No	Comments
Is there a tear in the liner?		x	
Are there holes in the liner?		x	
Is the liner retaining any fluids?		x	
Does the liner have integrity to contain a leak?	x
