Release Notification

Site Name Seymour 6	Site Type Well
Date Release Discovered: 8/18/2022 @ 08:30am (MT)	API# 30-045-10684

Re: Remediation Work Plan and Variance Request

Seymour 6
San Juan County, New Mexico
Hilcorp Energy Company
NMOCD Incident No: nAPP2224144740

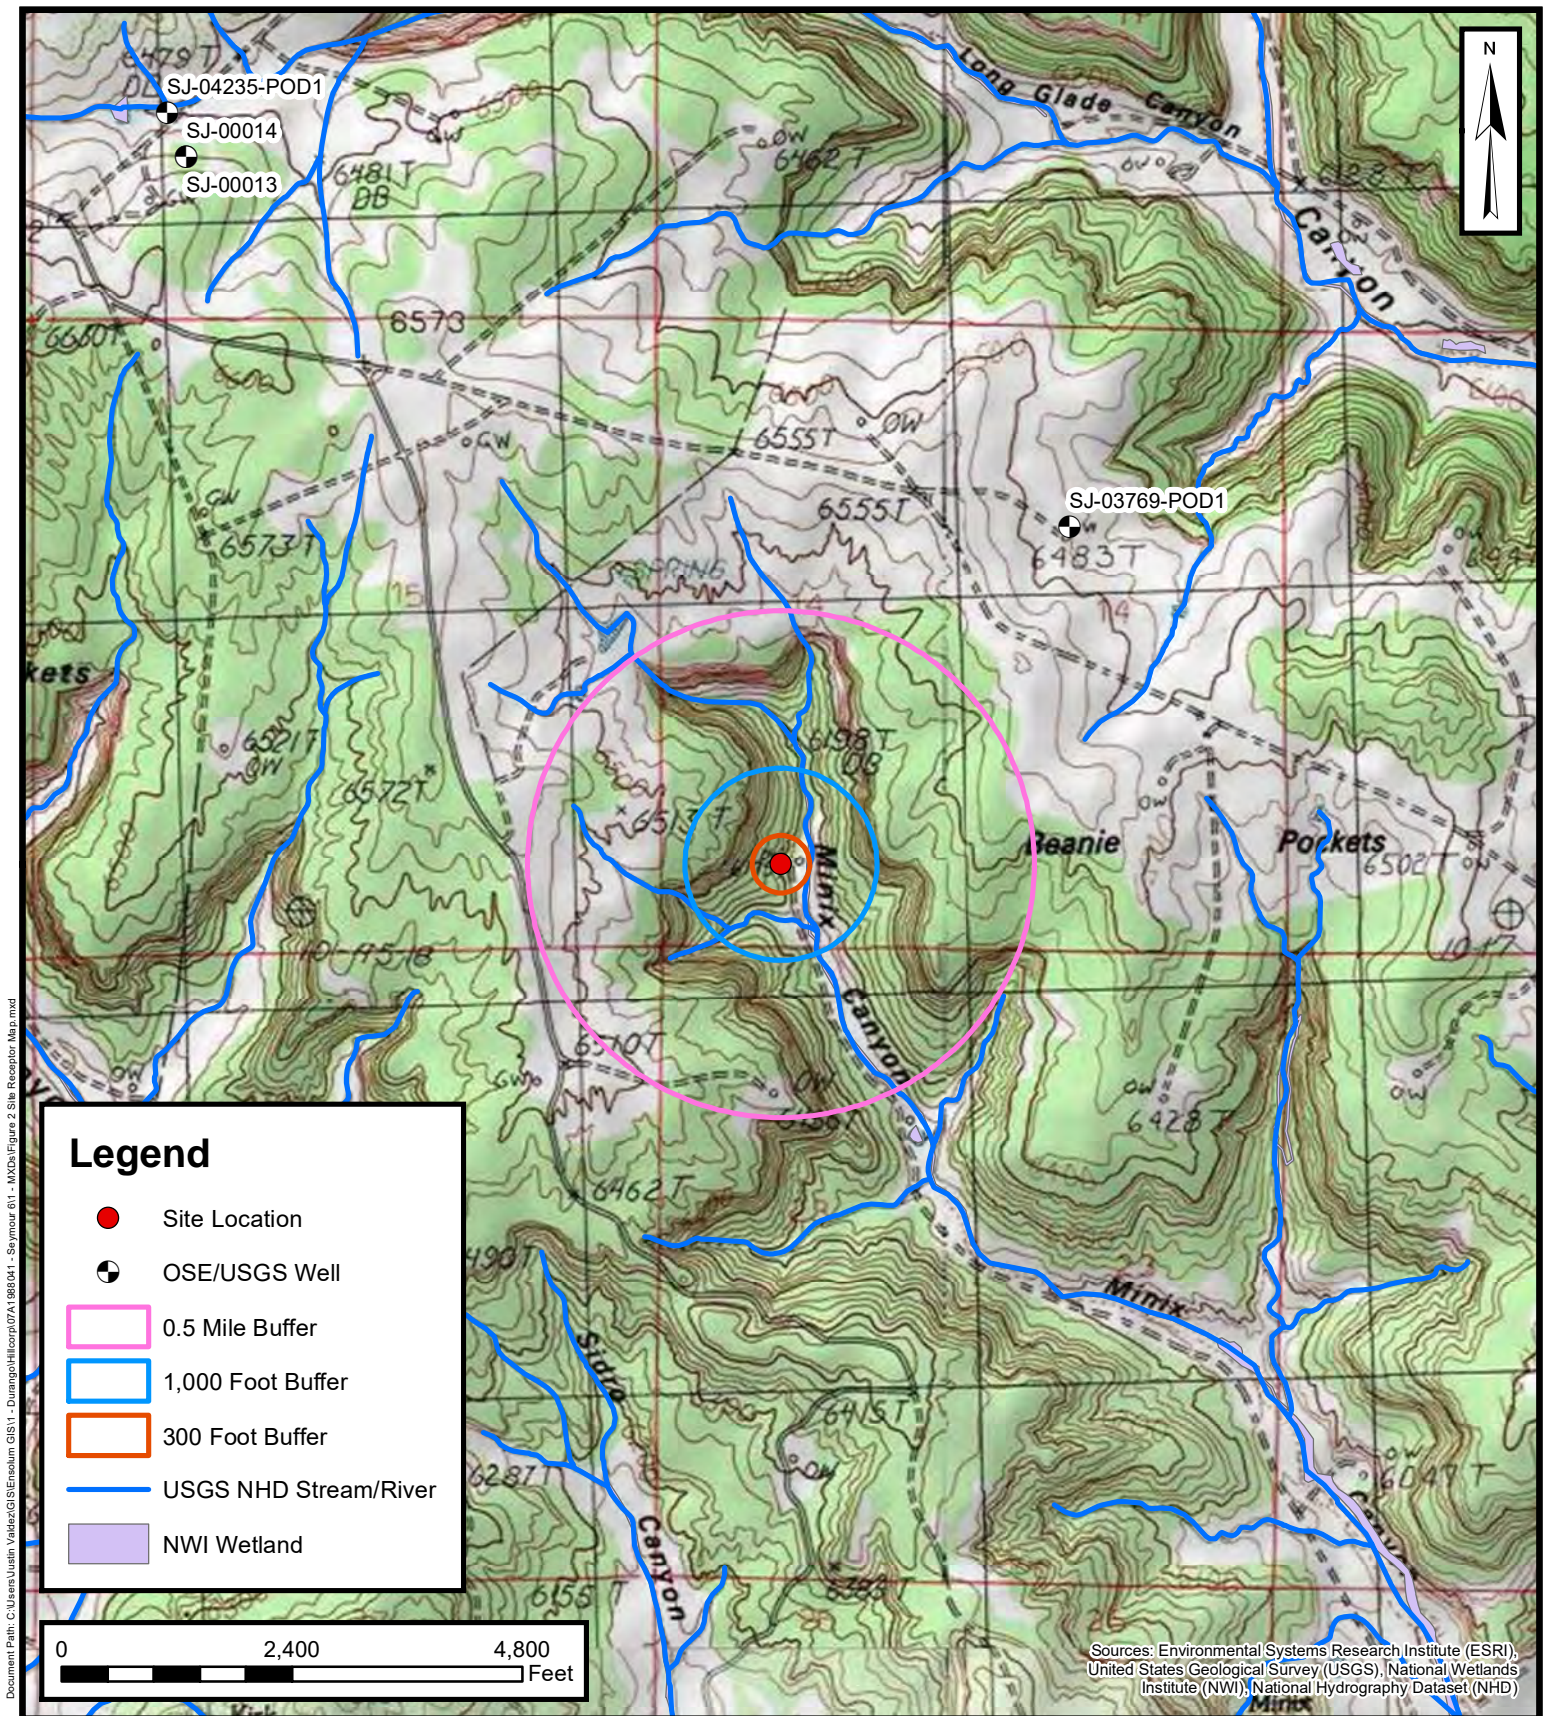
Site Receptor Map

The nearest significant watercourse and wetland to the Site is Minix Canyon located within 100 feet to the east of the well pad. The Site is greater than 200 feet from any lakebed, sinkhole, or playa lake (Figure 2). The nearest fresh-water well is NMOSE permitted well SJ-03769 (Appendix B), located approximately 0.66 miles northeast of the Site. The recorded depth to water on the NMOSE database is 390 feet below ground surface (bgs). No wellhead protection areas, springs, or domestic/stock wells are located within a ½-mile from the Site. The Site is not within a 100-year floodplain, overlying a subsurface mine, or located within an area underlain by unstable geology (area designated as low potential karst by the BLM). Schools, hospitals, institutions, churches, and/or other occupied permanent residence or structures are not located within 300 feet of the Site.

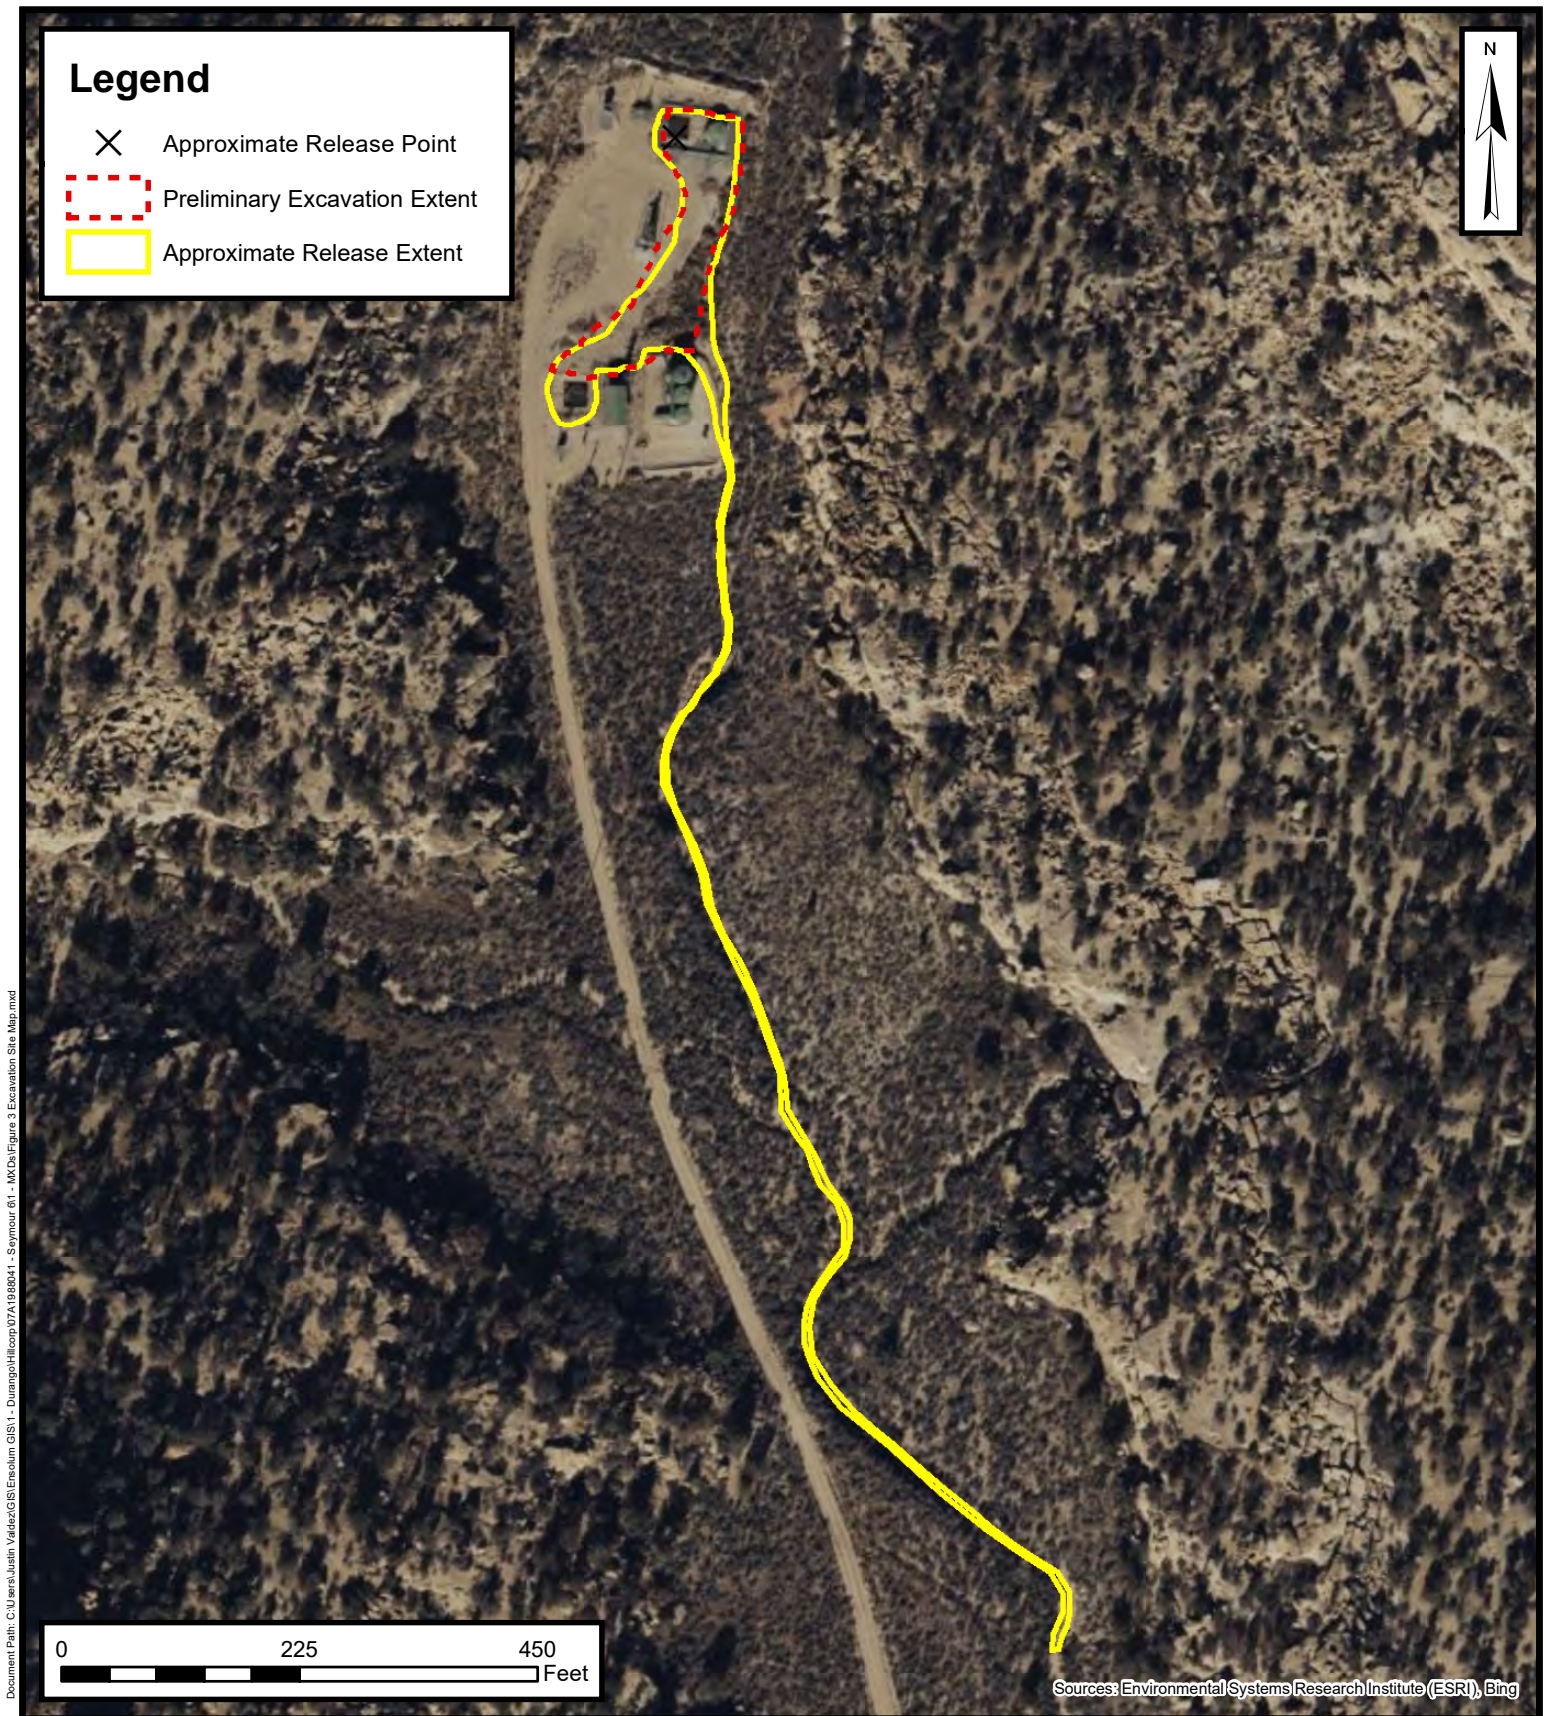
Excavation Site Map

At this time, the volume of remaining impacted soil at the Site has yet to be determined. As seen in the attached photographs (Appendix C), oil has accumulated on and around vegetation along the release footprint. To continue remediation efforts, Hilcorp proposes to remove by hand any vegetation impacted by the release, as indicated by the presence of an oily film on the vegetation and/or vegetation exhibiting stress caused by the release (e.g., browning or staining). Additionally, Hilcorp proposes to remove the remaining impacted soil from the well pad and dry wash by hand and/or mechanical excavation. The additional excavation would remove impacts not previously removed during the initial response efforts (shown on Figure 3).

Once impacted soil is removed, Hilcorp will collect one 5-point composite sample from the excavation floor and sidewalls. Due to the estimated 15,000 square foot size of the excavation on the well pad, Hilcorp requests a variance for the frequency of excavation confirmation samples. Hilcorp proposes the frequency of confirmation sampling for the excavation floor to be decreased from every 200 square feet (approximately 70 samples) to every 500 square feet (approximately 28 samples). Sidewall samples will be collected at a frequency of one composite sample for every 200 square feet. Additionally, because the release fluid migrated along a narrow pathway in the

Once impacted vegetation and soil has been removed, excavated areas will be backfilled and recontoured to match the original land surface grade using clean topsoil. Areas originally vegetated at the Site (outside of the dry wash) will then be reseeded with a BLM-approved seed mix.

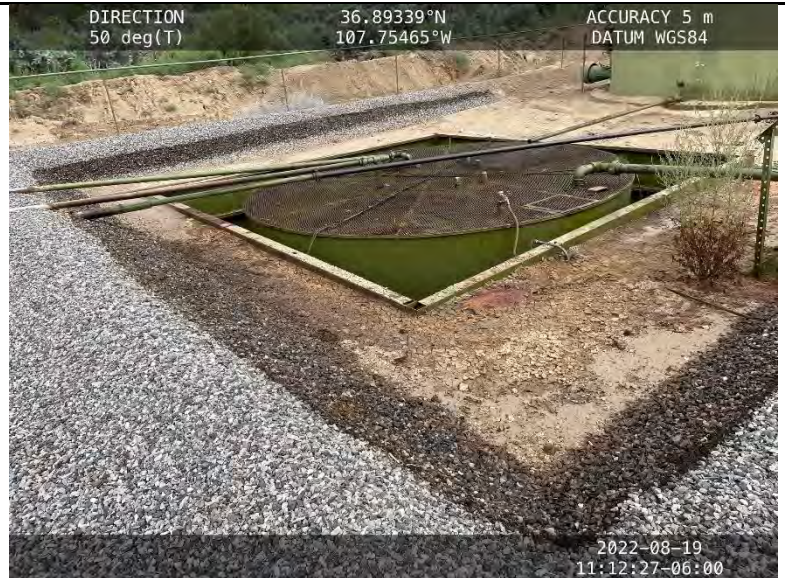
Photograph 1

View looking northeast at the below grade tank where the release originated. Oil staining can be seen on the soil and containment berm gravel.

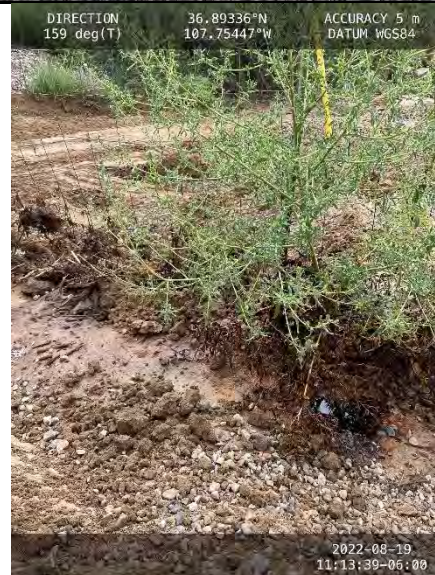
**Photograph 2**

View looking east at the eastern edge of the Seymour 6 well pad.
