November 19, 2020

Vertex Project #: 20E-00141-007

Spill Closure Report: Sea Snake 35 State #001H
Unit M, Section 35, Township 23 South, Range 33 East
County: Lea
API: 30-025-41625
Incident Tracking Number: 1RP-4301

Prepared For: Devon Energy Production Company
6488 Seven Rivers Hwy
Artesia, New Mexico 88210

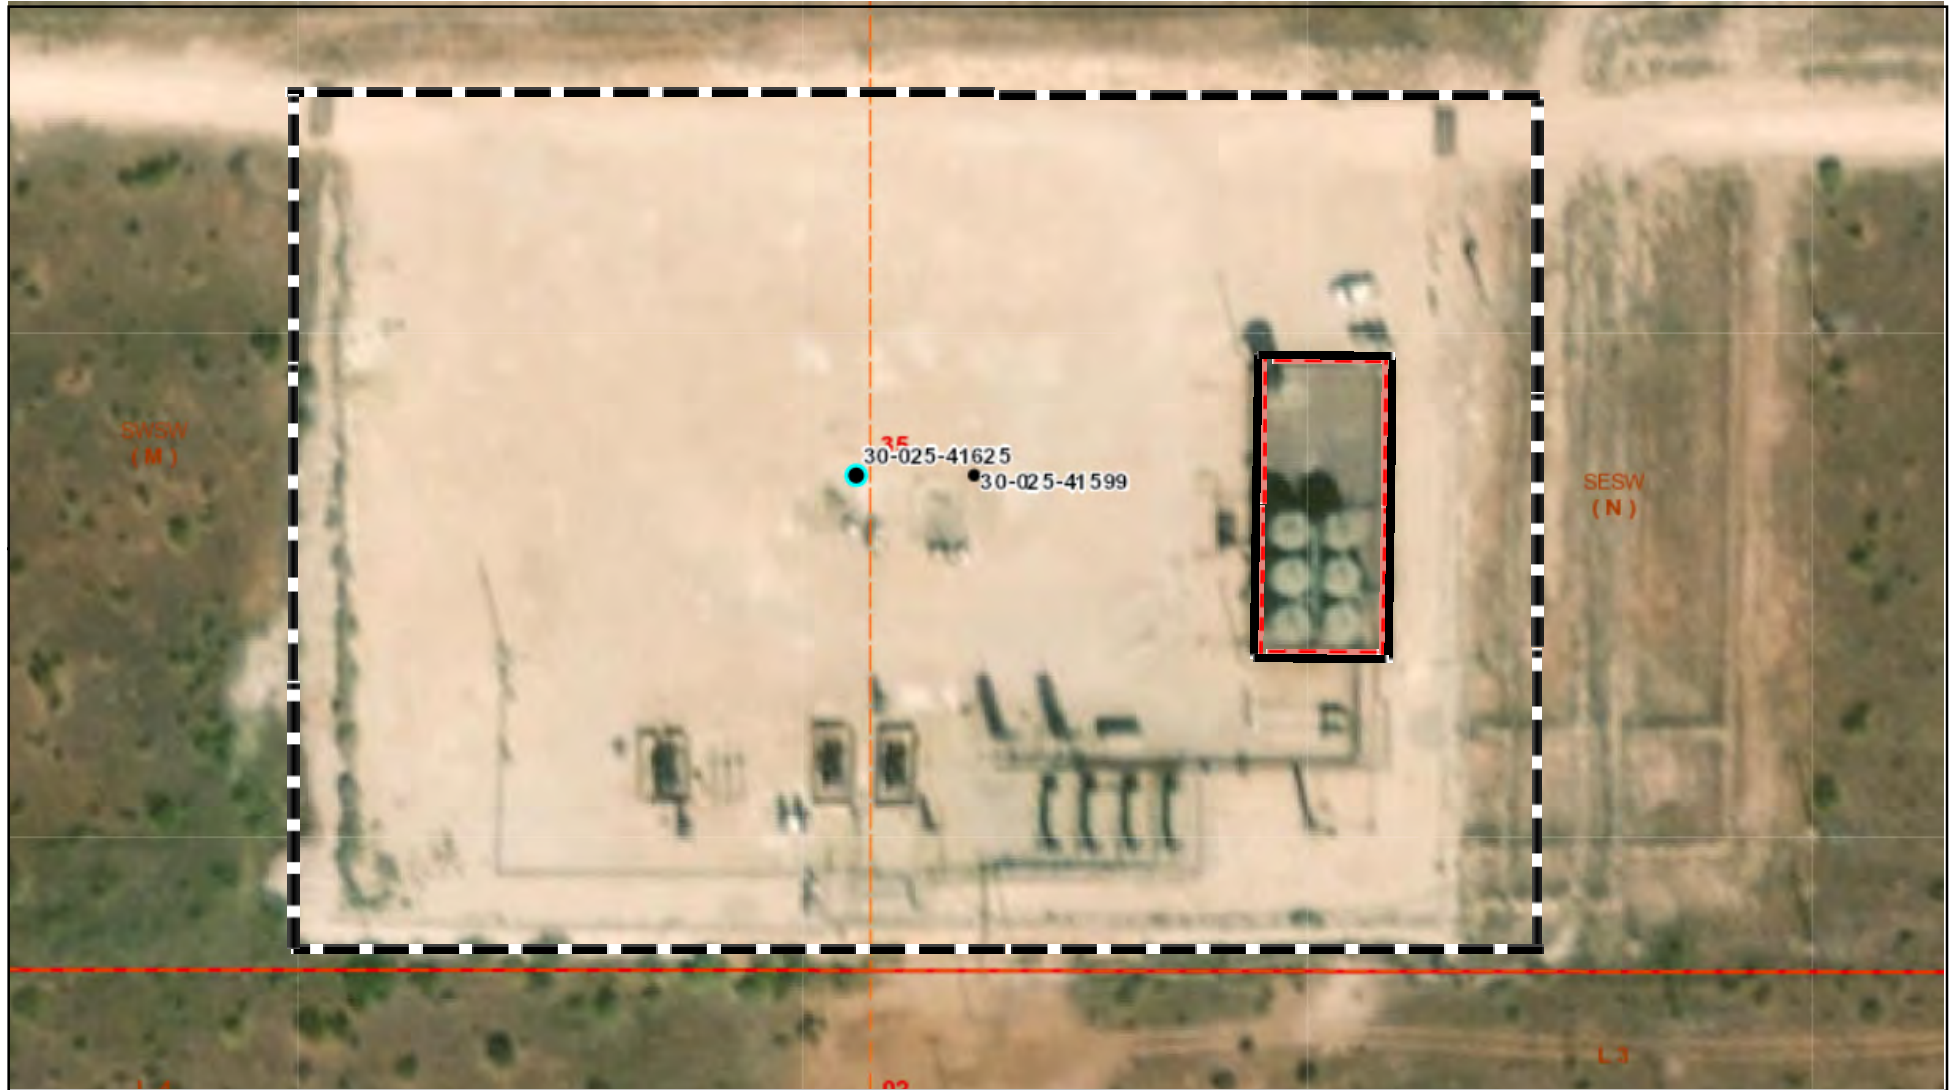
Site Schematic
 Sea Snake 35 State #001H

Approximate Spill Extent (~ 7,200 sq.ft.)

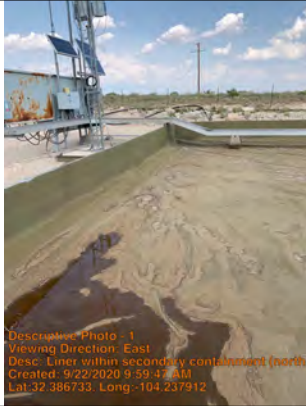
- 1 No tears, cracks, holes or any integrity deficiencies were identified in the liner inspection. No visible of signs of the incident in question escaping the secondary containment. Rainwater was present in the containment as shown in the inspection photos.
- 2 No further remediation activity is recommended at this time for this incident.

Liner within secondary containment (north wall)

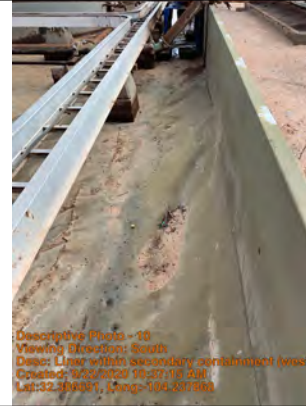
Liner within secondary containment (west wall)

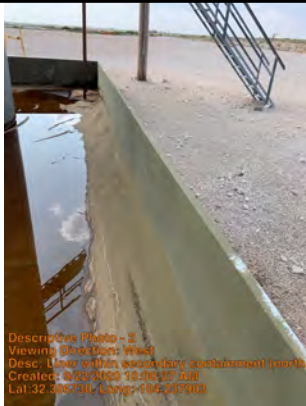
Liner within secondary containment (north wall)

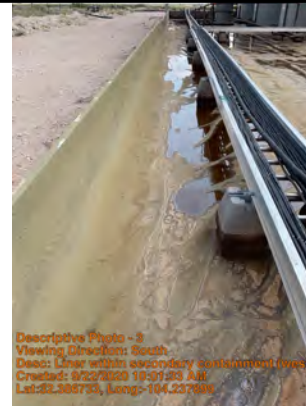
Liner within secondary containment (west wall)

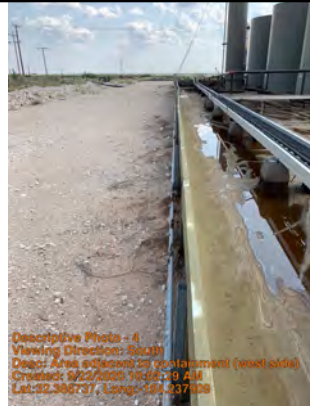
Area adjacent to containment

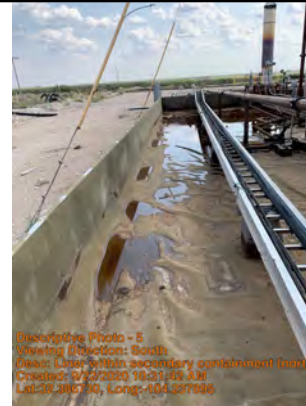
Liner within secondary containment (west wall)

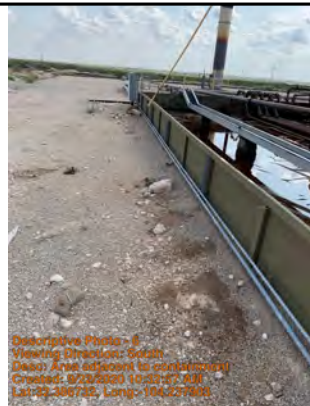
Area adjacent to containment

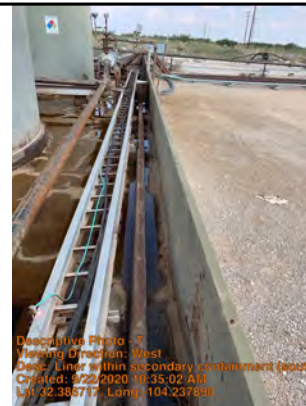
Liner within secondary containment (south wall)

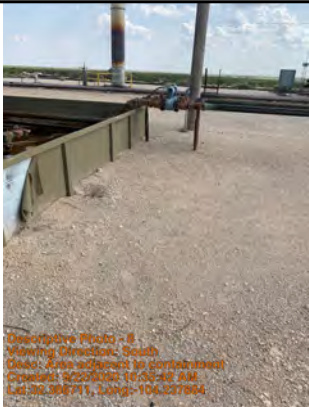
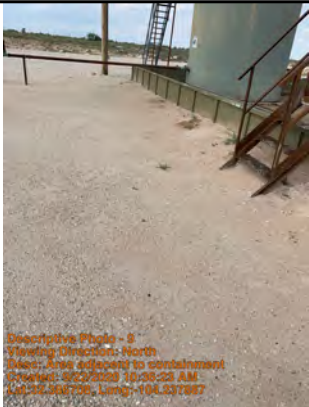
| Viewing Direction: South | Viewing Direction: North |
|---|---|
| Area adjacent to containment | Area adjacent to containment |
