**Closure Report**  
**Hambone Federal 8K CTB (10.30.22)**  
**Eddy County, New Mexico**  
**Incident ID: NAPP2231848987**  
**Unit K Sec 08 T26S R29E**  
**32.0567°, -104.0077°**

**Produced Water Release**  
**Point of Release: Ball Valve failure due to corrosion**  
**Release Date: 10.30.2022**  
**Volume Released: 32.397 barrels of Produced Water**  
**Volume Recovered: 32 barrels of Produced Water**

**Re: Closure Report  
Hambone Federal 8K CTB (10.30.22)  
Concho Operating, LLC  
Incident ID NAPP2231848987  
Site Location: Unit K, S08, T26S, R29E  
(Lat 32.0567°, Long -104.0077°)  
Eddy County, New Mexico**

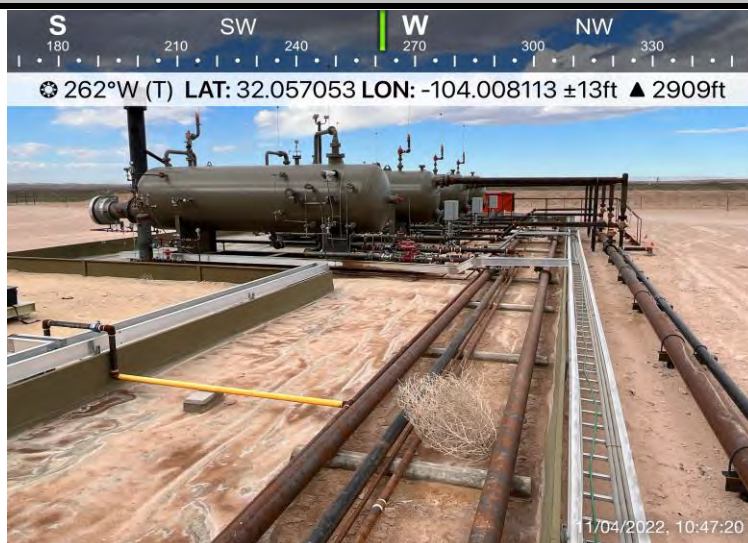
### Photograph No. 1

On November 4, 2022, Carmona Resources, LLC conducted liner inspection activities to assess the liner's integrity within the facility. Carmona Resources, LLC personnel proceeded to inspect the liner visually. The liner was found to be intact with no integrity issues. Refer to the Photolog.

View West of the lined facility.

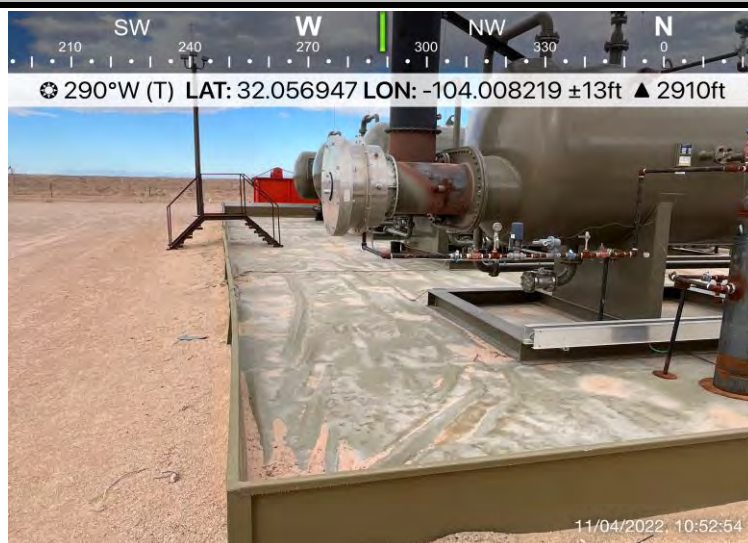
### Photograph No. 2

View West of the lined facility.

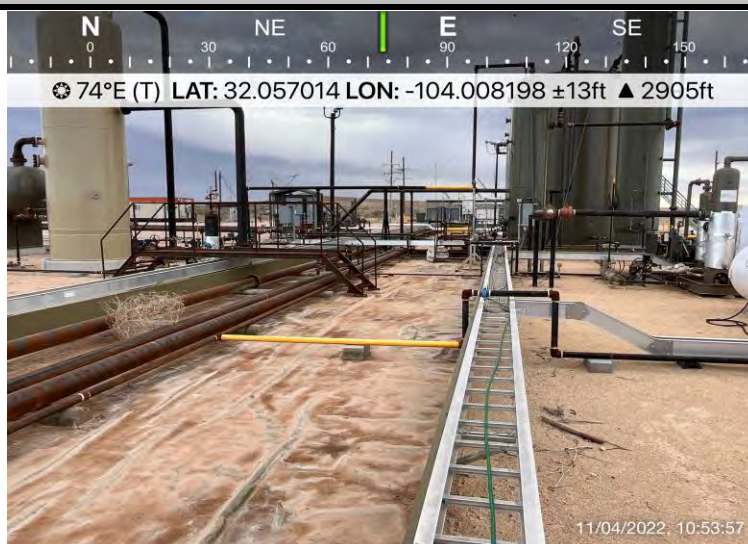
### Photograph No. 3

View East of the lined facility.

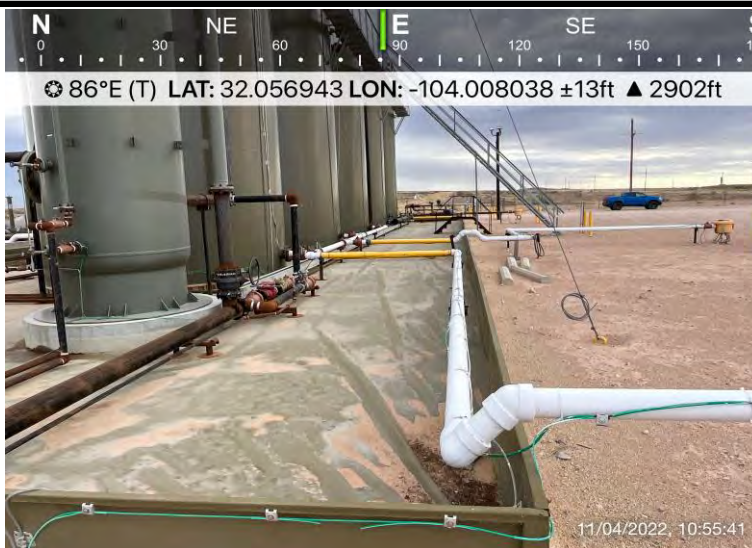
### Photograph No. 4

View East of the lined facility.

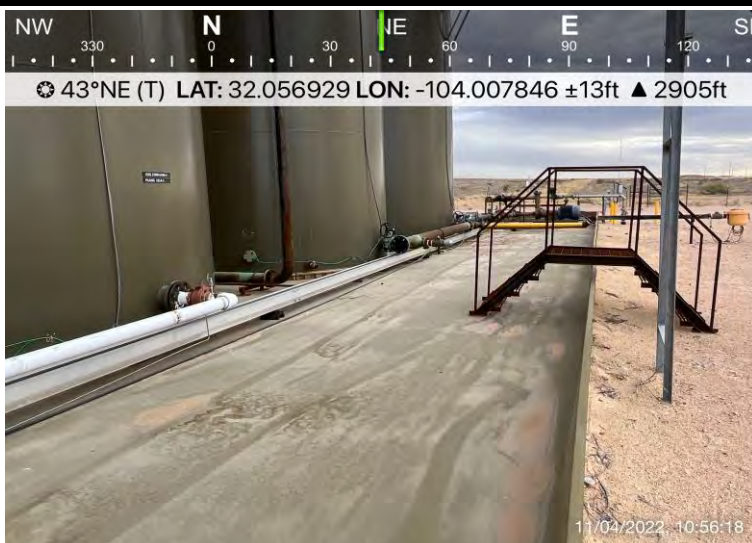
### Photograph No. 5

View Northeast of the lined facility.

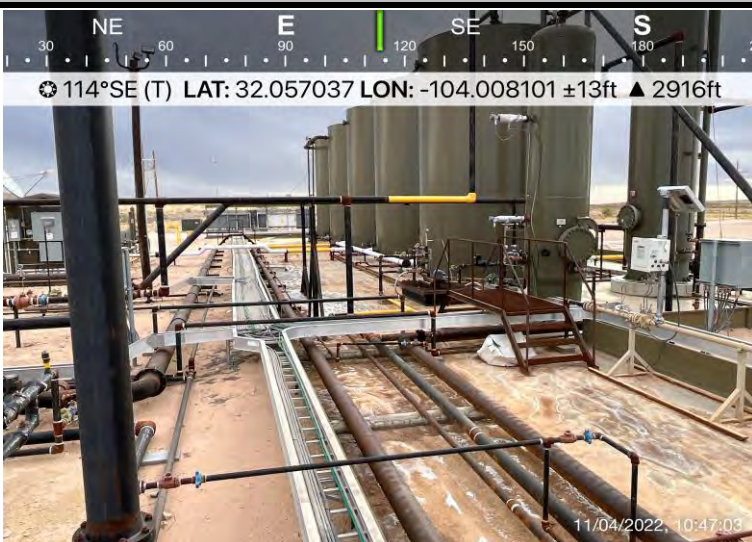
### Photograph No. 6

View Southeast of the lined facility.
