LINER INSPECTION AND CLOSURE REPORT **REPORTABLE RELEASE**

Spur Energy Partners
Hearse 36 State Com Battery
Incident ID: NAPP2113945611
Eddy County, NM

This report was prepared by Paragon Environmental LLC (Paragon) in response to the release for Spur Energy Partners (Spur) at the **Hearse 36 St Com Battery (Hearse)**.

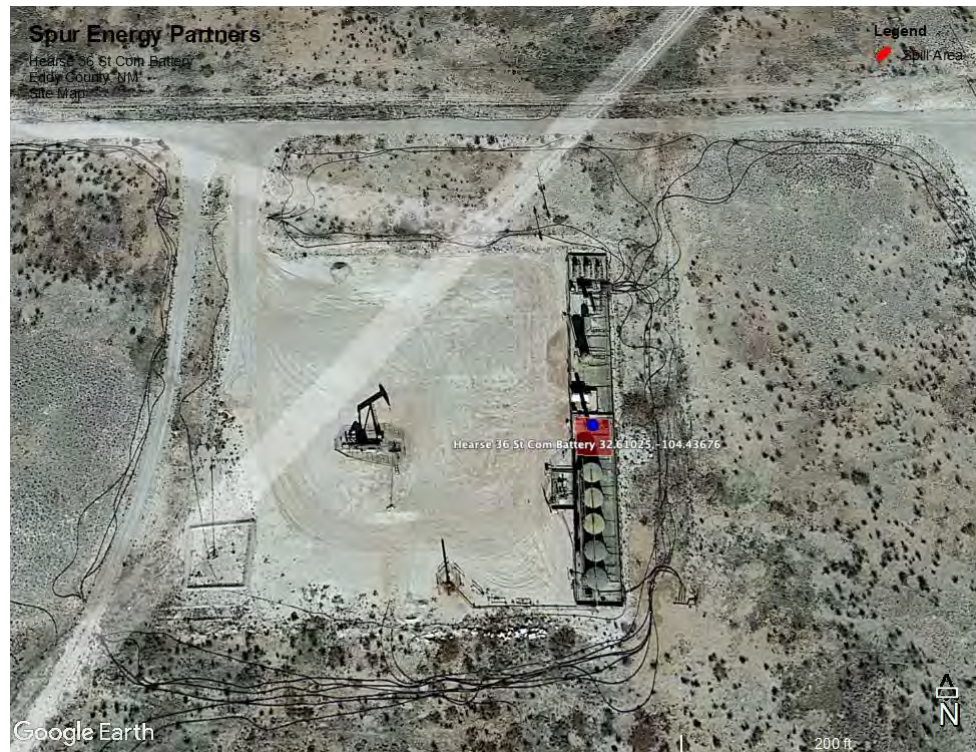
On July 12, 2022, Paragon went to the Hearse and conducted an initial assessment. There was obvious staining on the liner from the spill. There were no signs outside the containment showing no signs that the liner had been breached. Therefore, no samples were taken. See the site map below showing the affected area.

On July 17, 2022, Paragon returned to the site with equipment and personnel to conduct cleanup activities. We initially sprayed the affected area with surface cleaner. We then power washed and squeegeed the runoff to where the vacuum truck could capture the fluids.

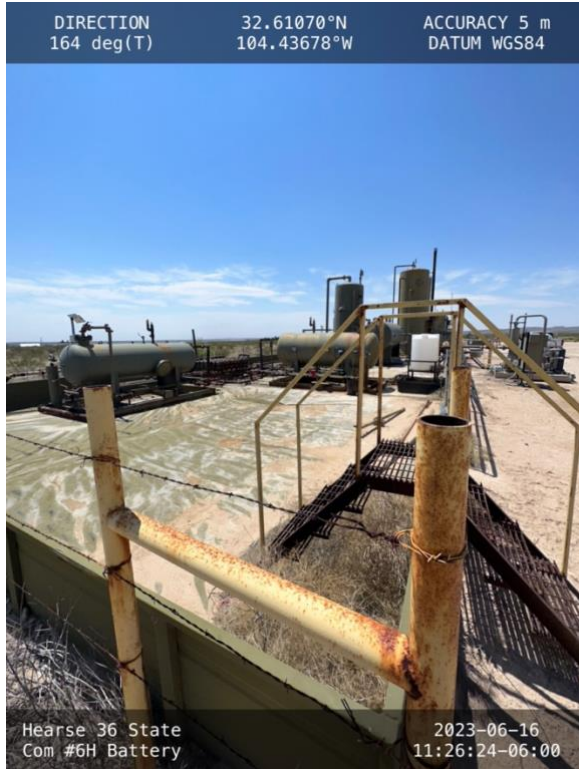
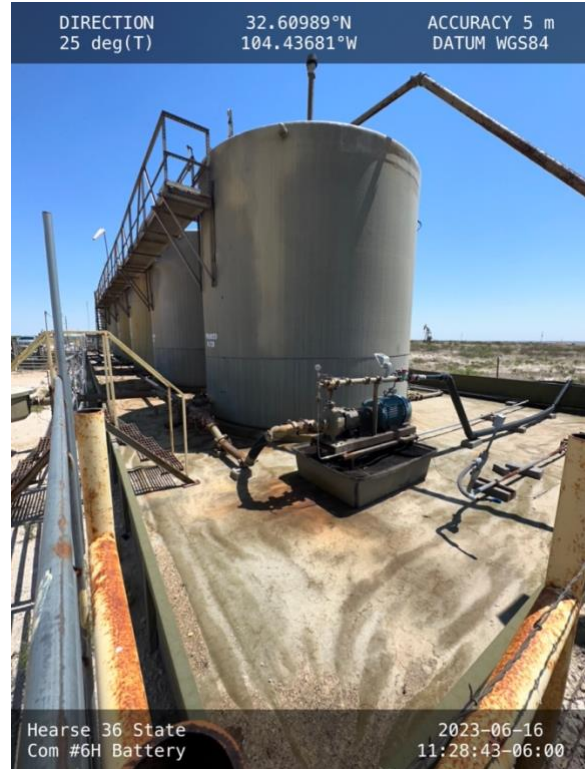
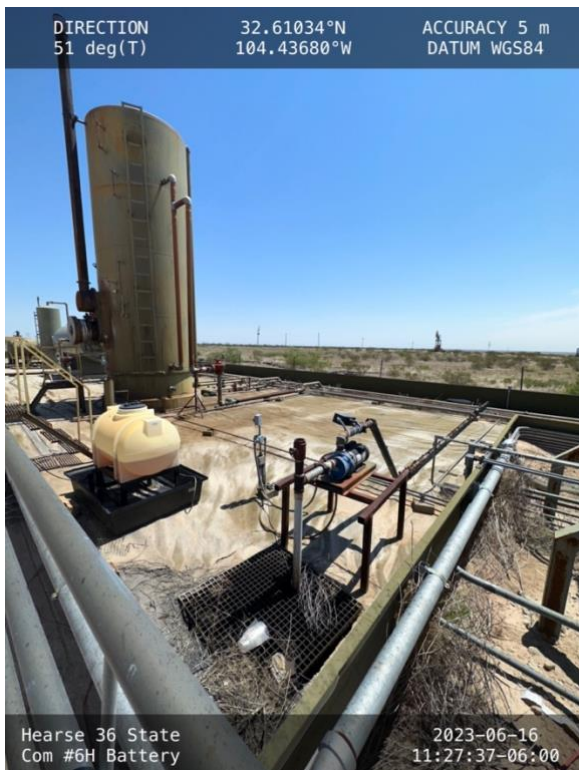
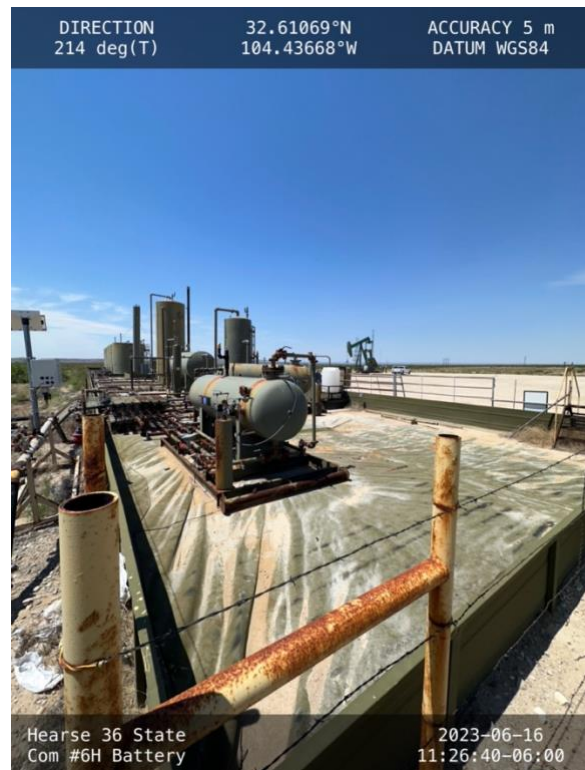
Liner Inspection

On July 20, 2022, Paragon returned to the site to conduct a liner inspection. A 48-hour notification was sent out to the NMOCD on July 18, 2022. The liner inspection concluded that the liner was all intact and in good condition. The integrity of the liner appears to have the ability to contain spills. See Appendix D for the email notification and liner report.

Visualization	Yes	No	Comments
Is there a tear in the liner?		x	
Are there holes in the liner?		x	
Is the liner retaining any fluids?		x	
Does the liner have integrity to contain a leak?	x
