Closure Report
SRO State Com 048H (05.09.2023)
Eddy County, New Mexico
Unit B Sec 7 T26S R28E
32.0637°, -104.1252°

Produced Water Release
Point of Release: Pinhole Leak
Release Date: 05.09.2023
Volume Released: 7.9872 Barrels of Produced Water
Volume Recovered: 6 Barrels of Produced Water

Re: Closure Report
SRO State Com 048H (05.09.2023)
Concho Operating, LLC
Incident ID NAPP2314537018
Site Location: Unit B, S7, T26S, R28E
(Lat 32.0637°, Long -104.1252°)
Eddy County, New Mexico

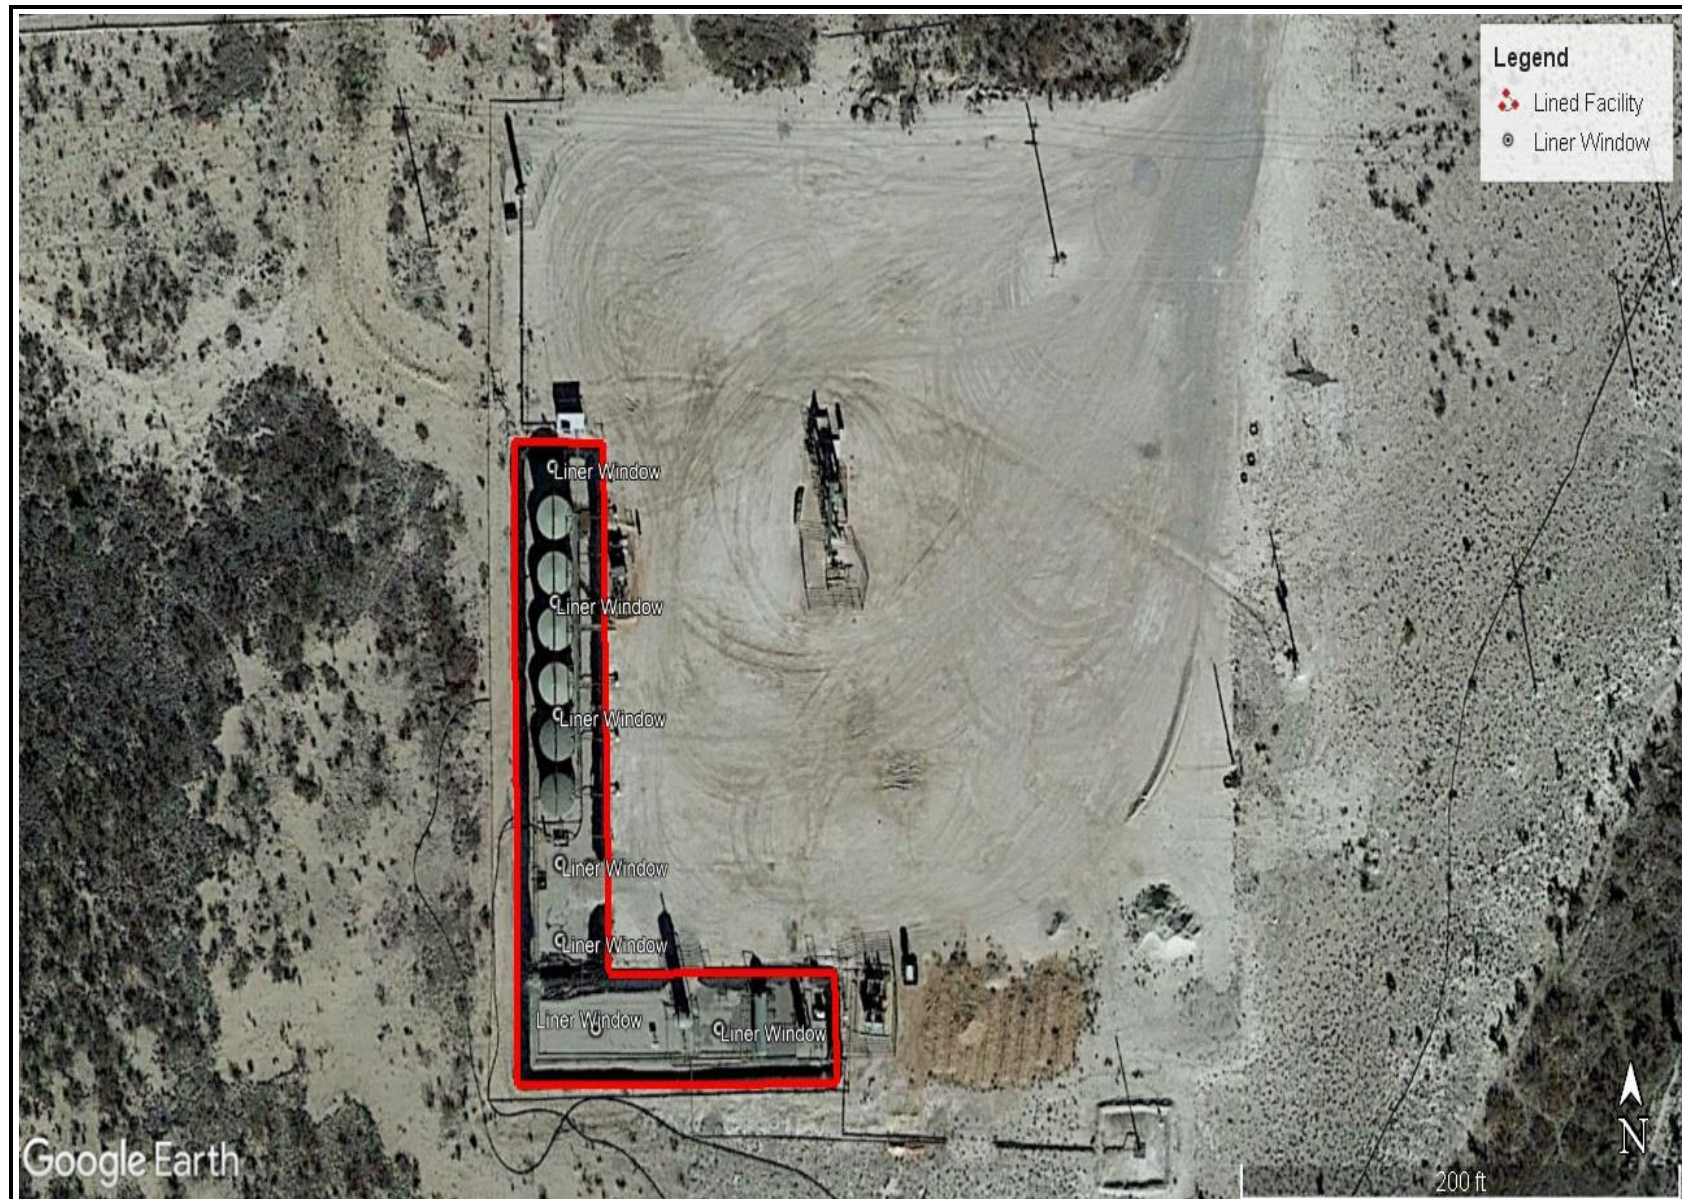
FIGURE 3

Based on the initial C-141 obtained from the New Mexico Oil Conservation Division (NMOCD), the release was discovered on May 9, 2023, caused by a pinhole leak due to corrosion. It resulted in approximately seven point nine eight seven two (7.9872) barrels of produced water to be released and approximately six (6) barrels of produced water recovered. The remaining one point nine eight seven two (1.9872) barrels of produced water were removed when the pea gravel was removed and replaced during the facility clean-up. See Figure 3. The initial C-141 form is attached in Appendix B.

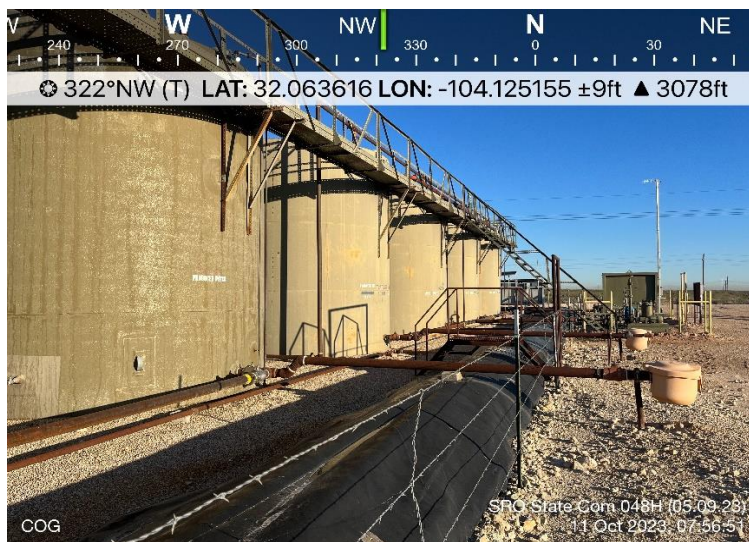
Photograph No. 1

View Northwest of lined facility.

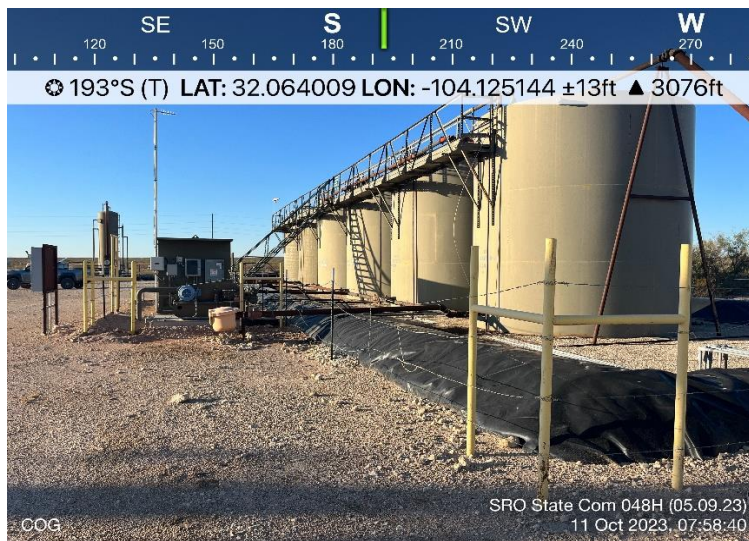
Photograph No. 2

View South of lined facility.

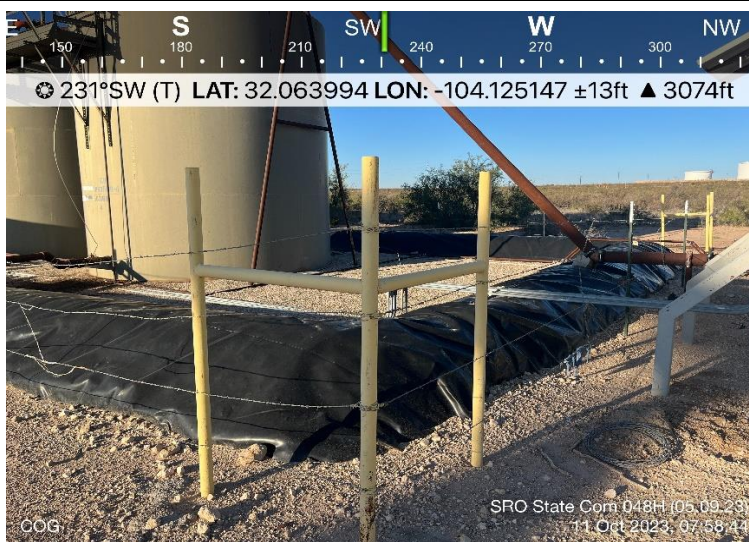
Photograph No. 3

View Southwest of lined facility and area of liner window.

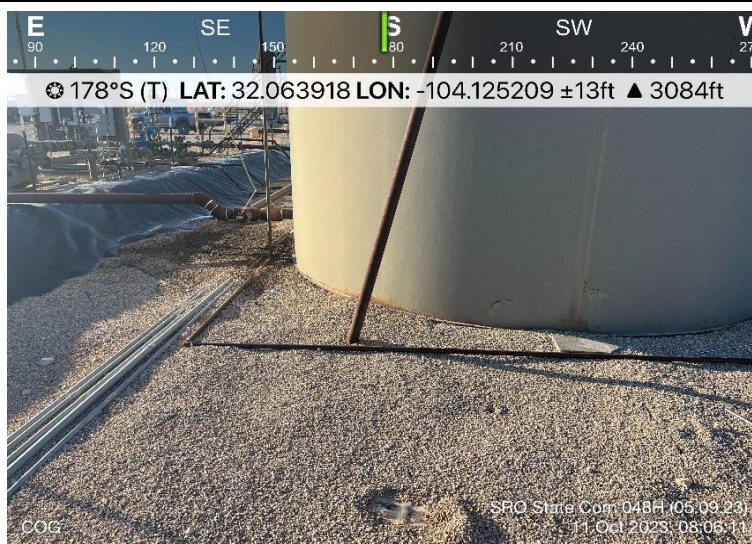
View South of liner window.

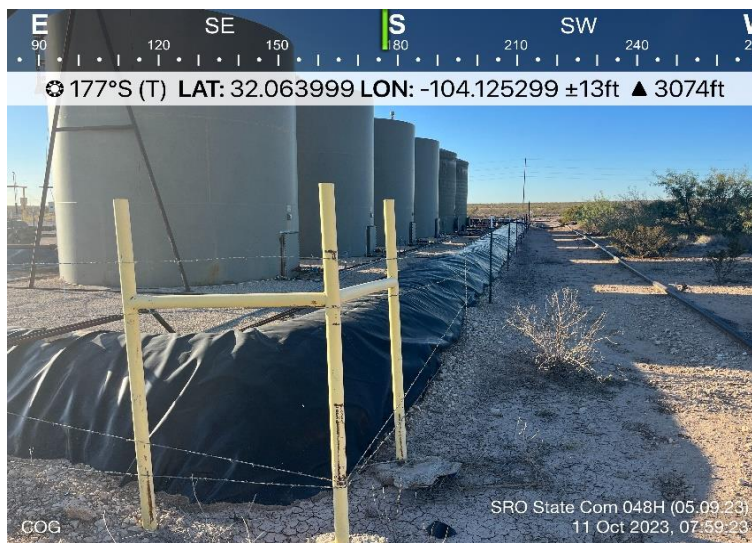
View South of lined facility.

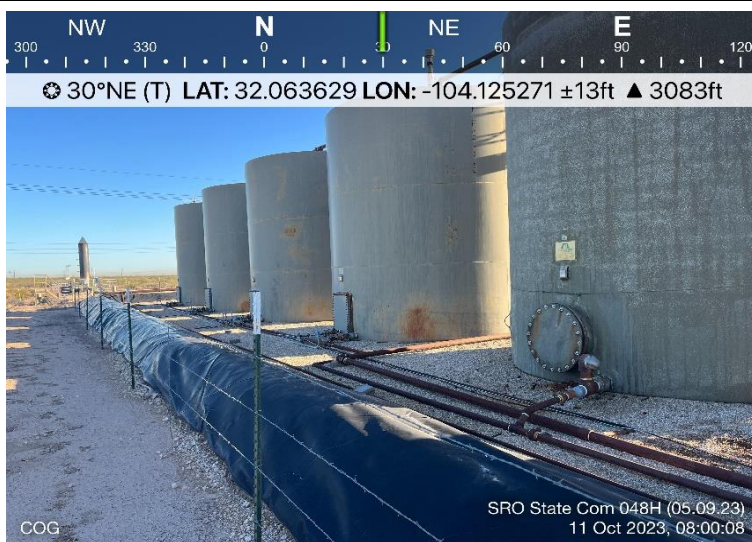
View Northeast of lined facility.

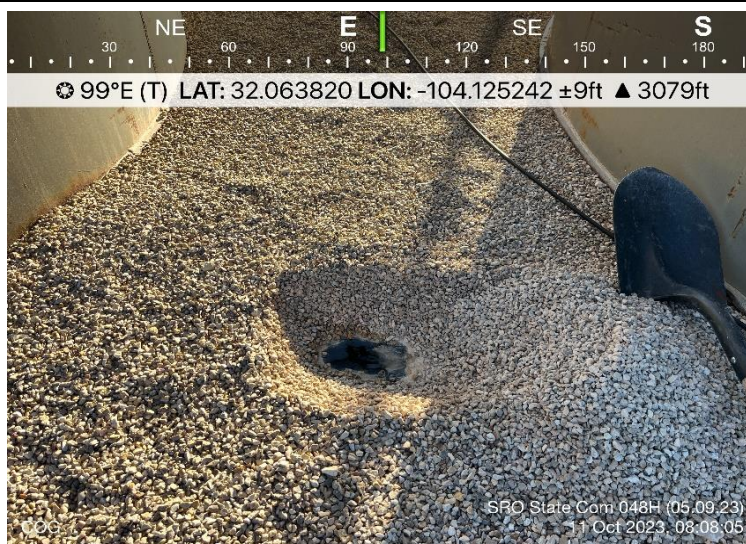
Photograph No. 7

View East of liner window.

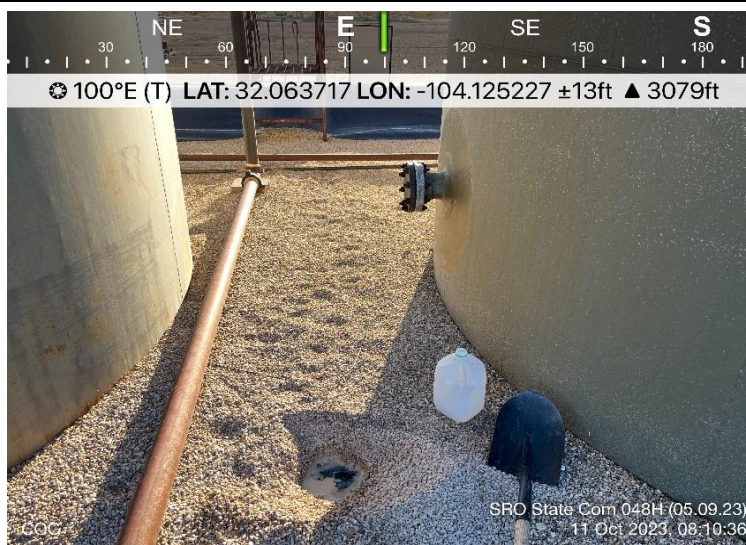
Photograph No. 8

View East of liner window.

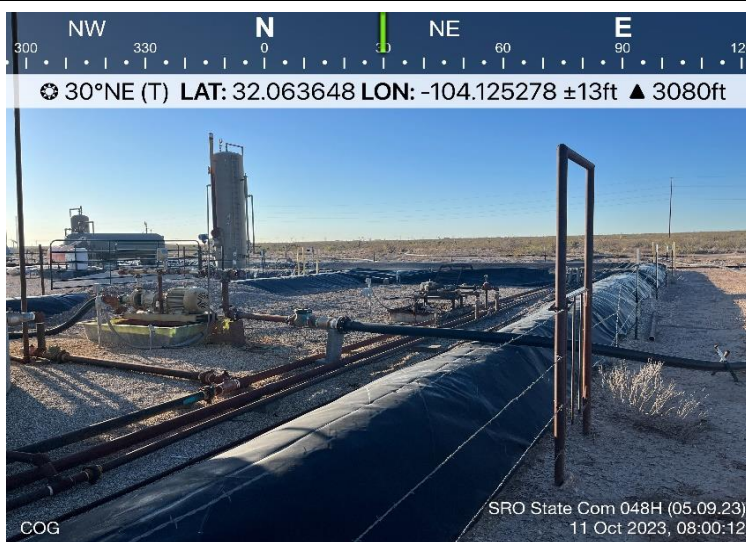
Photograph No. 9

View Northeast of lined facility and area of liner window.

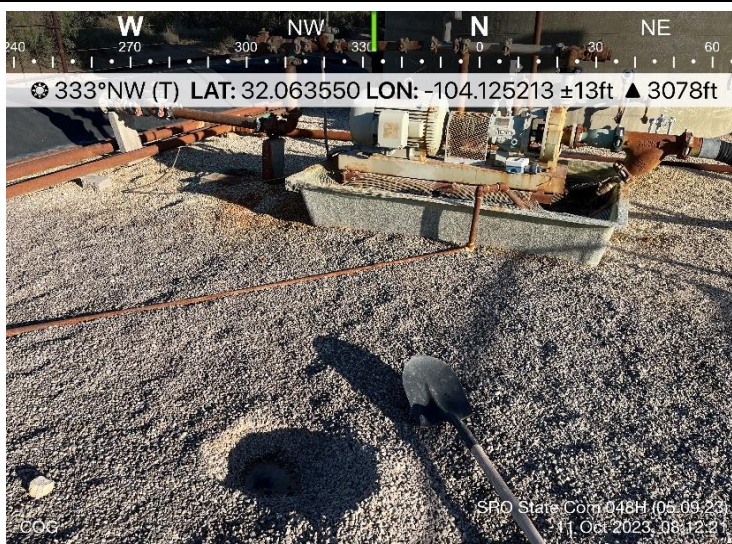
Photograph No. 10

View Northwest of liner window.

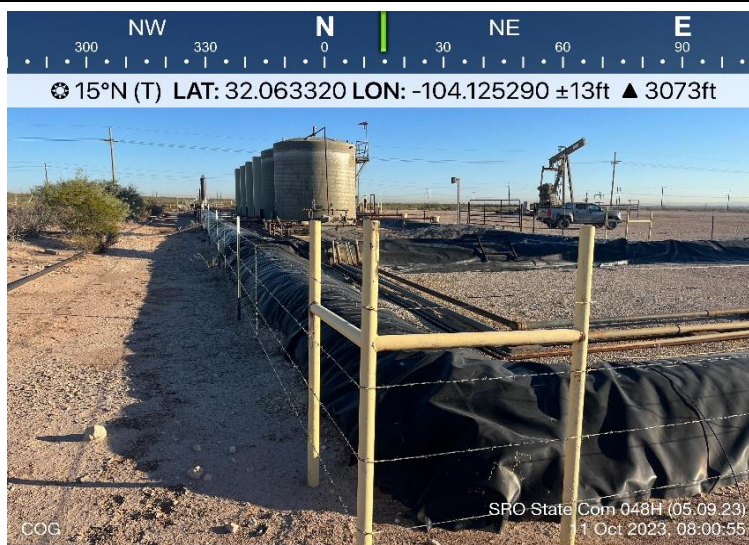
Photograph No. 11

View North of lined facility.

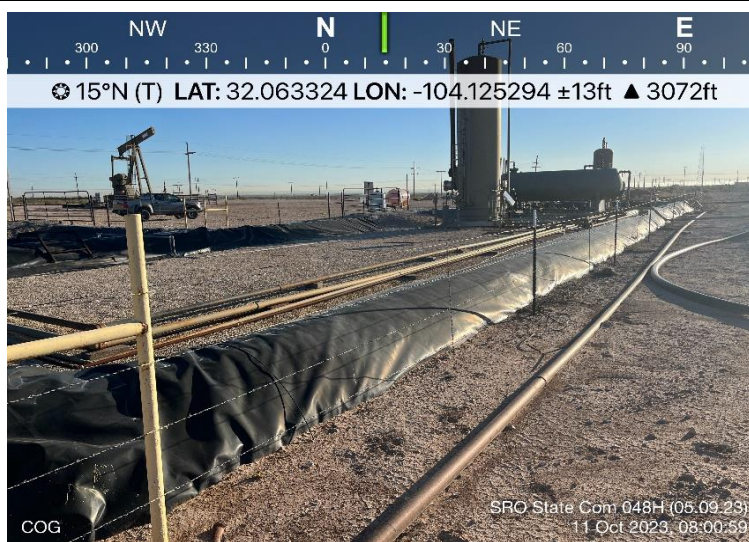
Photograph No. 12

View North of lined facility and liner window.

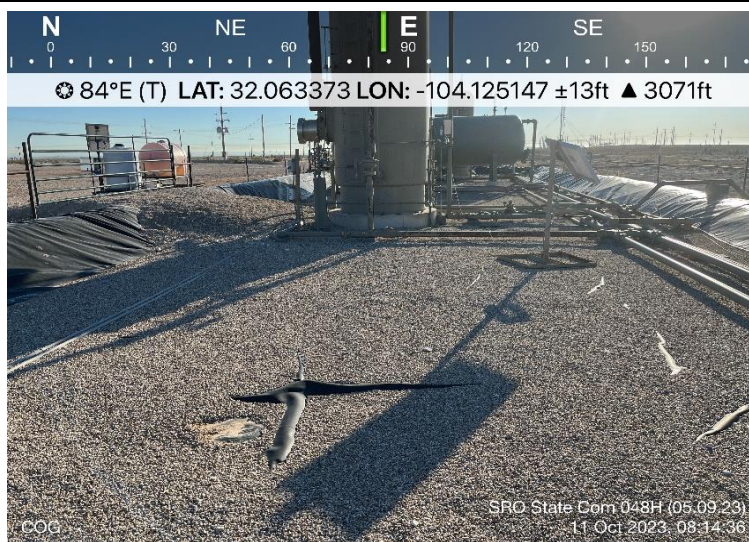
Photograph No. 13

View East of liner window.

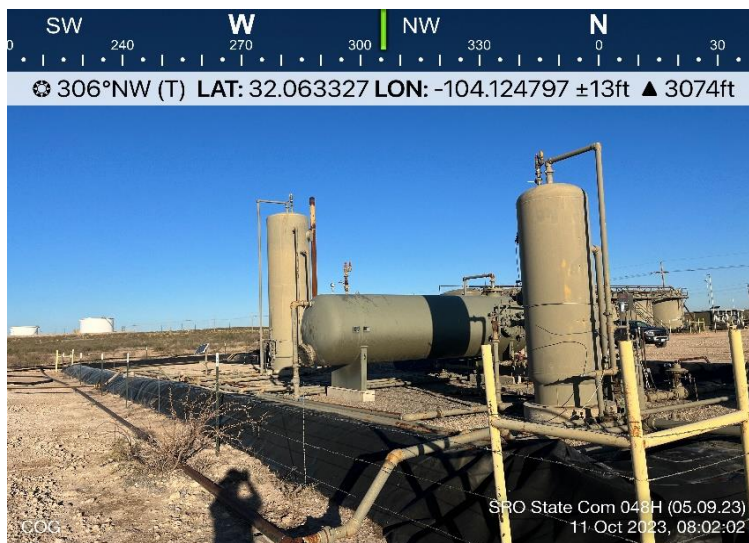
Photograph No. 14

View Northwest of lined facility and liner window.

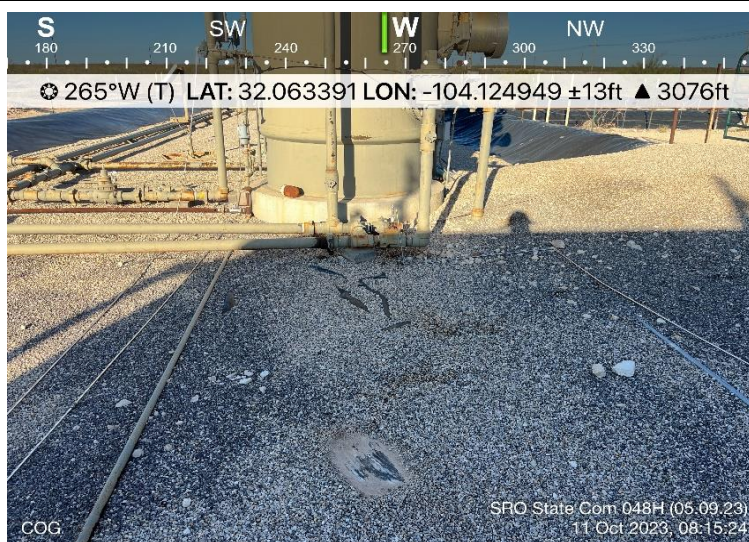
Photograph No. 15

View West of liner window.

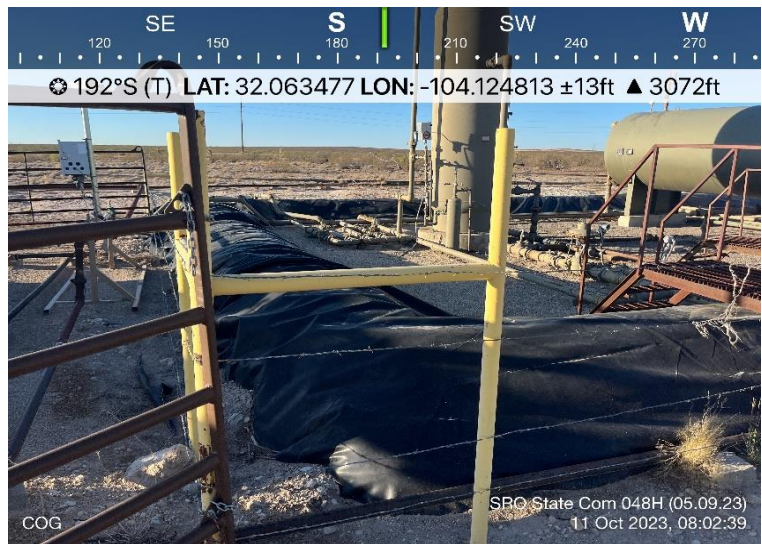
View South of lined facility.

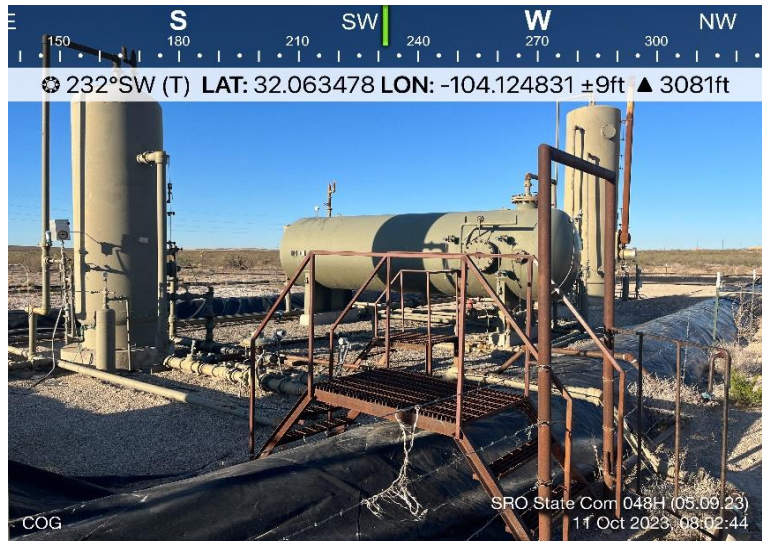
View Southwest of lined facility.
