Exotic Cat 5 CTB 2

nAPP2406175802

April 12, 2024

RE: Liner Inspection and Closure Report
Exotic Cat 5 CTB 2
API No. N/A
GPS : Latitude 32.3361252 Longitude -103.6989382
UL- F, Section 05, Township 23S, Range 32E
Lea County, NM
NMOCD Reference No. NAPP2406175802

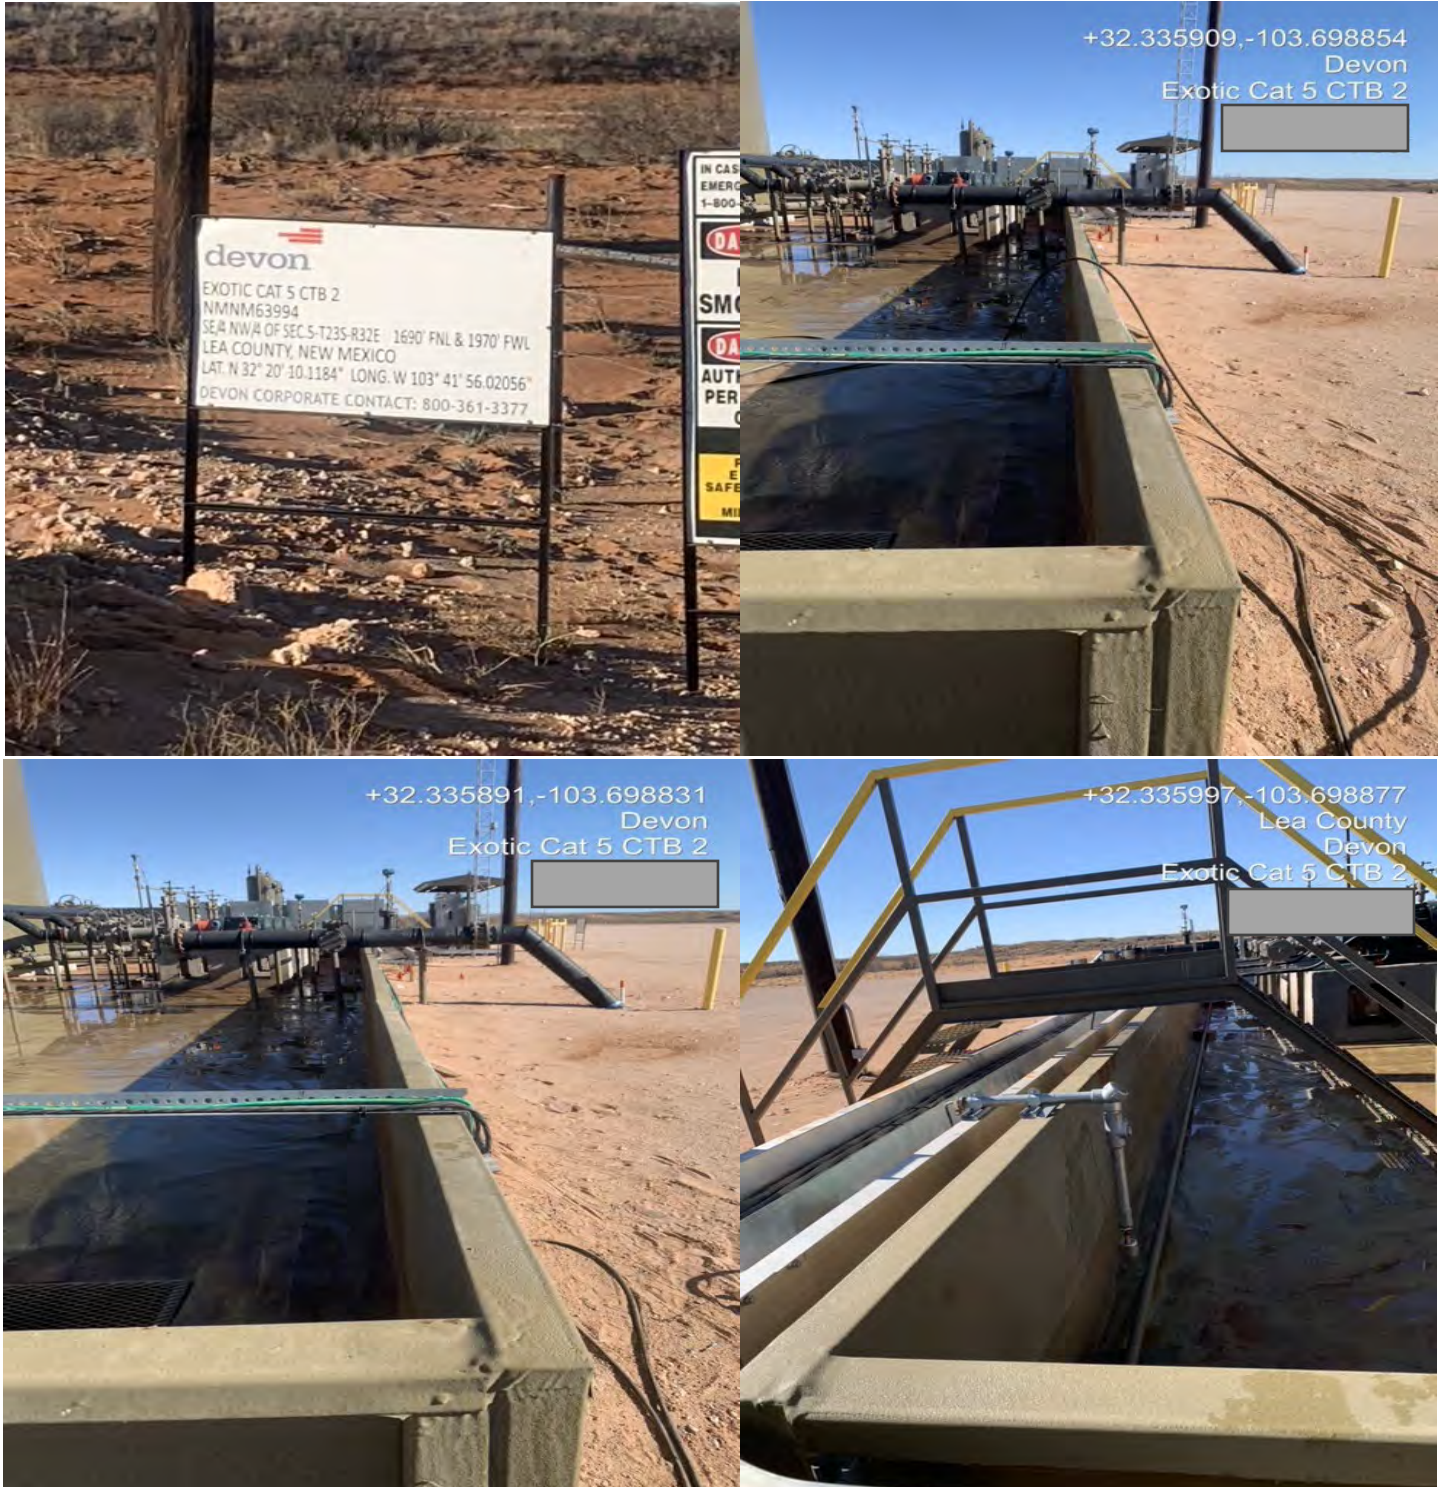
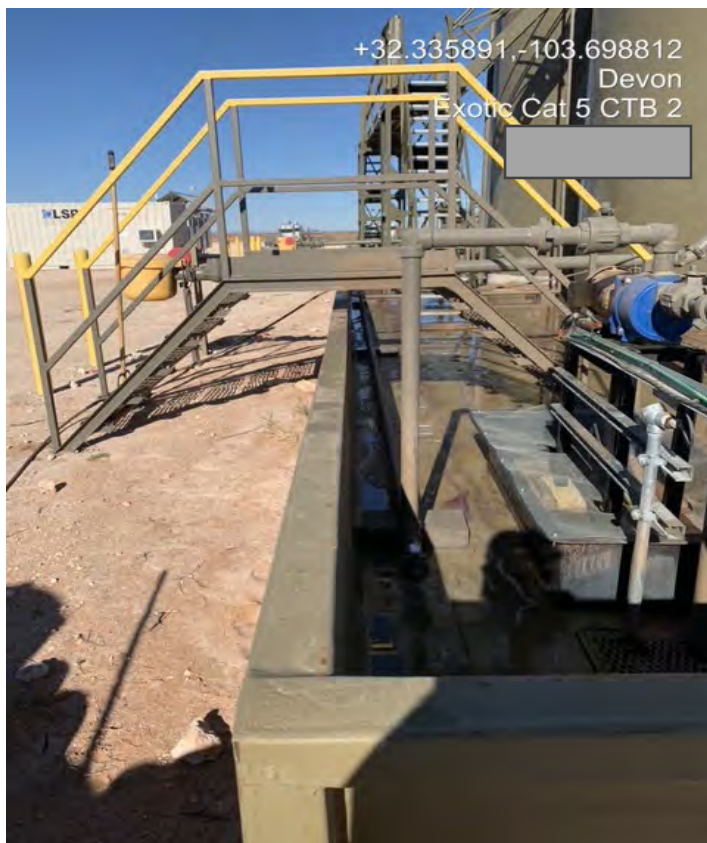
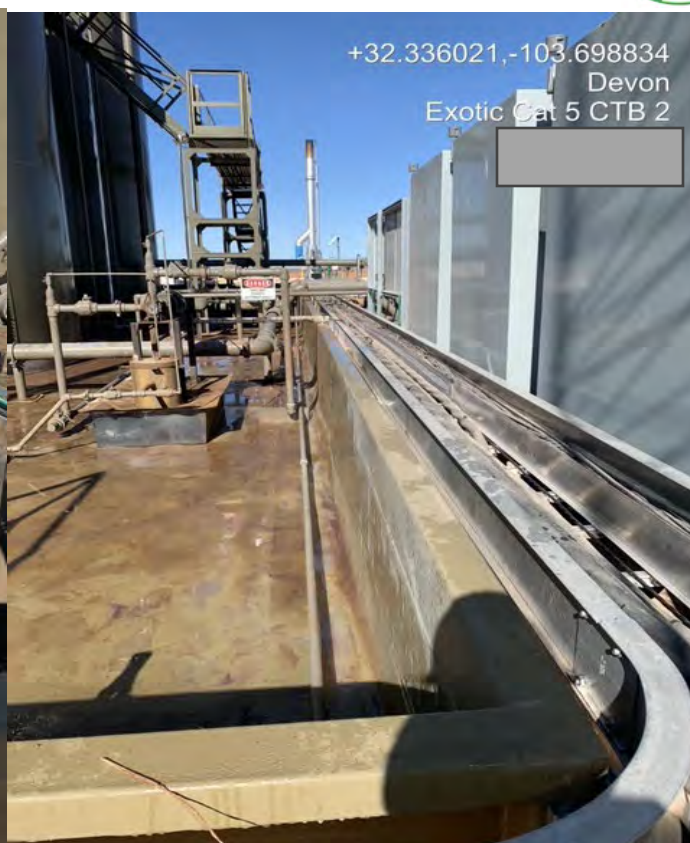
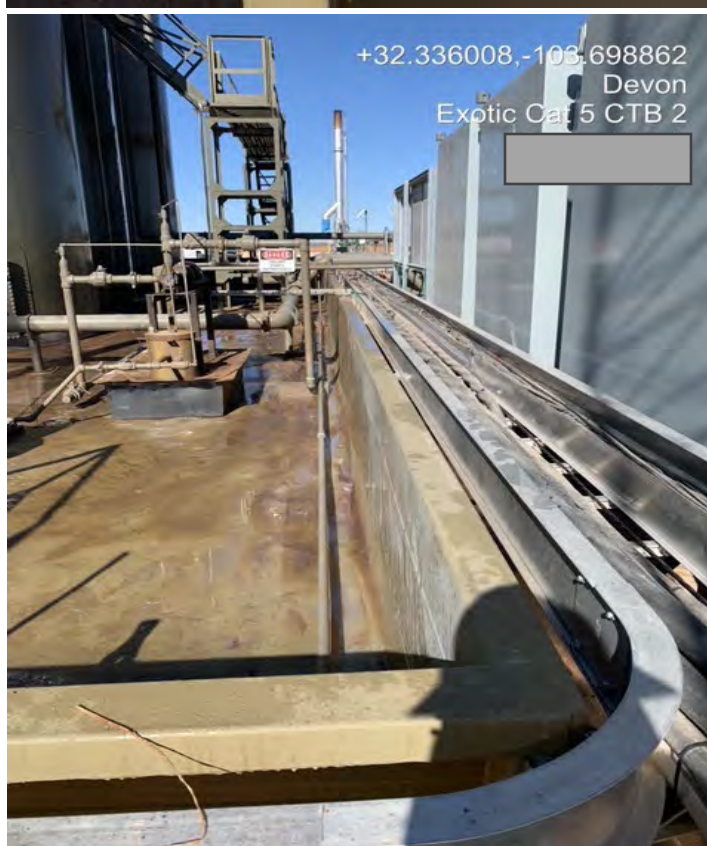
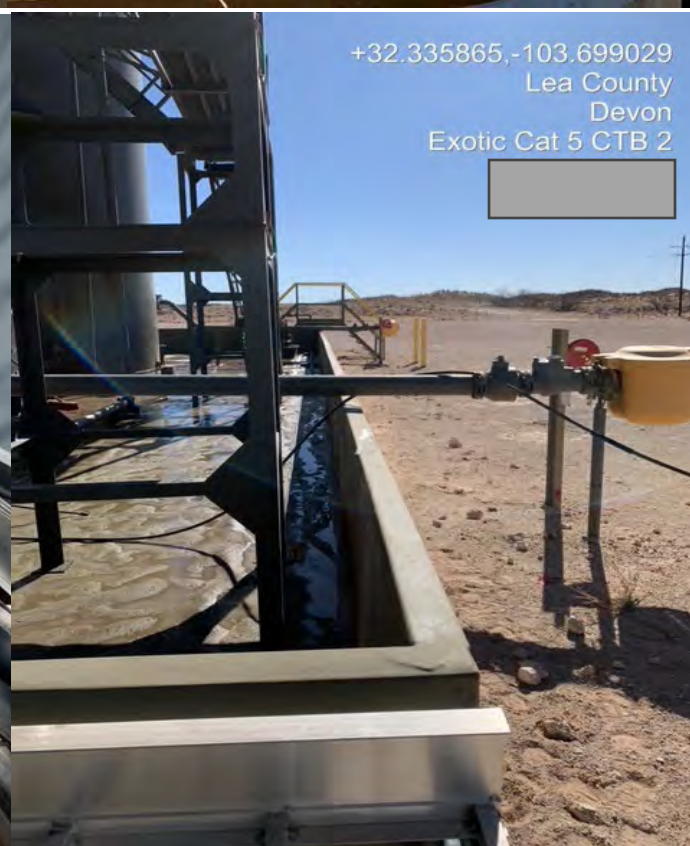
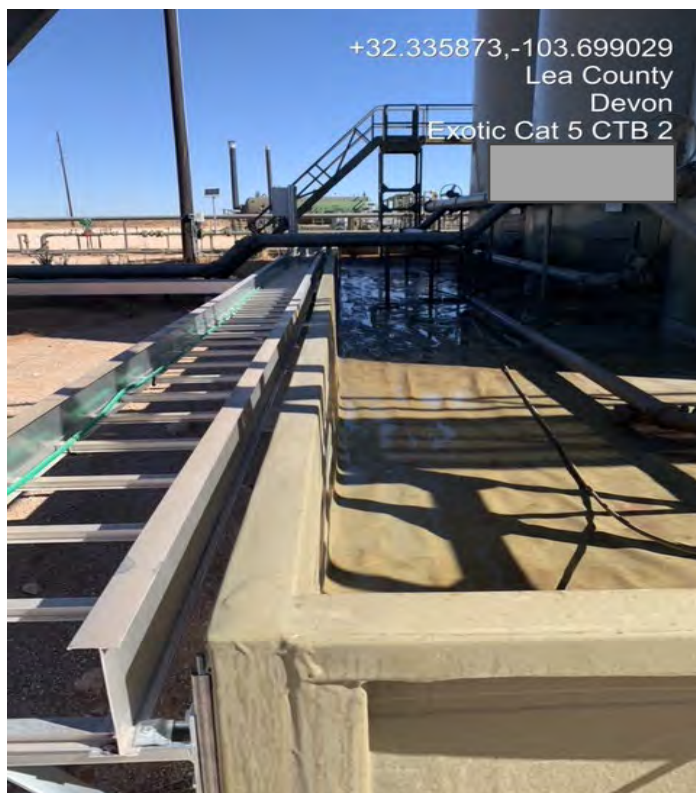
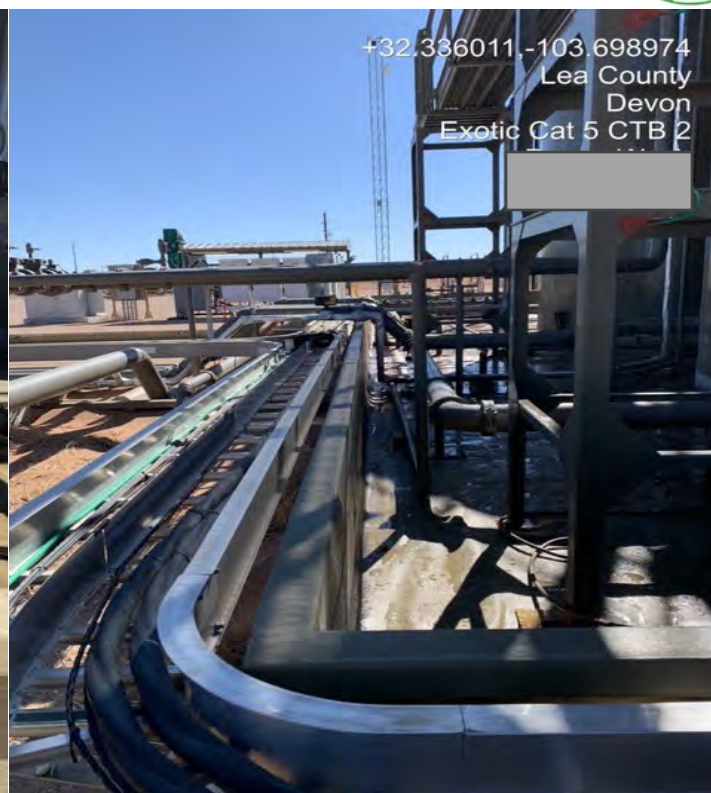
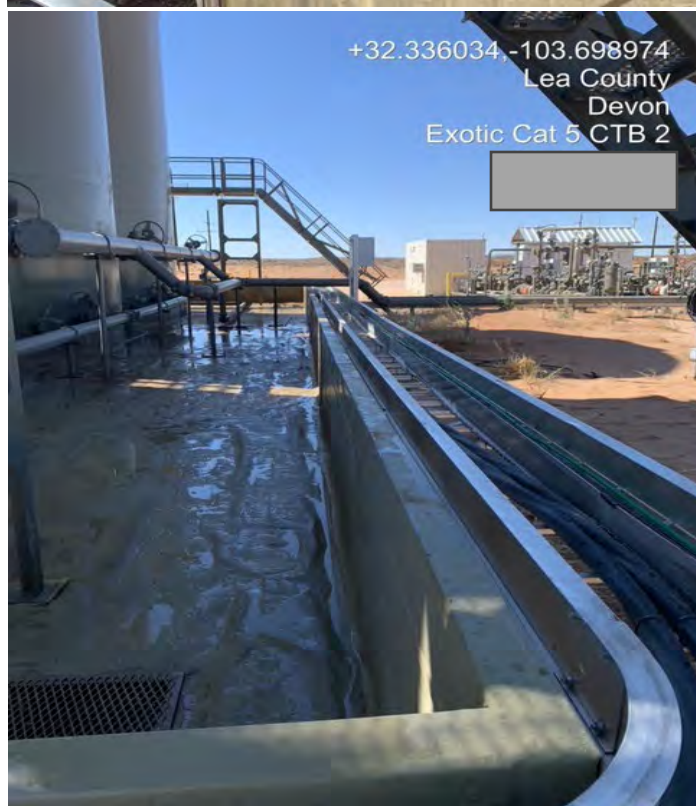
Liner Inspection

On April 11, 2024, after submitting the 48-hour notification application ID:331326 to the OCD, Pima Environmental conducted a liner inspection at this location. Pima concluded that this liner and containment maintained its integrity and was able to retain the fluids. The liner inspection form and photographic documentation can be found in Appendix C.

Visualization	Yes	No	Comments
Is there a tear in the liner?		X	
Are there holes in the liner?		X	
Is the liner retaining any fluids?	X		Fluid from power washing the Liner
Does the liner have integrity to contain a leak?	X
