**Subject: 2021 Annual Groundwater Report  
Florance 47X  
RP Number 3RP-317-0  
Incident Number nAUTOfAB000185  
San Juan County, New Mexico**

WSP USA Inc. (WSP), on behalf of Harvest Four Corners, LLC (Harvest) has prepared this report detailing annual groundwater monitoring activities completed between January 2021 and December 2021 at the Florance #47X (Site), Remediation Permit (RP) Number 3RP-317-0 and Incident Number nAUTOfAB000185. The purpose of this project was to continue phase-separated hydrocarbon (PSH) recovery and monitoring of petroleum hydrocarbon impacts to groundwater resulting from a release involving a former earthen dehydrator pit.

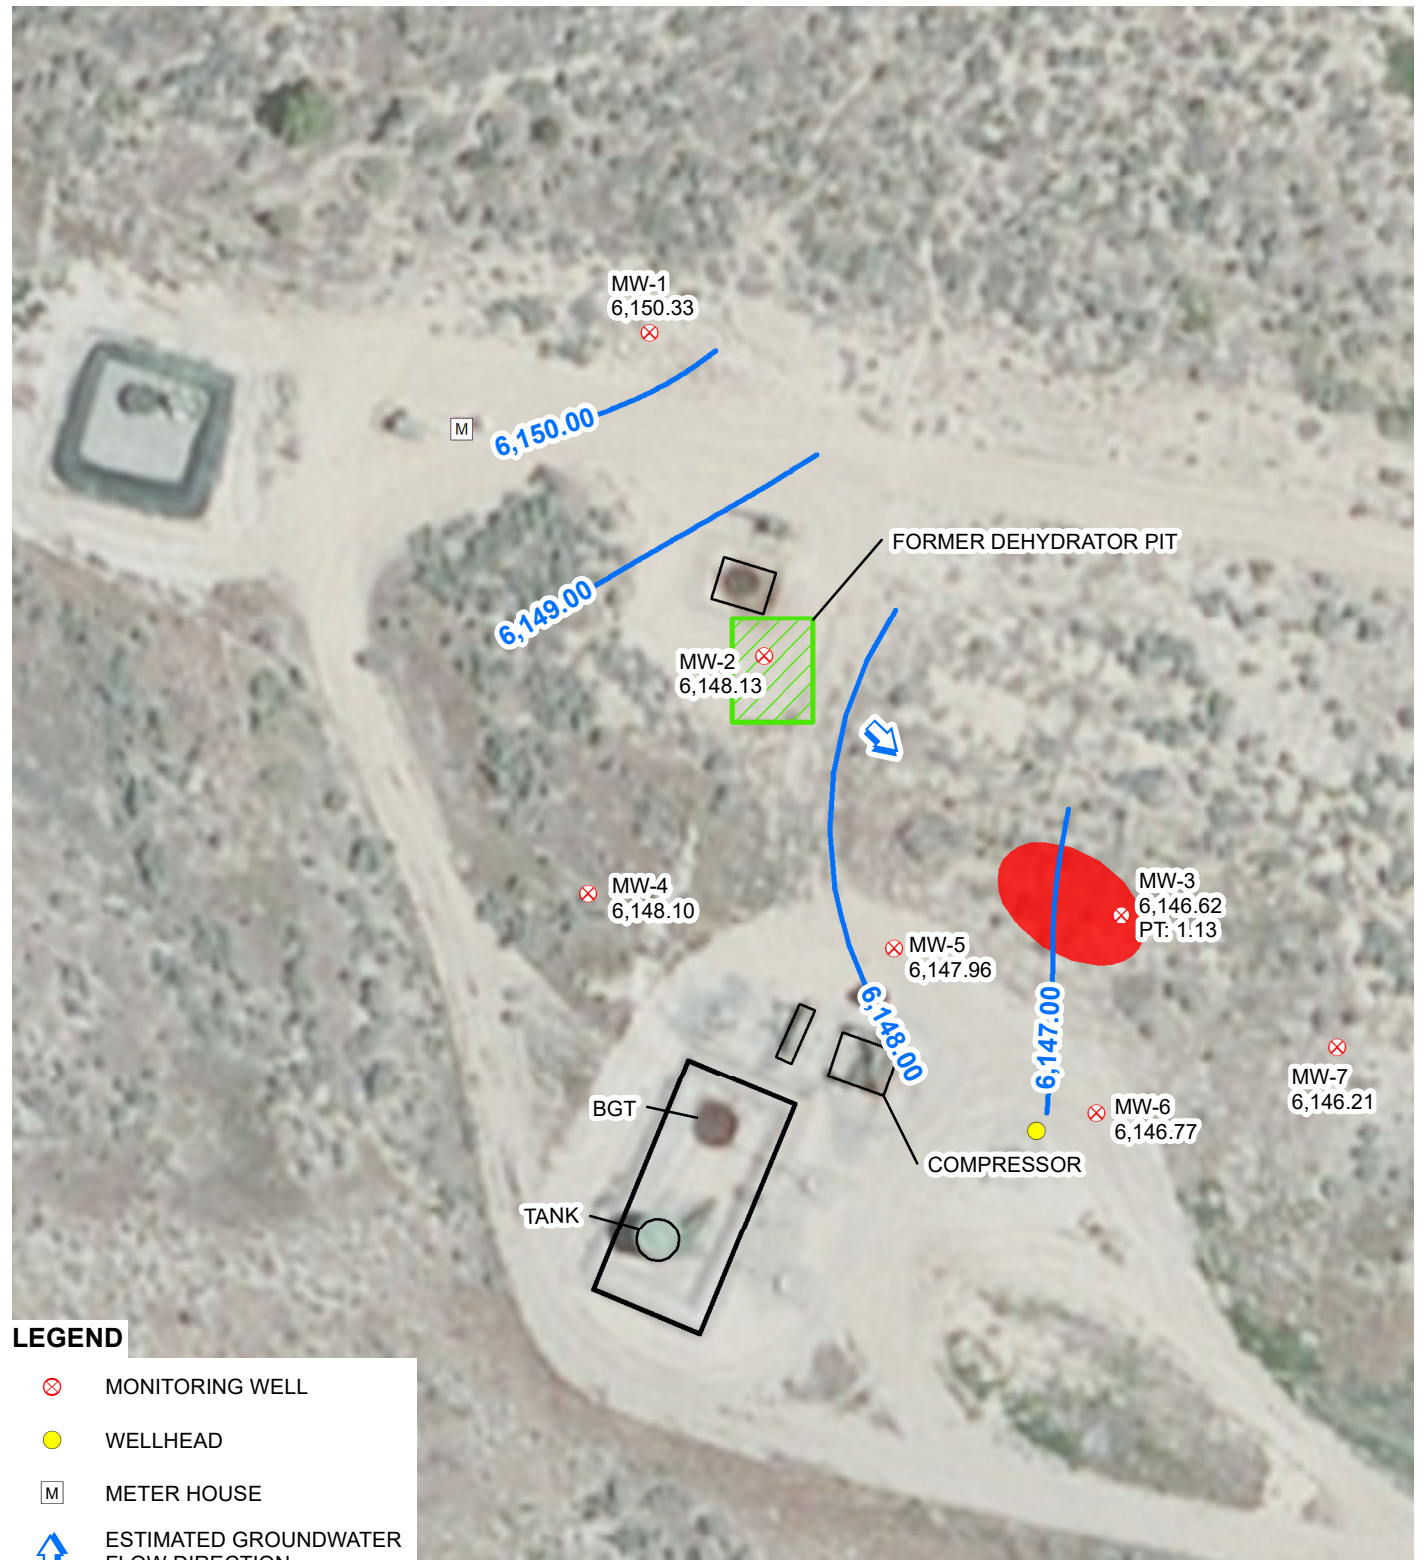
**FIGURE 5**  
**GROUNDWATER ELEVATION CONTOUR MAP**  
**(NOVEMBER 2021)**  
**FLORANCE #47X**  
**SWNE SEC 5 T30N R9W**  
**SAN JUAN COUNTY, NEW MEXICO**  
**HARVEST FOUR CORNERS, LLC.**

Depth to groundwater was collected on March 31, 2021, May 24, 2021, August 23, 2021, and November 23, 2021. Depth to groundwater data collected on May 23, 2021, during the annual groundwater sampling event, indicated groundwater was present at elevations between 6,146.15 feet (MW-7) and 6,150.74 feet (MW-1) amsl. Based on data collected during the four quarterly events, the interpreted groundwater-flow direction is to the southeast (contours shown on Figures 2 through 5). Contours were inferred based on groundwater elevations and physical characteristics at the Site (topography, proximity to irrigation ditches, etc.). PSH levels in MW-3 ranged in thickness from 0.52 feet in March 2021 to 2.03 feet in August 2021. PSH thickness and approximate plume extent are depicted on Figures 2 through 5.

Approximately 34.3 gallons of PSH have been recovered from monitoring well MW-3 through pneumatic pumping since PSH recovery installation on November 18, 2019, through December 17, 2021. A total of 12.0 gallons of PSH were recovered in 2021. At the time of the installation of the PSH recovery system in November 2019, the PSH thickness was 1.93 feet; in 2021, PSH ranged in thickness from 0.52 feet in March 2021 to 2.03 feet in August 2021. Operation data and system maintenance data are summarized in Table 3.

With the installation of the PSH recovery system, WSP recommends monthly site visits for O&M purposes. Additional O&M visits may be necessary depending on product recovery rates and system maintenance requirements. In addition, WSP recommends groundwater monitoring through quarterly well gauging (depth-to-groundwater and depth-to-PSH measurements) and annual groundwater sampling for laboratory analysis of BTEX compounds.
