# Liner Inspection Closure Report

**Belloq 11 CTB 1**

Prepared by Pima Environmental Services, LLC for  
Devon Energy Production, LP

**RE: Liner Inspection and Closure Report**  
**Belloq 11 CTB 1**  
**Facility ID fAPP2129456577**  
**GPS: Latitude 32.31470991 Longitude -103.7534095**  
**ULSTR – M – 11 – 23S – 31E 1088 FNL 1140 FWL Eddy County, NM**  
**NMOCD Incident ID nAPP2420945437**

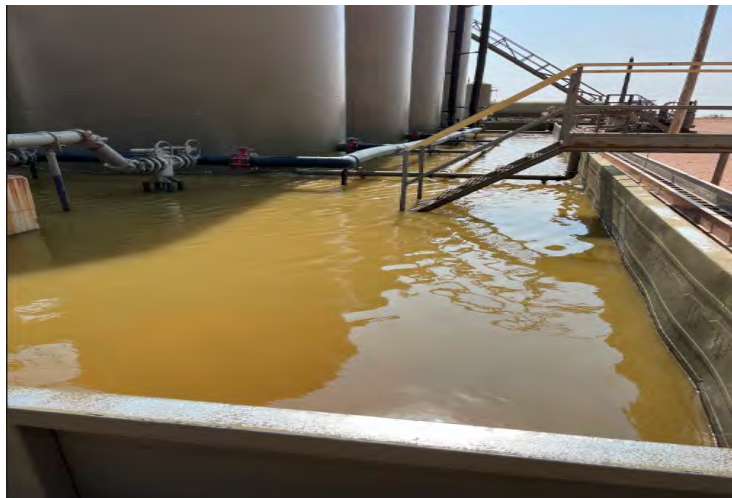
Contained spill 1

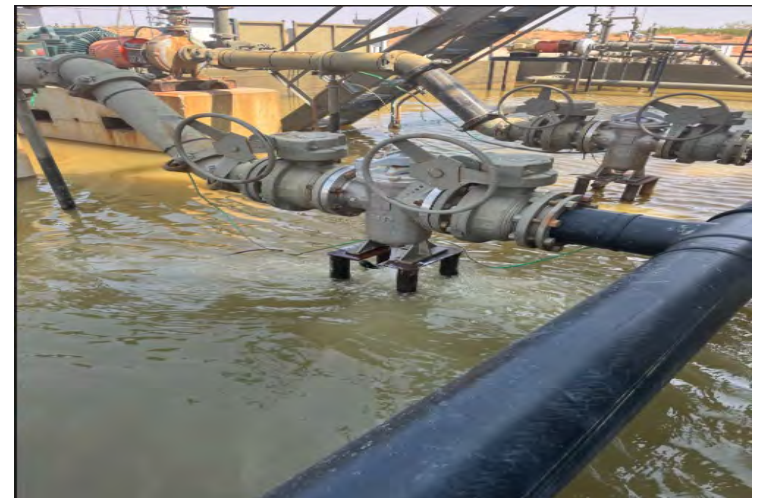
Contained spill 2
