Rose South CTB

Incident ID nAPP2435429070

PREPARED BY:
PIMA ENVIRONMENTAL SERVICES, LLC

Liner Inspection and Closure Report

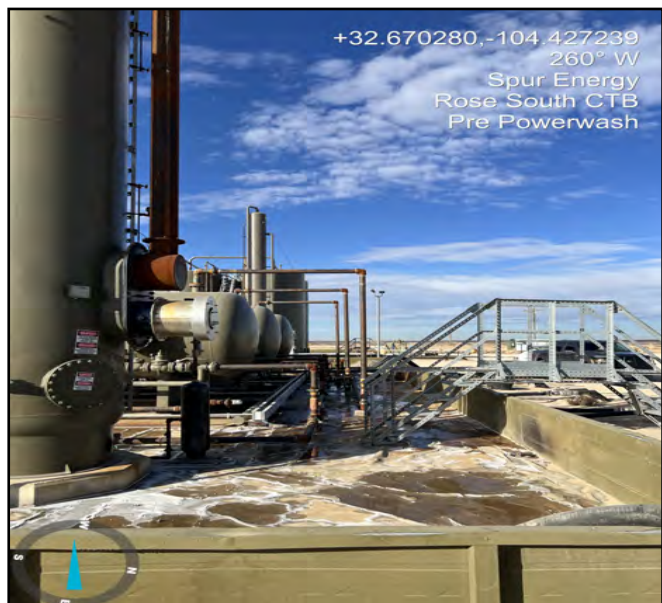
Photo of liner taken prior to power washing.
Facing West.

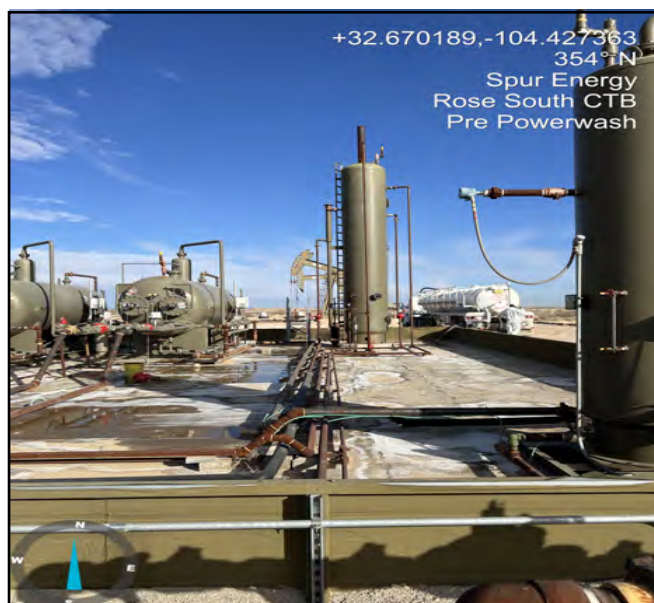
Photo of liner taken prior to power washing.
Facing North.

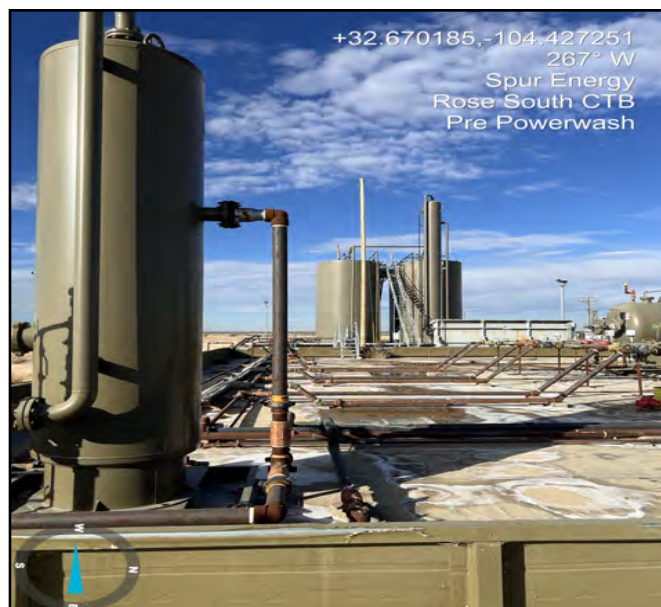
Photo of liner taken prior to power washing.
Facing West.

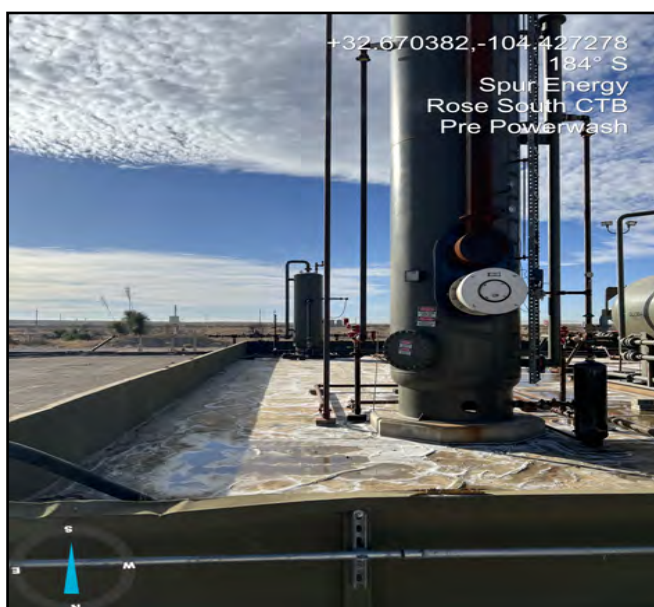
Photo of liner taken prior to power washing.
Facing South

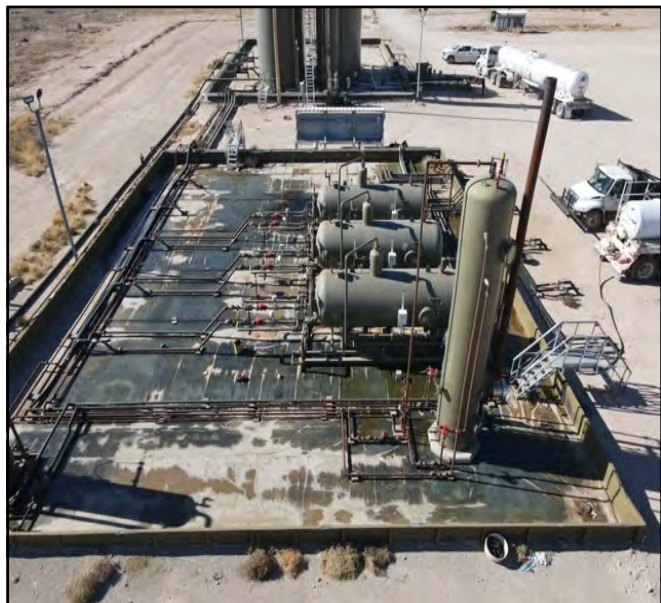
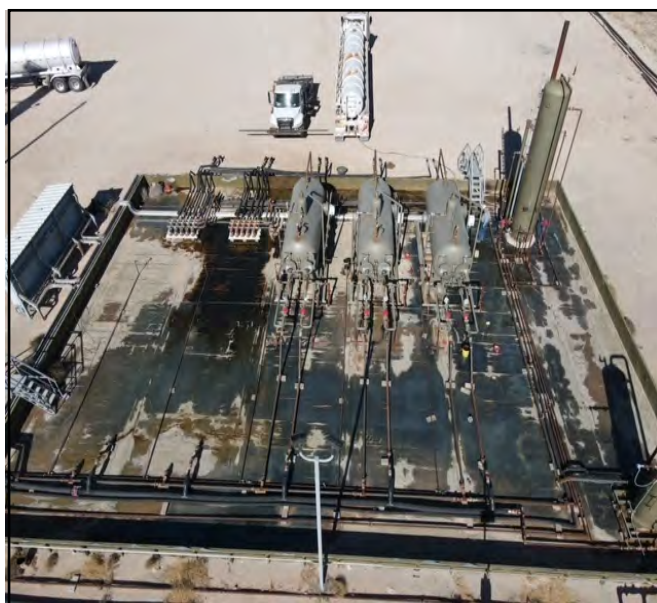
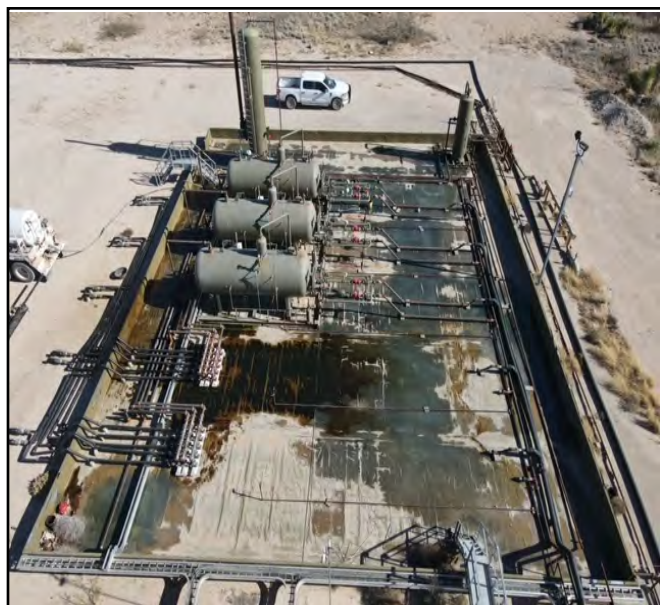
Aerial Photos prior to power wash.

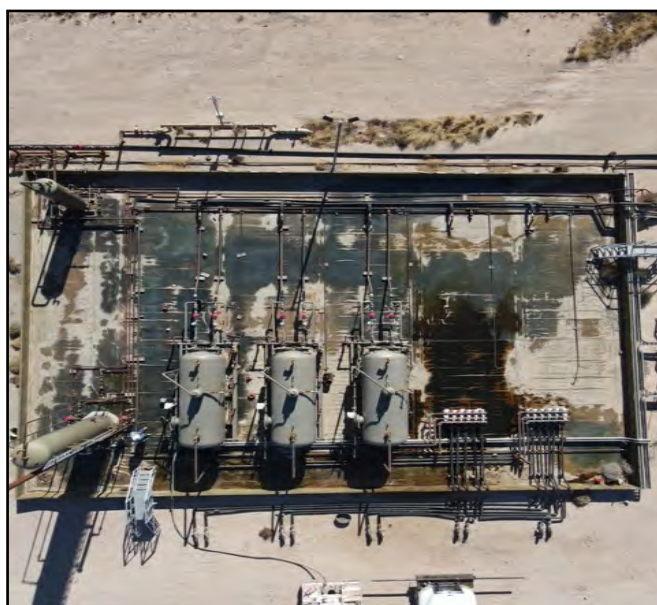
Photo of liner taken prior to power washing.
Facing South

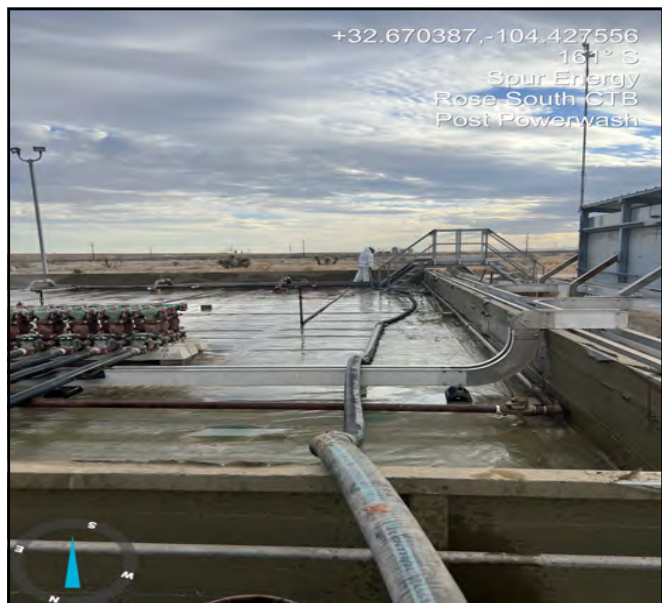
Visualization	Yes	No	Comments
Is there a tear in the liner?		X	
Are there holes in the liner?		X	
Is the liner retaining any fluids?	X		Residual liquid is visible in the photo log from the power washing cleaning event.
Does the liner have integrity to contain a leak?	X

Photo taken pursuant to power washing.
Facing South.

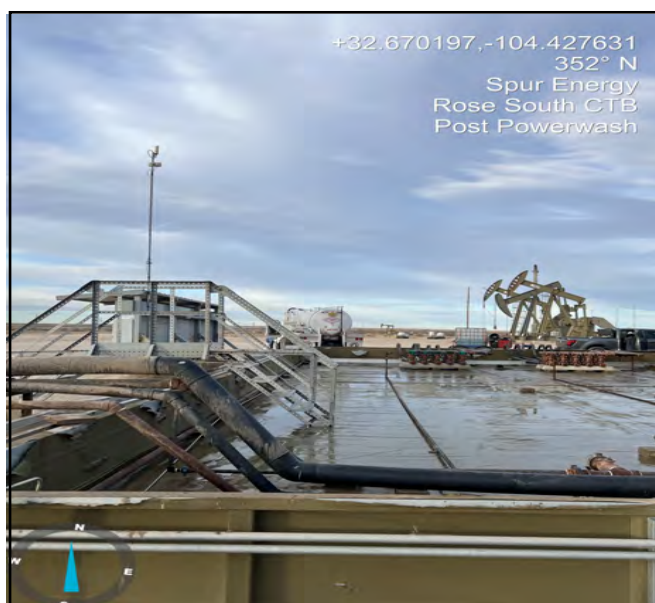
Photo taken pursuant to power washing.
Facing North.

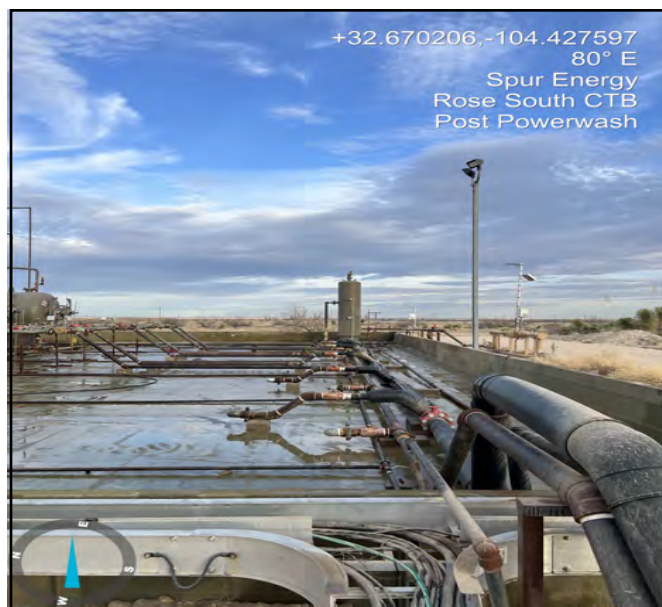
Photo taken pursuant to power washing.
Facing East.

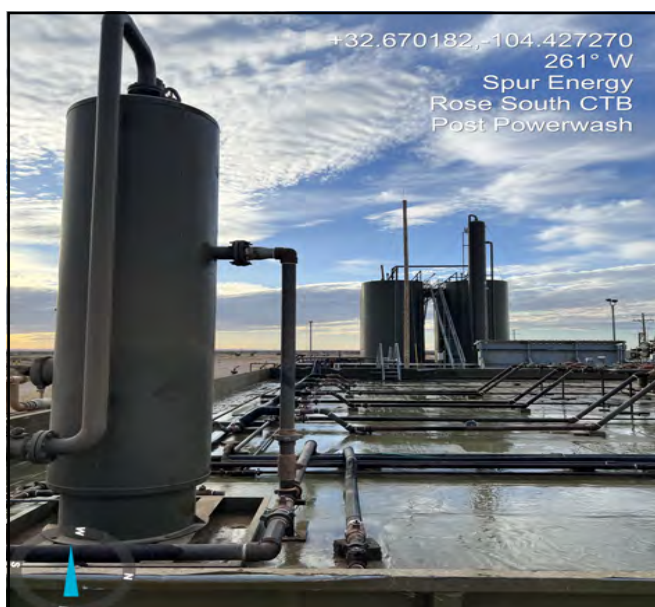
Photo taken pursuant to power washing.
Facing West.

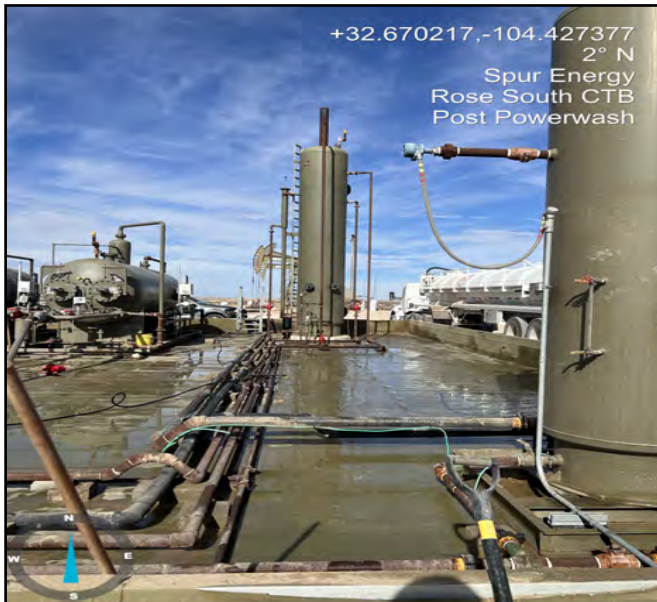
Photo taken pursuant to power washing.
Facing North.

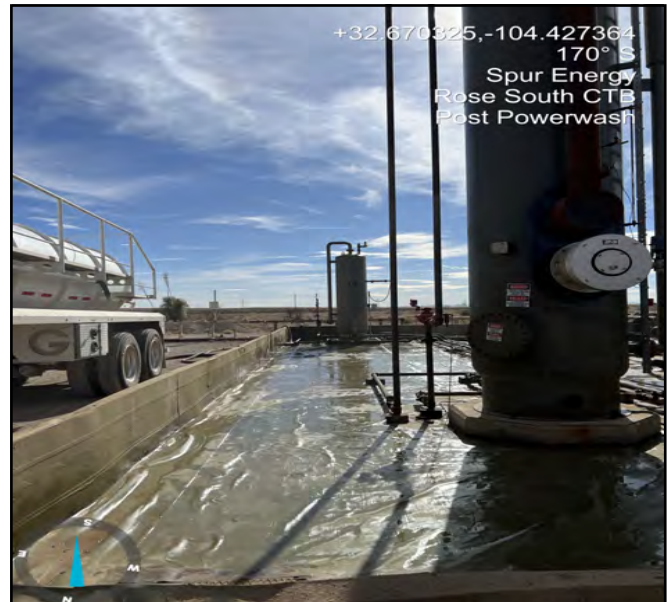
Photo taken pursuant to power washing.
Facing South.

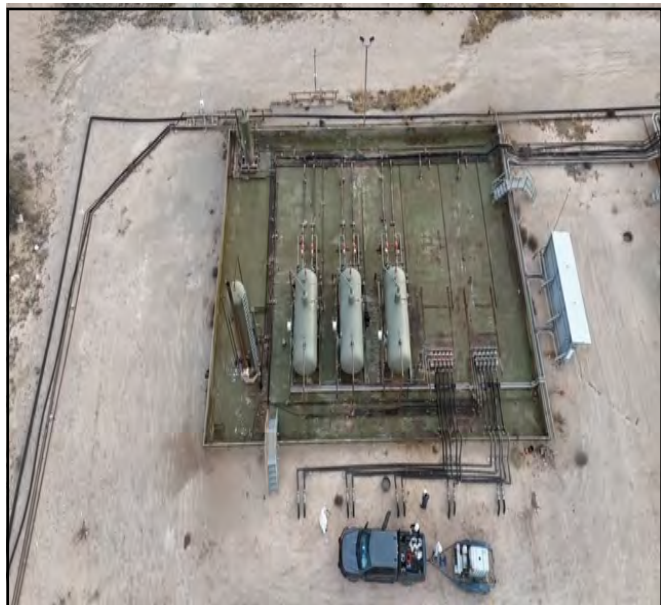
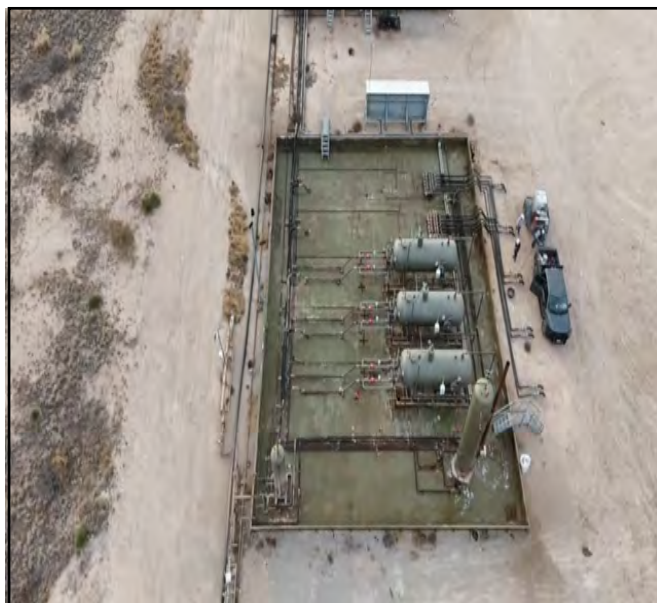
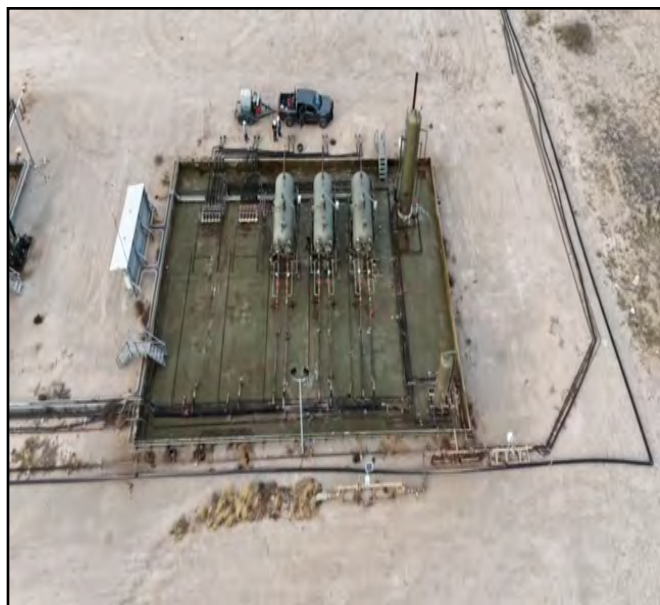
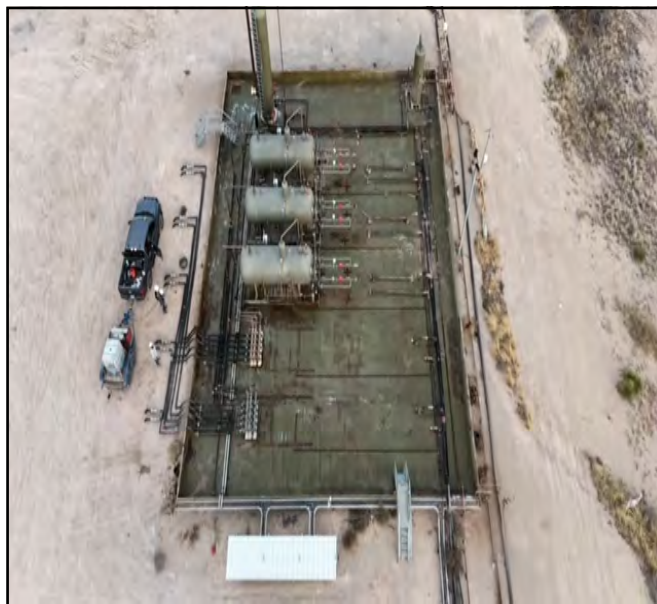
Aerial Photos pursuant to power wash.
