PROJECT # 5E33088 BG# 5

SUBJECT: Closure Request Report for the RDX Federal 21 #022/ 21-22 Pad, Incident ID #'s nAPP2430235253 and nAPP2430930089, Eddy County, New Mexico.

Site Inspection Report

Site Name: RDX Federal 21 #022

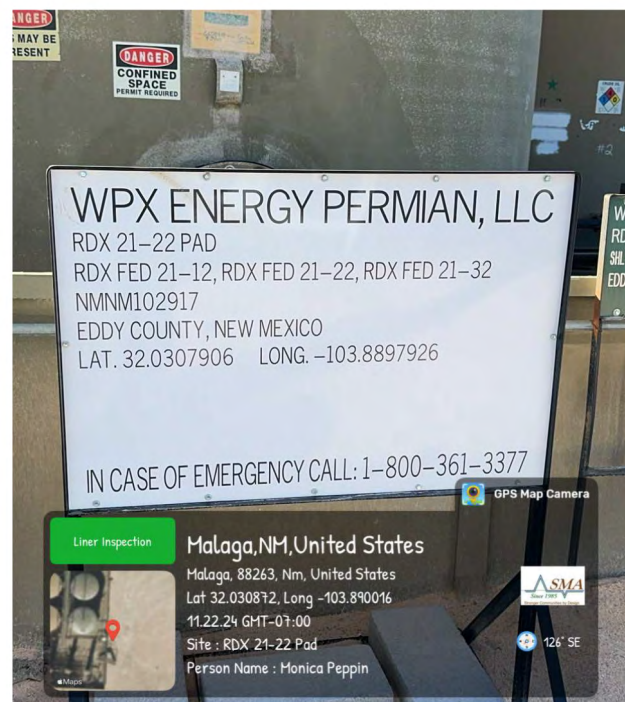
**Photograph #1: Lease sign for
proof of being at correct site**

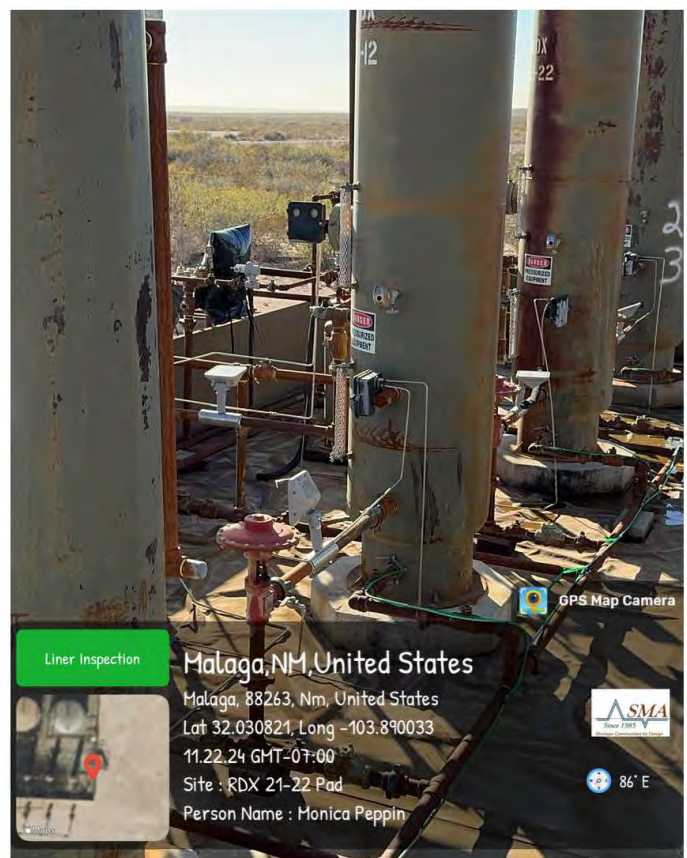
Photograph #3: East side showing east to south area

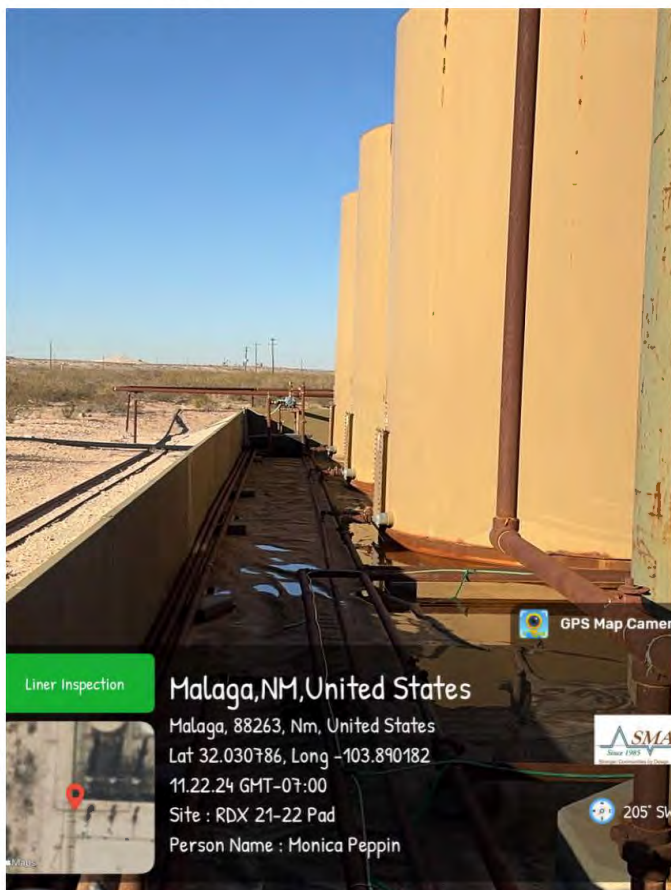
Photograph #4: east side looking west showing south end of liner

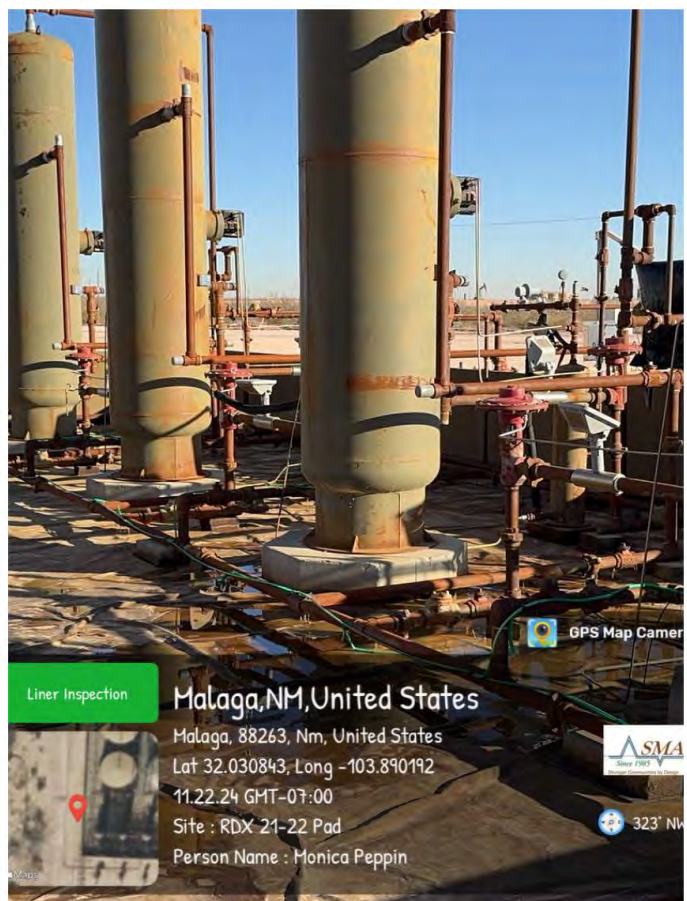
Photograph #5: Facing north from southwest corner showing west side of containment

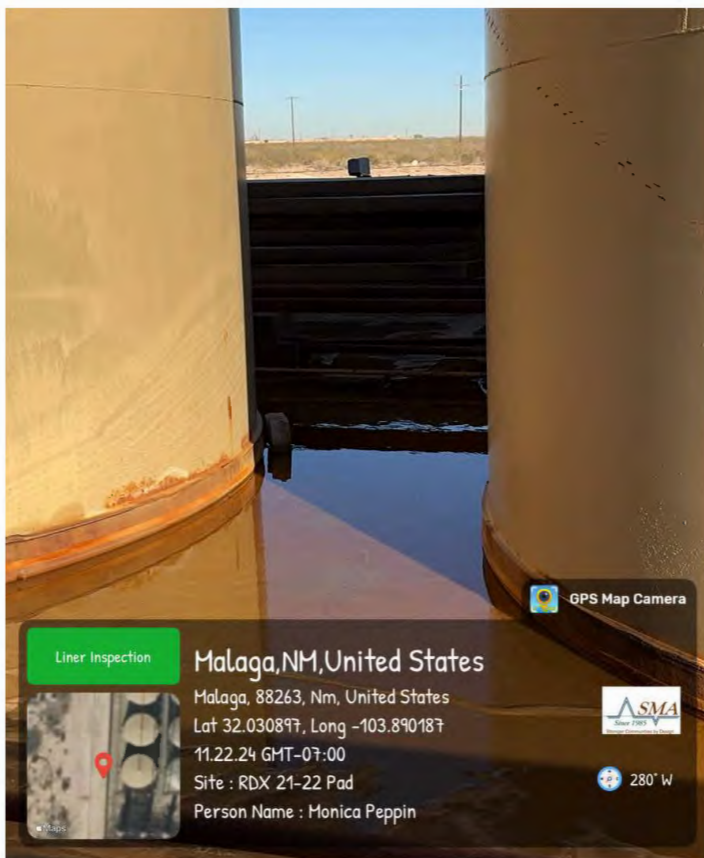
Photograph #6: Facing southeast to show south end from southwest corner

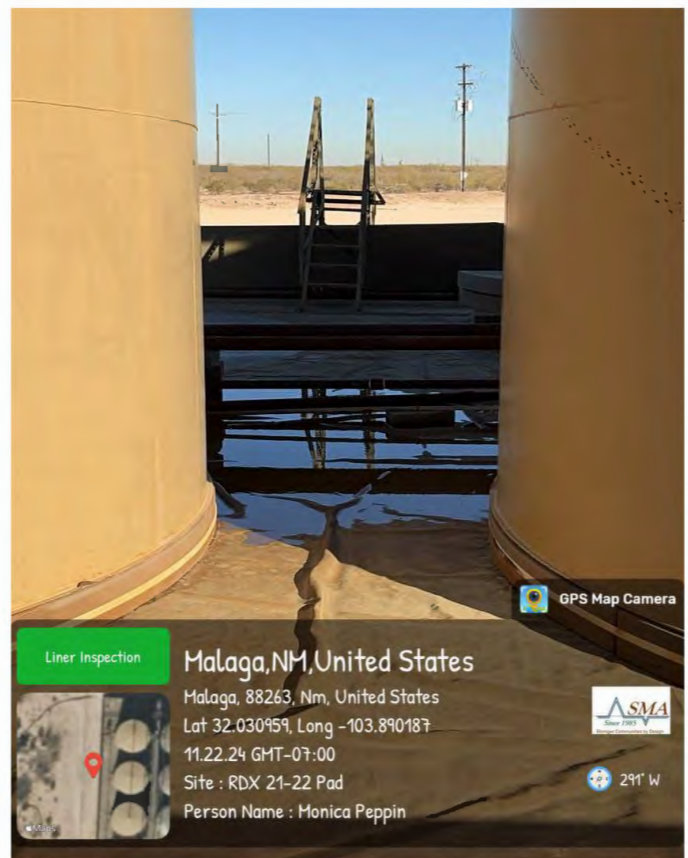
Photograph #7: Facing west showing middle area between tanks

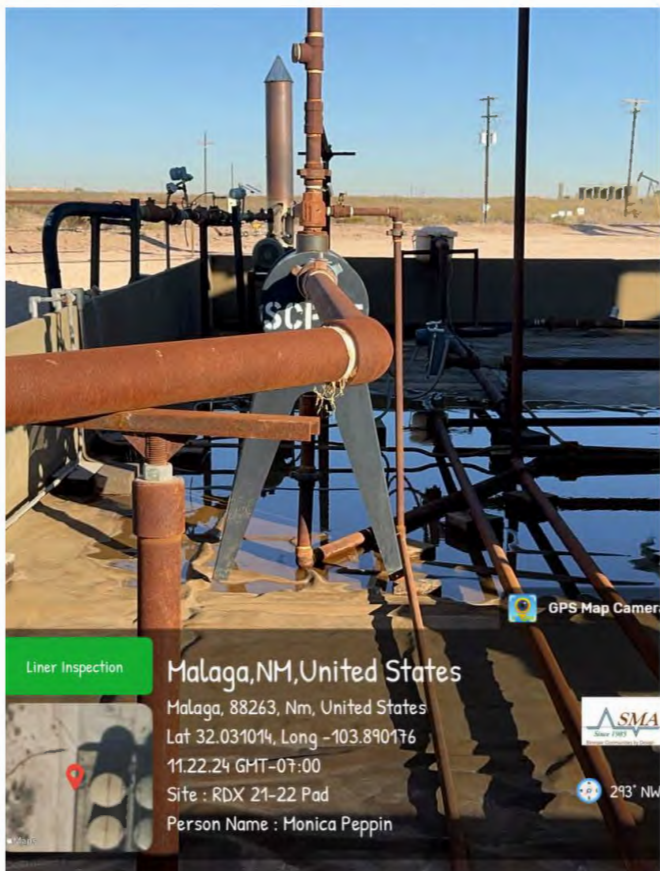
Photograph #8: Facing east from west middle area of containment

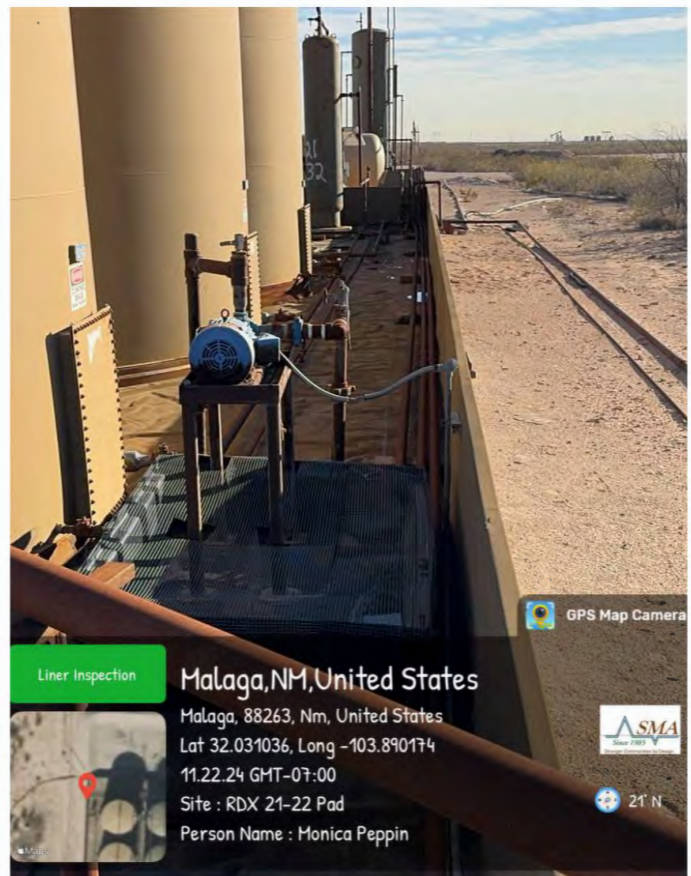
Photograph #9: Facing east from west/northwest side

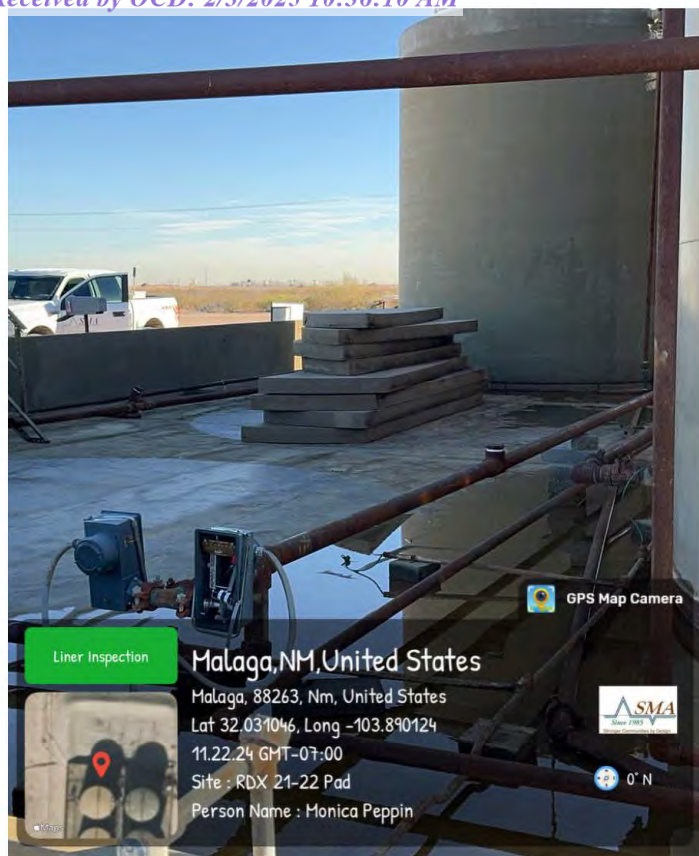
Photograph #10: Facing south from north west corner

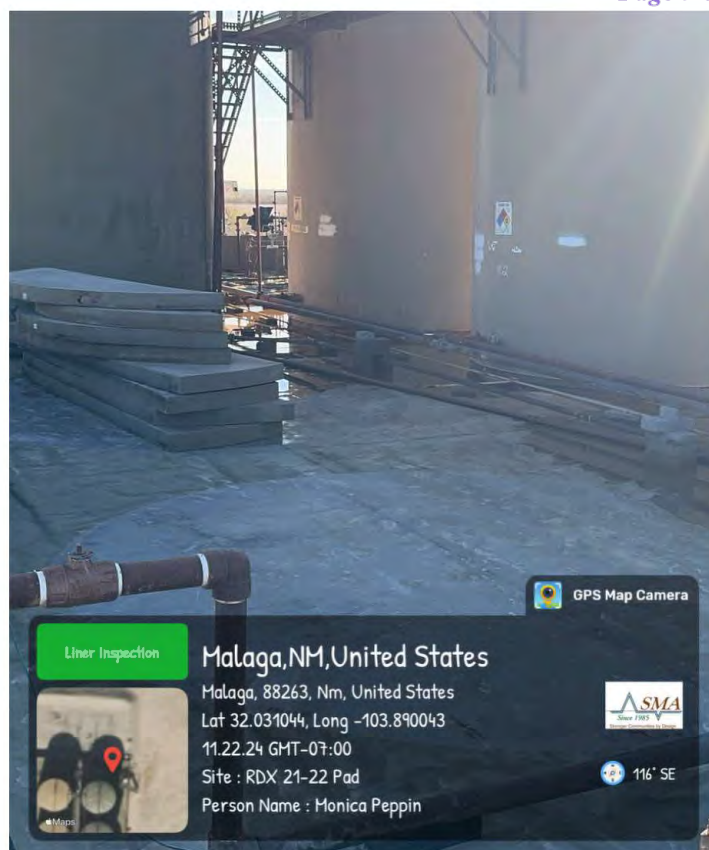
Photograph #11: Facing south from northwest corner

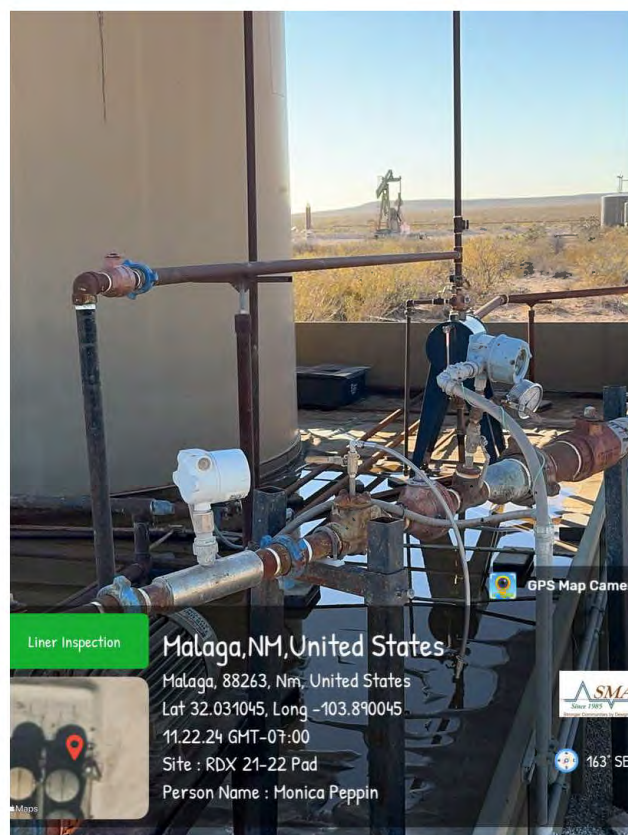
Photograph #12: Facing south from northeast side of containment

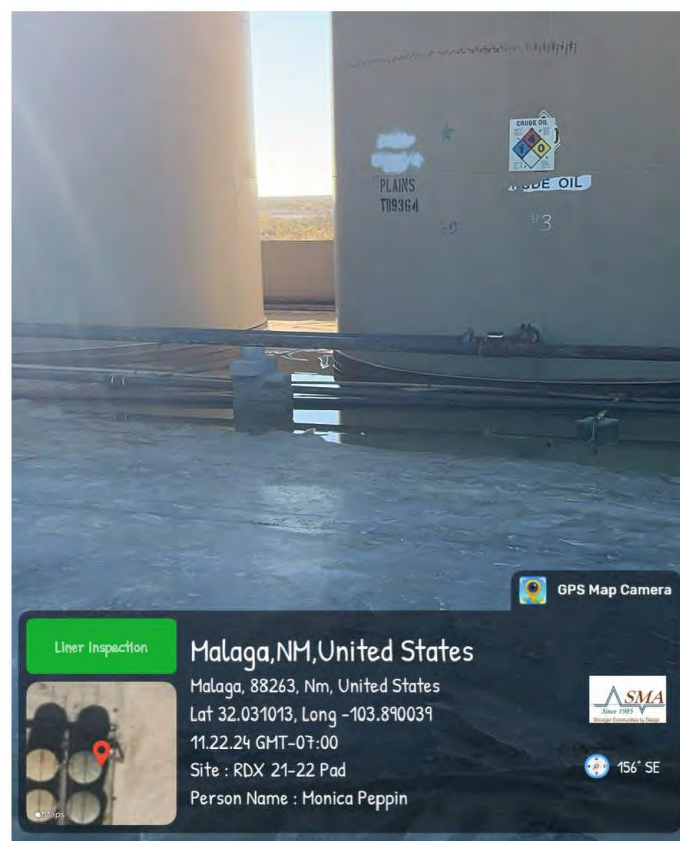
Photograph #13: north end of containment facing west

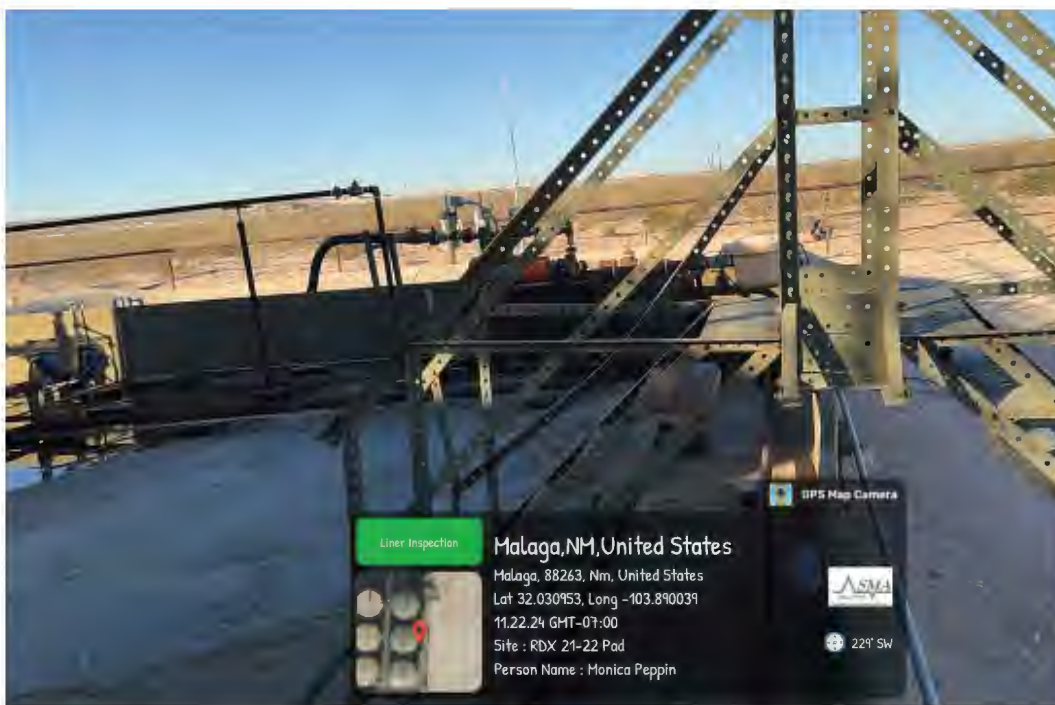
Photograph #14: Facing west/southwest from mid area on east side
