Closure Report

Salado Draw 23 Central Tank Battery (05.29.2025)

Incident #: NAPP2515528266

Motor Oil Release

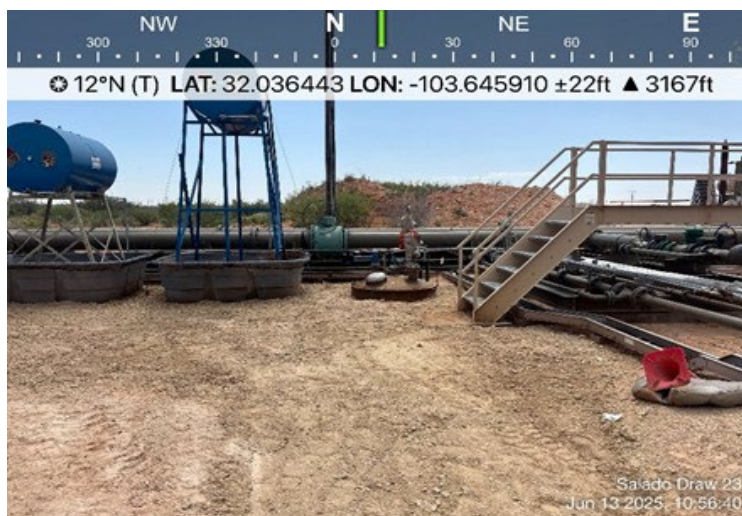
Photograph No. 3

Description:
View North, area of CS-3 & CS-4.

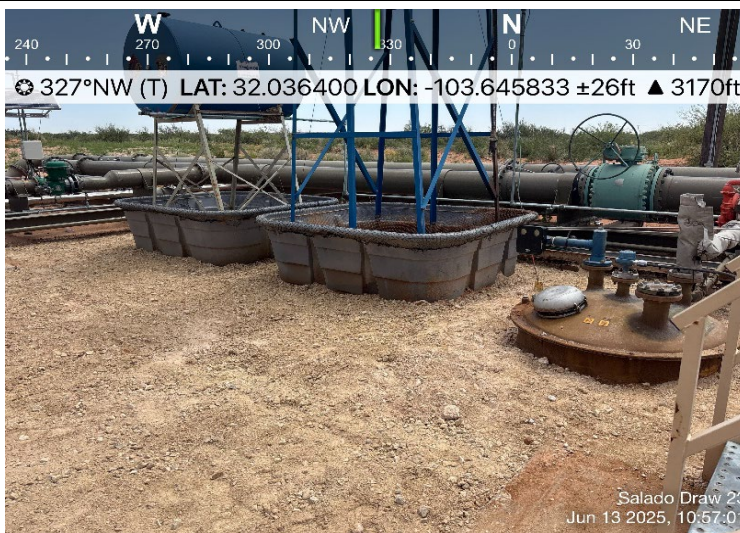
View Northwest, area of CS-2 through CS-4.

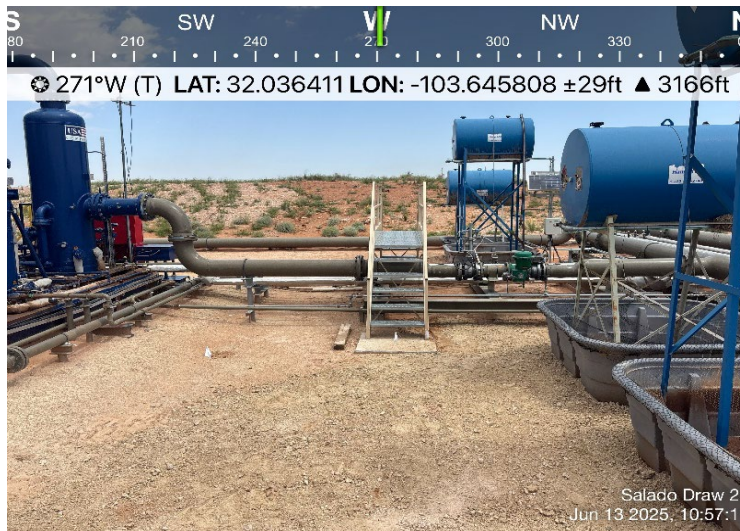
Photograph No. 5

View West, area of CS-3 & CS-4.
