**Re: Closure Request
Burton Flat Deep Unit 35 Facility 1
Incident Number nAPP2512565999
Eddy County, New Mexico**

Burton Flat Deep Unit 35 Facility 1

Devon Energy Production Company, LP
Burton Flat Deep Unit 35 Facility 1
Incident Number: nAPP2512565999
Unit C, Section 35, T 20S, R 28E
Eddy County, New Mexico

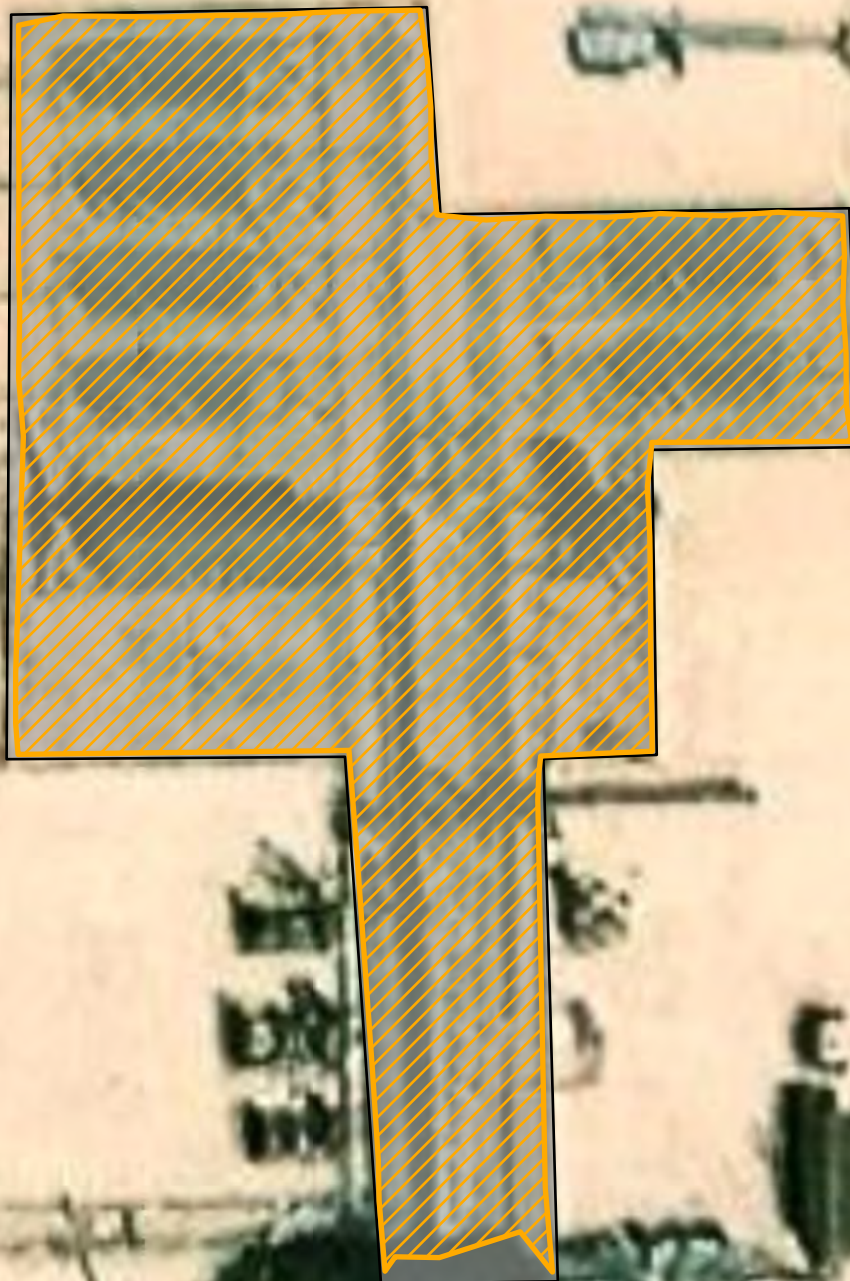
FIGURE
2

On May 5, 2025, Site assessment activities were conducted to evaluate the release extent based on information provided on the Form C-141 and visual observations. On June 23, 2025, Ensolum personnel completed a liner integrity inspection, and it was determined the liner remained intact. The Site Diagram is depicted on Figure 2. Photographs were taken during the liner integrity inspection activities, and a photographic log is included in Appendix B

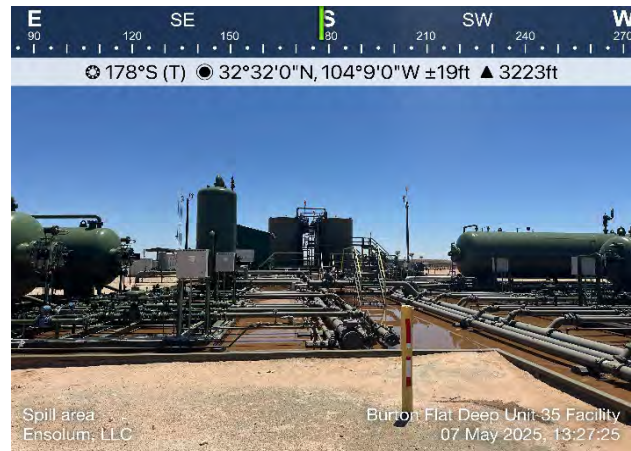
Photograph 2
Description: Spill area
View: South
Date: 5/7/2025

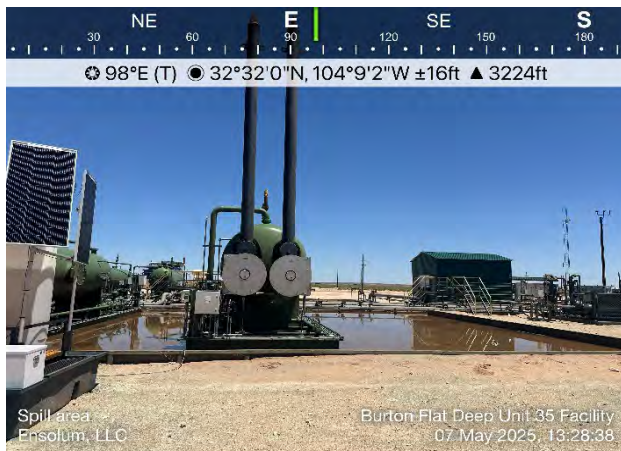
Photograph 3
Description: Spill area
View: East
Date: 5/7/2025

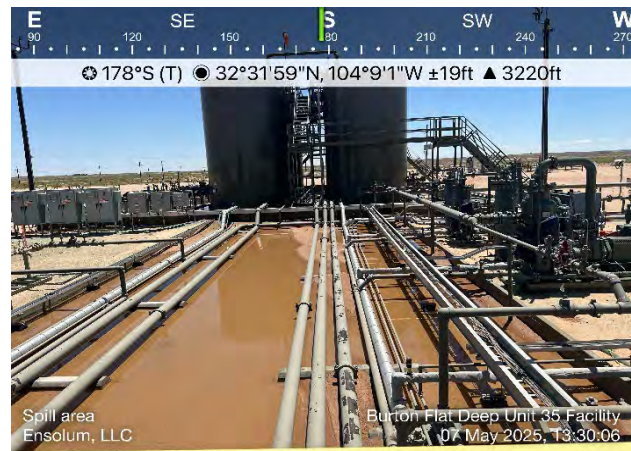
Photograph 4
Description: Spill area
View: South
Date: 5/7/2025

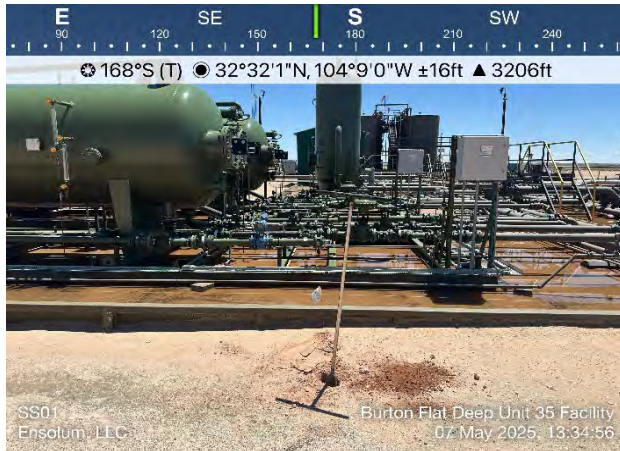
Photograph 5
Description: Spill area
View: South

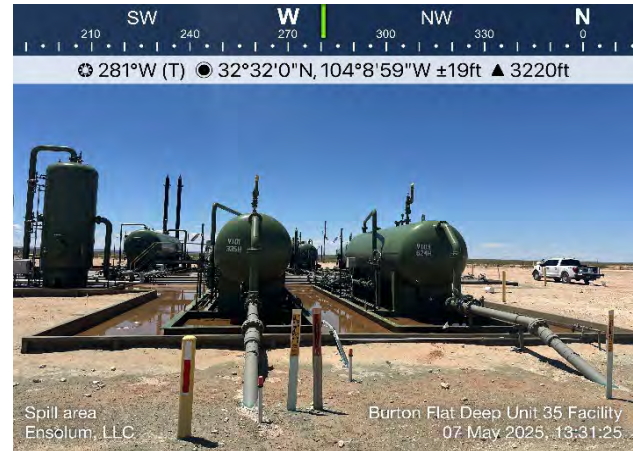
Photograph 6
Description: Spill area
View: West

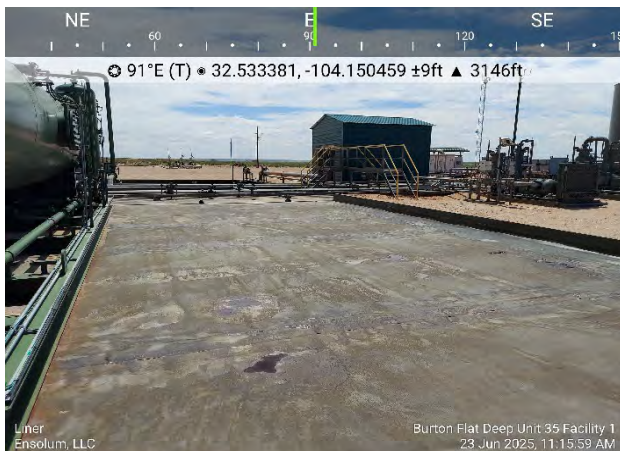
Photograph 7
Description: Liner Inspection
View: East

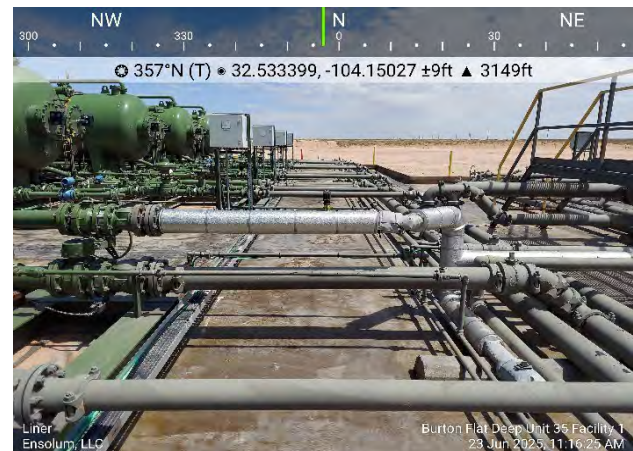
Photograph 8
Description: Liner Inspection
View: North

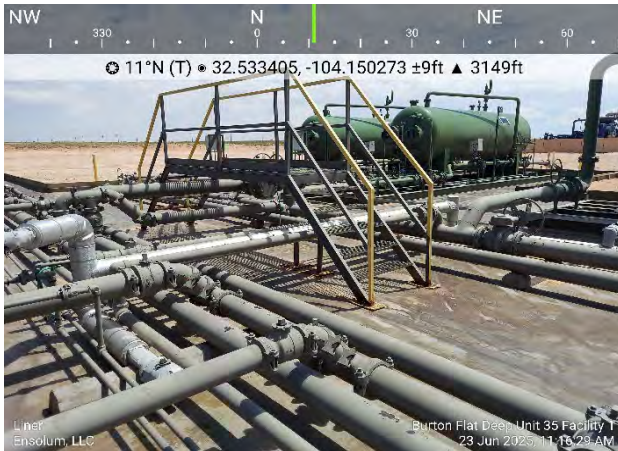
Photograph 9
Description: Liner Inspection
View: North

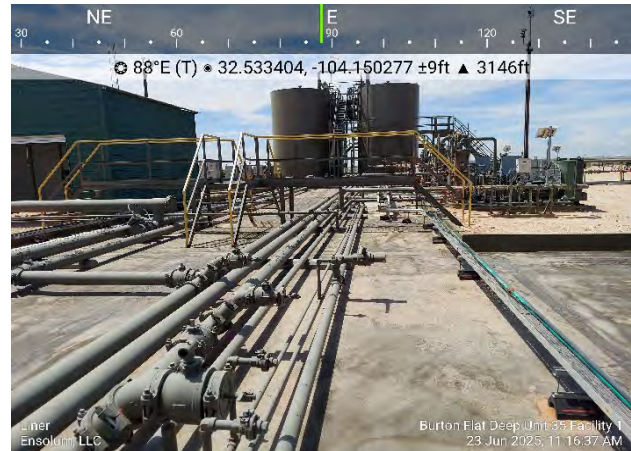
Photograph 10
Description: Liner Inspection
View: East

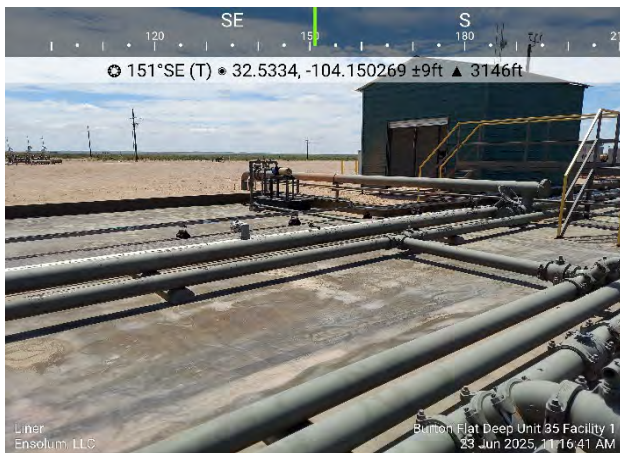
Photograph 11
Description: Liner Inspection
View: Southeast

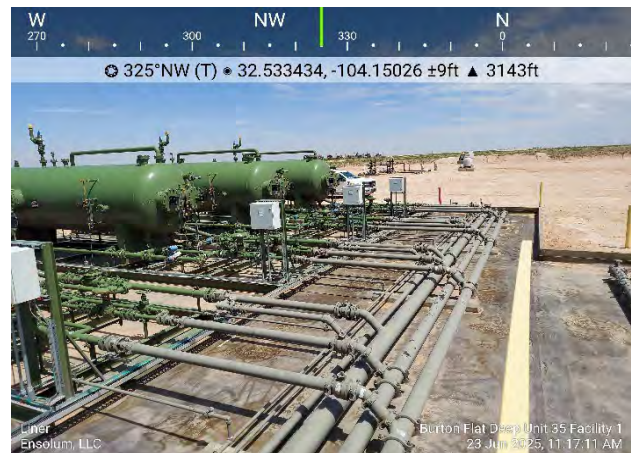
Photograph 12
Description: Liner Inspection
View: Northwest

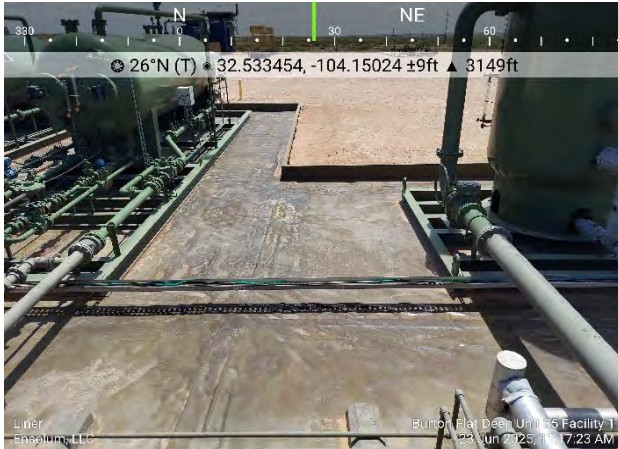
Photograph 13
Description: Liner Inspection
View: Northeast

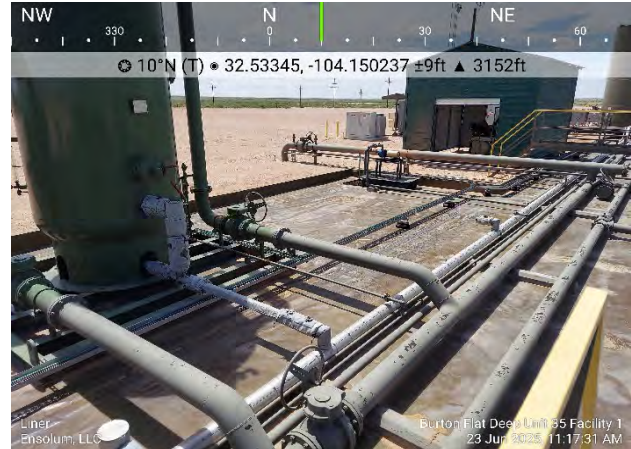
Photograph 14
Description: Liner Inspection
View: North

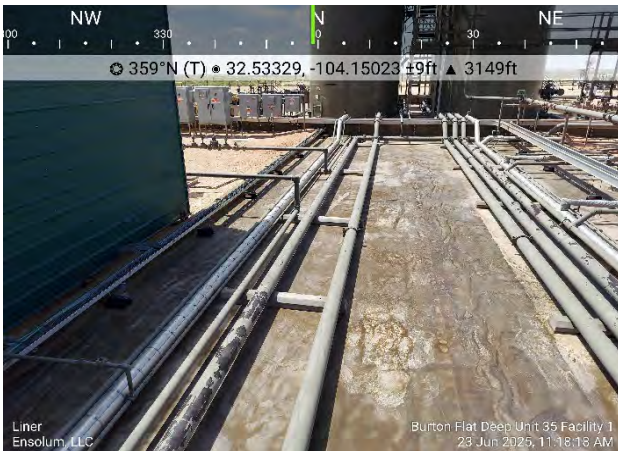
Photograph 15
Description: Liner Inspection
View: North

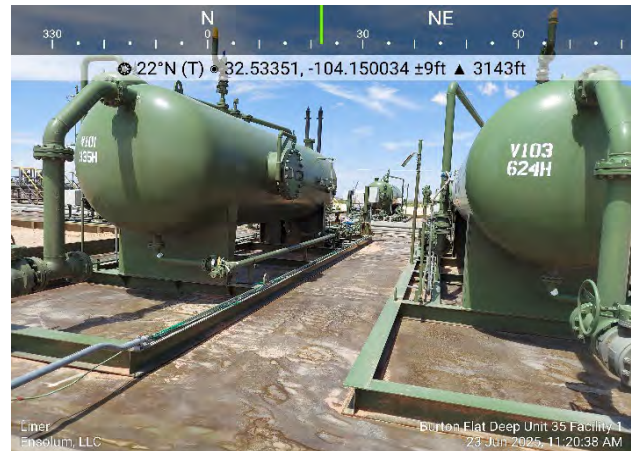
Photograph 16
Description: Liner Inspection
View: North
