Burch Keely Unit 18B Battery

Incident ID NAPP2511132829

Liner Inspection and Closure Report

July 14, 2025

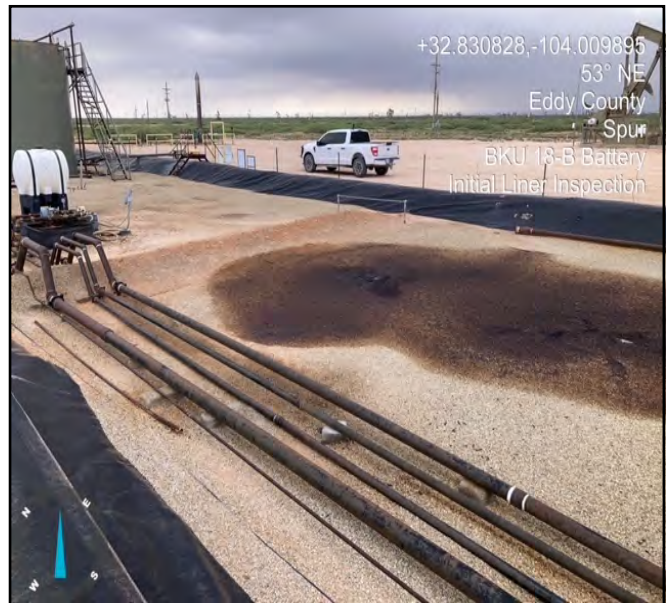
Photo of liner taken during initial liner inspection facing northeast.

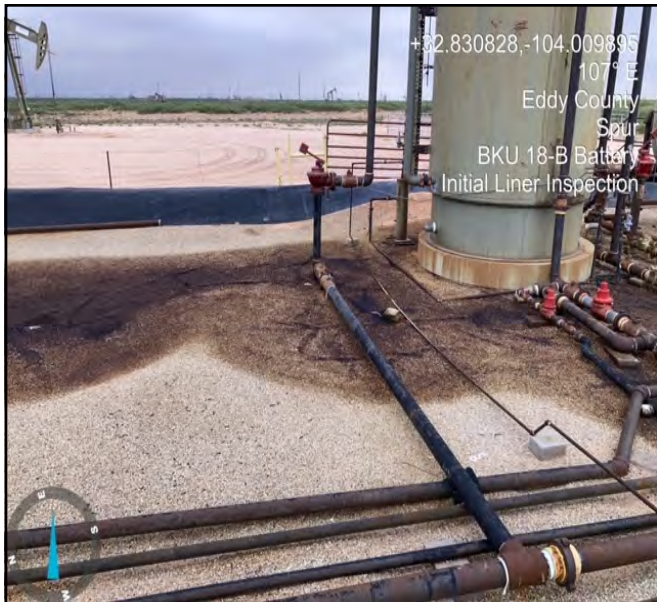
Photo of liner taken during initial liner inspection facing east.

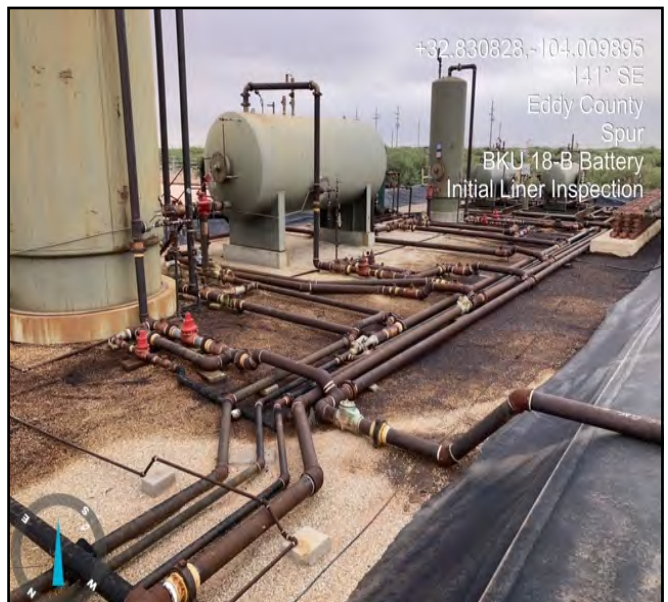
Photo of liner taken during initial liner inspection facing southeast.

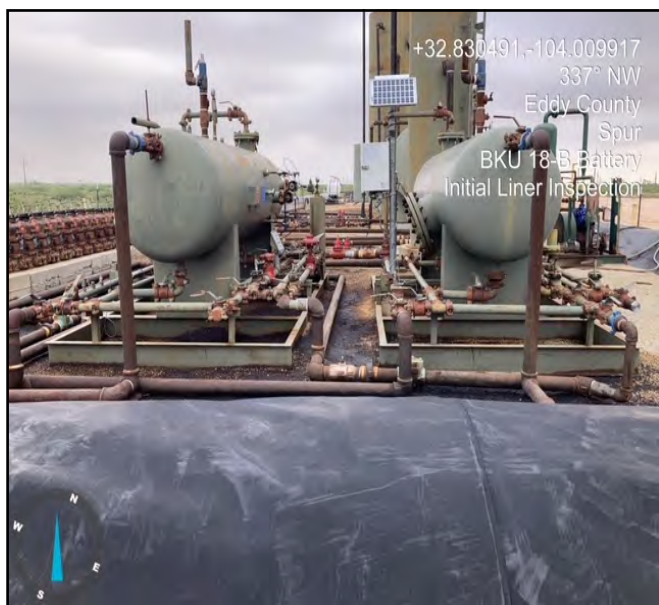
Photo of liner taken during initial liner inspection facing northwest.

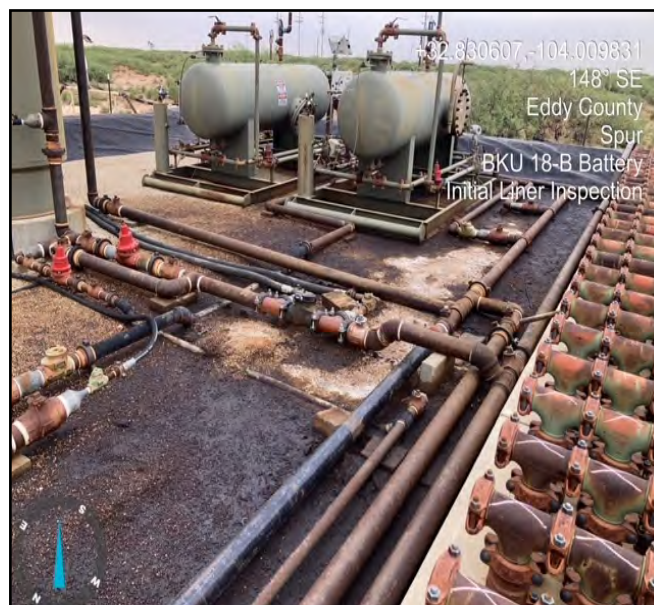
Photo of liner taken during initial liner inspection facing southeast.

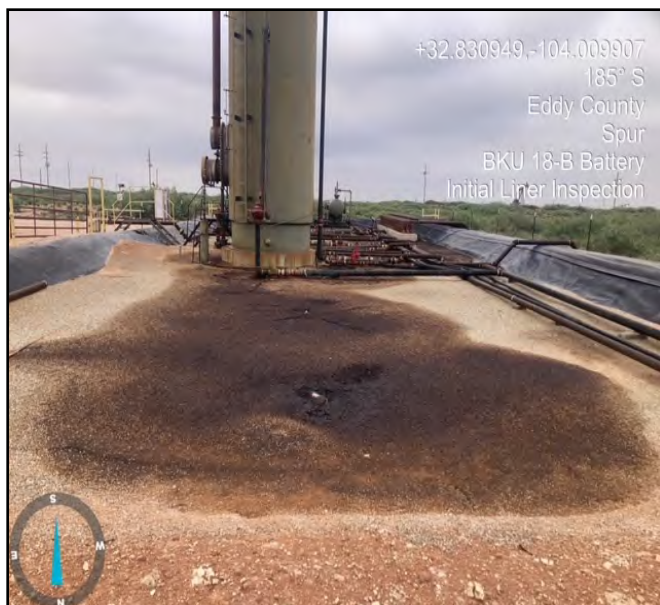
Photo of liner taken during initial liner inspection facing south.

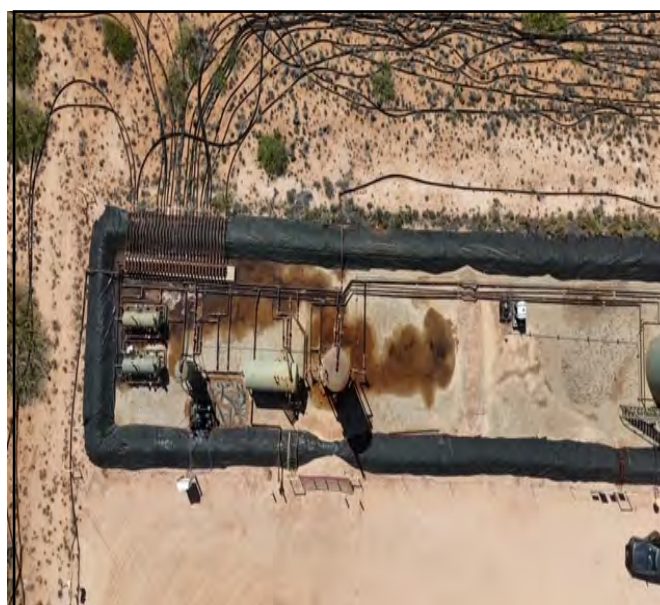
Aerial photo taken during initial liner inspection.

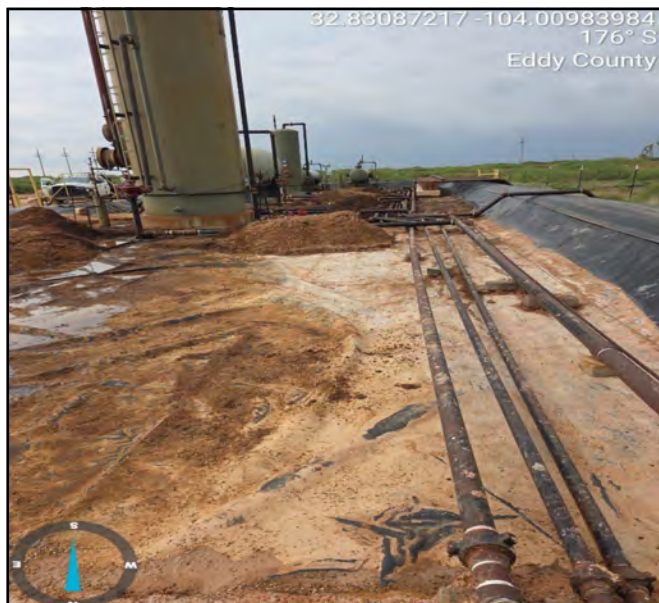
Photograph taken prior to gravel removal, facing south.

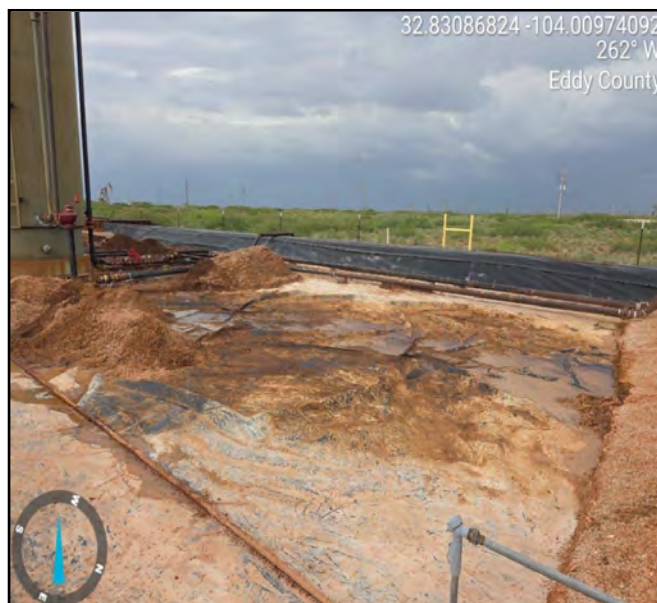
Photograph taken prior to gravel removal, facing west.

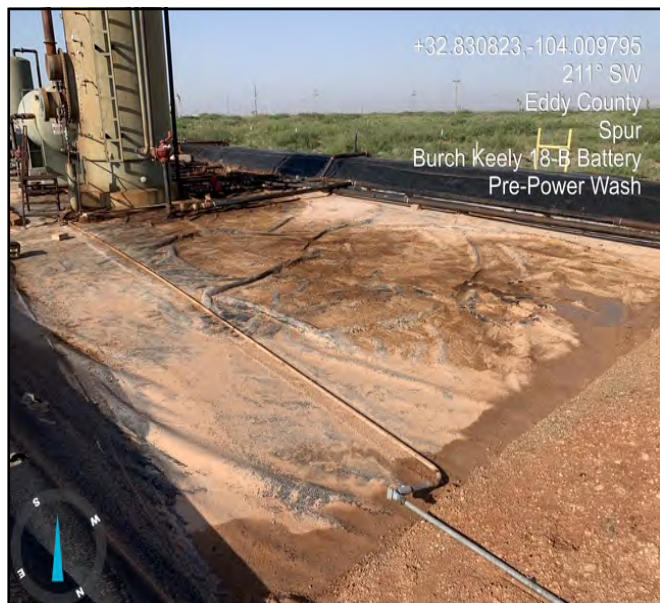
Photo of liner taken prior to power washing facing southwest.

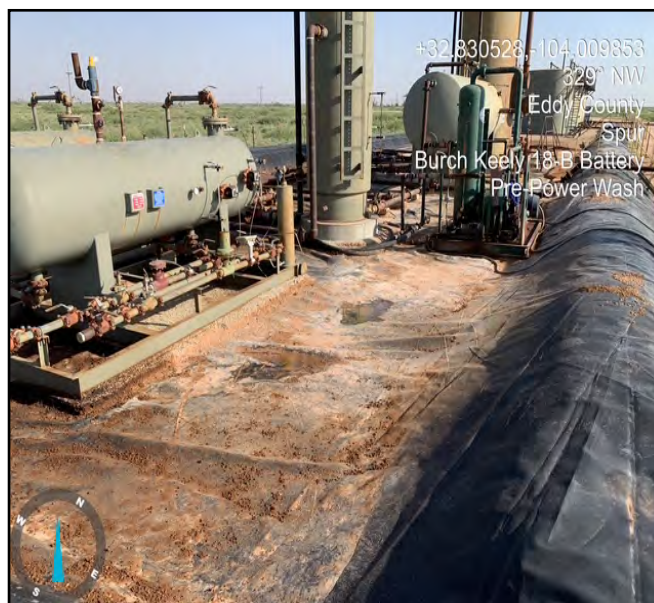
Photo of liner taken prior to power washing facing northwest.

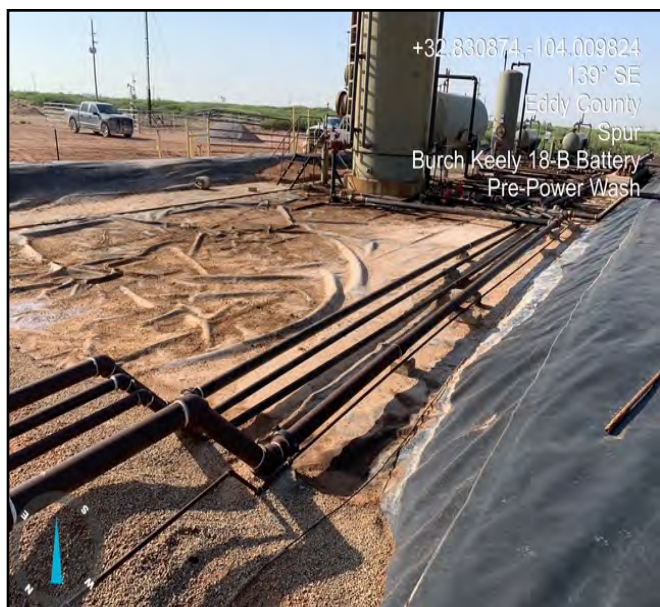
Photo of liner taken prior to power washing facing southeast.

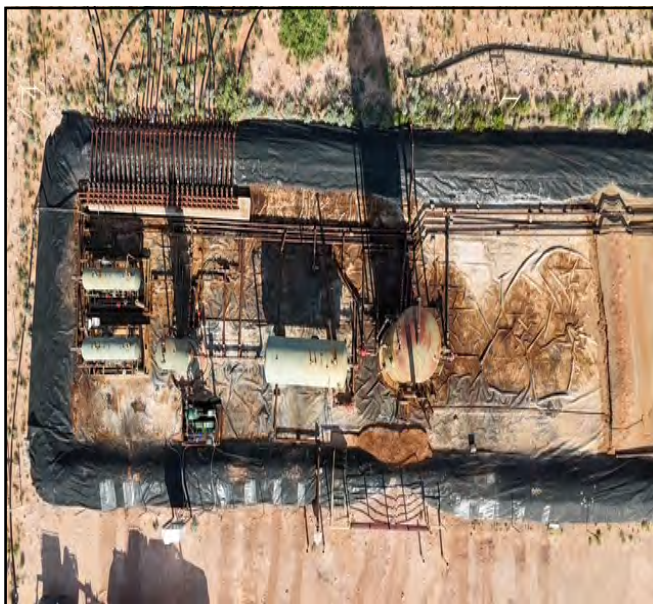
Aerial photo prior to powerwash.

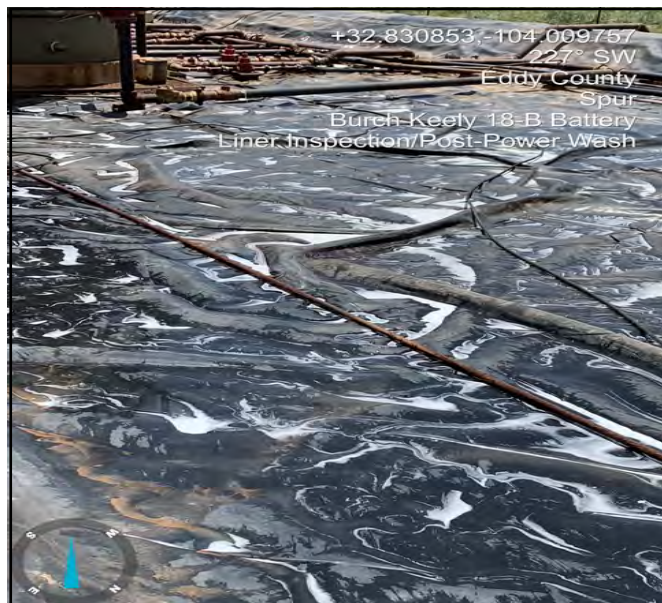
Photo of liner taken prior to power washing facing southwest.

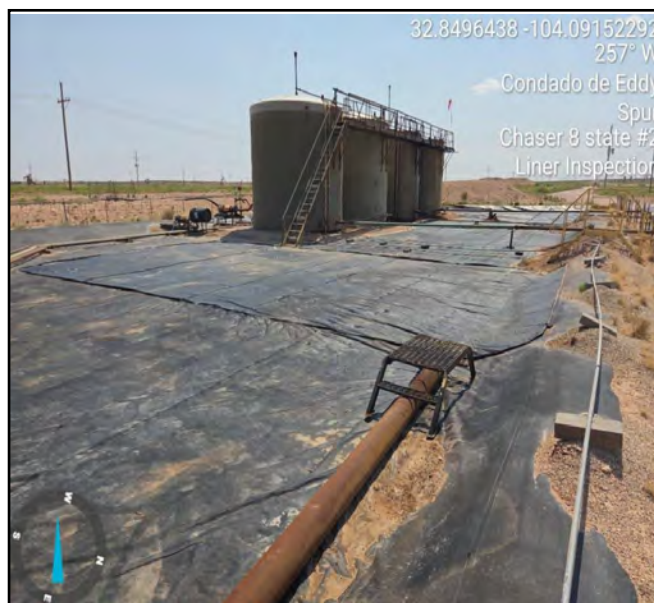
Photo of liner taken prior to power washing facing southwest.

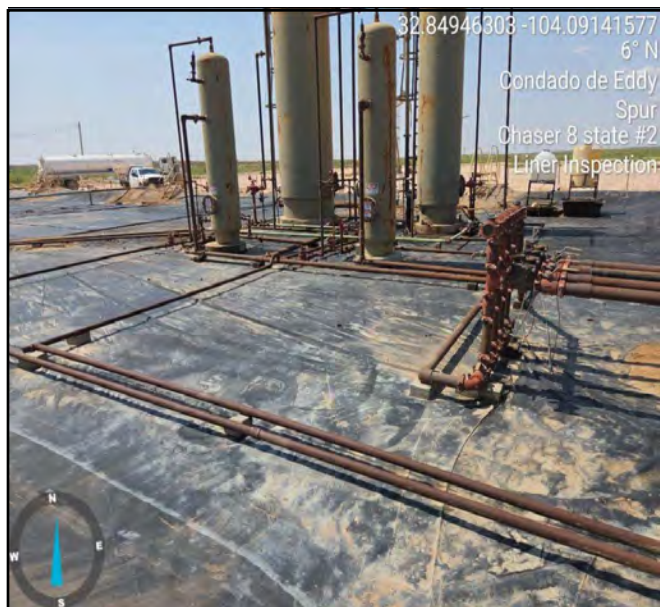
Photo of liner taken prior to power washing facing north.

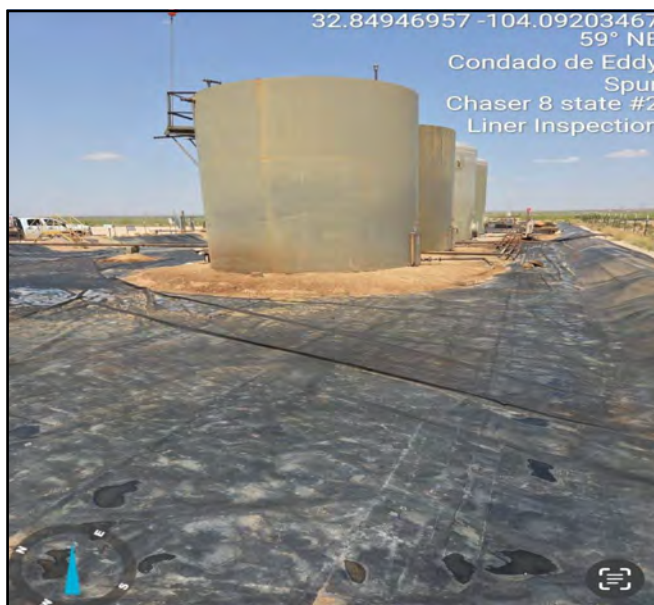
Photo of liner taken prior to power washing facing northeast.

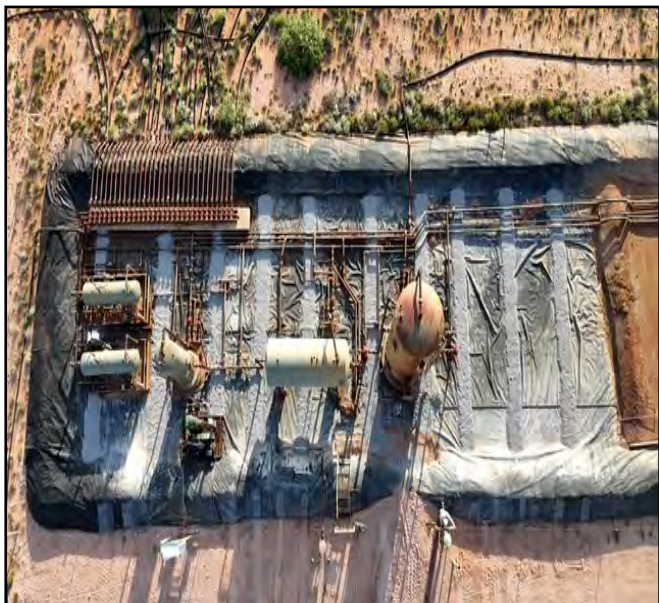
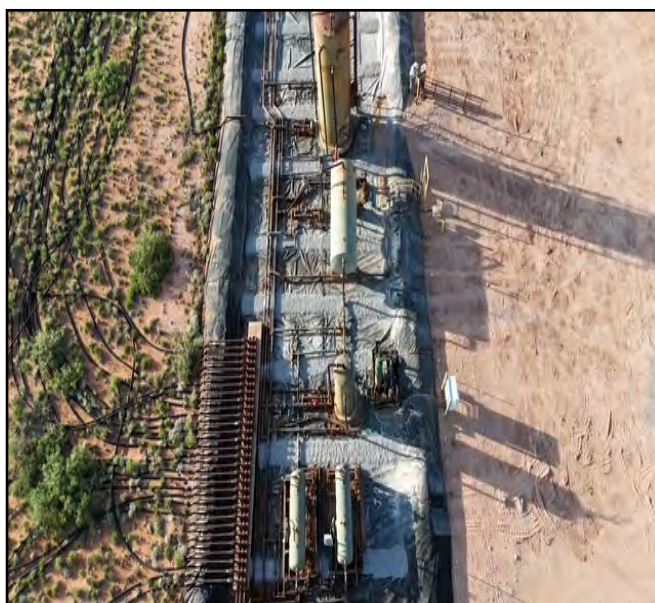
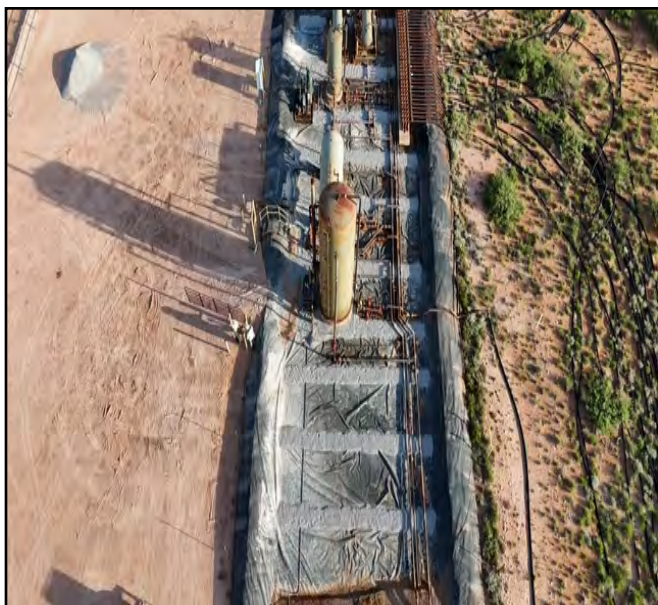
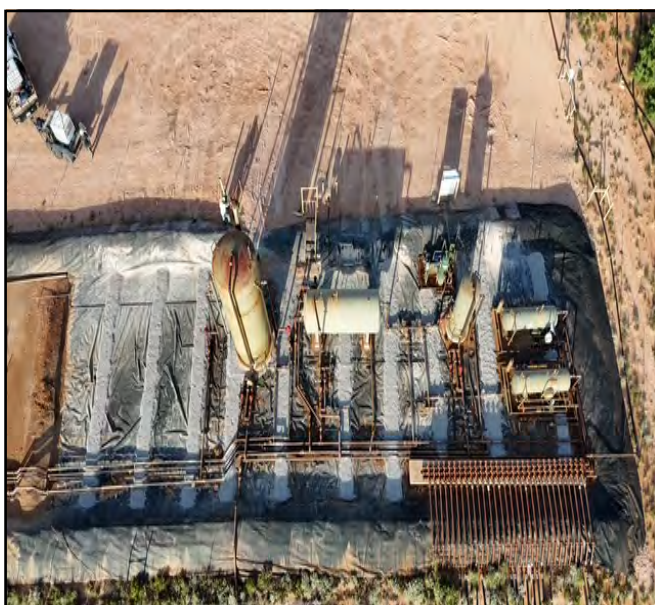
Aerial photo of location post power wash/
liner inspection.

Aerial photo of location post
power wash/ liner inspection.
