LOCO HILLS 6 SWD
Incident ID NAPP2515738380

Liner Inspection and Closure Report

July 14, 2025

RE: Liner Inspection and Closure Report
Loco Hills 6 SWD
API No. 30-015-39478
GPS: Latitude 32.79222 Longitude -103.97537
UL- G, Section 33, Township 17S, Range 30E
NMOCD Reference No. nAPP2515738380

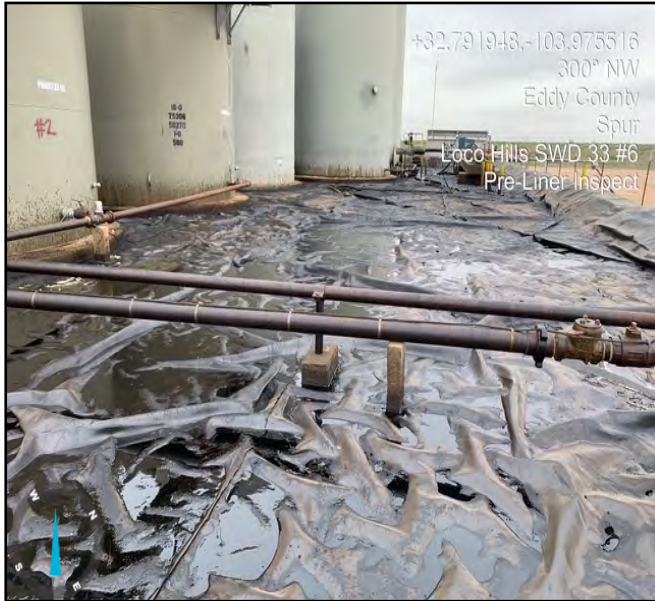
Photo of liner taken during initial liner inspection facing northwest.

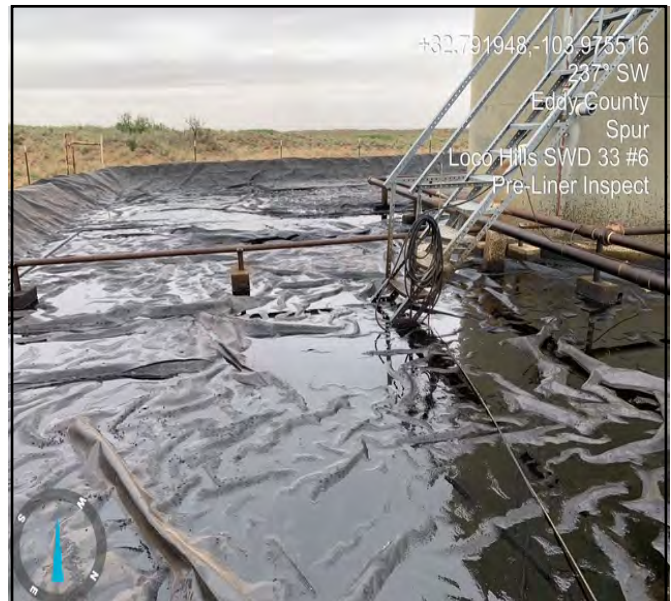
Photo of liner taken during initial liner inspection facing southwest.

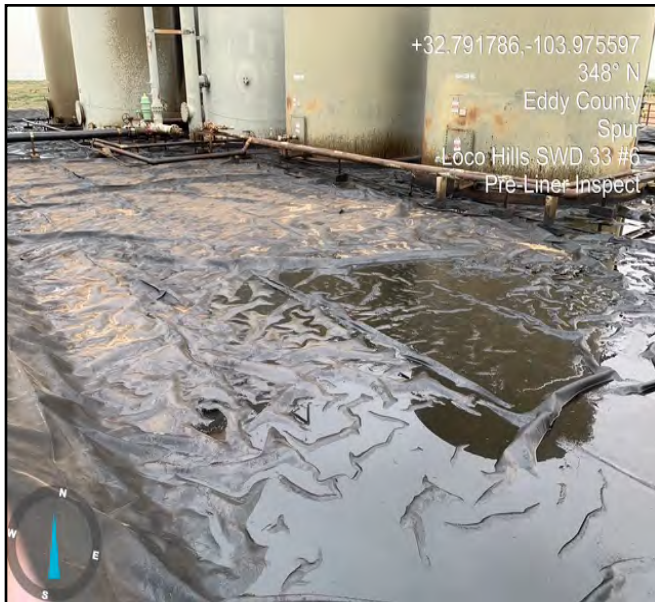
Photo of liner taken during initial liner inspection facing north.

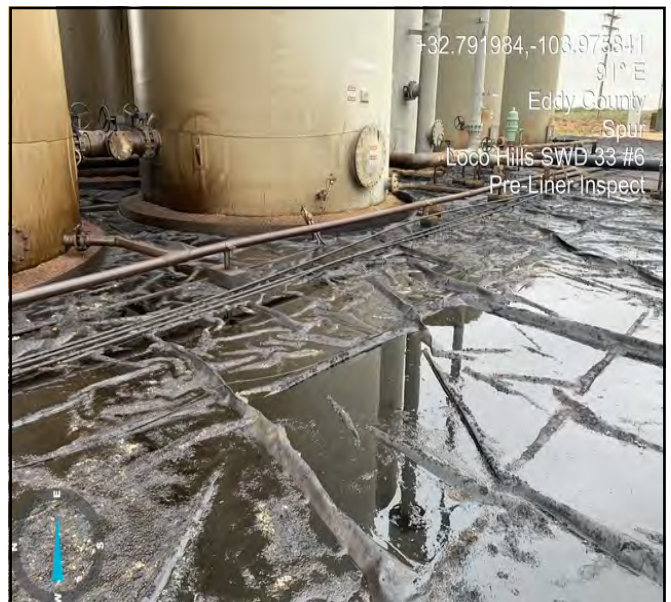
Photo of liner taken during initial liner inspection facing east.

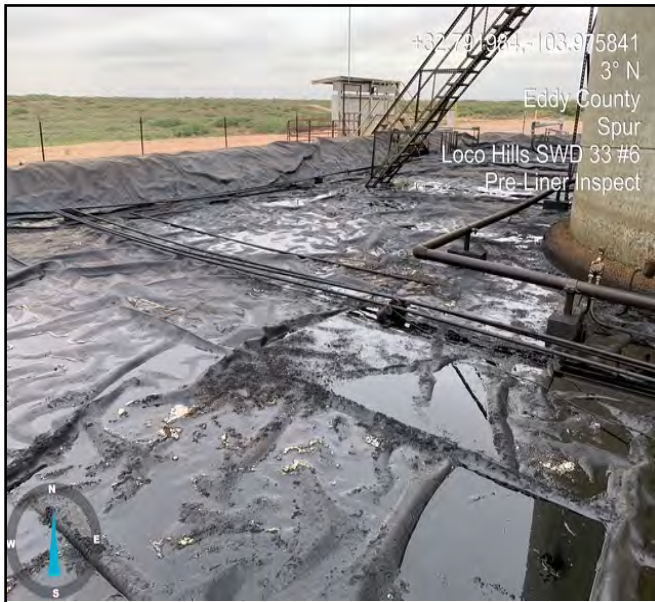
Photo of liner taken during initial liner inspection facing north.

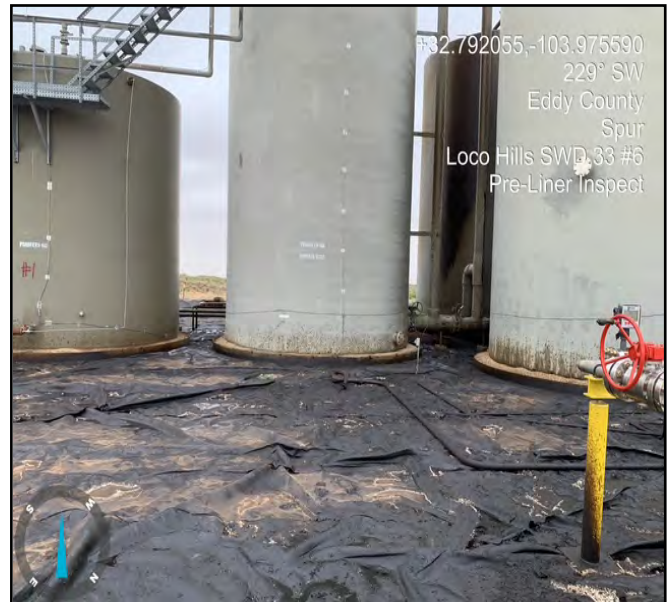
Photo of liner taken during initial liner inspection facing southwest.

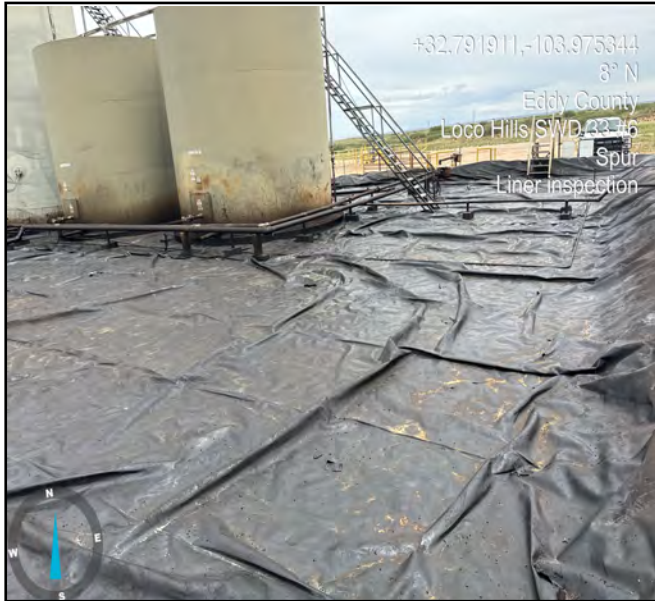
Photo of liner taken post to power washing facing north.

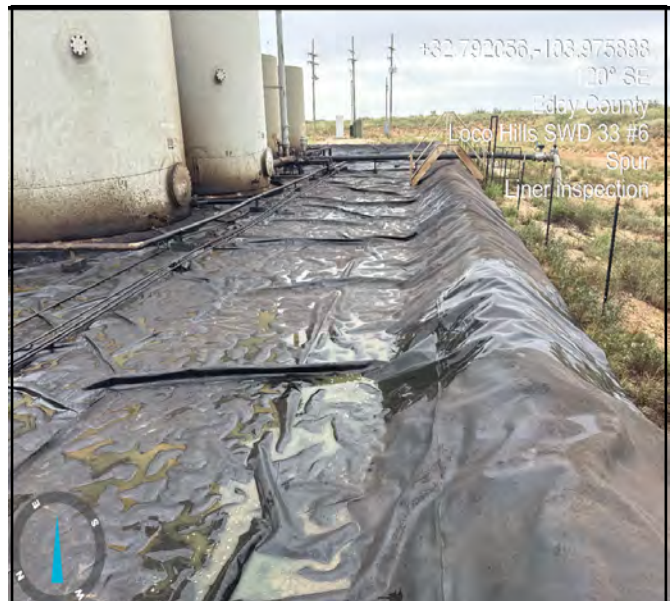
Photo of liner taken post to power washing facing southeast.

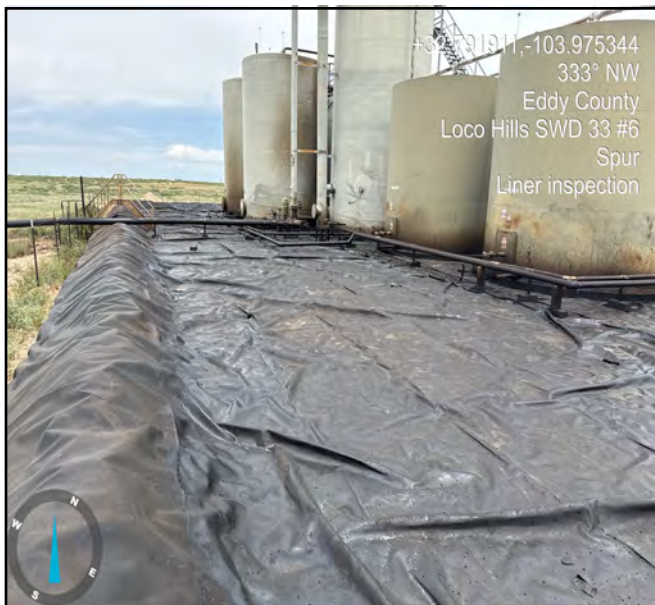
Photo of liner taken post to power washing facing northwest.

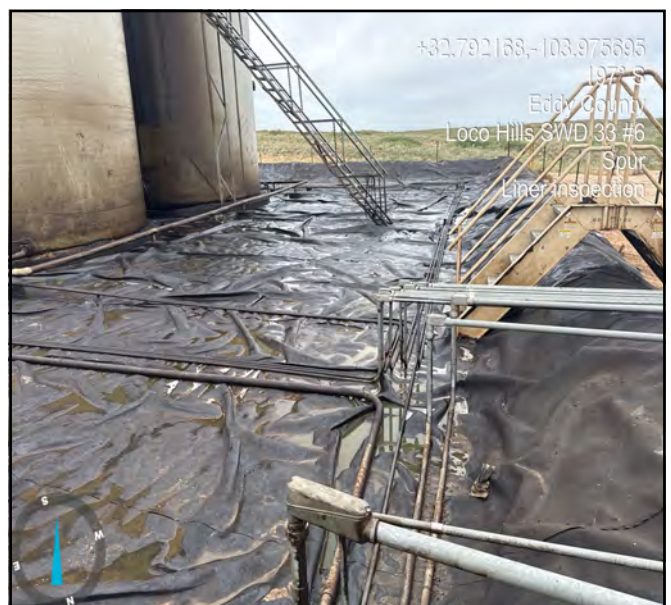
Photo of liner taken post to power washing facing south.
