Re: Site Assessment, Remediation, and Closure Request

Bradley 8 Fee 3H Battery

Eddy County, NM

NMOCD Ref. No. nAPP2307228945

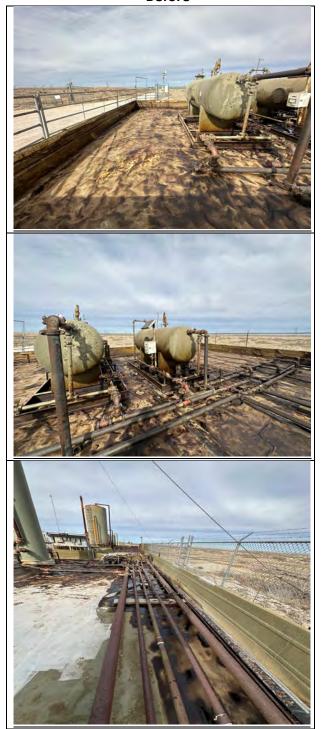
Photographic Documentation Before

Corrosion of a 4 inch pipe fitting caused an oil and produced water mix to release into lined containment.

• On March 15th, 2023, utilizing a power washer, a vacuum truck and a hand crew, Paragon was able to remove all the contamination from the containment. Upon finishing this we scheduled a liner inspection to close out the spill. We performed a liner inspection on July 28th, 2025, the results of this inspection concluded that the liner was in good condition and had the integrity to contain a spill.

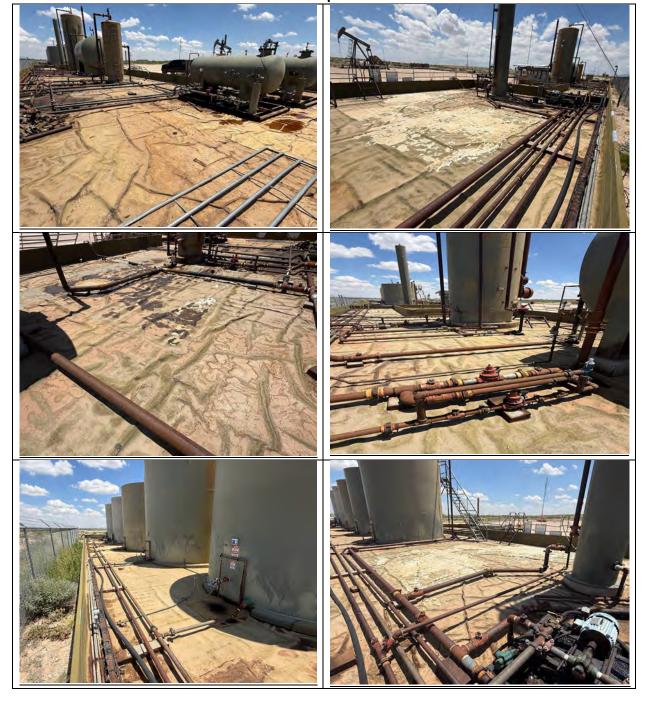
Photographic Documentation Liner Inspection

| Company Name: | Spur Energy Partners | | | | | | | | | |
|--|---|---|--|---|--|--|--|--|--|--|
| Comments: Liner is in | n good w | orking | ndition | | | | | | | |
