PREPARED BY:
PIMA ENVIRONMENTAL SERVICES, LLC

PREPARED FOR:
Spur Energy

Chaser 8 State 2

Liner Inspection and Closure Report

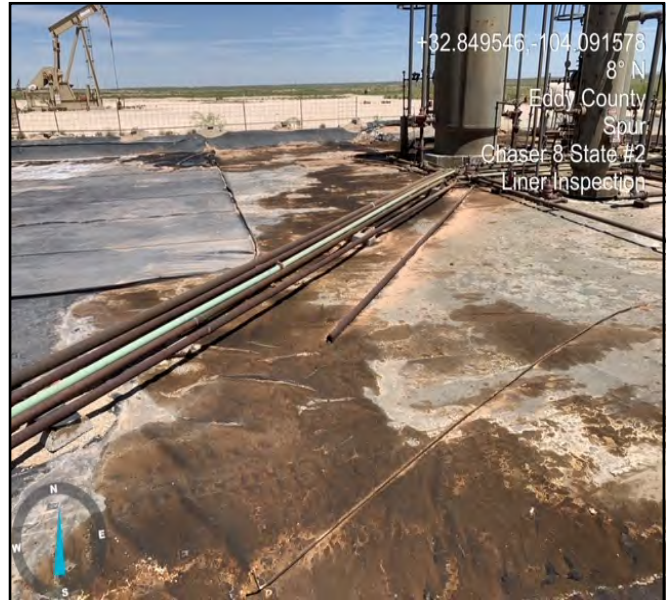
Photo of liner taken during initial site assessment inspection facing north.

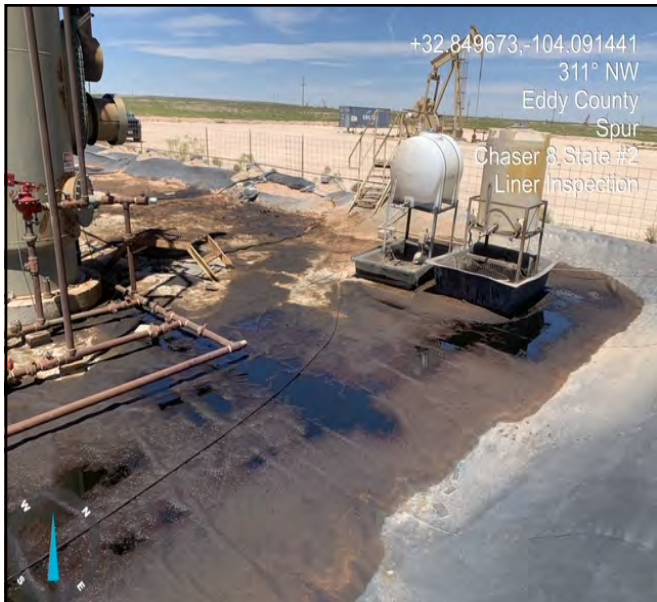
Photo of liner taken during initial site assessment facing northwest.

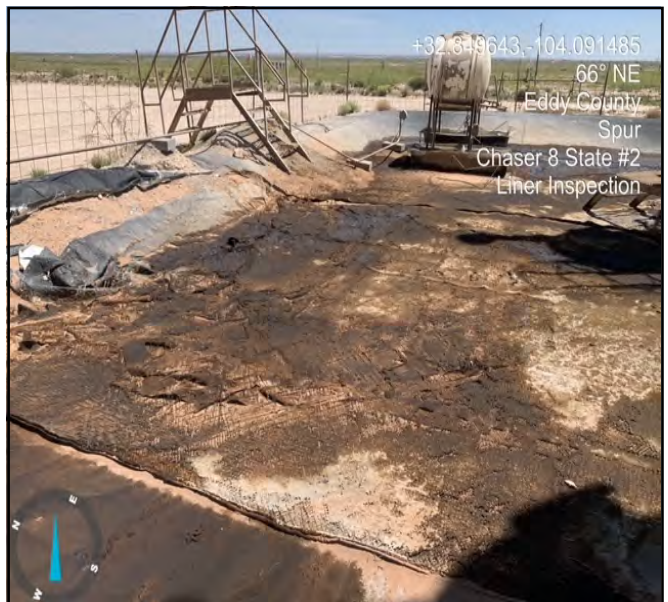
Photo of liner taken during initial site assessment facing northeast.

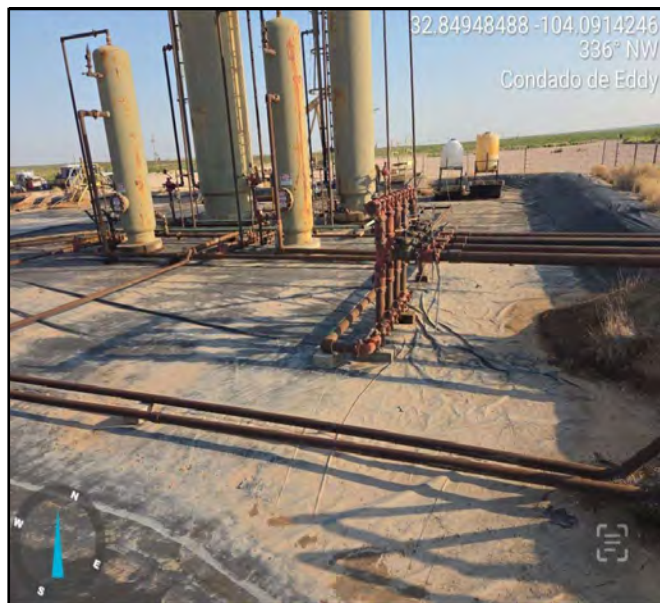
Photo of liner taken prior to power washing facing northwest.

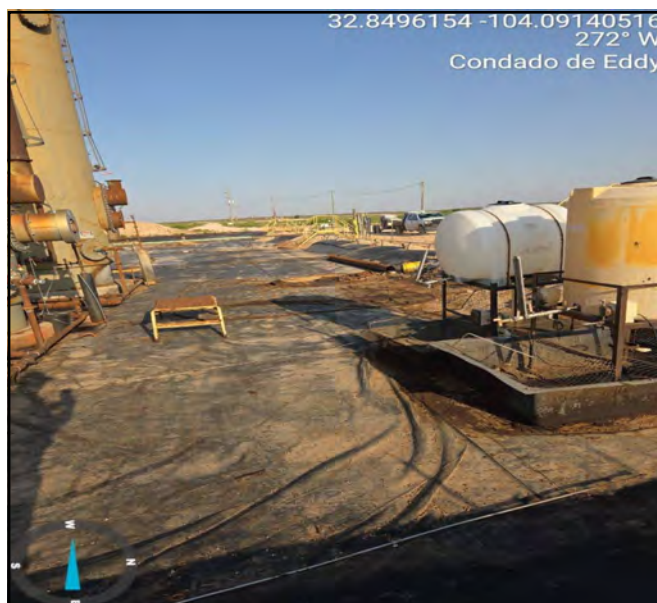
Photo of liner taken prior to power washing facing west.

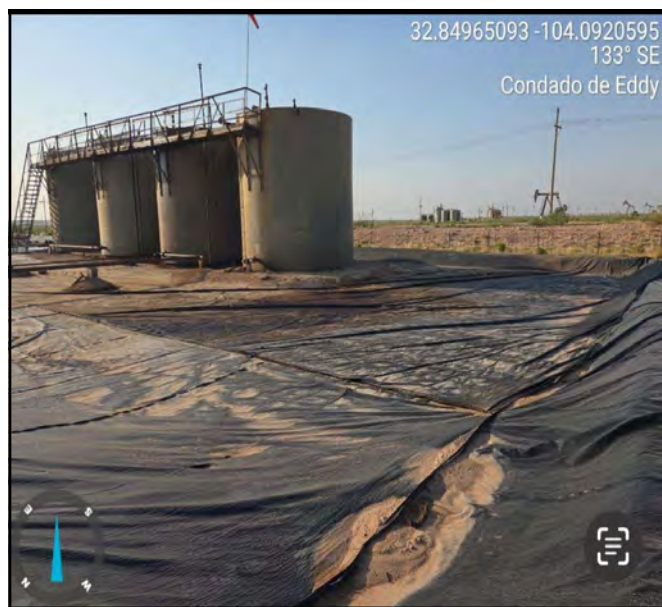
Photo of liner taken prior to power washing facing southeast.

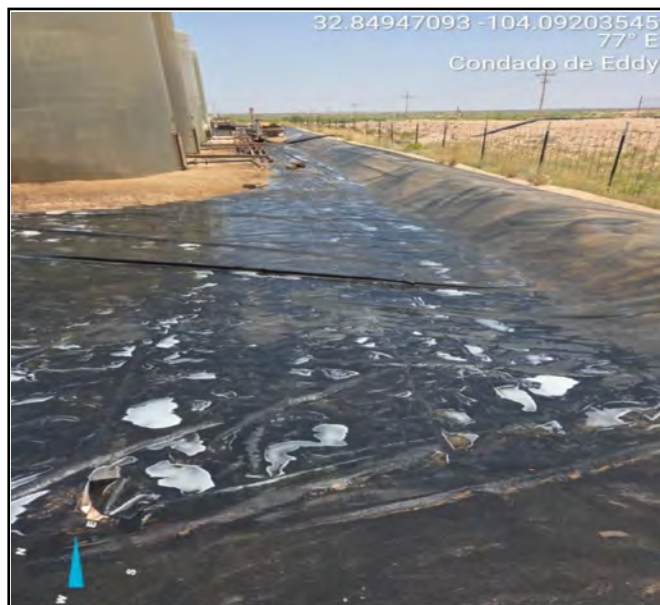
Photo of liner inspection post power wash facing east.

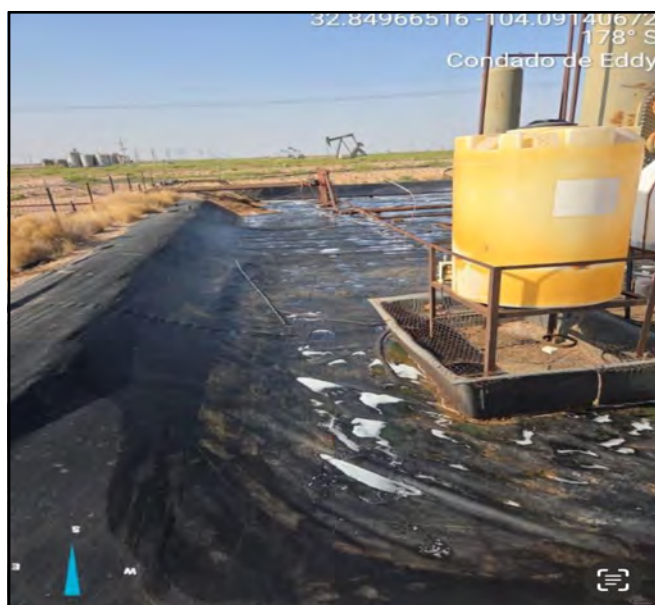
Photo of liner inspection post power wash facing south.

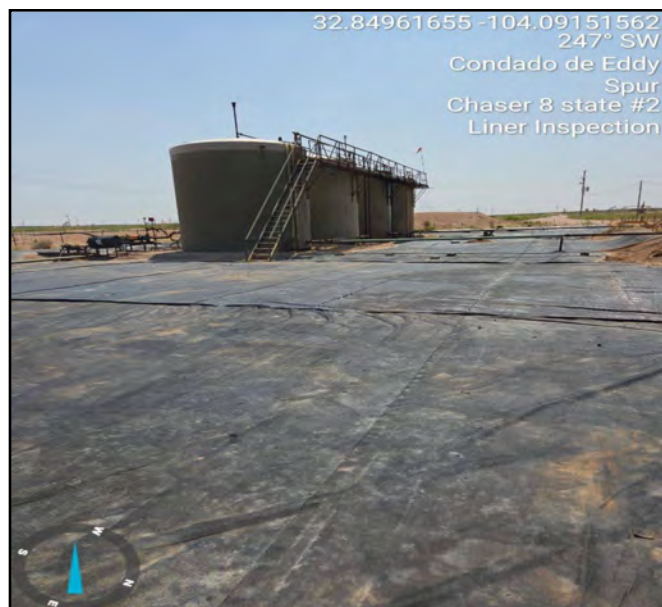
Photo of liner inspection post power wash facing southwest.

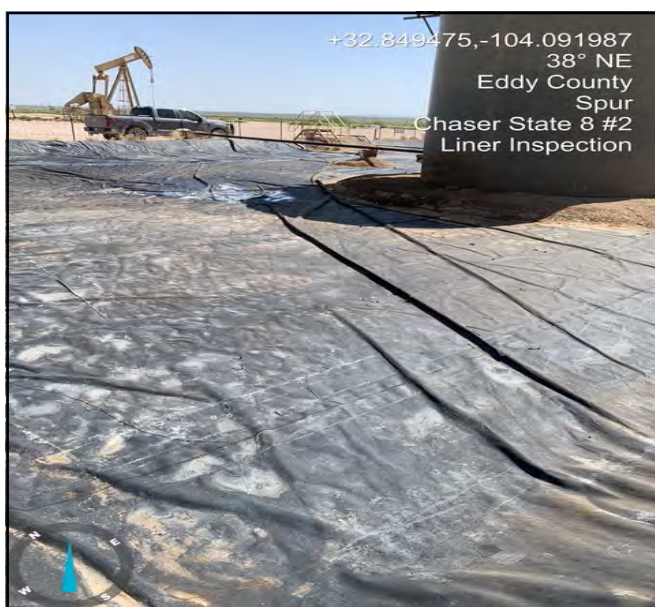
Photo of liner inspection post power wash facing northeast.

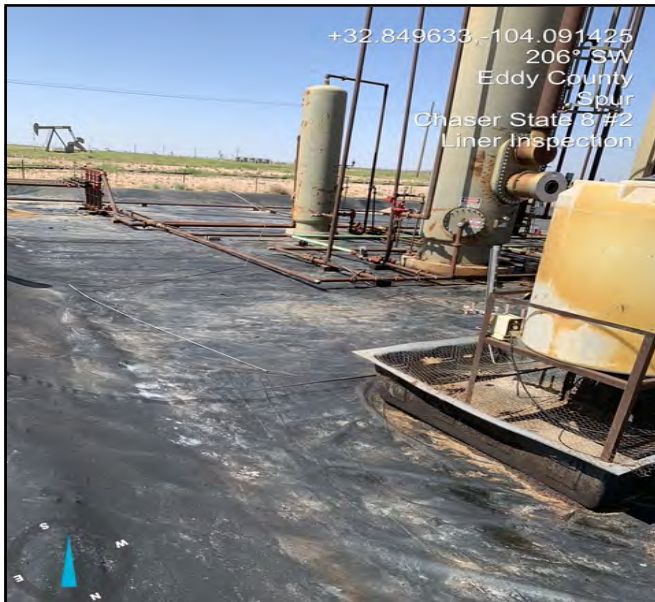
Photo of liner inspection post power wash facing southwest.
