PREPARED BY:  
PIMA ENVIRONMENTAL SERVICES, LLC

Chaser 8 State 2

Incident ID NAPP2515736465

## Liner Inspection and Closure Report

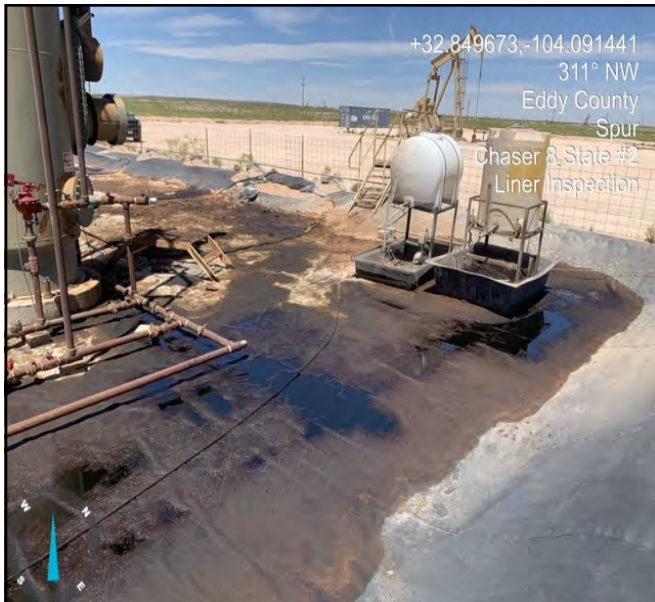
Photo of liner taken during initial site assessment facing northwest.

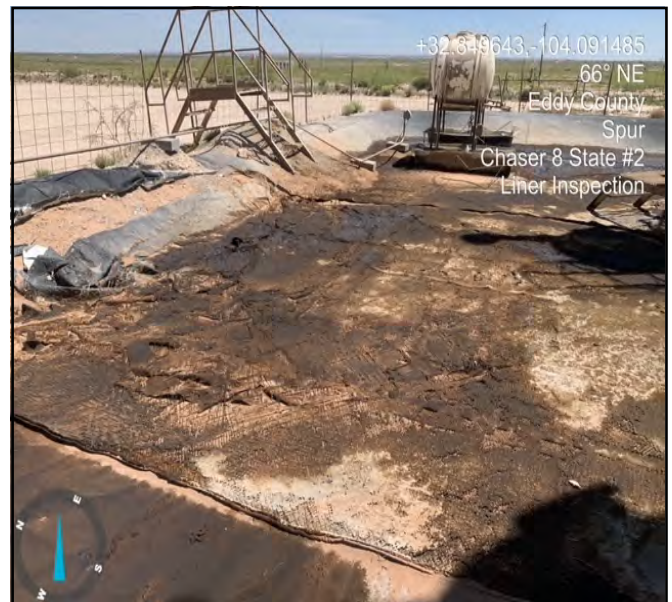
Photo of liner taken during initial site assessment facing northeast.
