Our Ref.: 12672651-NMOCD-1

September 12, 2025

Closure Report  
Devon Energy Production Company, LP  
White Dove 17 CTB 1  
Unit Letter N, Section 17, T23S, R34E  
GPS: 32.29941977, -103.4947387  
Lea County, New Mexico

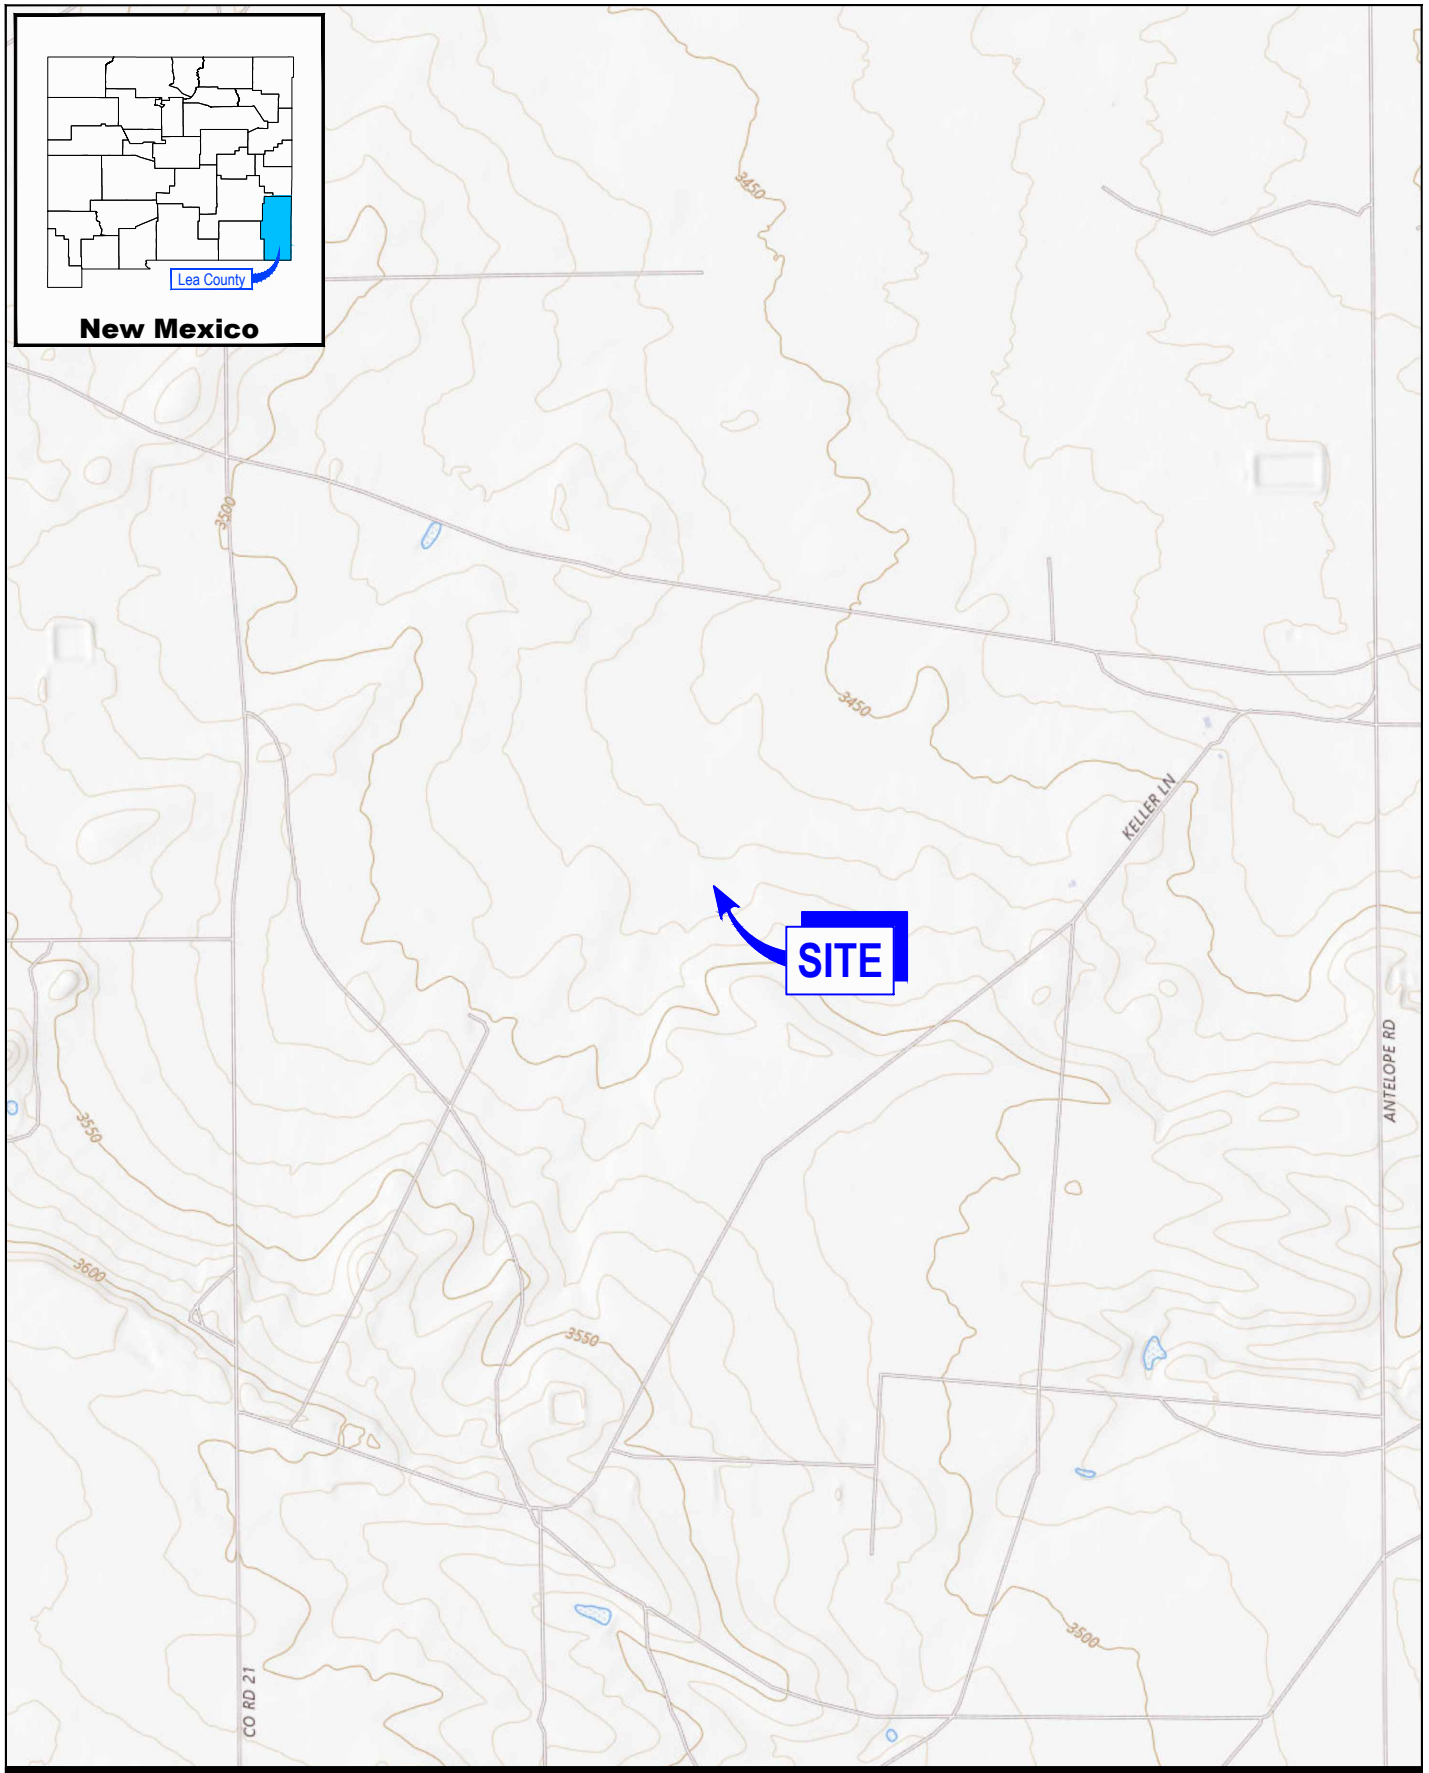
FIGURE 1

SITE LOCATION MAP

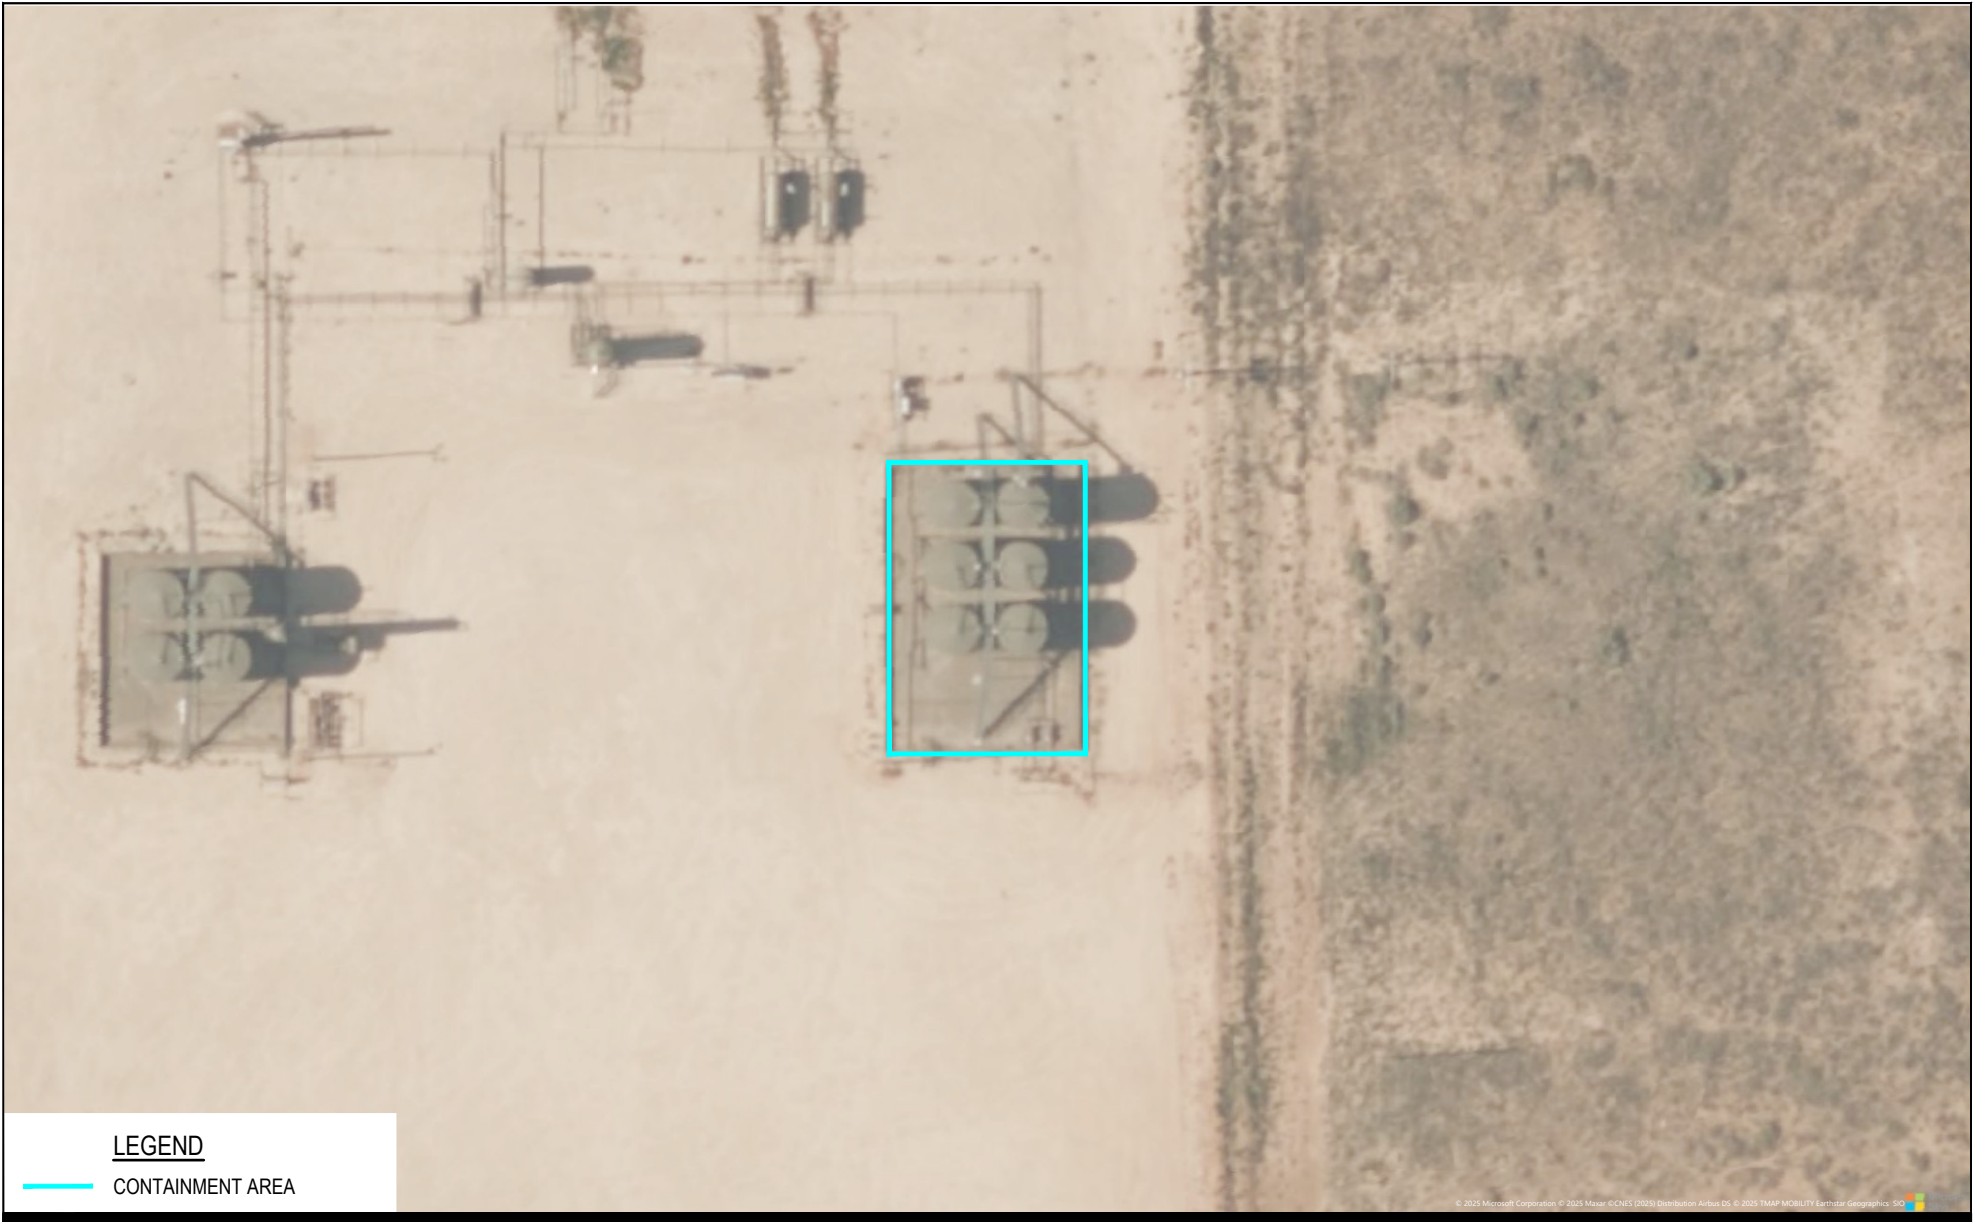
**FIGURE 2**

**SITE DETAILS MAP**

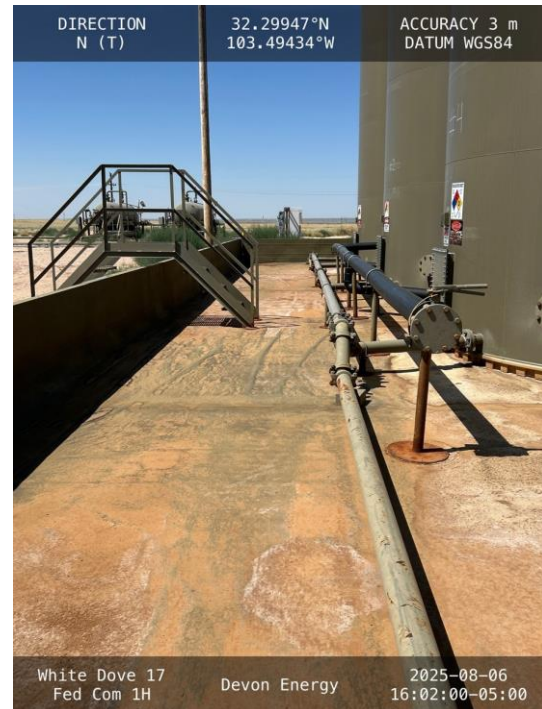
The liner inspection notice was provided on August 1, 2025. A liner integrity inspection was performed on August 6, 2025. The liner was visually inspected and no rips, tears, holes, or damages in the liner was observed. The liner was determined to be intact with no integrity issues. Photographic documentation of the liner inspection is presented in **Attachment 3**.

Photo 2 View of western portion of containment facing north.

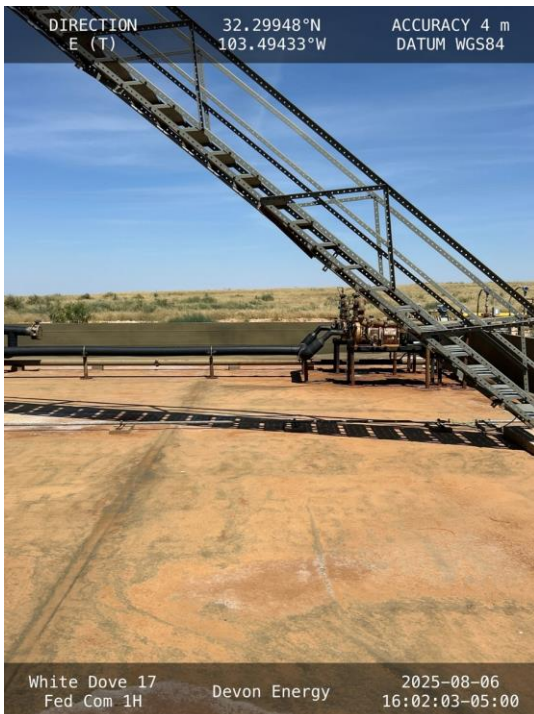
Photo 3 View of southern portion of containment facing east.

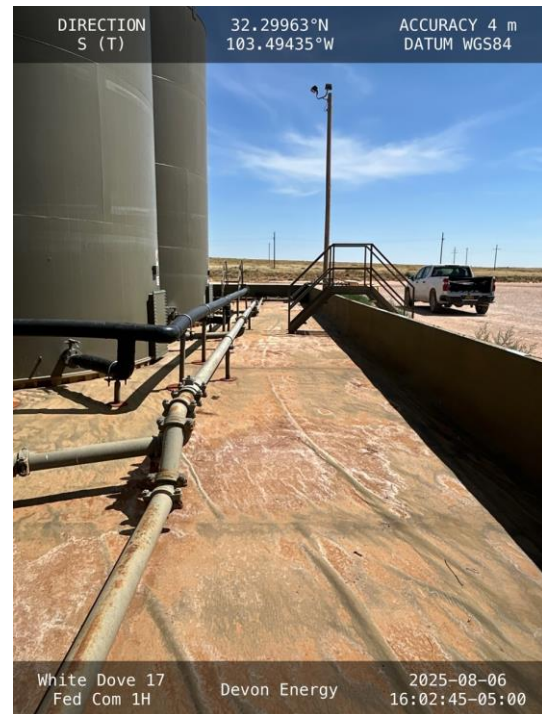
Photo 4 View of western portion of containment facing south.

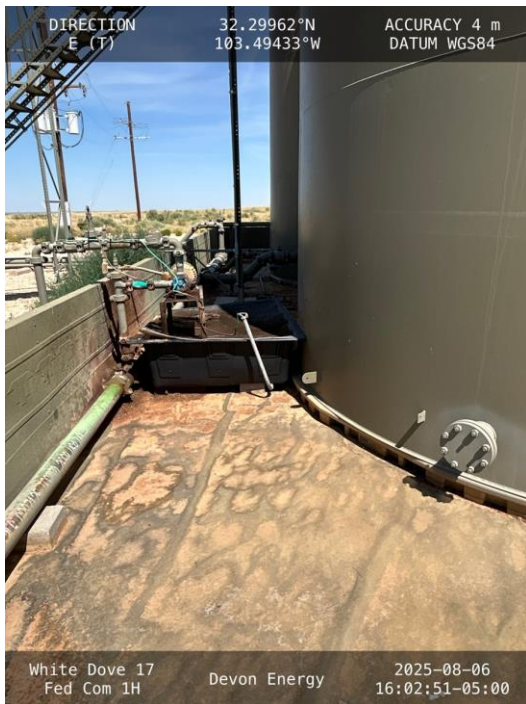
**Photo 5** View of northern portion of containment facing east.

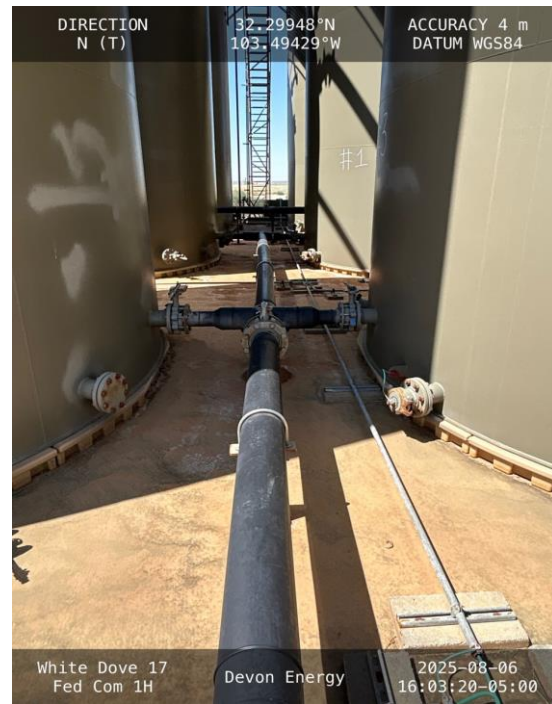
**Photo 6** View of central portion of containment facing north.

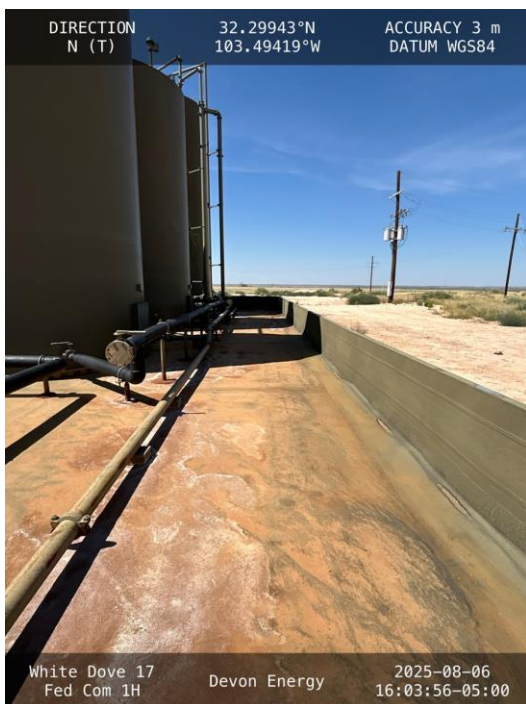
**Photo 7** View of eastern portion of containment facing north.

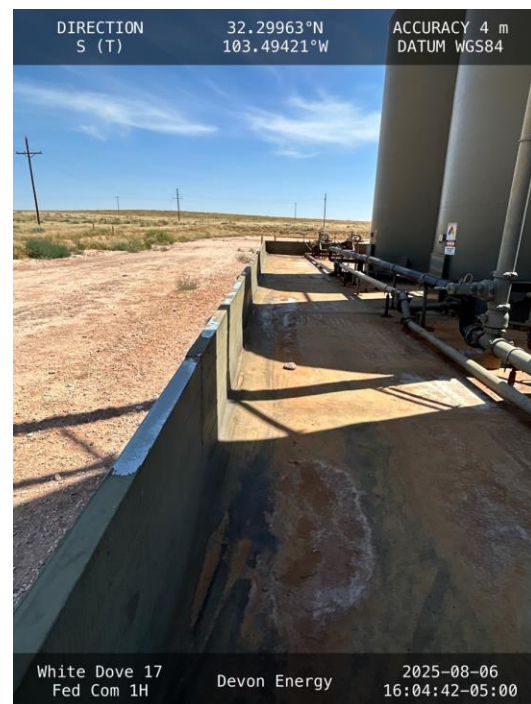
**Photo 8** View of eastern portion of containment facing south.
