HALBERD 27 STATE 3H TB

Incident ID nAPP2523833191

PREPARED BY:  
PIMA ENVIRONMENTAL SERVICES, LLC

## Liner Inspection and Closure Report

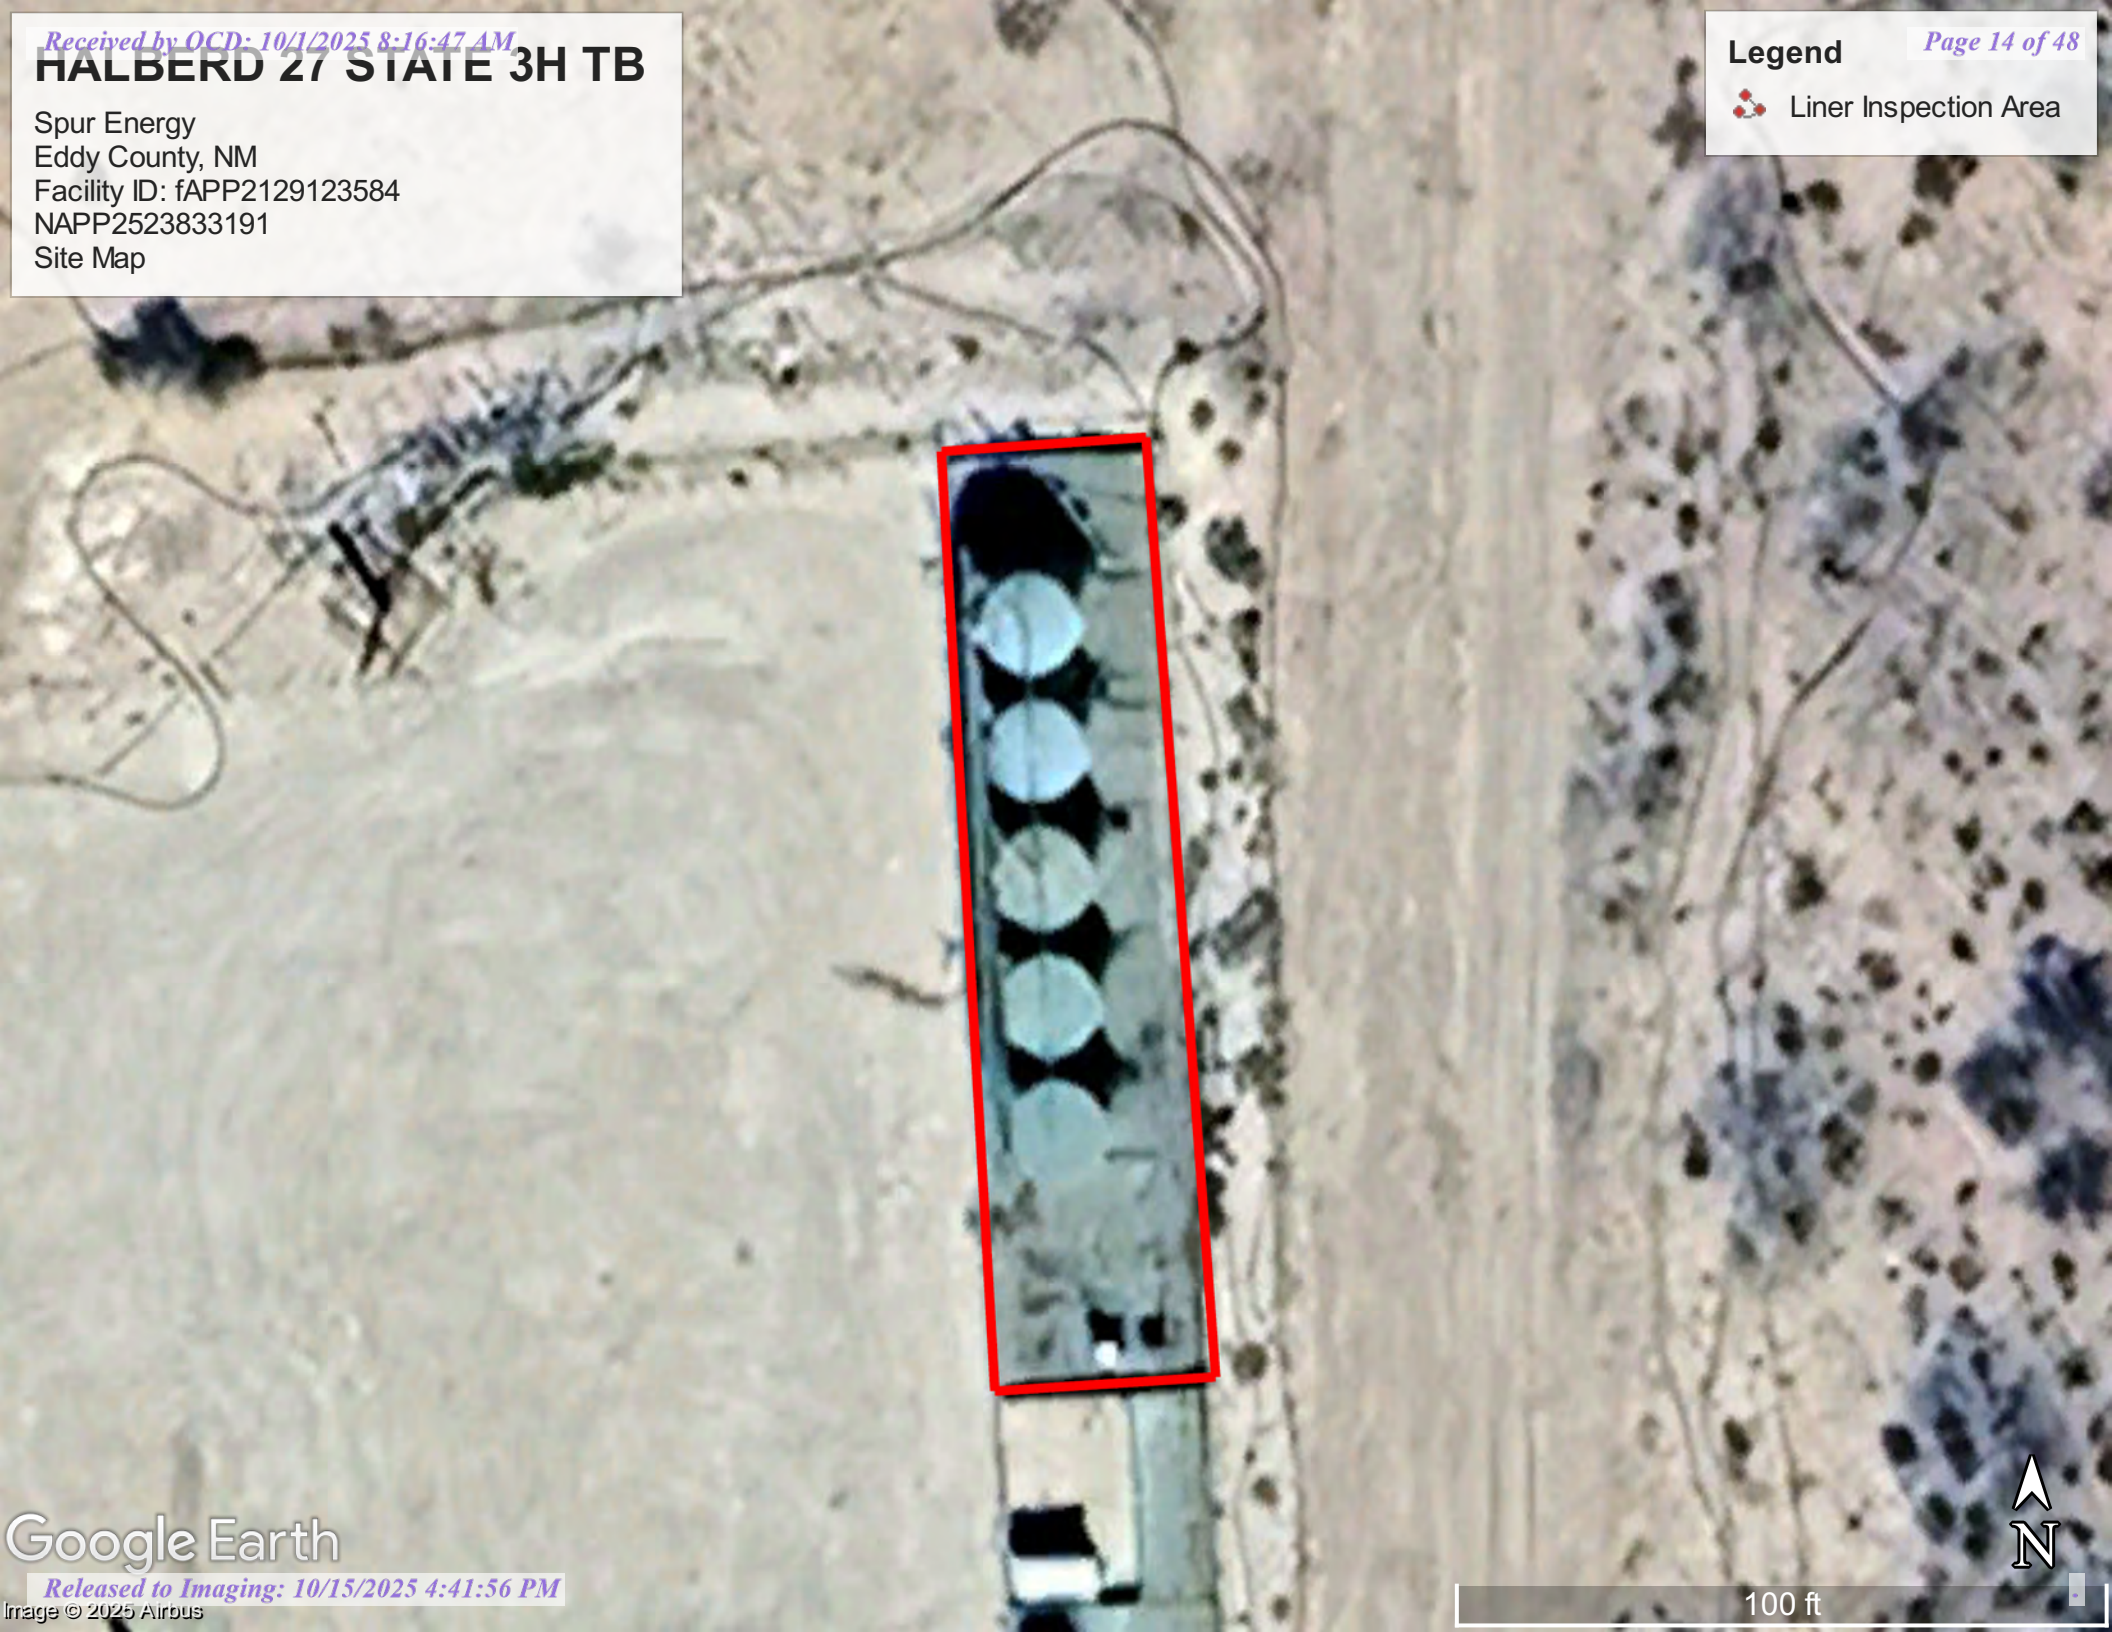
Figure 4- Site Map

**nAPP2523833191:** On August 23, 2025, a pinhole leak in a flow line released approximately 20 barrels of crude oil into the lined containment. Spur personnel promptly responded and successfully recovered the entire volume using a vacuum truck. A site map is provided in Figure 4 for reference.

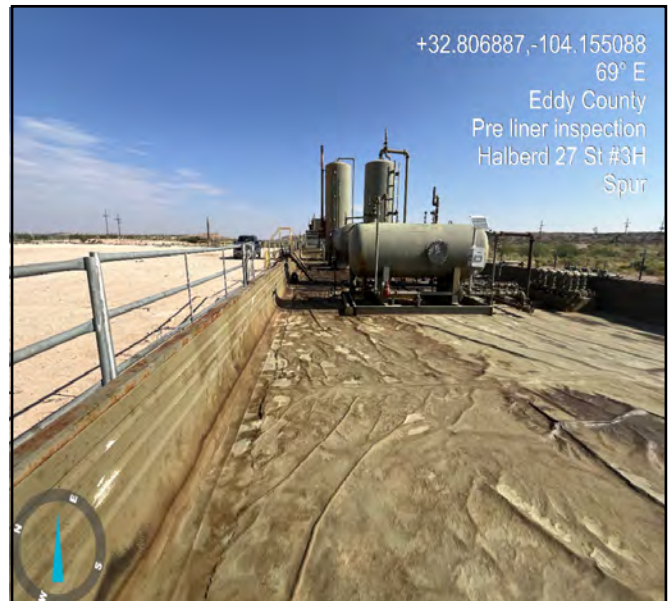
Photo of liner taken during initial liner inspection facing east

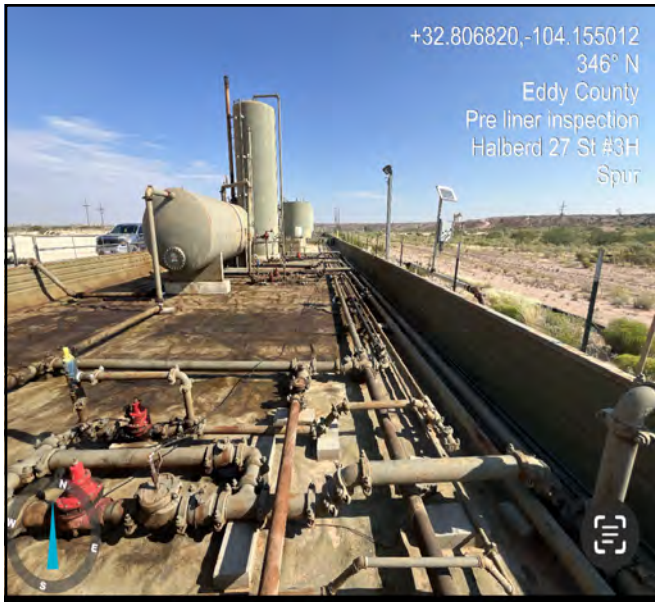
Photo of liner taken during initial liner inspection facing north.

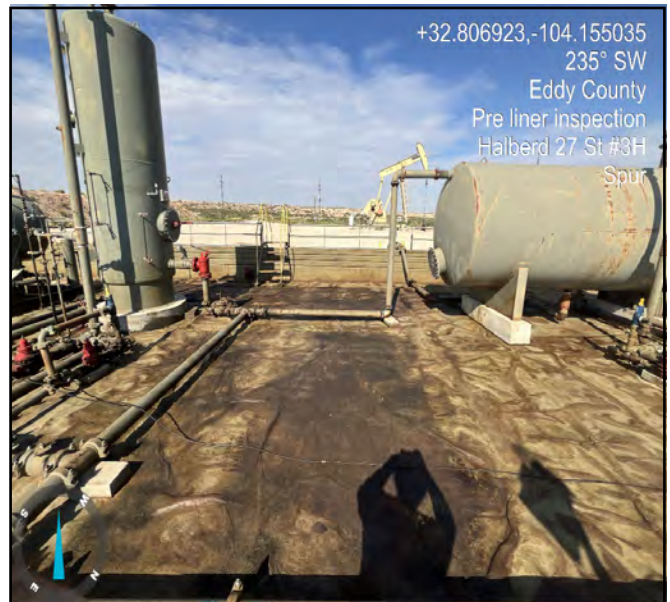
Photo of liner taken during initial liner inspection facing southwest.

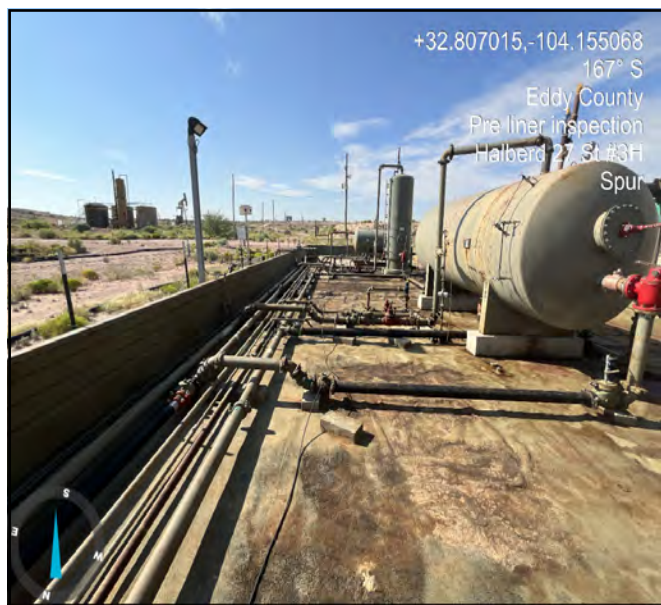
Photo of liner taken during initial liner inspection facing south.

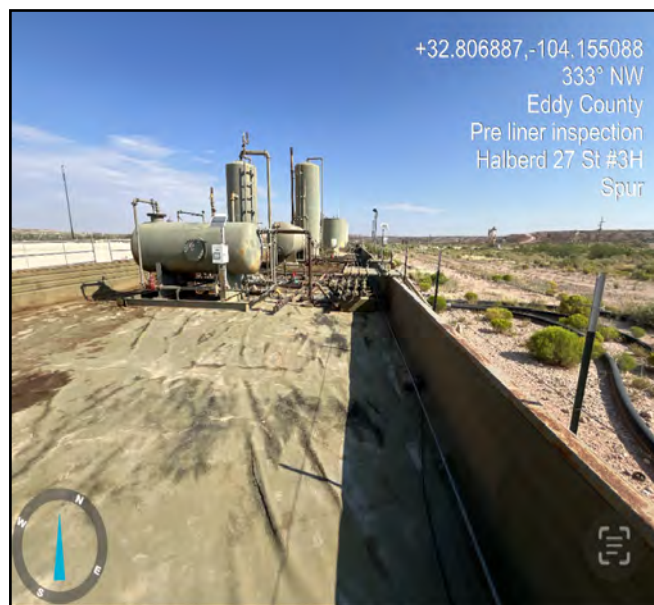
Photo of liner taken during initial liner inspection facing northwest.

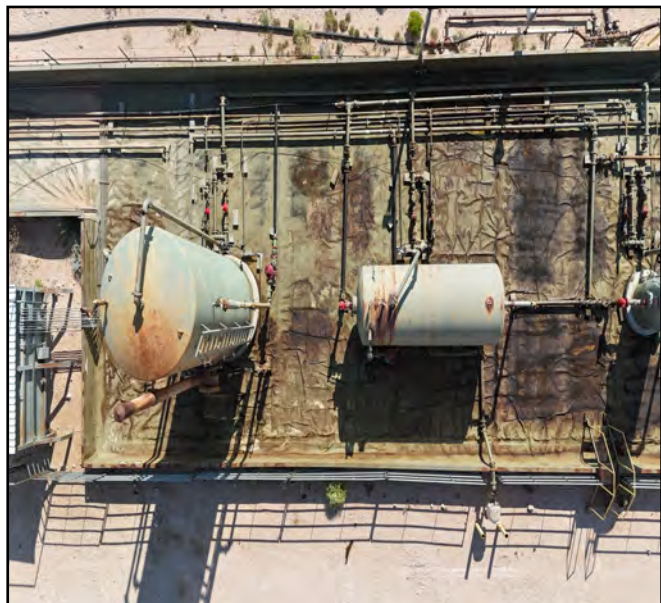
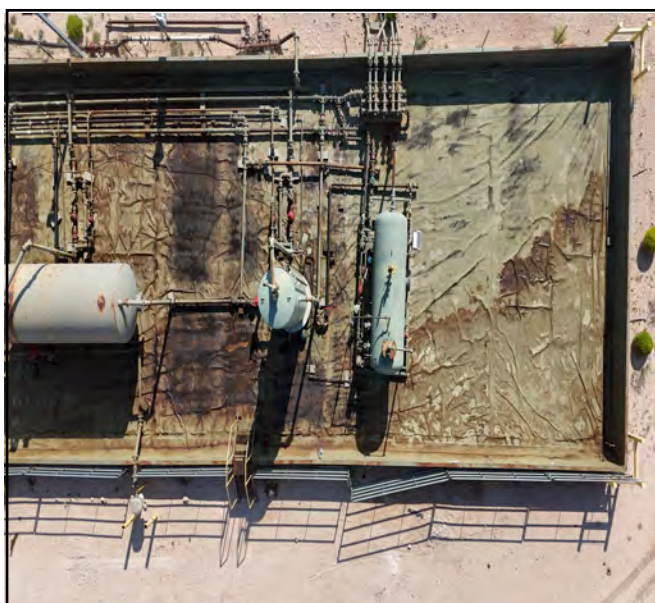
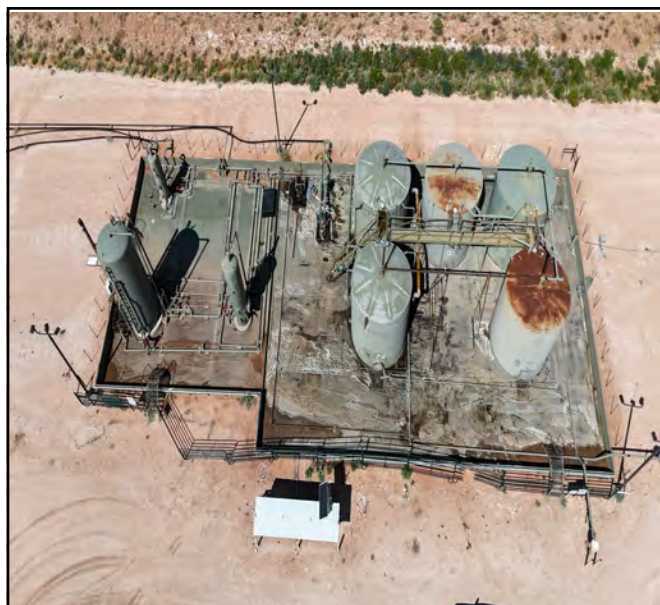
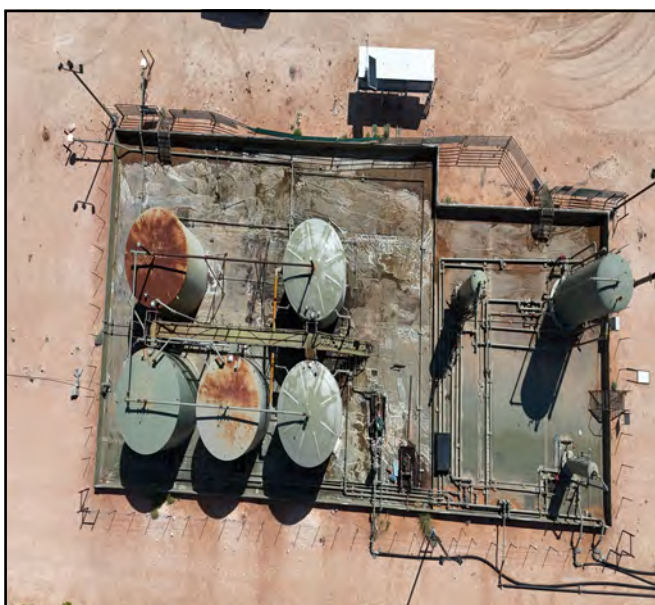
Pre Powerwash aerial photos.

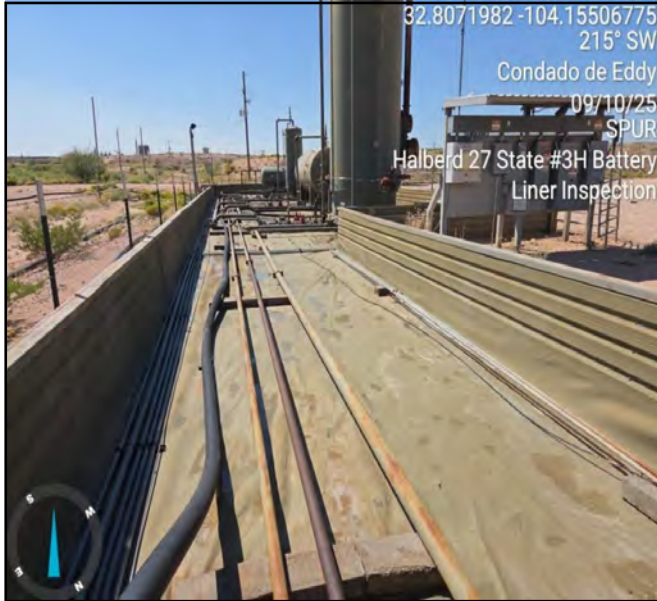
Photo of location taken post power wash facing southwest.

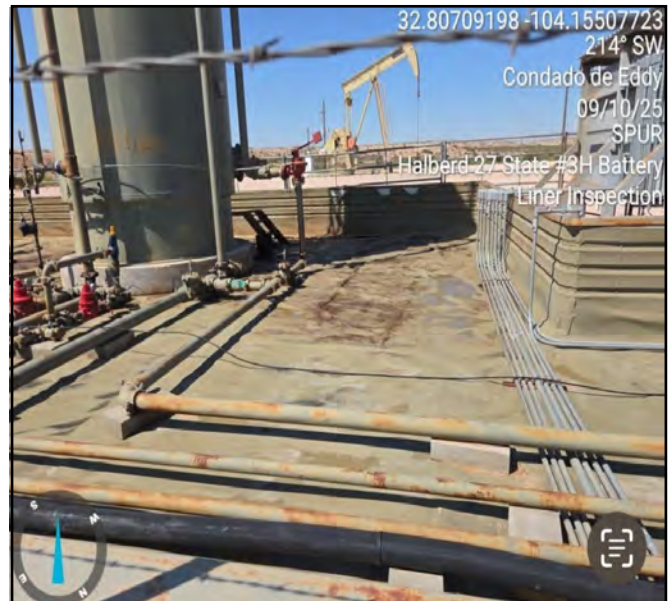
Photo of location taken post power wash facing southwest.

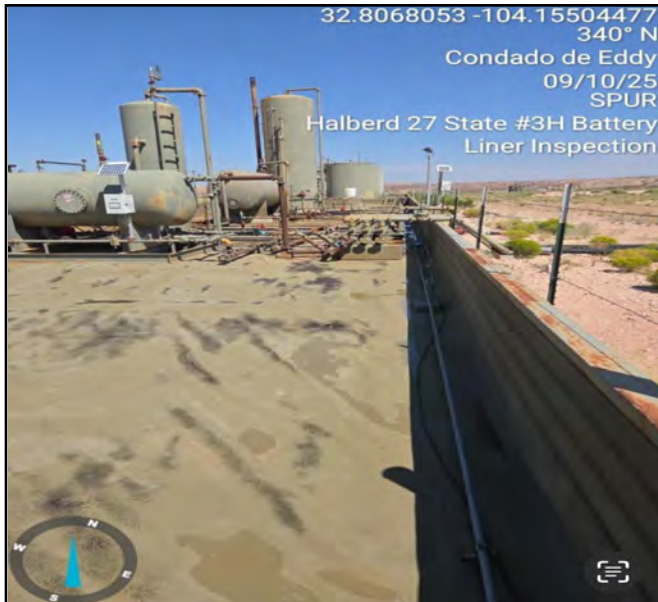
Photo of location taken post power wash facing north.

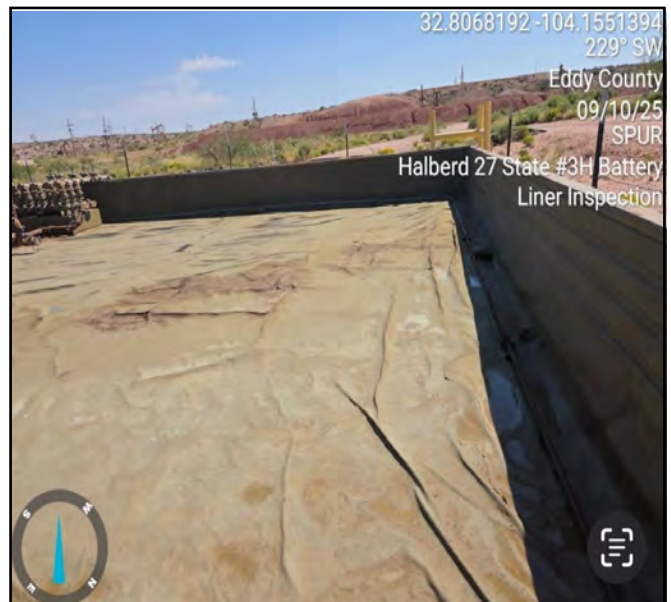
Photo of location taken post power wash facing southwest.
