Our ref.: 12670290-NMOCD-1

September 29, 2025

Closure Report
Devon Energy Production Company, LP
Jayhawk 6 CTB 2
Unit Letter C, Section 06, T26S, R34E
GPS: 32.07629704, -103.51193
Lea County, New Mexico

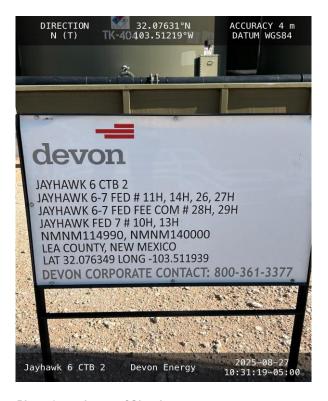
Photo 1 Image of Site signage.

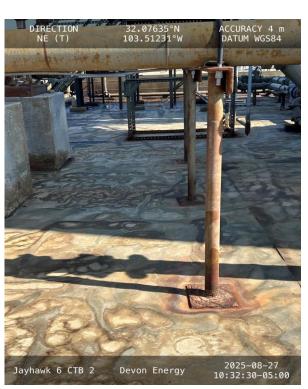
Photo 2 View of western portion of secondary containment facing north.

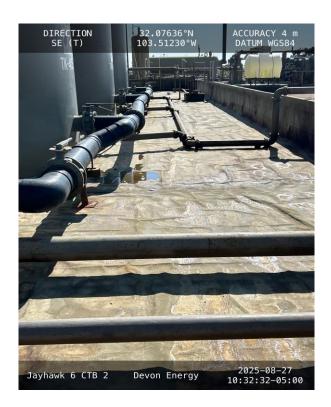
Photo 3 View of southern portion of secondary containment facing southeast.

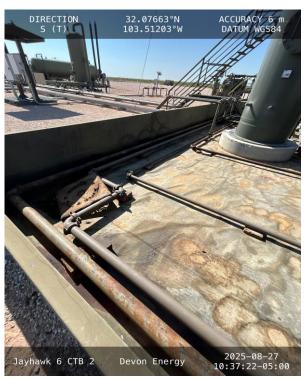
Photo 4 View of northeast corner of secondary containment.

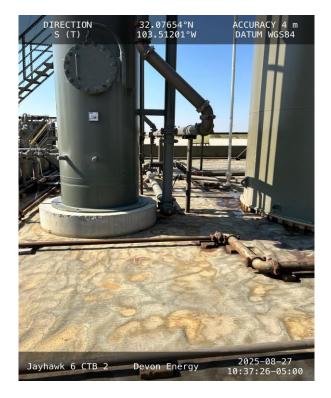
Photo 5 View of eastern portion of secondary containment towards south.

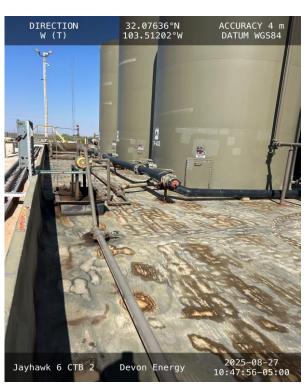
Photo 6 View of southern portion of secondary containment facing west.

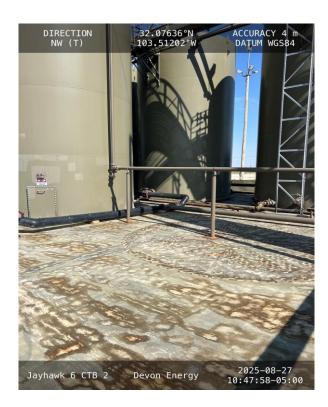
Photo 7 View towards central portion of secondary containment.

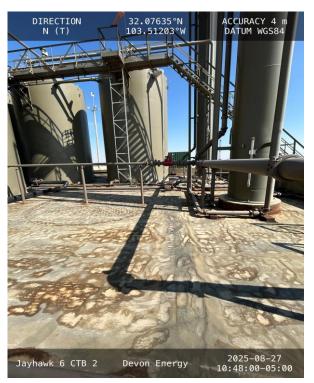
Photo 8 View of eastern portion of secondary containment facing north.

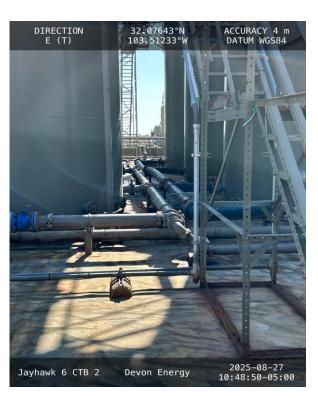
Photo 10 View of central portion of secondary containment facing east.
