PREPARED BY:  
PIMA ENVIRONMENTAL SERVICES, LLC

PREPARED FOR:  
Spur Energy

Taylor D 3 Battery  
Incident ID nAPP2522539609

## Liner Inspection and Closure Report

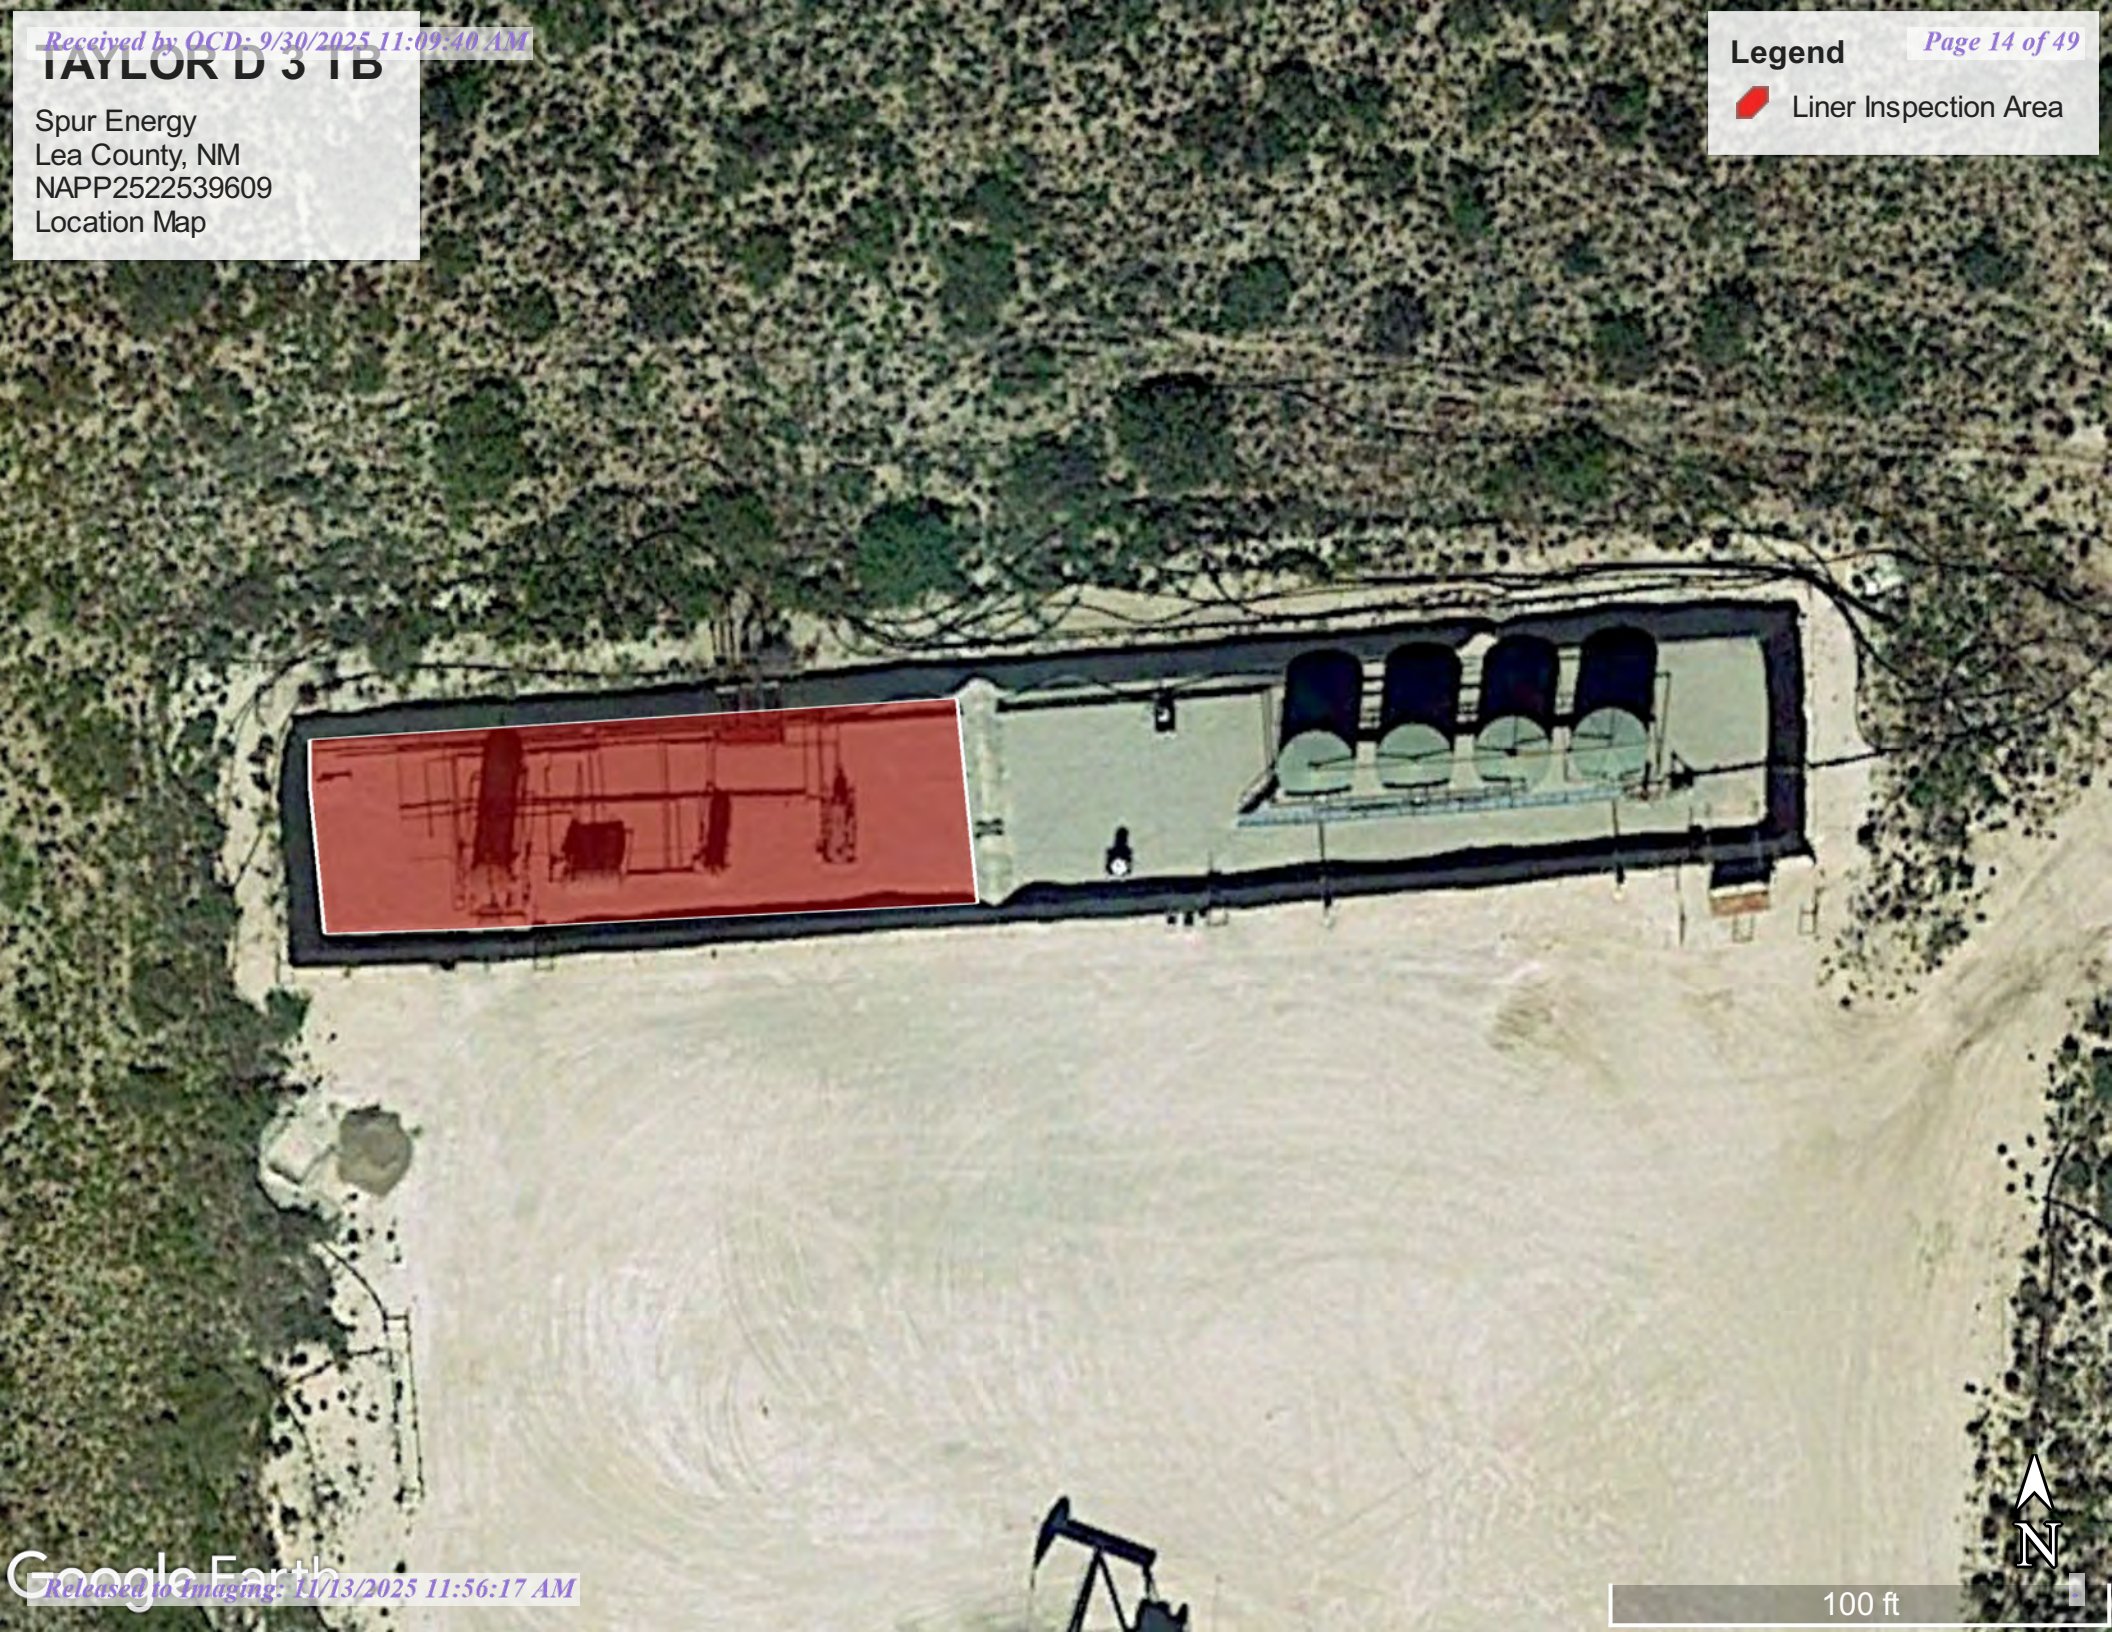
Figure 4- Site Map

**nAPP2522539609:** On August 3, 2025, a heater treater line developed a hole, resulting in the release of approximately 3 barrels of crude oil and 20 barrels of produced water into the lined containment area. Spur personnel promptly responded to the incident and successfully recovered the entire volume of released fluids using a vacuum truck. A site map is provided in Figure 4 for reference.

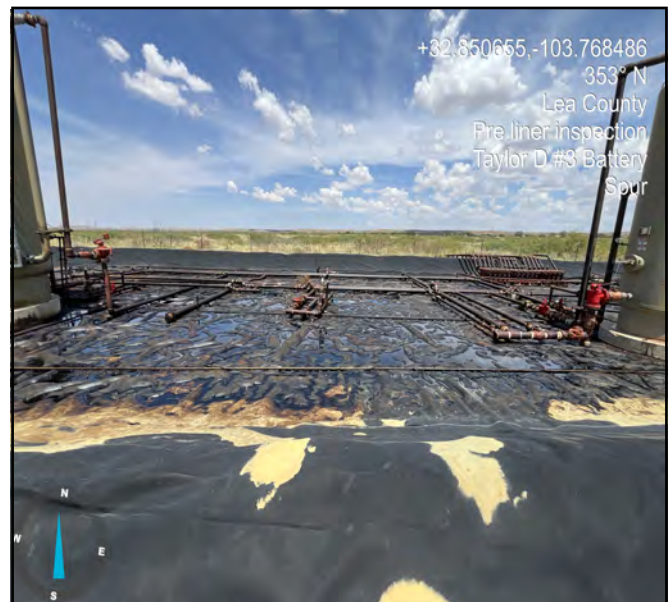
Photo of liner taken during initial liner inspection facing north.

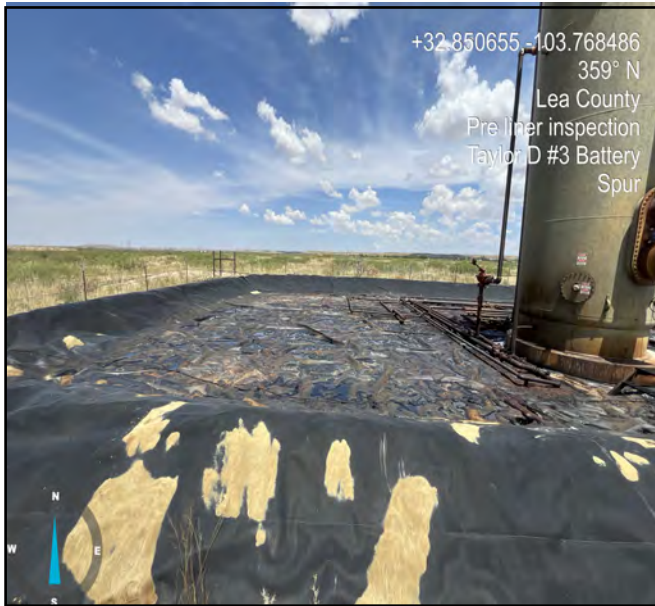
Photo of liner taken during initial liner inspection facing north.

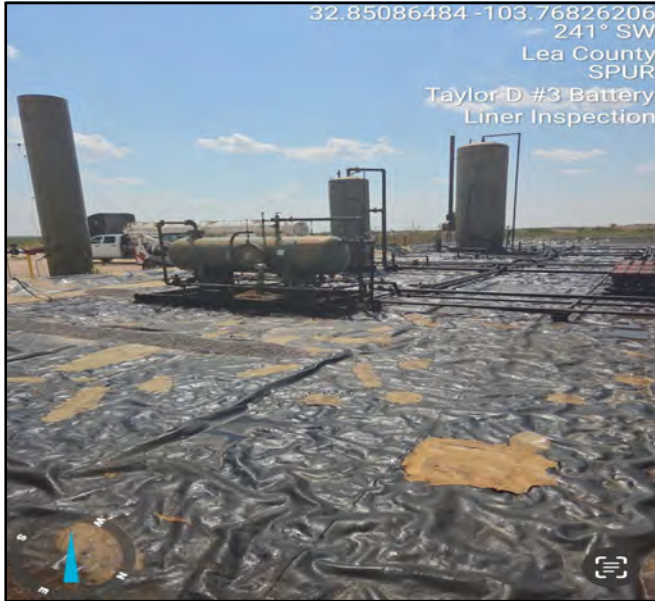
Photo of location taken post power wash facing southwest.

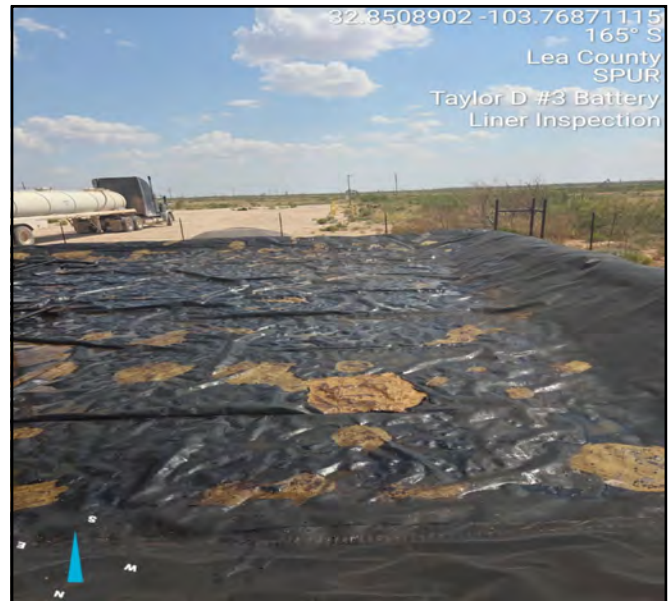
Photo of location taken post power wash facing southwest.

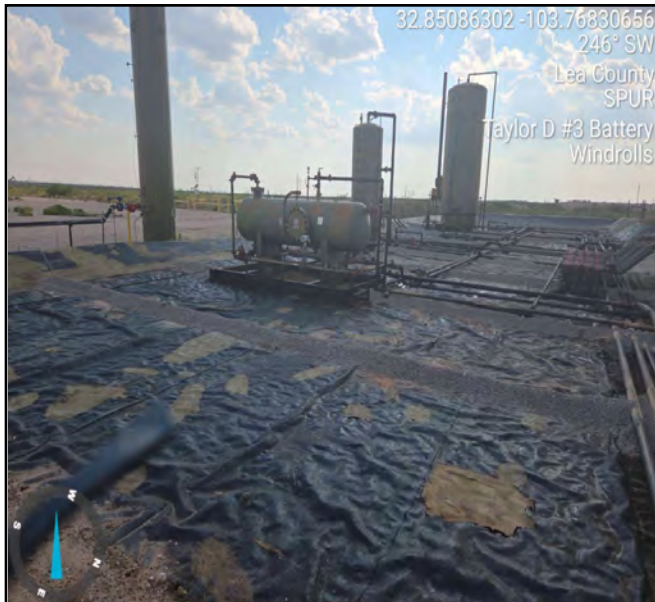
Photo of location taken after windrolls were laid facing southwest.

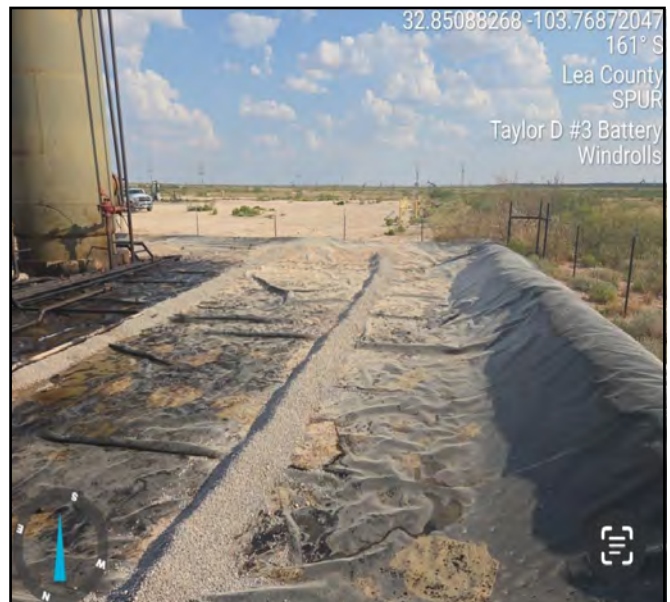
Photo of location taken after windrolls were laid facing south.
