Red Skies 10 Fed Com TB

Incident ID nAPP2524531404

## Liner Inspection and Closure Report

October 14, 2025

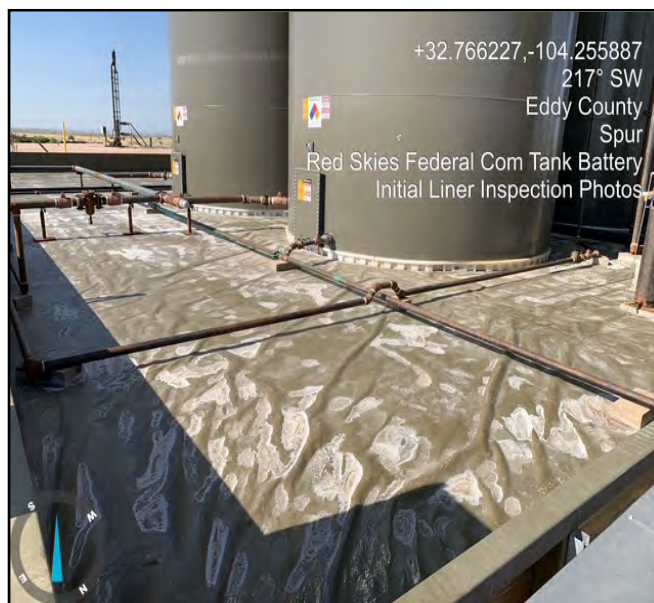
Photo of liner taken during initial liner inspection facing southwest.

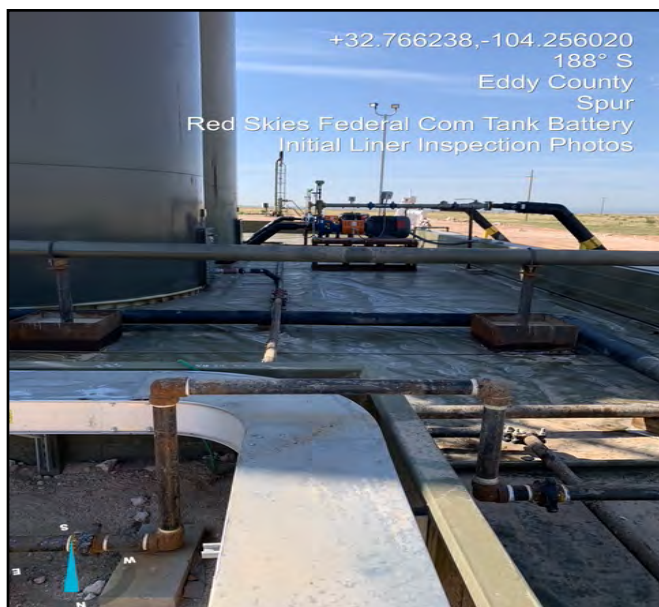
Photo of liner taken during initial liner inspection facing south.

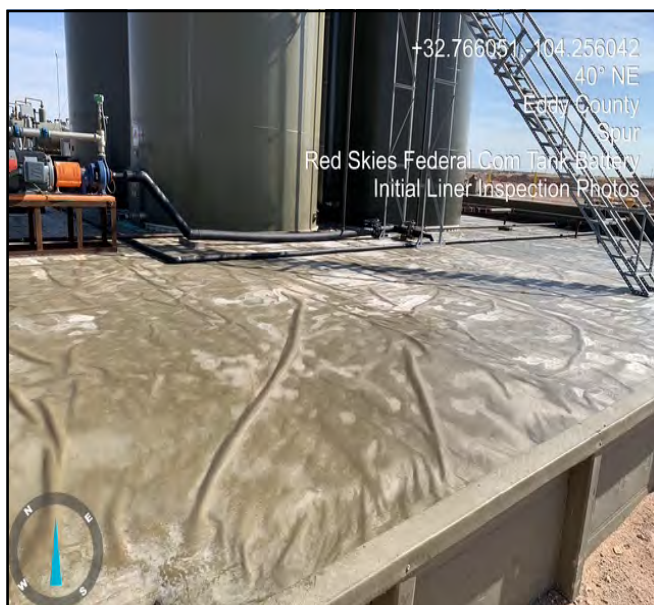
Photo of liner taken during initial liner inspection facing northeast.

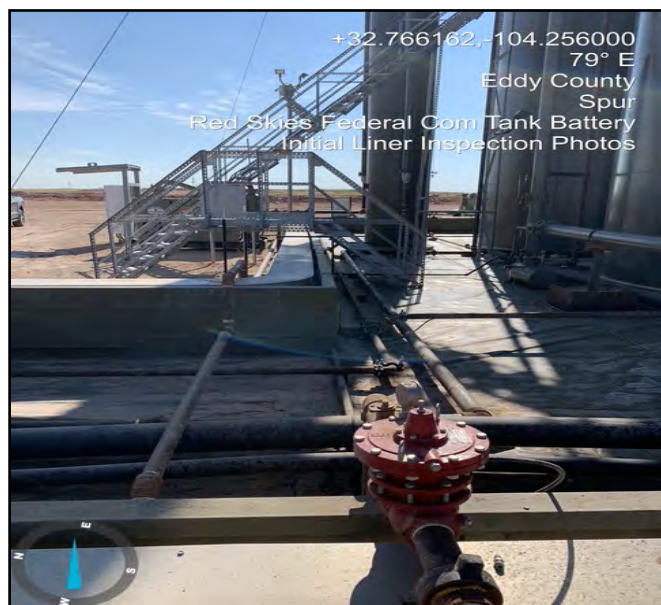
Photo of liner taken during initial liner inspection facing east.

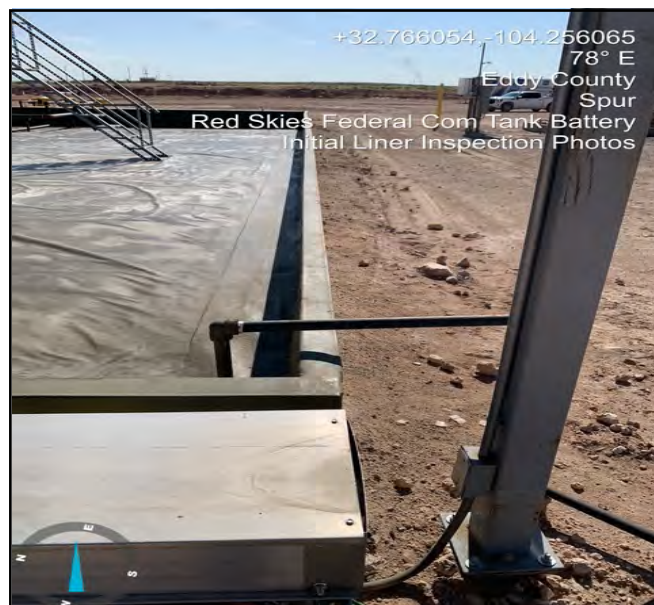
Photo of liner taken during initial liner inspection facing east.

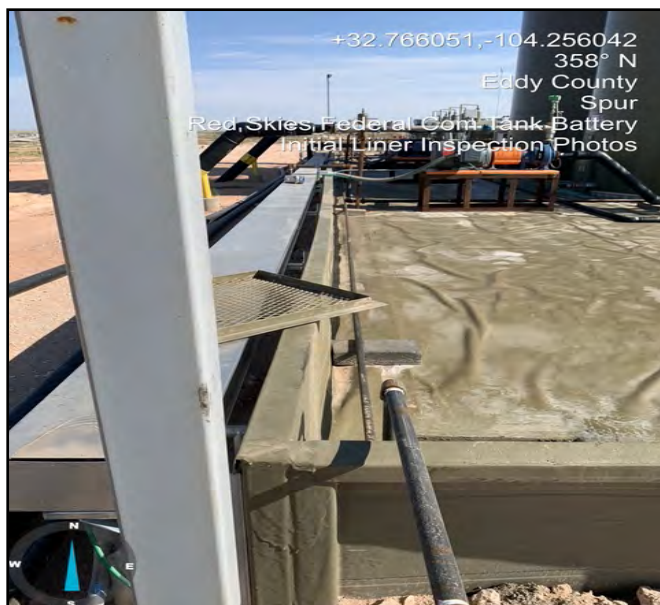
Photo of liner taken during initial liner inspection facing north.

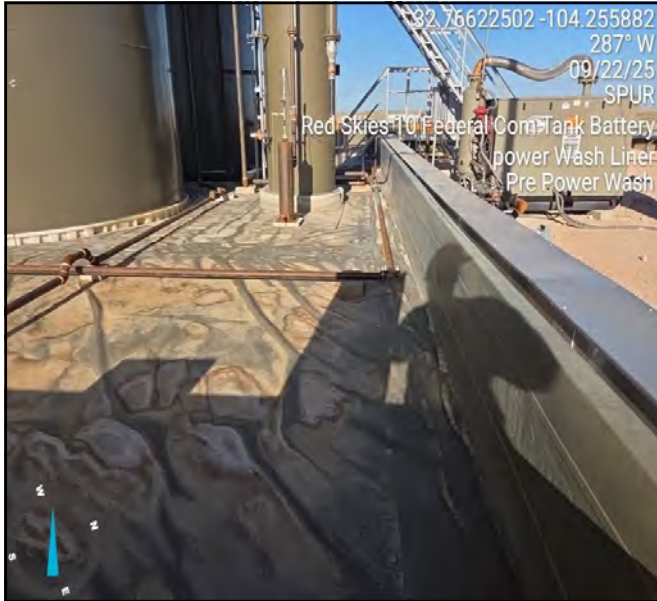
Photograph taken pre power-wash process facing west.

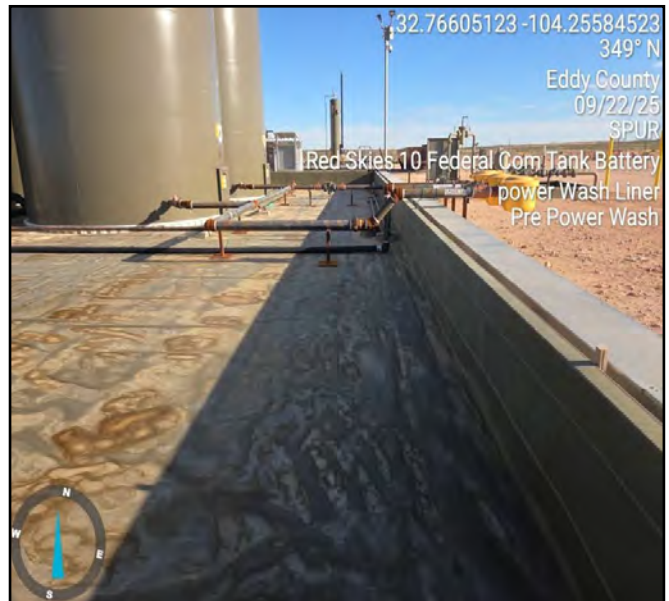
Photograph taken pre power-wash process facing north.

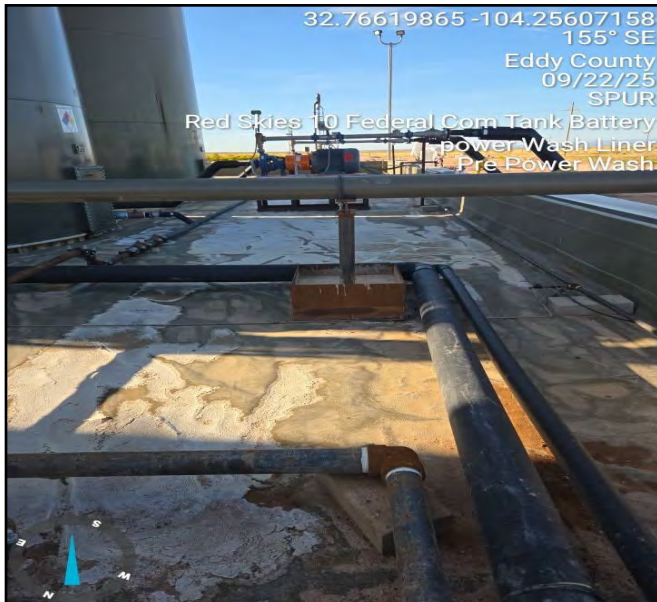
Photograph taken pre power-wash process facing southeast.

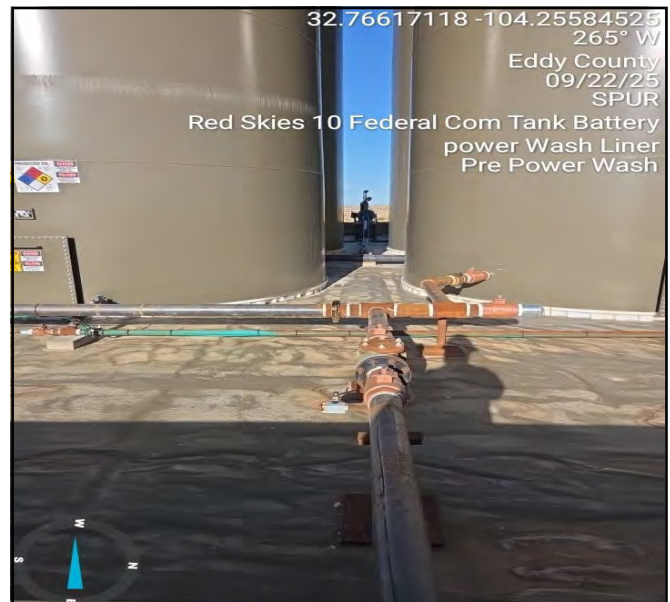
Photograph taken pre power-wash process facing west.

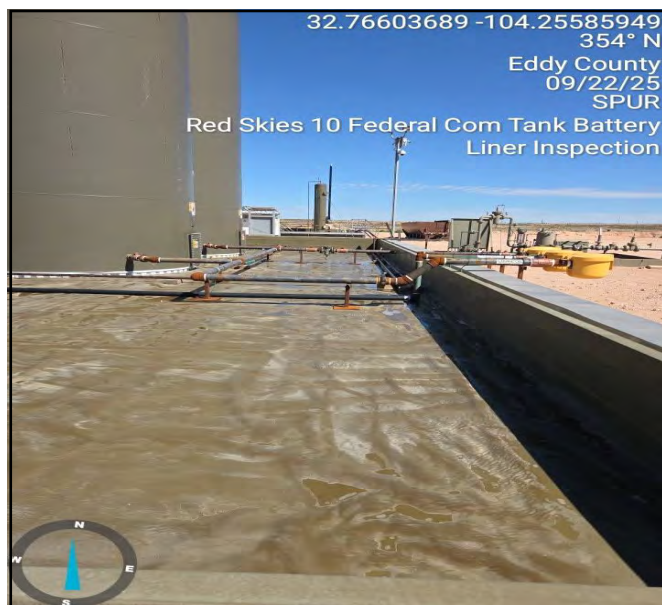
Photo of location taken post power wash facing north.

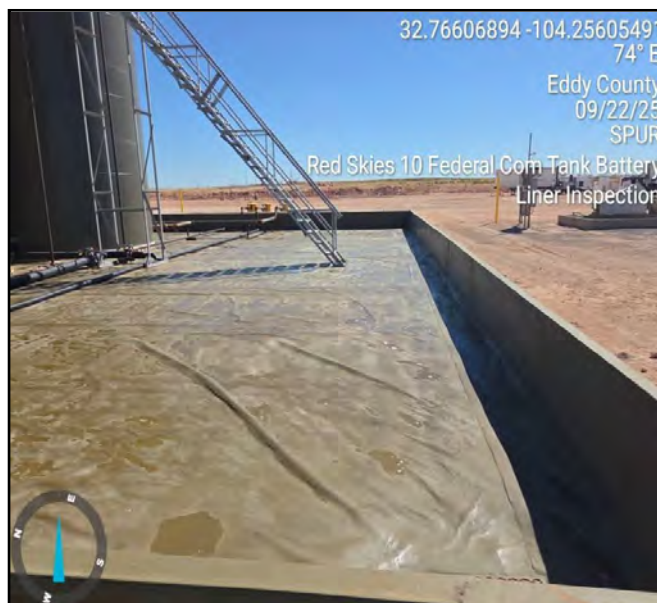
Photo of location taken post power wash facing east.

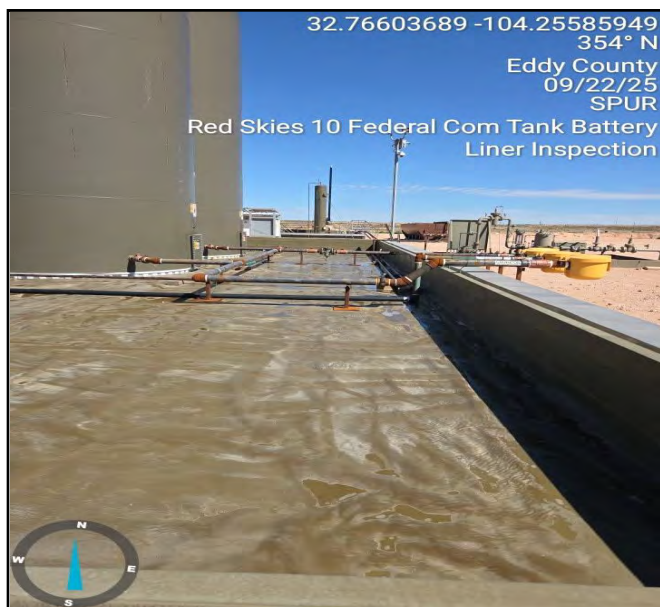
Photo of location taken post power wash facing north.

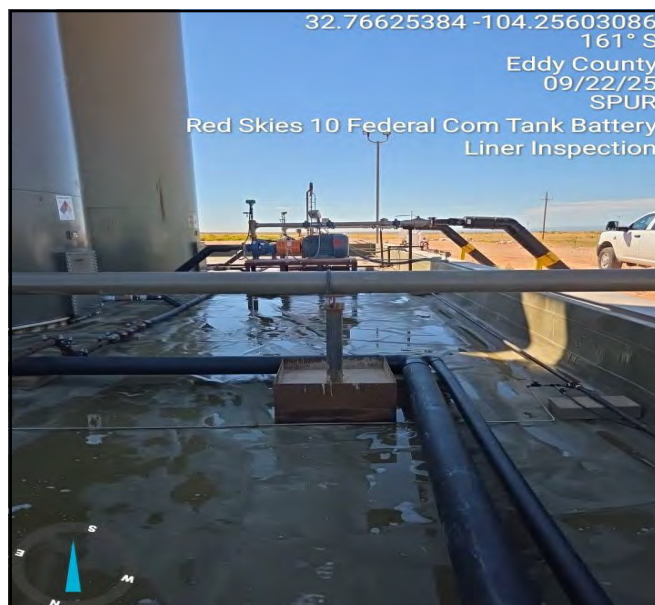
Photo of location taken post power wash facing south.

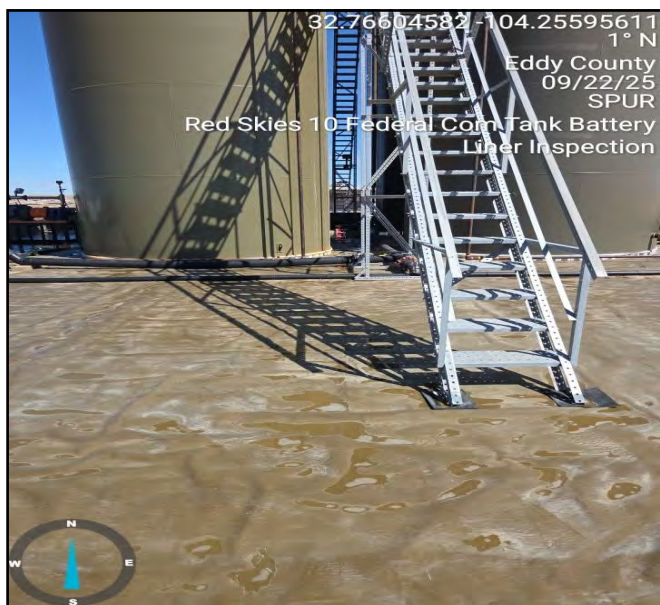
Photo of location taken post power wash facing north.

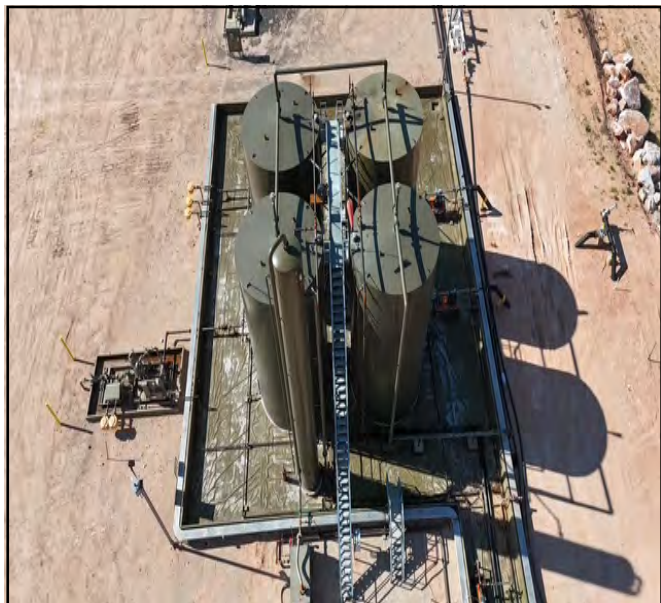
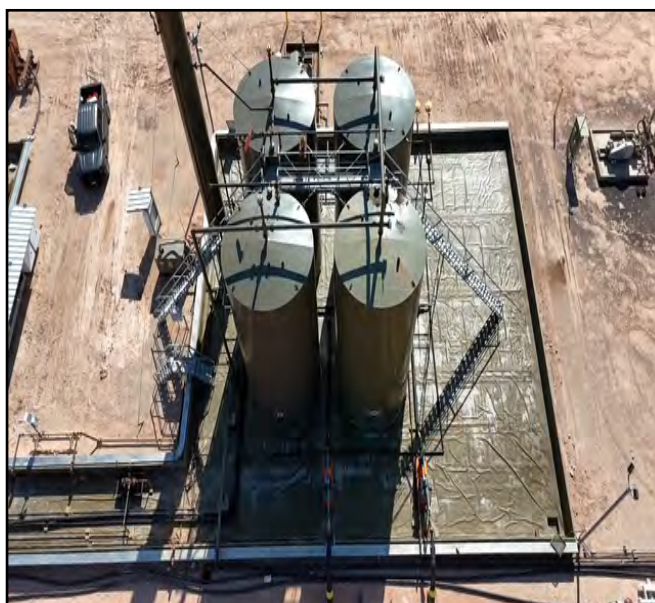
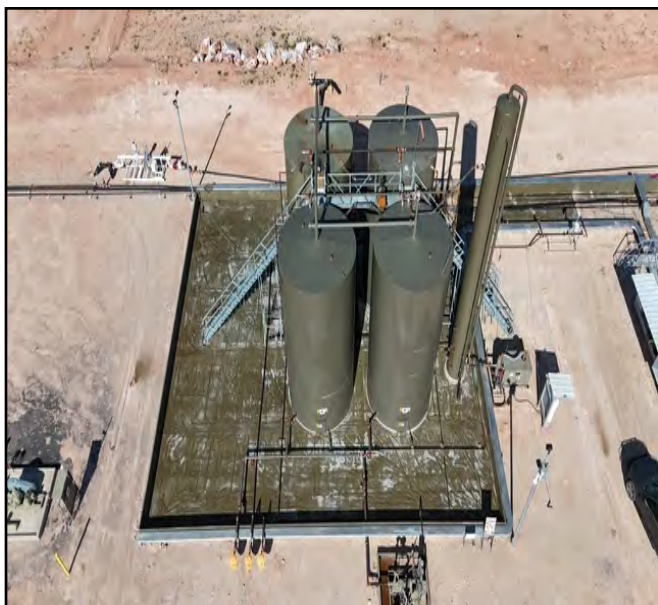
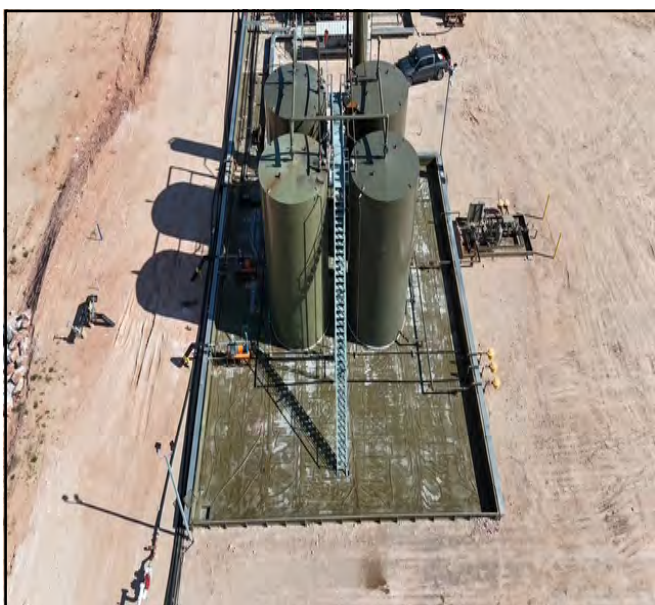
Aerial photos taken before powerwash.
