RONCO FEDERAL #1

Incident ID NAPP2523335077

Liner Inspection and Closure Report

September 22, 2025

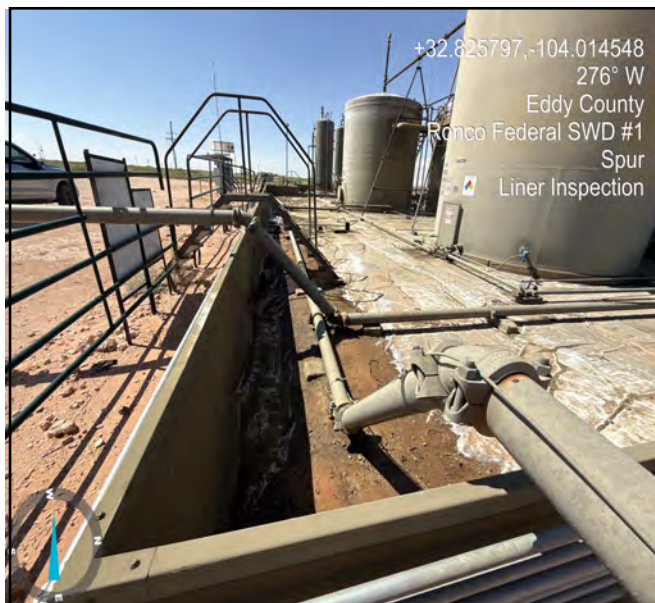
Photo of liner taken during initial liner inspection facing west.

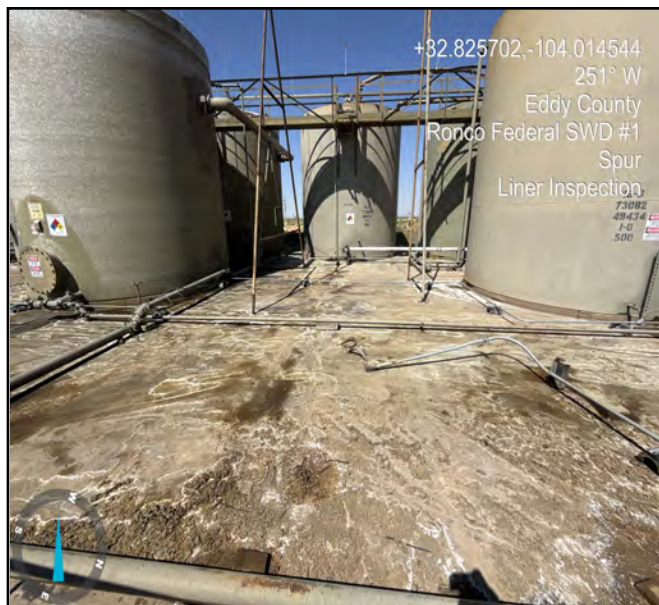
Photo of liner taken during initial liner inspection facing west.

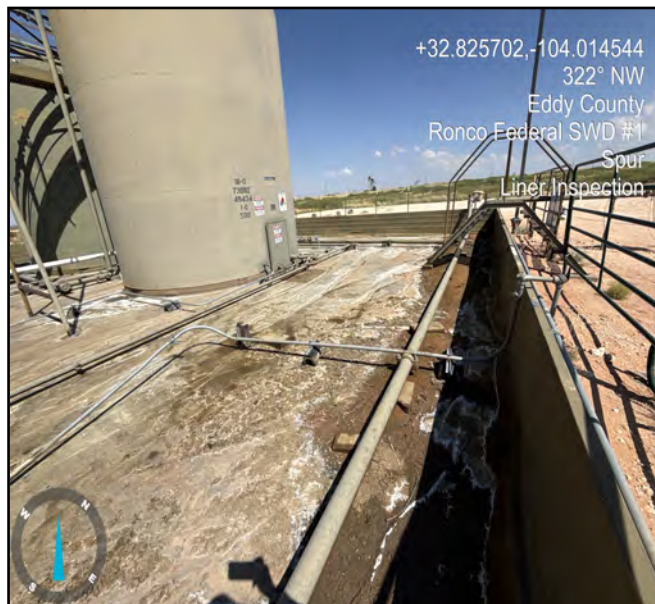
Photo of liner taken during initial liner inspection facing northwest.

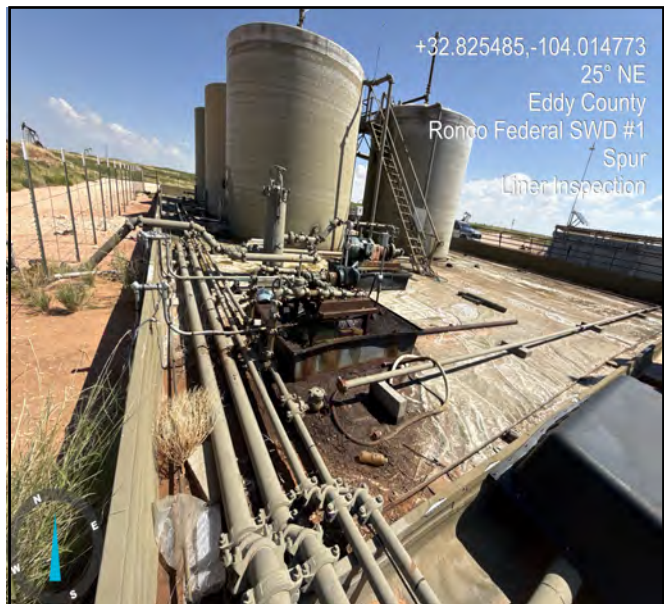
Photo of liner taken during initial liner inspection facing northeast.

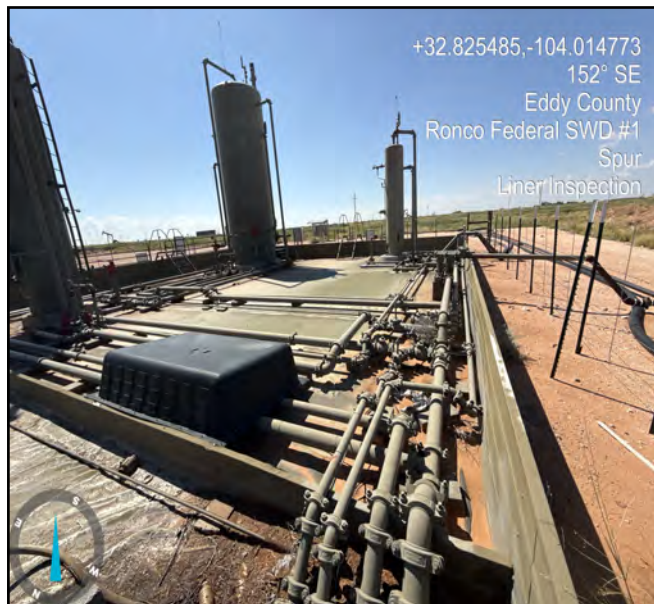
Photo of liner taken during initial liner inspection facing southeast.

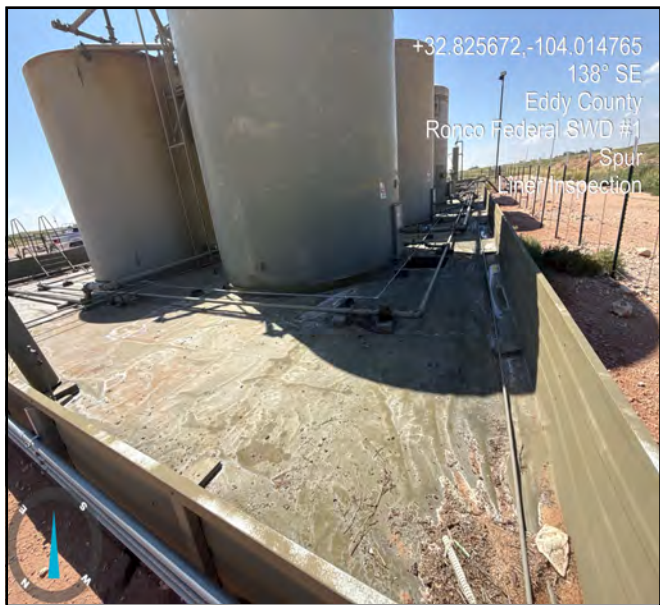
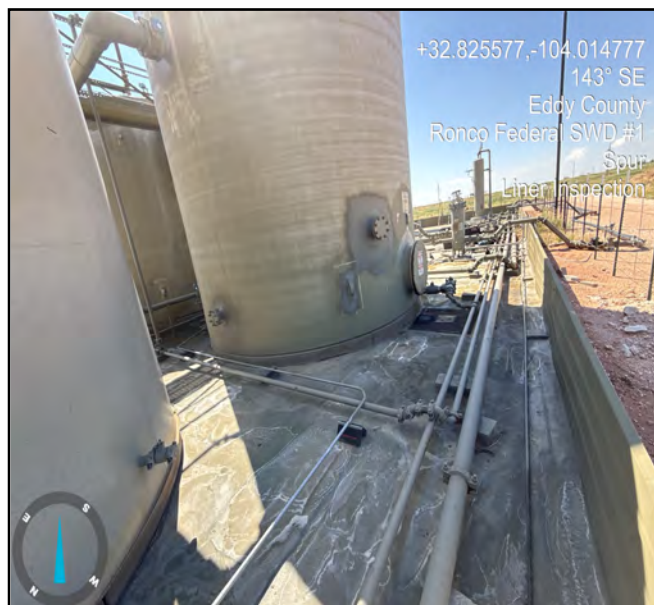
Photo of liner taken during initial liner inspection facing southeast.

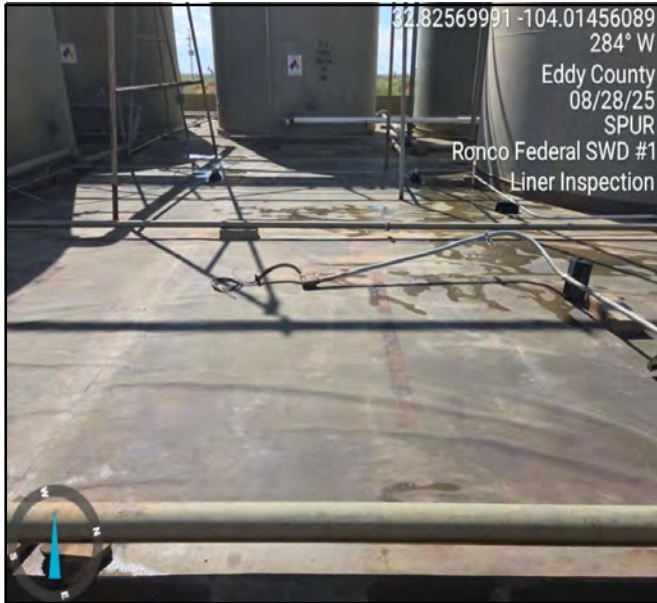
Photo of location taken post power wash facing west.

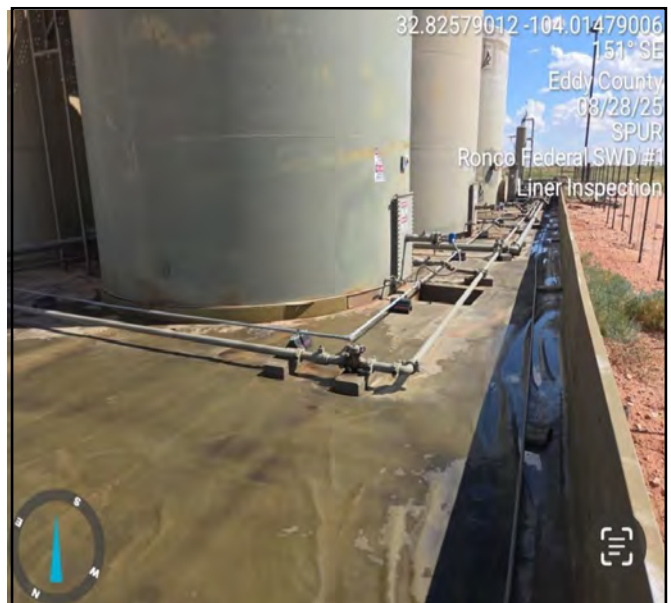
Photo of location taken post power wash facing southeast.

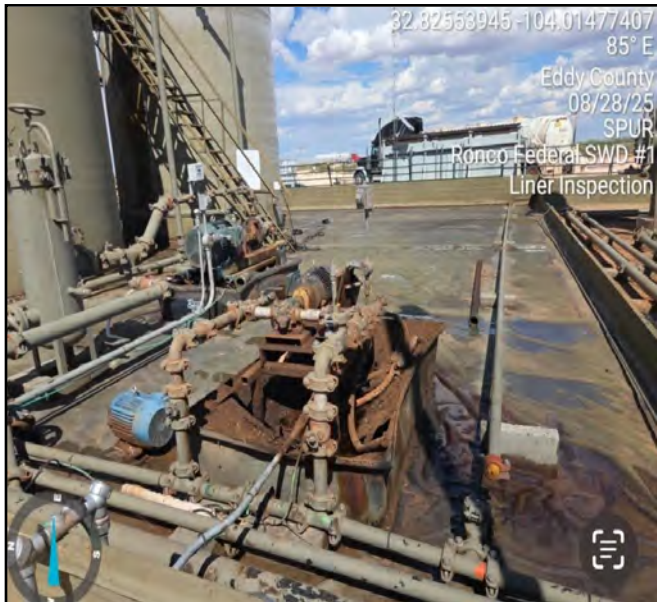
Photo of location taken post power wash facing east.

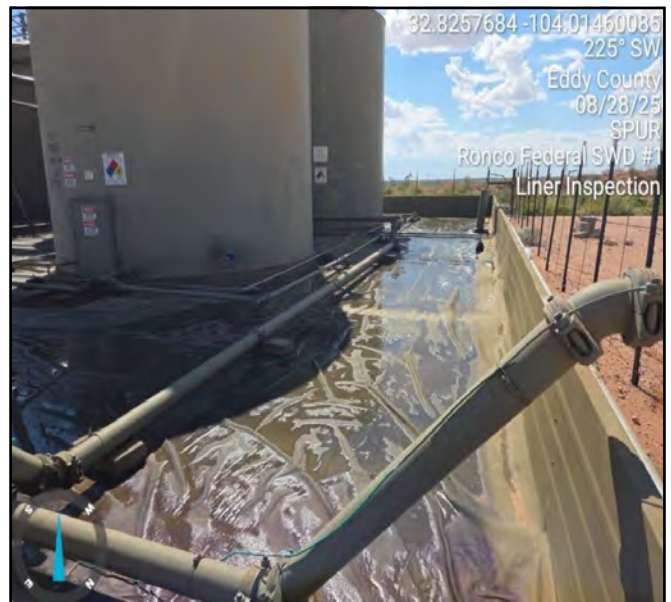
Photo of location taken post power wash facing southwest.

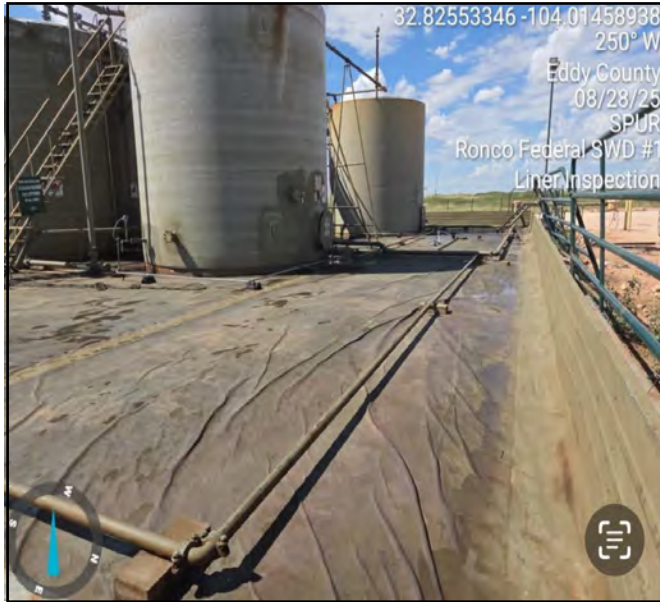
Photo of location taken post power wash facing west.
