## LINER INSPECTION AND CLOSURE REPORT

PREPARED FOR:  
DEVON ENERGY PRODUCTION, LP.

**LOCATION:** Bora Bora 13 CTB 2

**NMOCD REF. NO.** NAPP2520327915

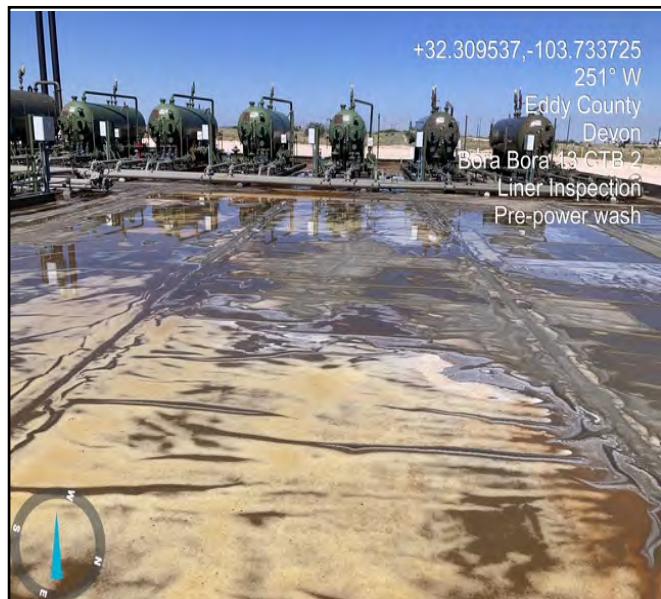
Photo of liner taken during initial liner inspection facing west.

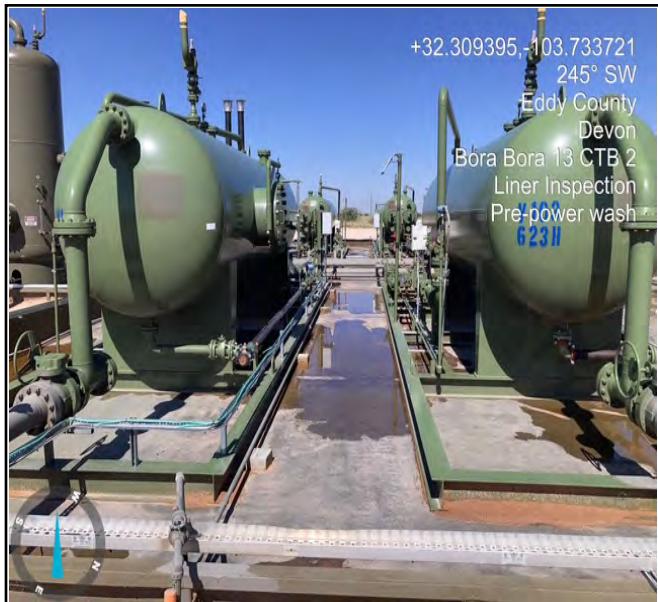
Photo of liner taken during initial liner inspection facing southwest.

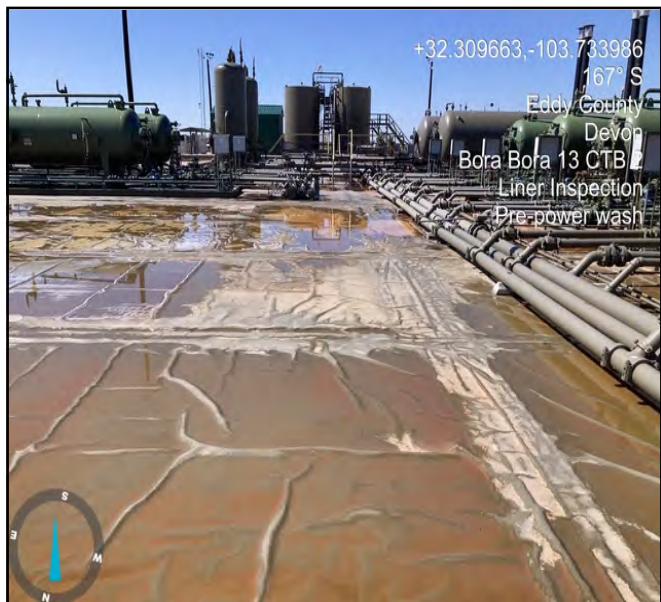
Photo of liner taken during initial liner inspection facing south.

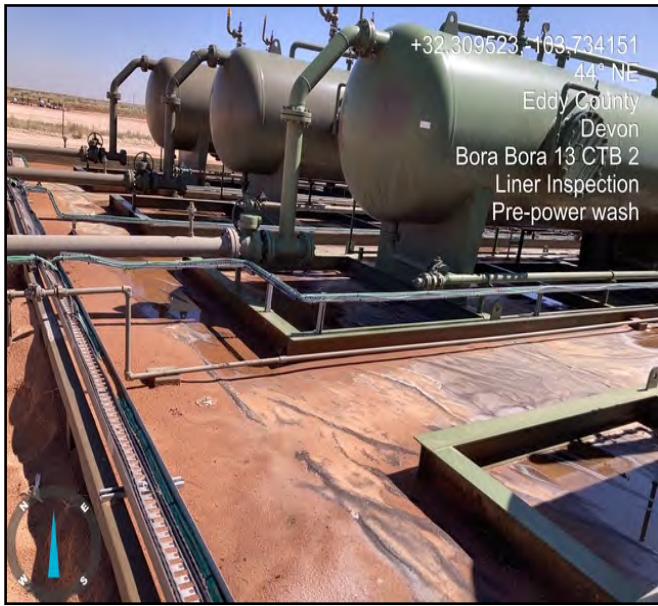
Photo of liner taken during initial liner inspection facing northeast.

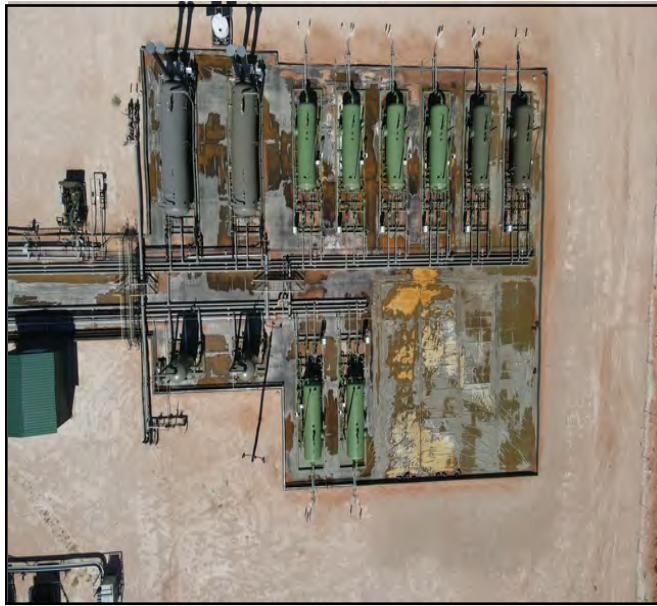
Aerial photo taken during initial liner inspection.

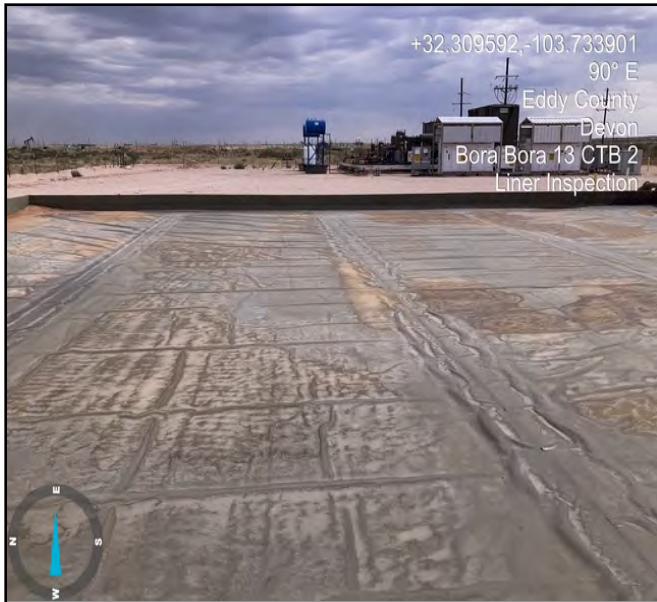
Photo of liner inspection post pressure washing facing east.

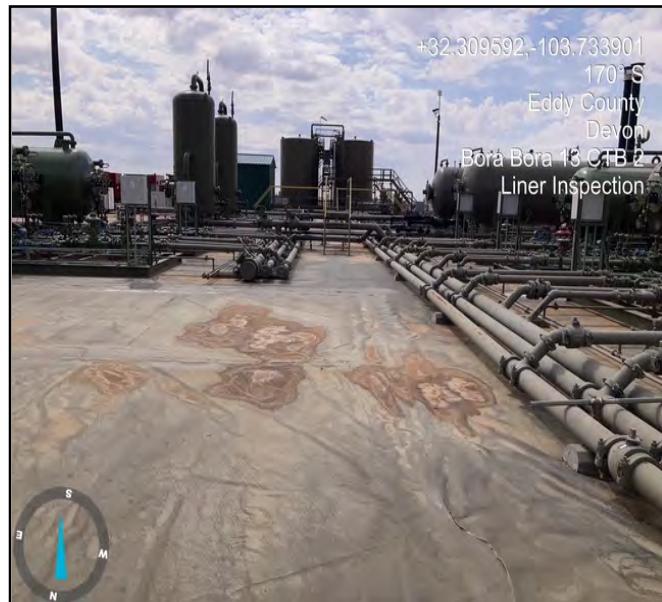
Photo of liner inspection post pressure washing facing south.

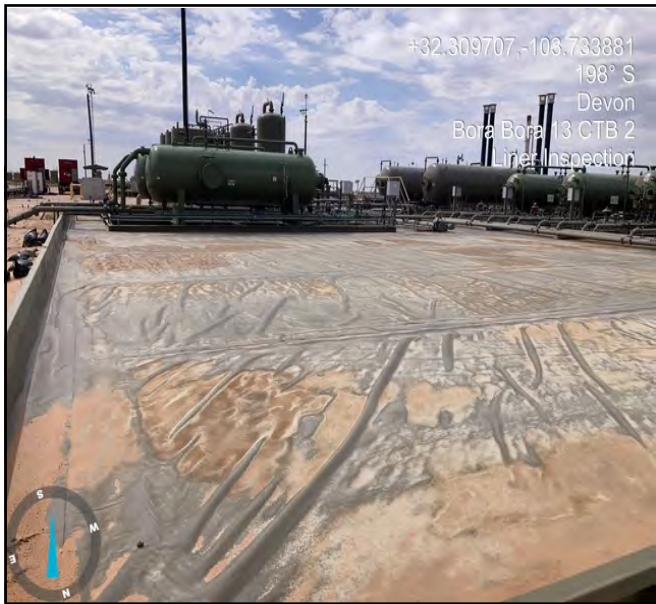
Photo of liner inspection post pressure washing facing west.

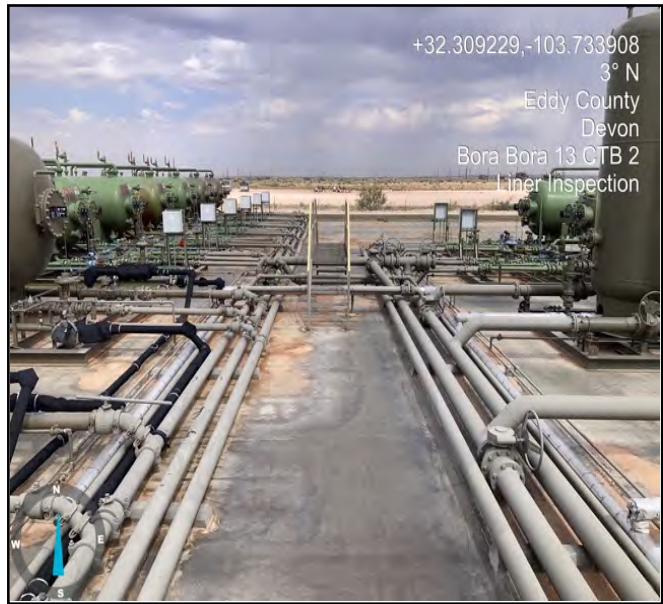
Photo of liner inspection post pressure washing facing north.

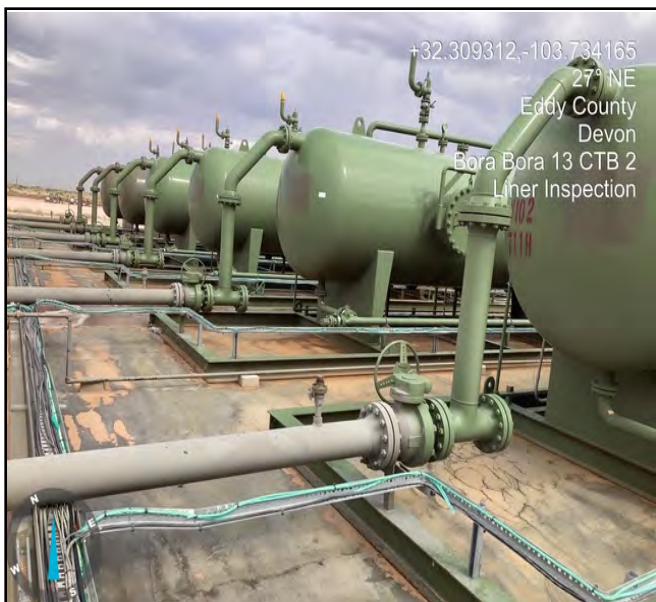
Photo of liner inspection post pressure washing facing northeast.

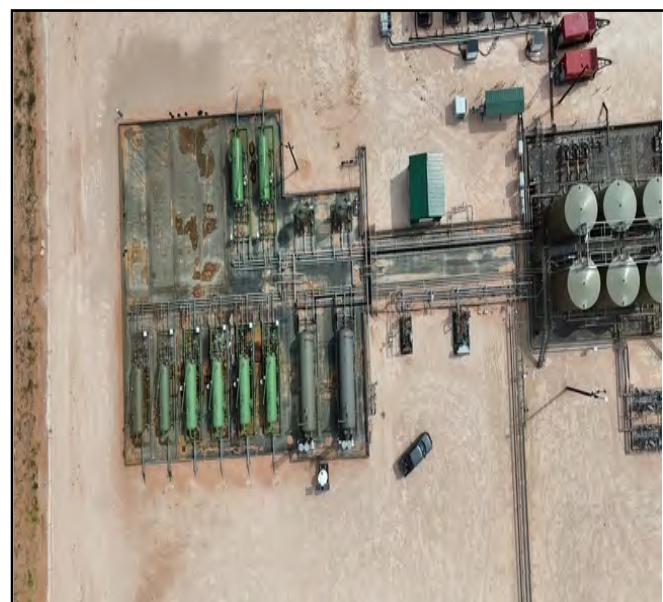
Aerial photo of liner inspection post pressure washing.
